**USIBWC Riparian Habitat Restoration  
MONITORING NOTES AND PHOTOGRAPHS  
SUMMER 2021**

**U.S. Section International Boundary and Water Commission**

**April 20, 2022**

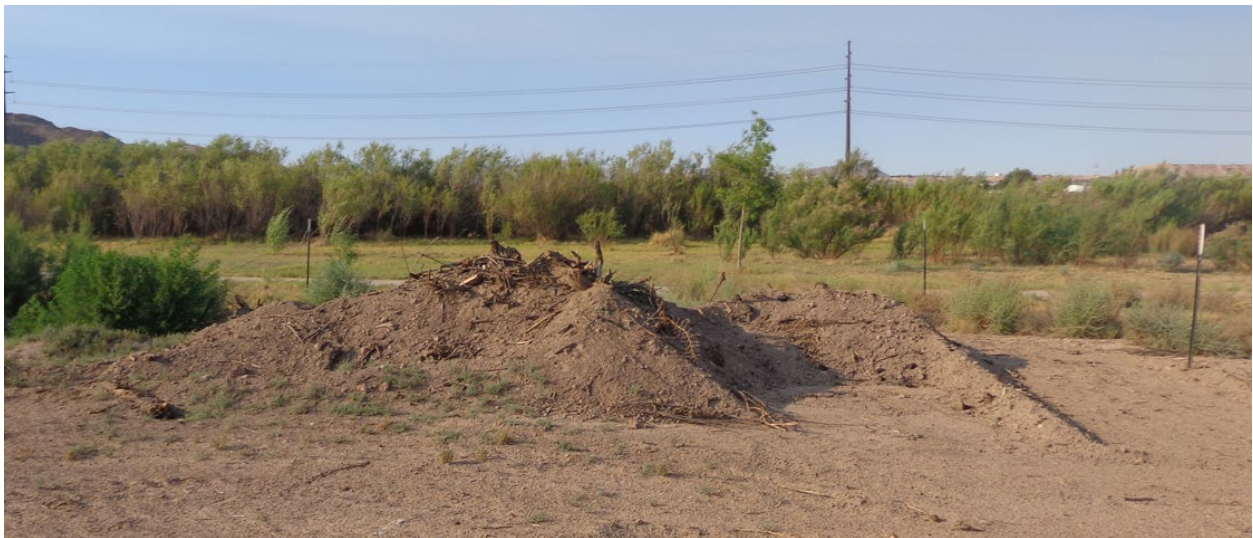
A sediment pile is still remaining.

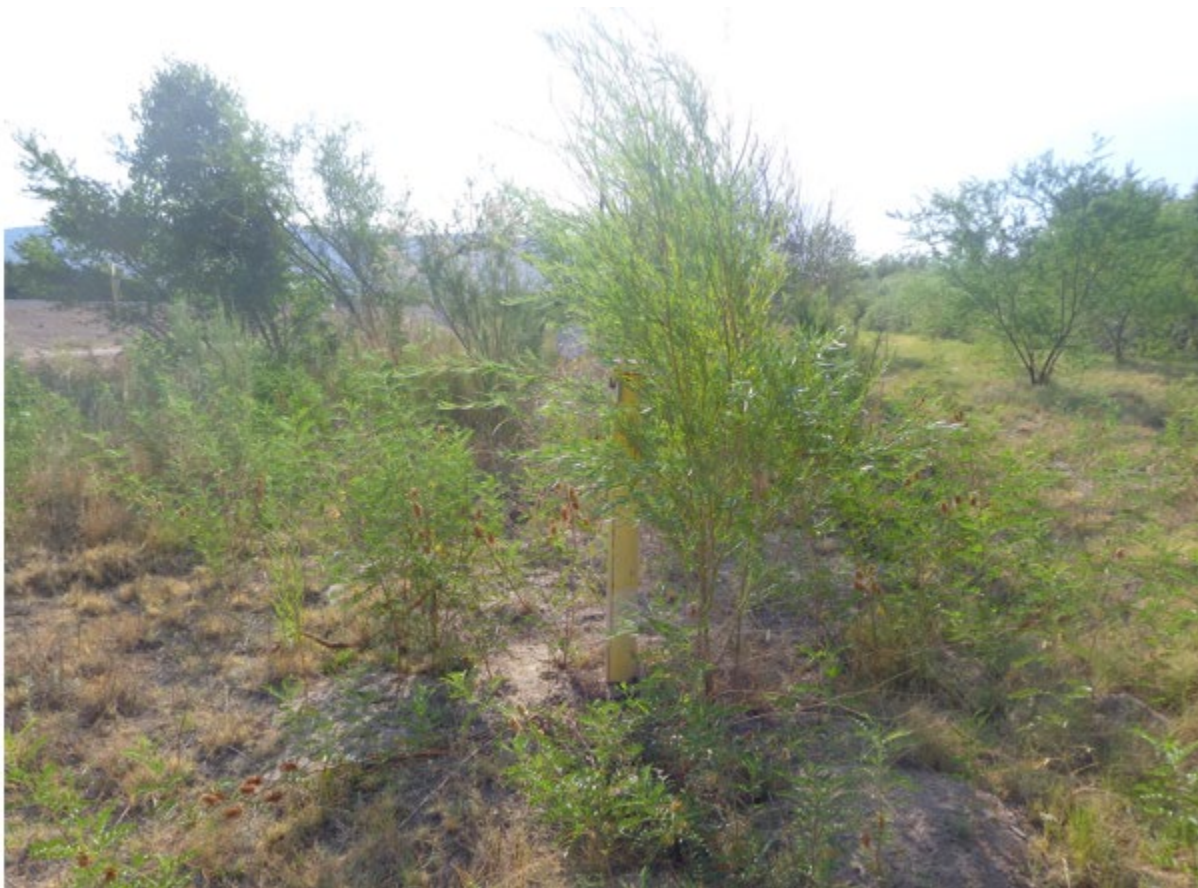
Well 1 surrounded by brush and willows.

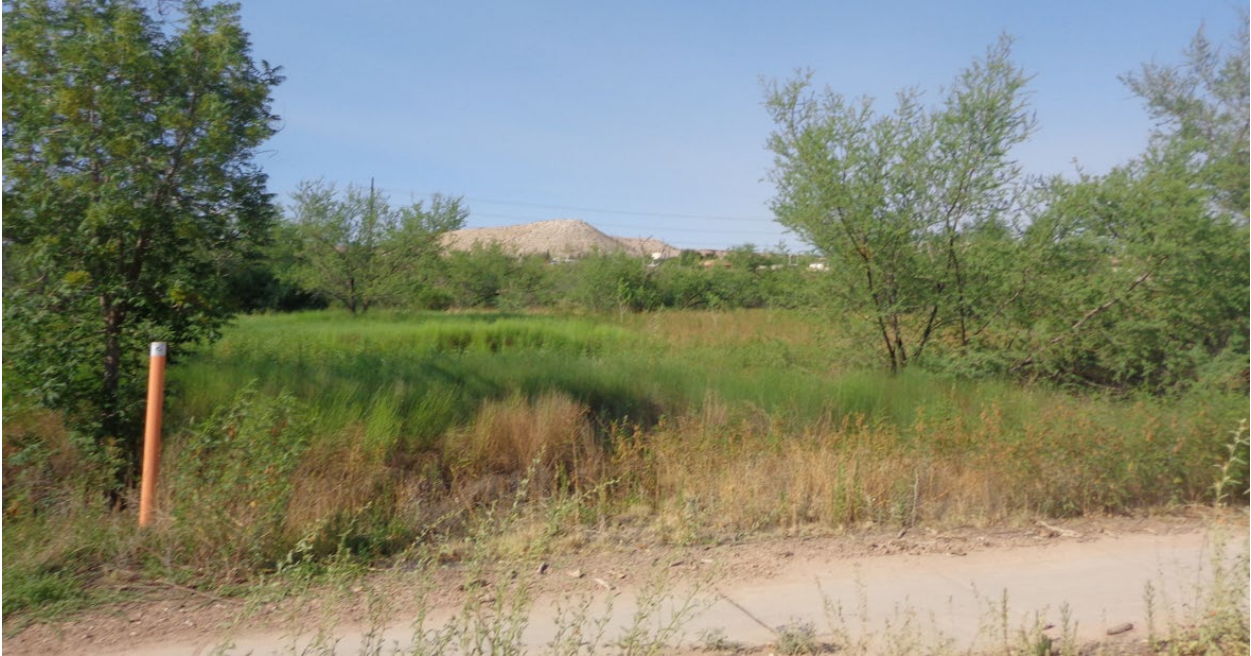
Grasses are green where a contractor requested permission to put water from dewatering activities for construction across the levee in Sunland Park.

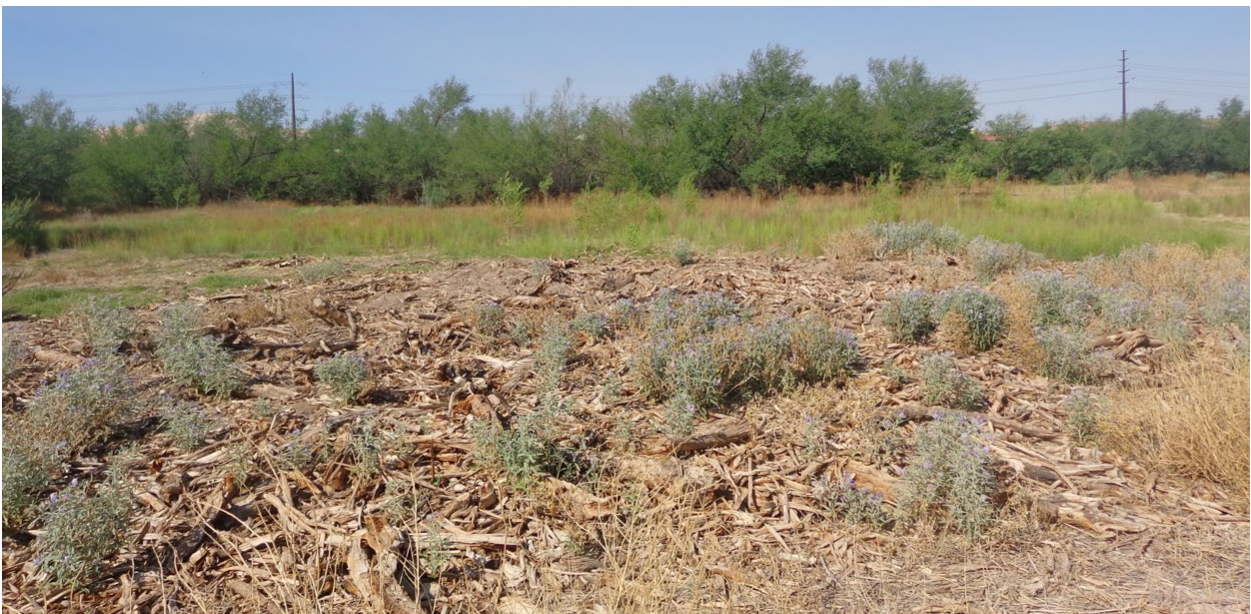
USIBWC crews assisted with mastication of the debris piles but the crews did not spread the mulch throughout the site in order to avoid damage to plantings and native grasses.

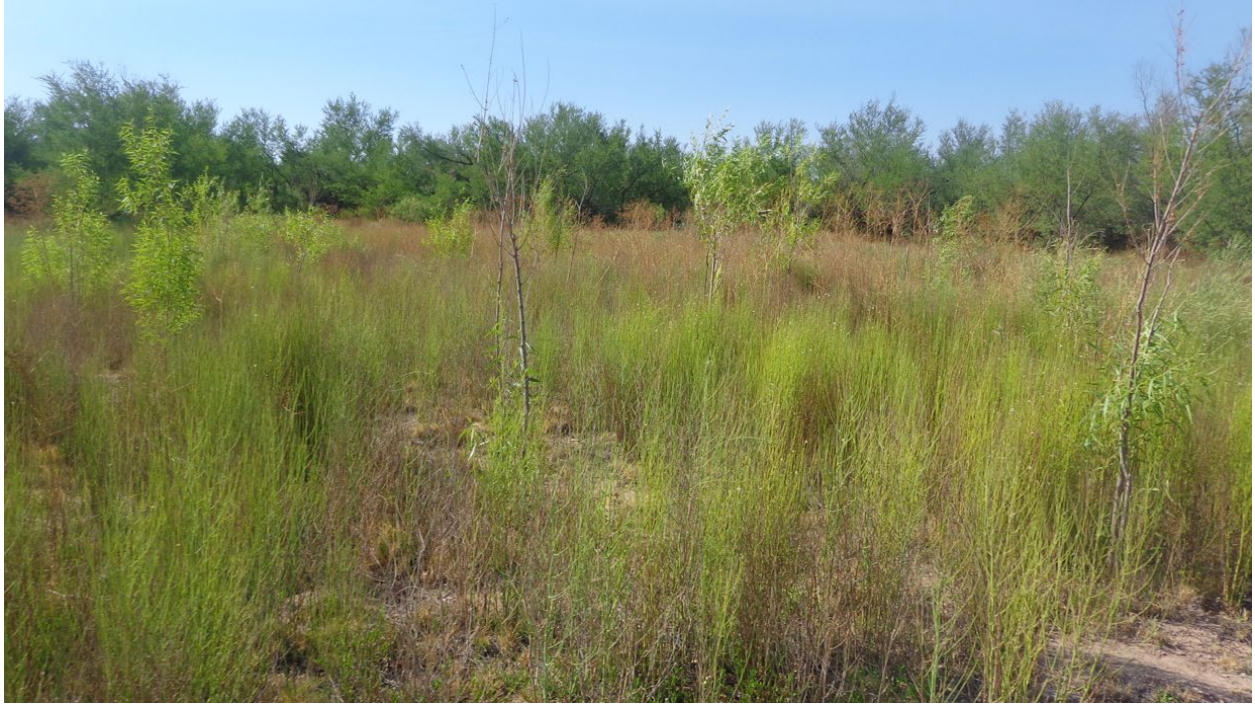
Area of high Gooddings willow survival and a mix of native and exotic shrubs

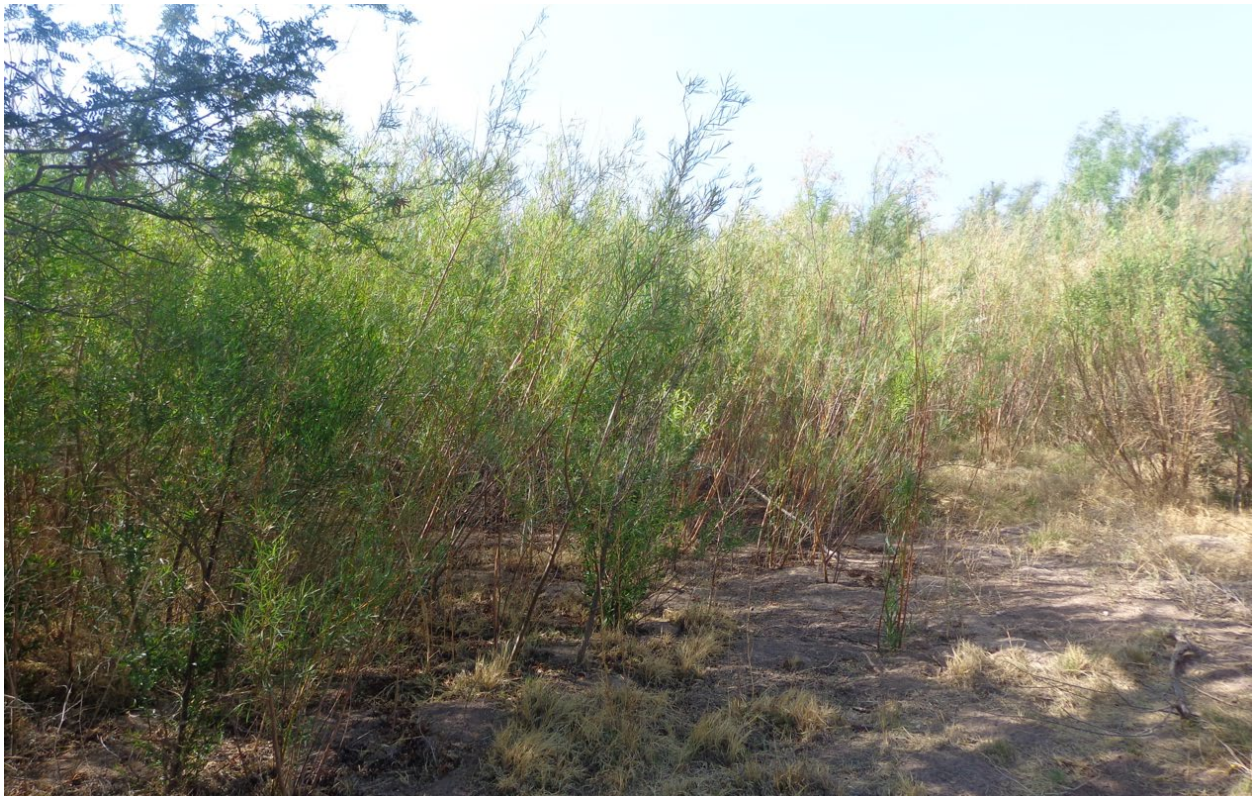
Area of targeted flycatcher habitat near the river, where contractors had planted transplanted island willows in trenches. These willows were transplanted with the rootball, and their survival was near 100%, with density unlike pole plantings.

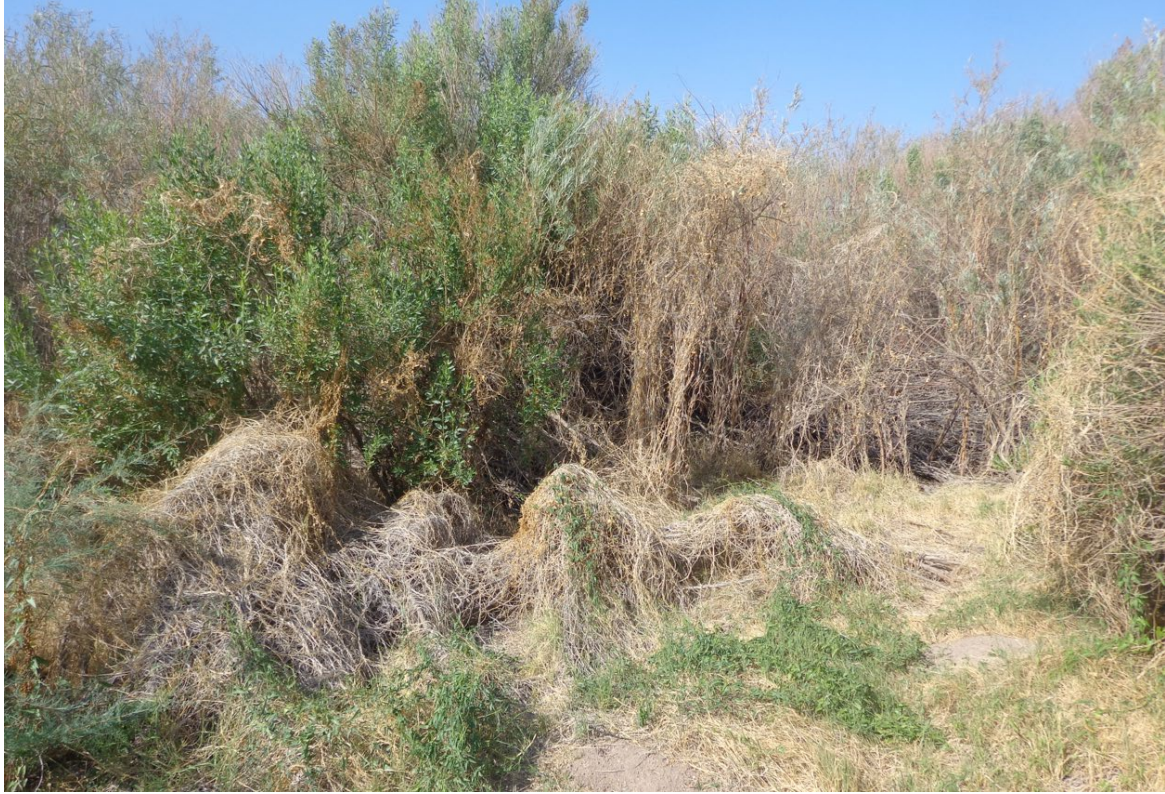
Coyote and Goddings willows covered with funastrum vine at Sunland Park. Many willows appear to be surviving the attack.

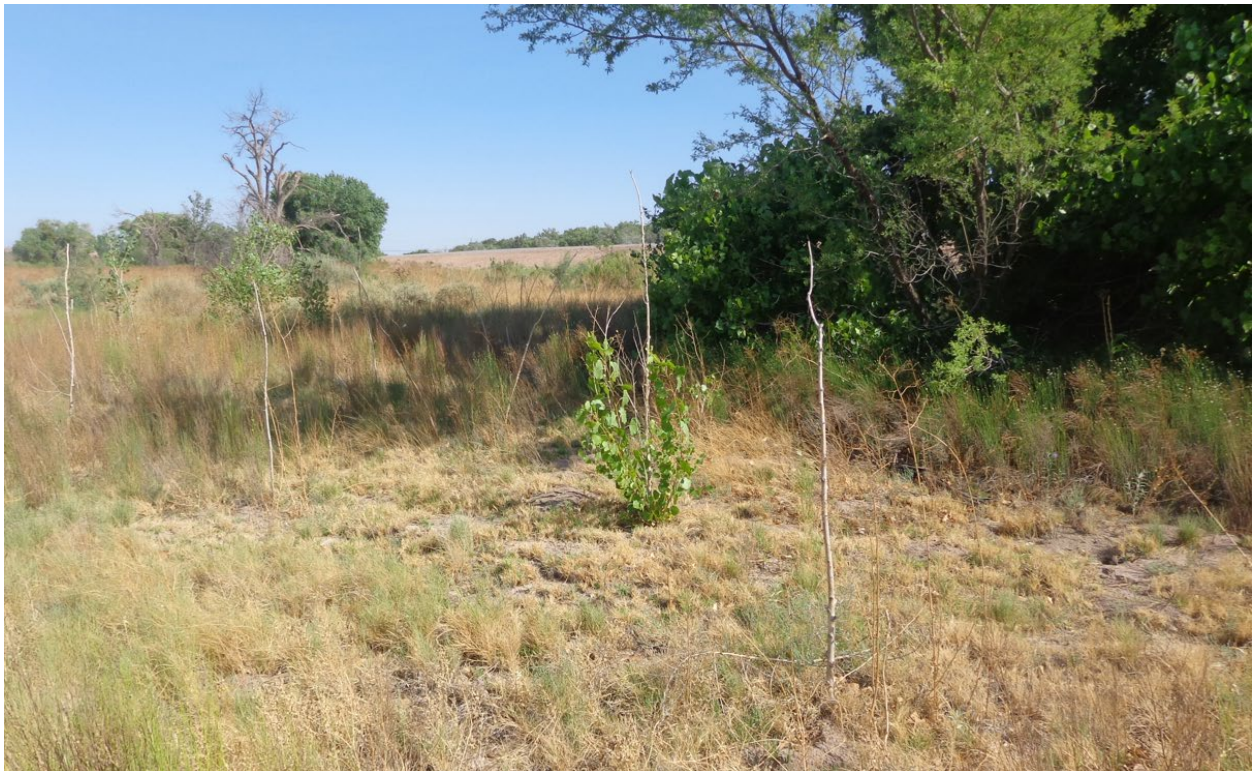
The middle of the site had minimal success with cottonwoods.

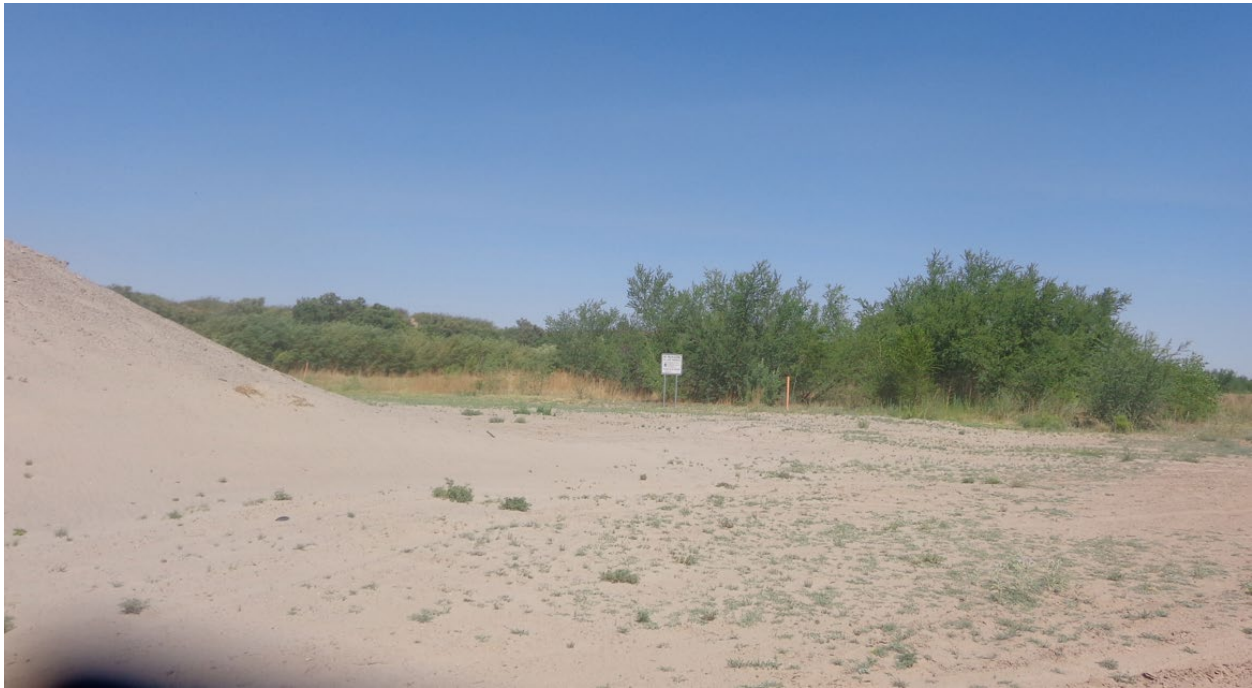
USIBWC's sediment piles immediately south of the site.

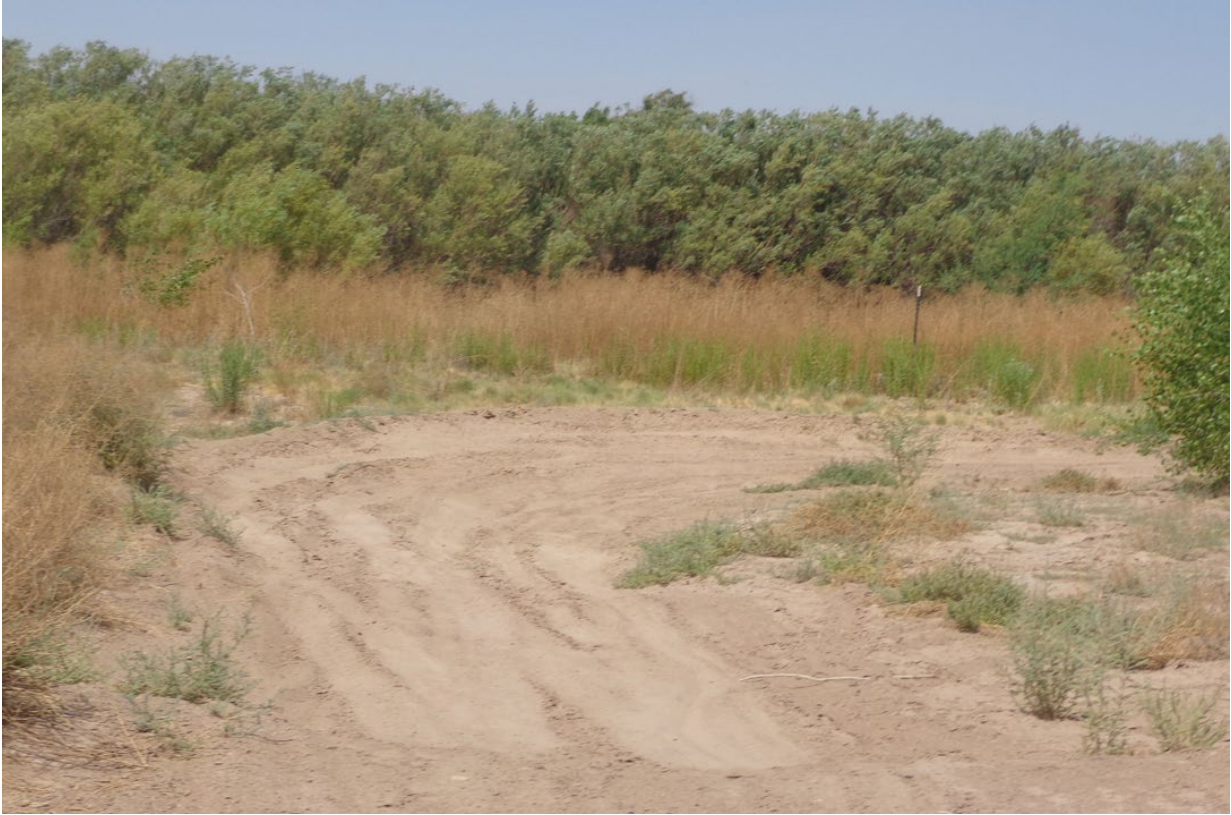
Another constructed swale being used by ATVs

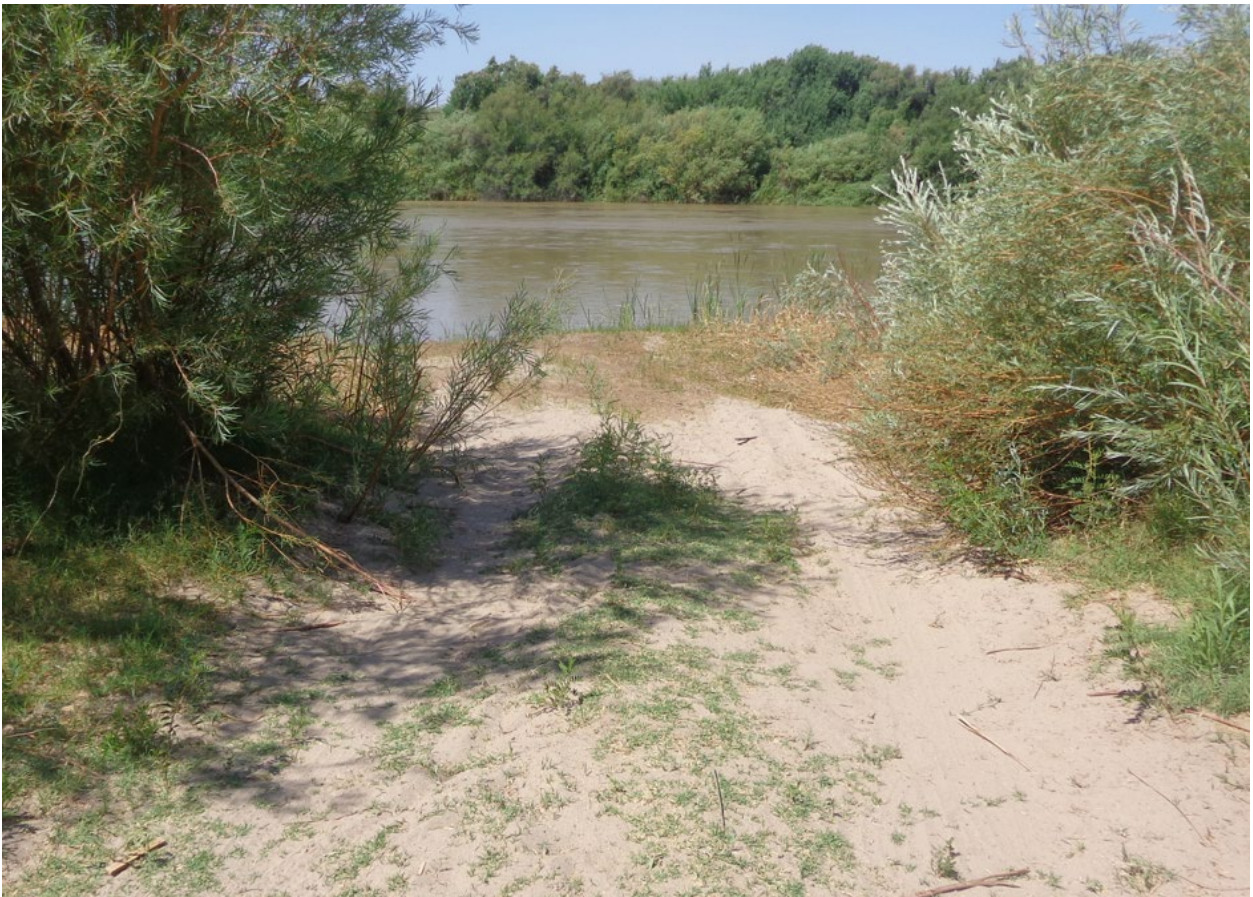
High water bank cut

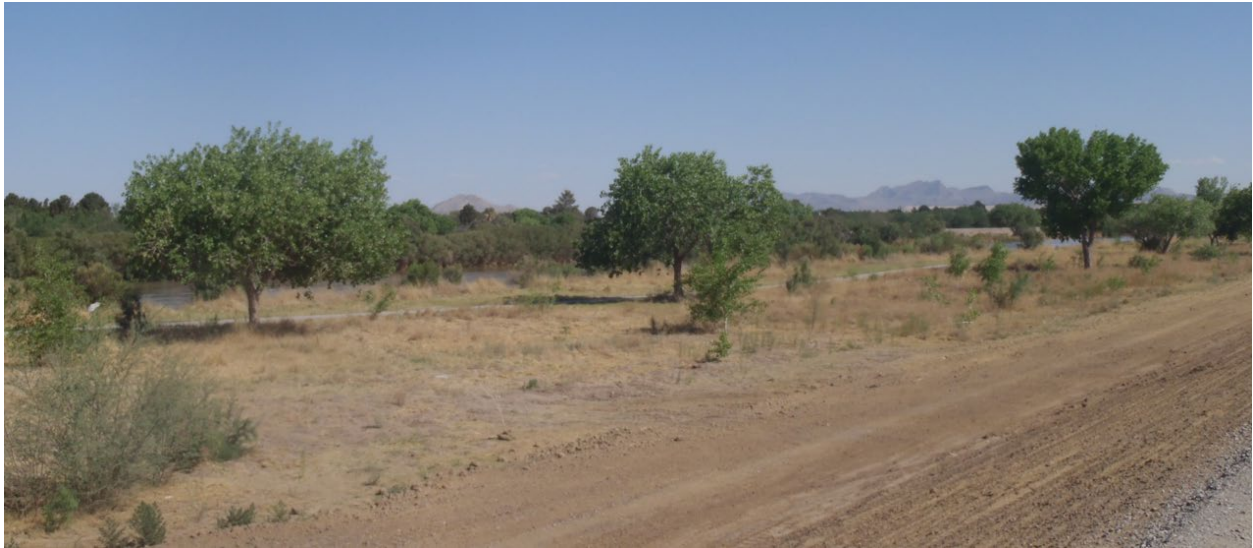
Site of northernmost plot for cottonwood survival estimates, north of well 1, where plantings had only 45% survival.

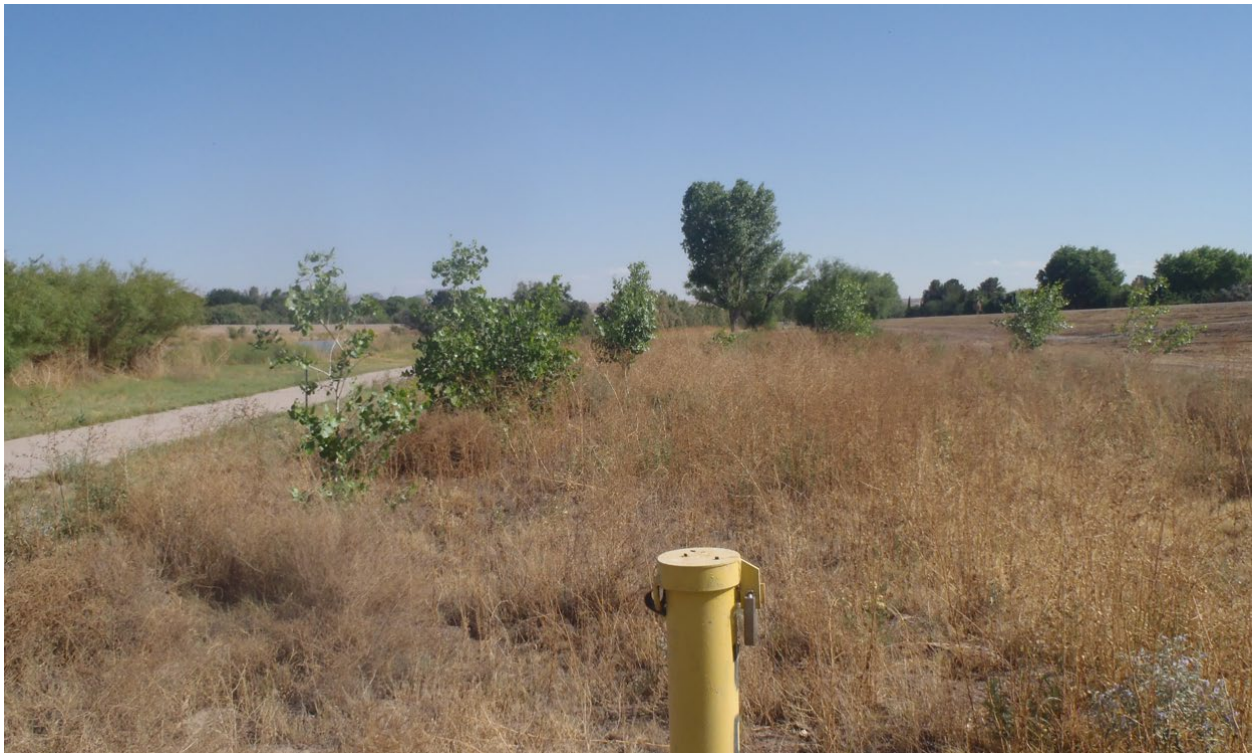
Site just south of well 2, where survival of cottonwoods was greater (70%), as was the vigor of the trees. Future plantings could focus on the southern stretch of the site.

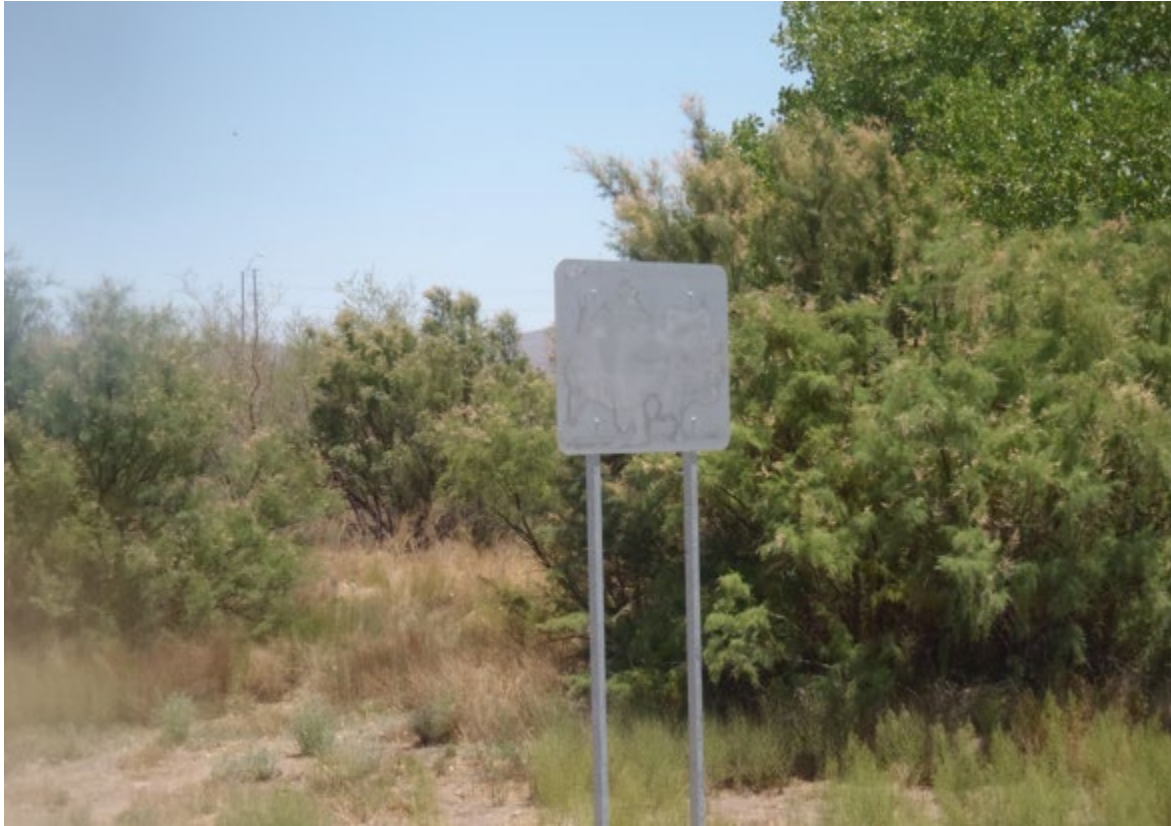
Vandalism of sign near Vinton Bridge. Mature saltcedars in the No Mow Zone immediately south of the site.

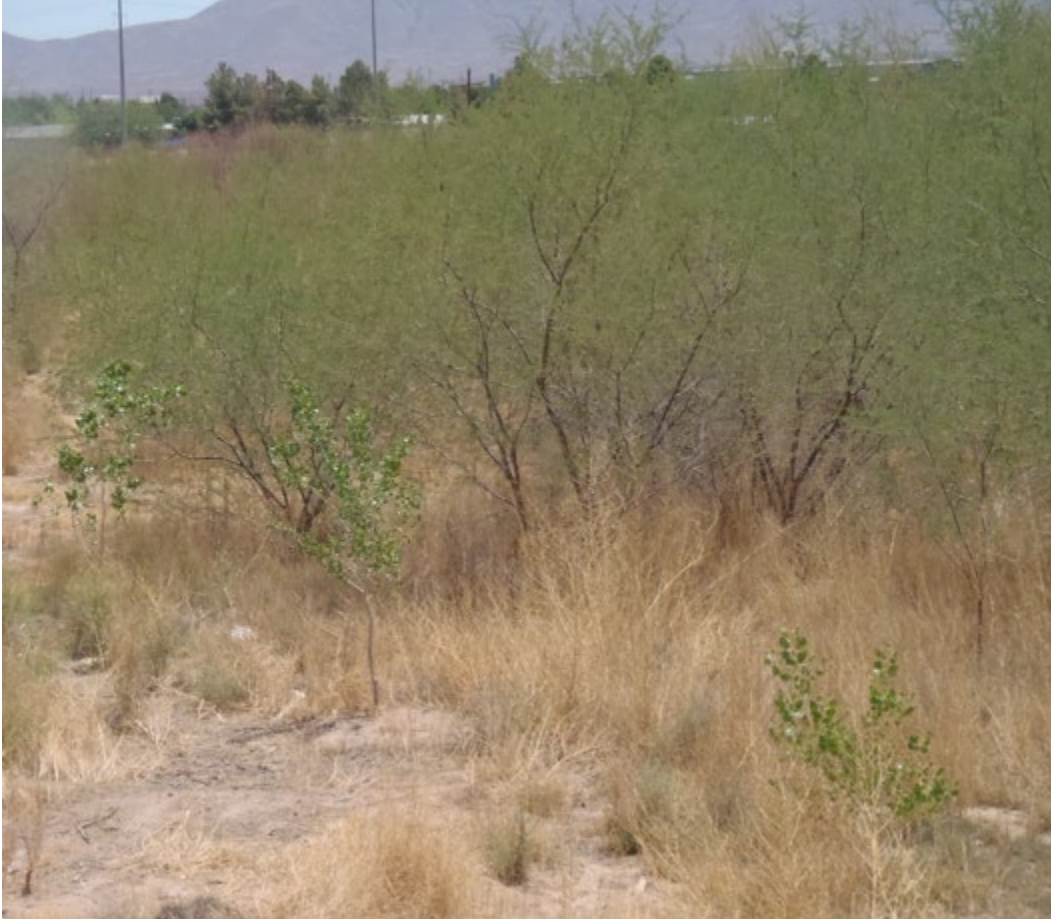
The southern end of the Vinton B site has large dense mesquite stands. Planted cottonwoods in the foreground.

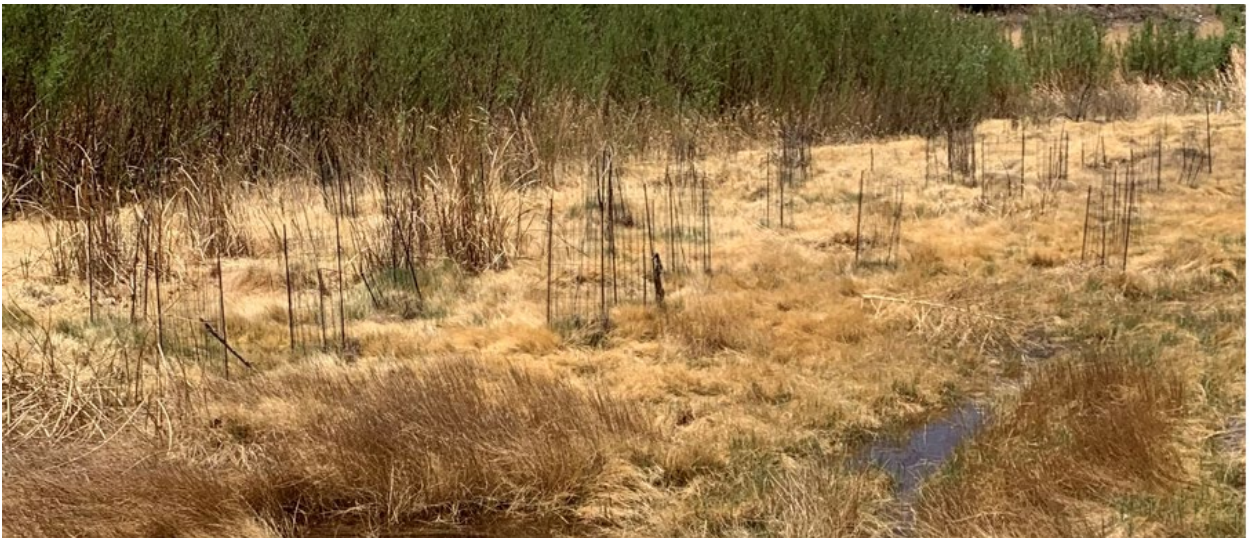
Unsuccessful plantings at the flat portion of the arroyo floodplain just upstream of the confluence with the Rio Grande. USFWS placed cages around each tree to prevent beaver damage. The USIBWC is proposing to excavate an embayment at this area where plantings have been unsuccessful but backwater conditions would create embayments for aquatic habitat.

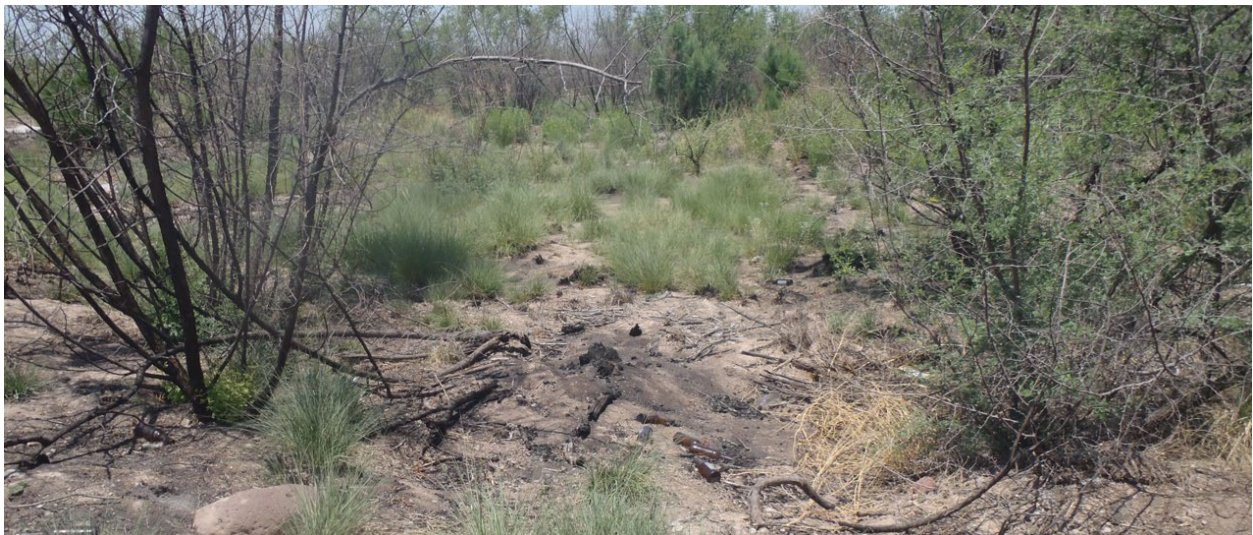
Campfire with trash that led to a burn at this site, killing shrubs, planted trees, and mesquite.

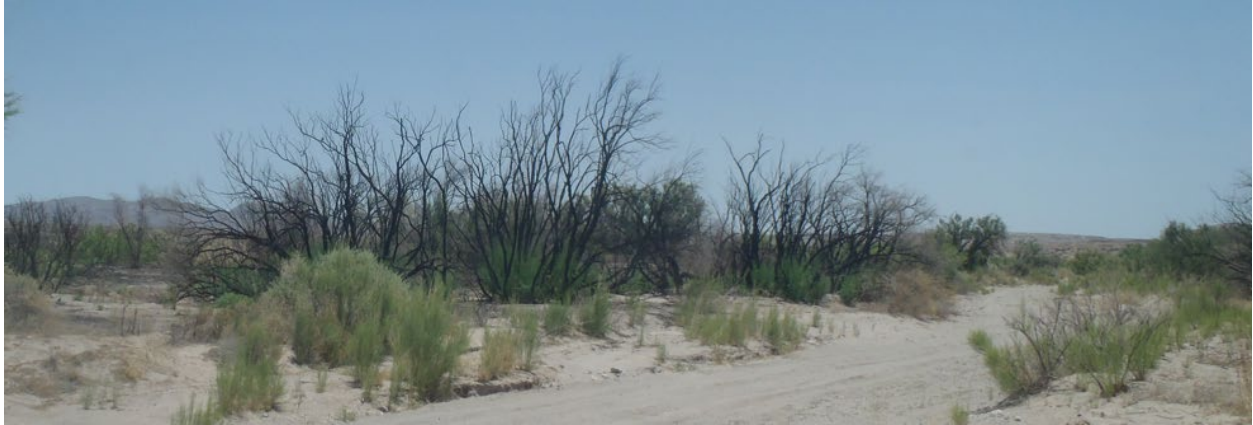
Burned mesquite trees in the No Mow Zone north of Rincon Siphon D.

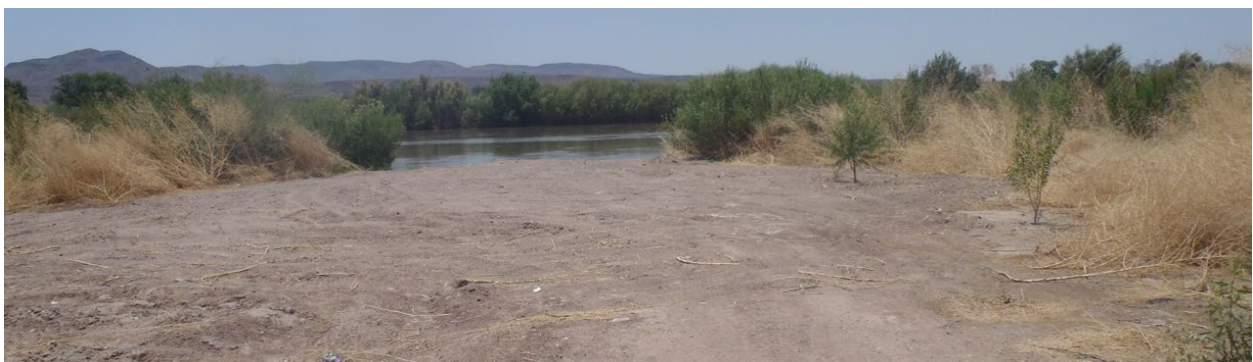
Path created right through the site by USIBWC contracted crews to haul sediment out of the river in 2020. In June 2021, USIBWC and USFWS discussed the possibility of keeping this path to have a designated place for equipment and avoid future damage to plantings.

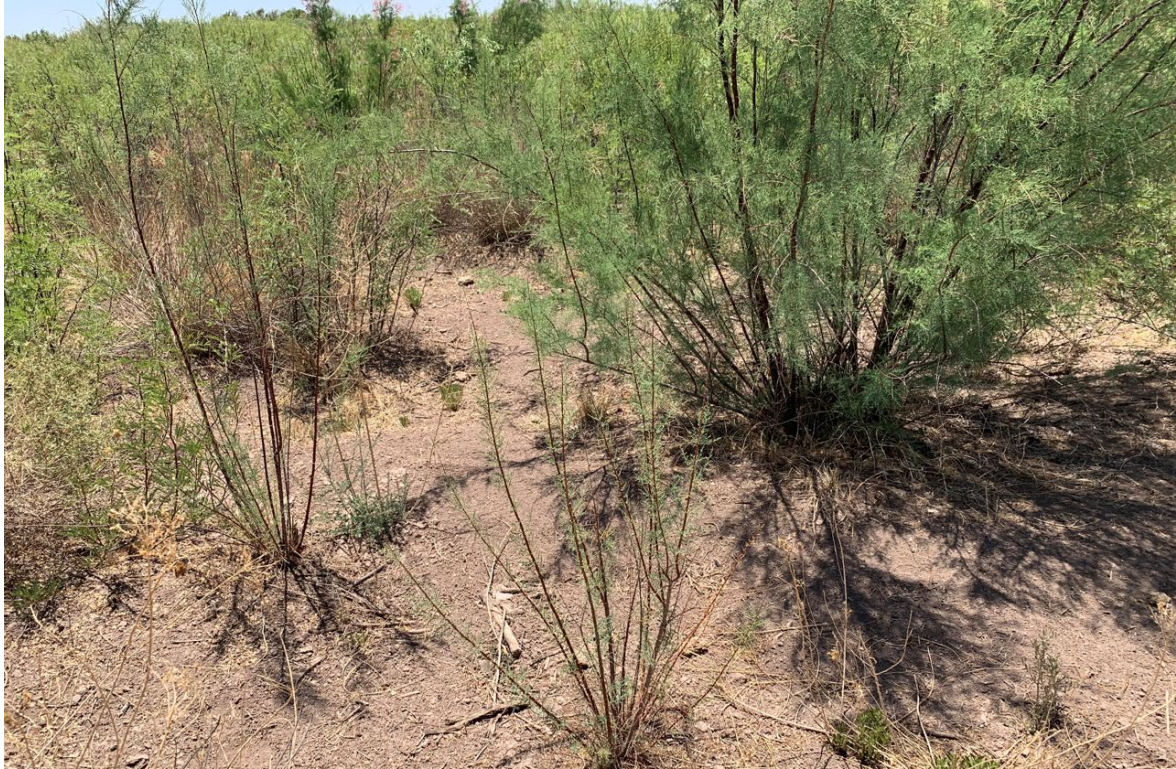
Saltcedar returning amongst the mesquites.

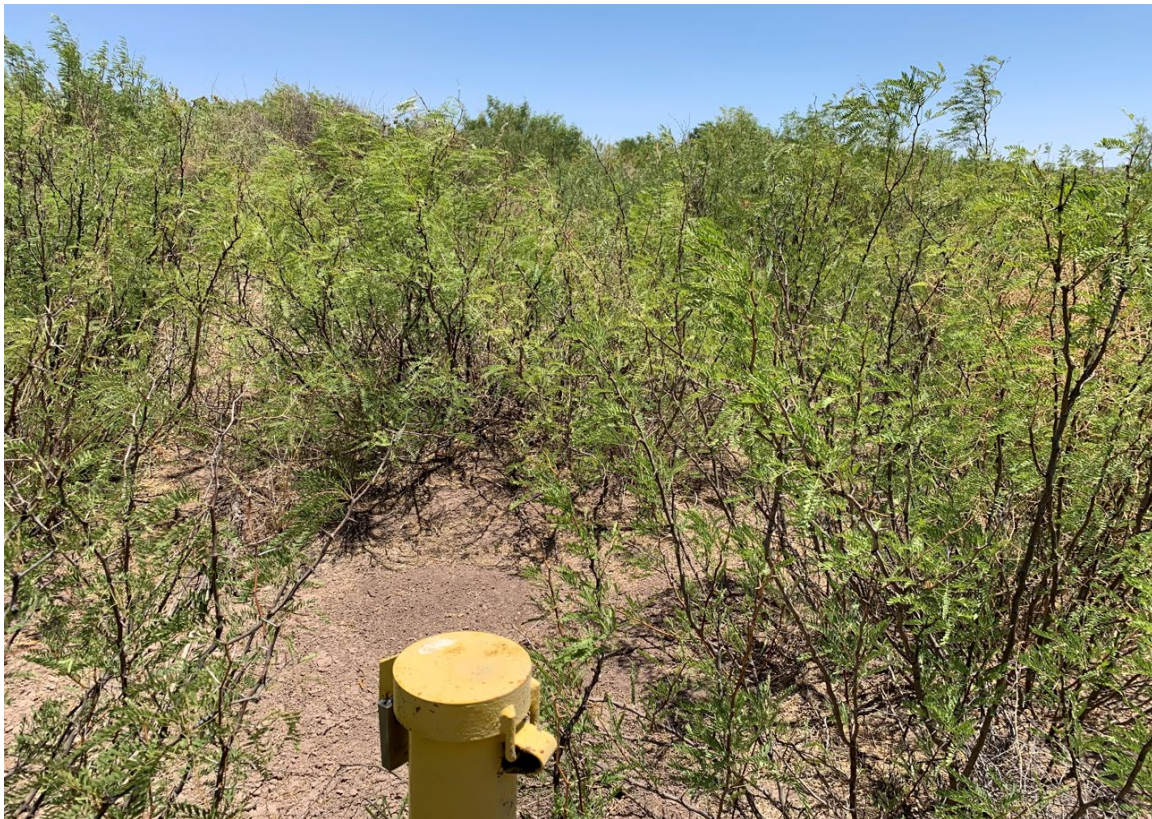
Well 3 is nearly lost in a thicket of mesquite bushes.

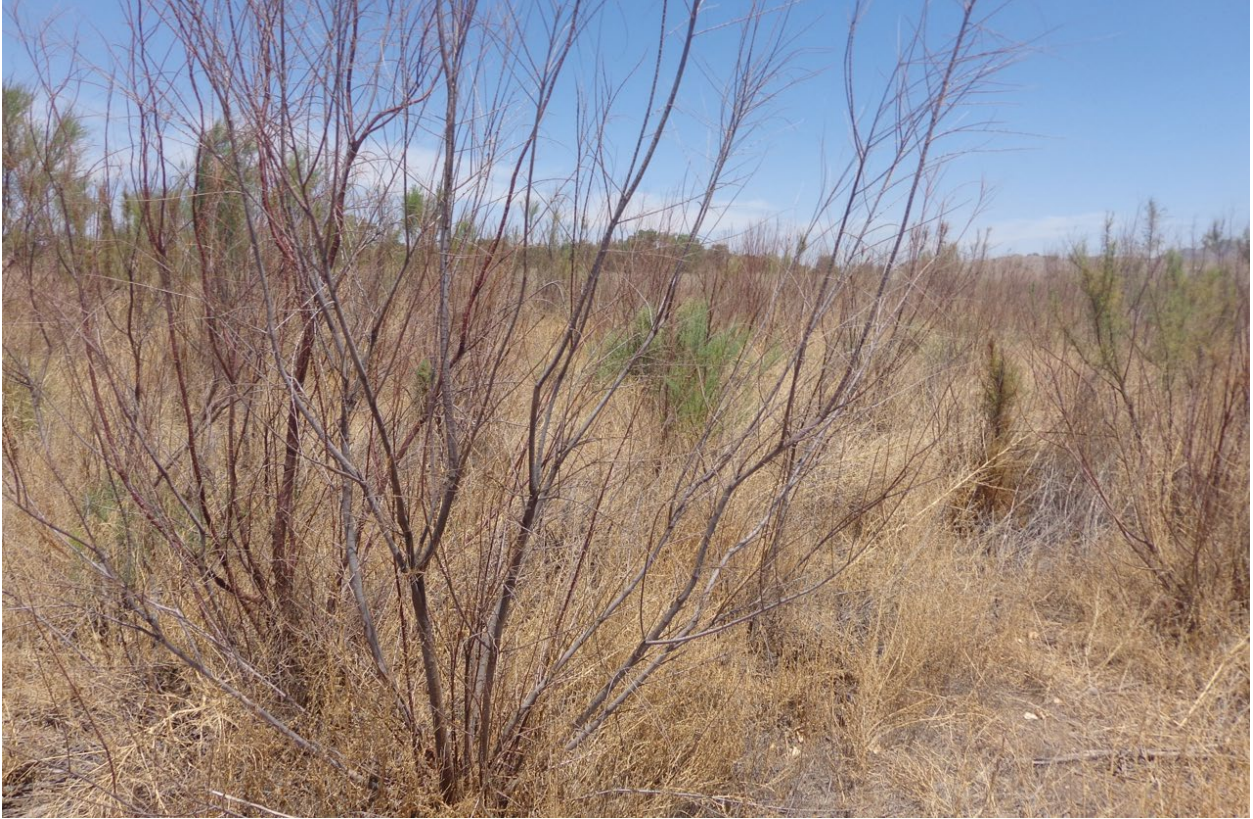
Saltcedar at the northern middle portion of the site.
