Riparian Habitat Restoration at Three Sites in New Mexico and Texas: Country Club East, Sunland Park, and Anapra Bridge Restoration Sites

Final Interim Annual Restoration Report

October 2017 to October 2018

IDEALS-AGEISS, LLC

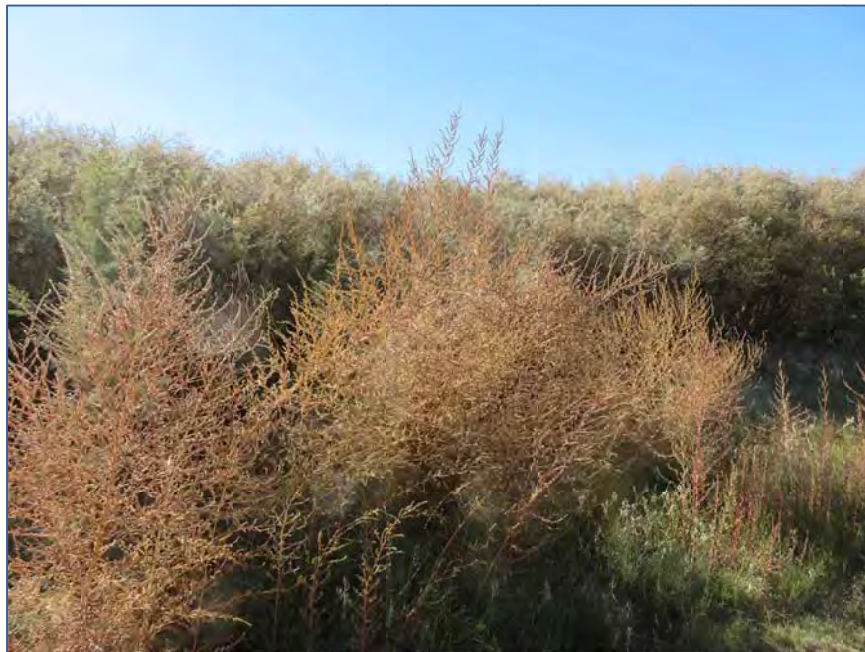
**Kochia found mixed with the transplanted coyote willows at
Country Club East, 18 October 2018**

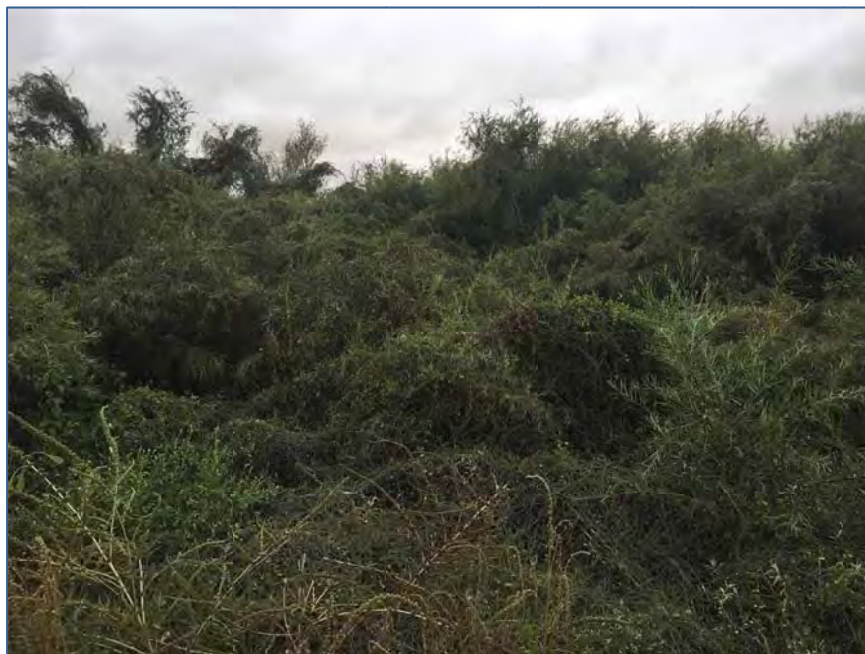
and coyote willows dominated the canopy layer. The willows planted for the flycatcher habitat were developing well during the August 2018 monitoring (Appendix B). In October, the non-native species Bermuda grass dominated the site, although several other forb species were present during the site monitoring (Appendix A). During the October monitoring, IDEALS-AGEISS biologists noted that funastrum (*Funastrum cynanchoides*), a twining milkweed species, established within the transplanted coyote willows and Goodding's willows area; the area recently exposed for the salt-cedar removal. At times, only individual trees were entwined by the vine, but in some areas the vine developed into a large mat which overgrew the naturally occurring coyote willows on the bank and engulfed the planted willows.

**Funastrum mat that has covered the coyote and Goodding's willows
along the banks at Sunland Park, 17 October 2018**

the missing 473 Goodding’s willows, IDEALS-AGEISS recommends replacing 80 additional Goodding’s willows based on documented October mortality rate of 17 percent (17 percent of 473). We believe that the willows under the funastrum are likely still viable, and that trees were missed in the flycatcher area because they were tucked away in existing vegetation and blended in with the transplants. The 145 additional coyote willows are a supplement to the flycatcher habitat and the potential loss of the Goodding’s willows. IDEALS-AGEISS recommends the Sunland Park replacement of the 188 cottonwoods be composed of half cottonwoods (94) and half Goodding’s willows (94) to further augment the flycatcher habitat.

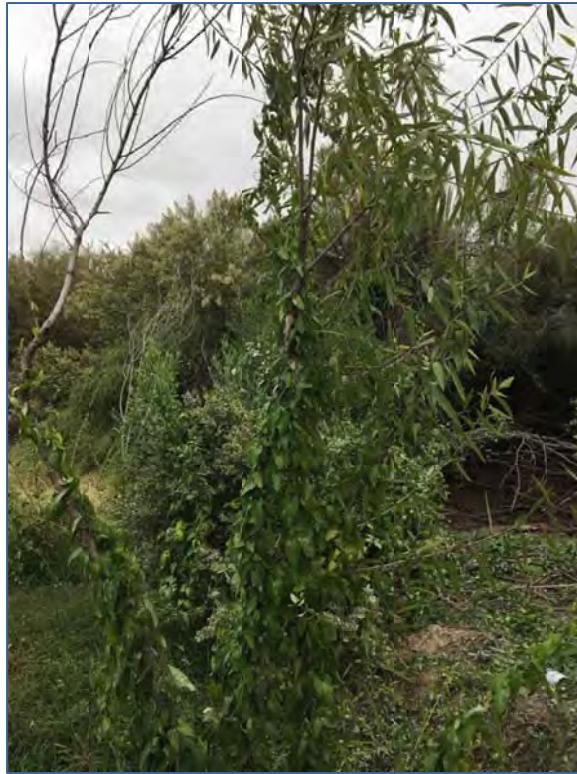
Example of a Goodding's willow covered with funastrum at Sunland Park, 17 October 2018

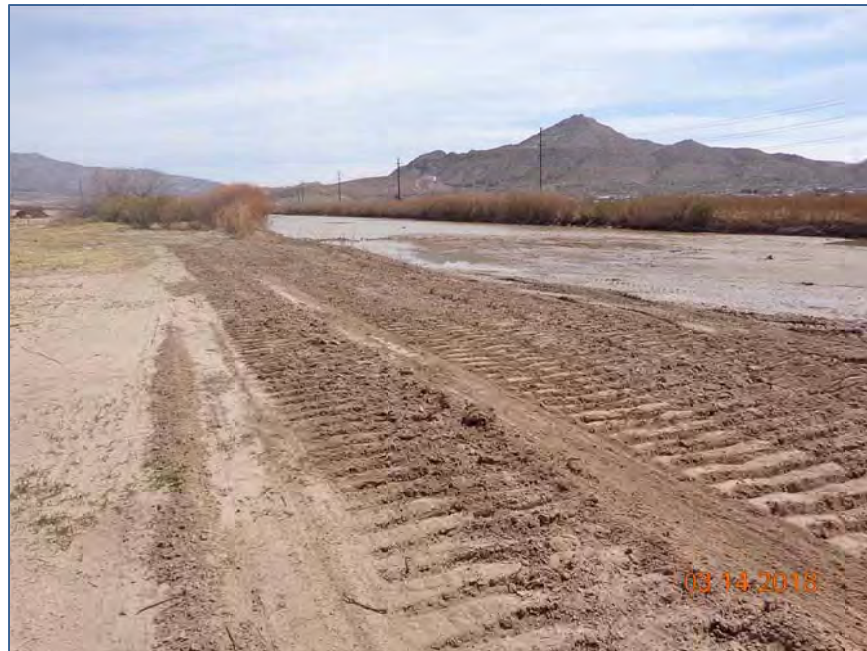
In March 2018, the USIBWC maintenance crew mowed the transplanted coyote willows at the Sunland Park Bridge at the Anapra site. Approximately 385 trees were mowed. USIBWC is revising the No Mow Zones accordingly to include the east bank of the Sunland Park Bridge as a No Mow Zone. USIBWC's River Management Plan notes that 300 feet upstream and downstream of bridges are mowed; however, USIBWC has noted the Sunland Park Bridge east bank as an exception and will be mowed only 100 feet upstream and downstream of the bridge at the Anapra site. In October 2018, the north side of the bridge appeared to have been mowed again and at the south side of the bridge some willows were re-sprouting. Heavy salt patches were documented in several areas on the site during the October monitoring.

Coyote willows mowed at the Sunland Bridge on the Anapra restoration site, 14 March 2018

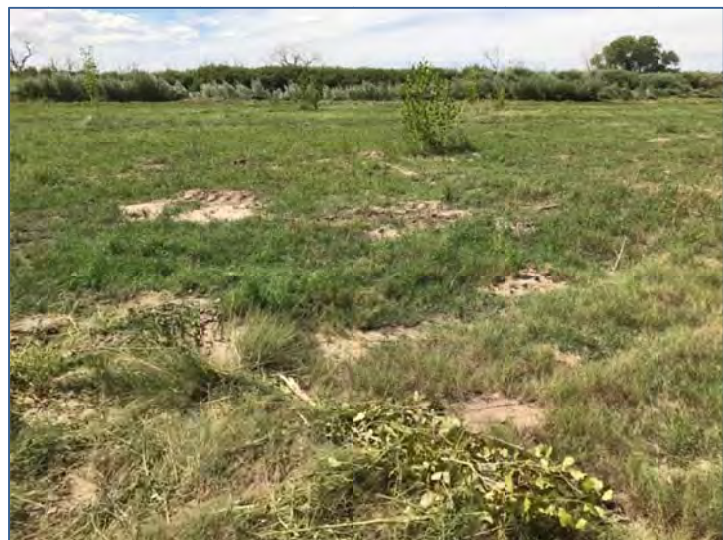
Example of cottonwood damage at Country Club East, August 2018

Cottonwood vigor varied across the site where cottonwoods within the swales and areas towards the river contained healthier trees than those cottonwoods closer to the levee toe road that were often impacted by recreationists. Shafroth, Auble, and Scott (1995) noted that cottonwood establishment success drops off if groundwater levels drop below 1 meter (3.3 feet) in the first year. The swales constructed through the site, with the fine sandy loam that poorly drains, provided sources of water retention for the cottonwoods and promoted increase survival. The transplanted coyote willows at the river bank are becoming indistinguishable from the already present native vegetation and will continue to develop into thick riparian habitat adjacent to the closed canopy habitat developed under the planting regime. Habitat will continue to improve along this site for flycatchers as the coyote willows fill in and the densely planted cottonwoods create the closed canopy habitat. IDEALS-AGEISS recommends that any cottonwoods that are planted to increase survival should be planted in the swales and towards the river edge and not at the ends of the site at the levee toe road. Strategically placing the cottonwoods in these areas may reduce the impacts from recreational and maintenance damage.

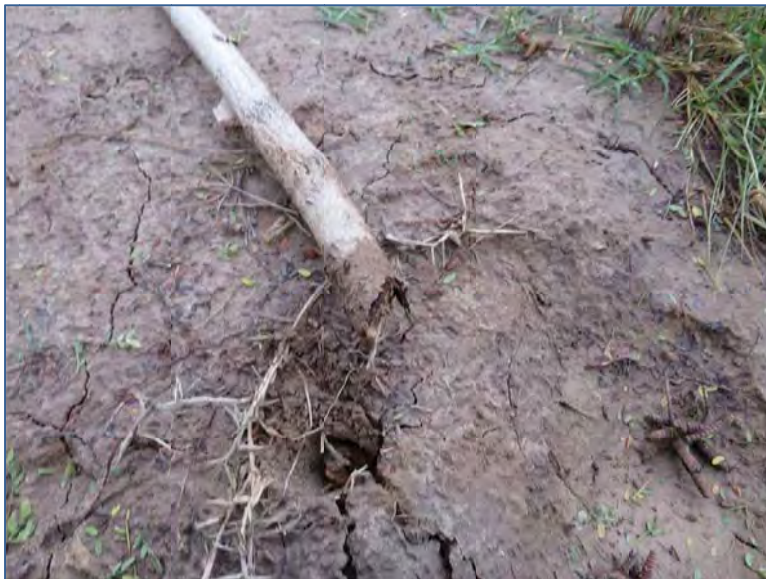
It was noted especially at the Anapra Bridge and Sunland Park restoration sites that some cottonwood poles rotted at the base of the pole. When the snap test was applied to these trees, the pole broke at ground level and the stem and the root system appeared to be rotted. These sites were not inundated with water to create prolonged exposure of submerged poles.

**Example of cottonwood that rotted at the base at
Anapra Bridge, 17 October 2018**

To improve survivorship of the cottonwoods at Anapra Bridge, 43 cottonwoods would need to be replanted (Table 3-7). IDEALS-AGEISS recommends considering other species, such as four-winged saltbush or mesquite, to replace the cottonwoods (see Section 4.3).

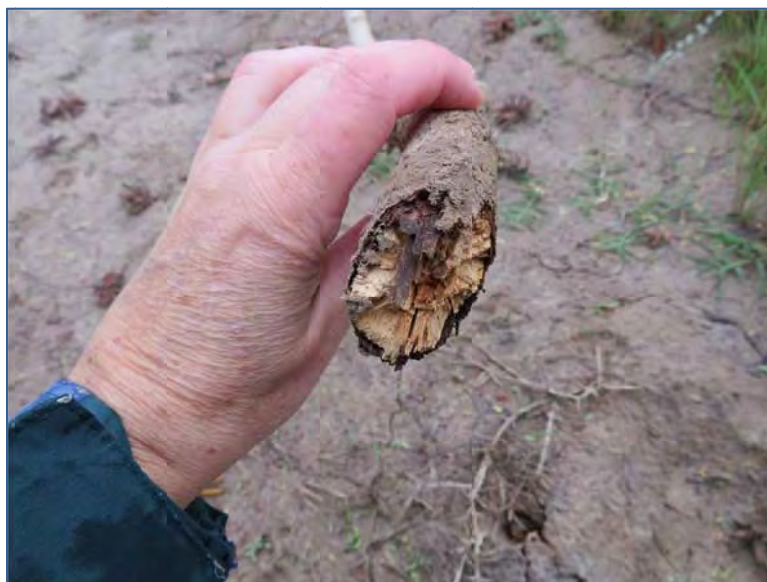
Base of rotted cottonwood at Anapra Bridge, 17 October 2018
