# **APPENDIX A**

## Well Monitoring Data

## Planting and Monitoring Datasheets

THURMAN MITIGATION (IBWC CONTRACT NO. IBM15D0006) – SITE II

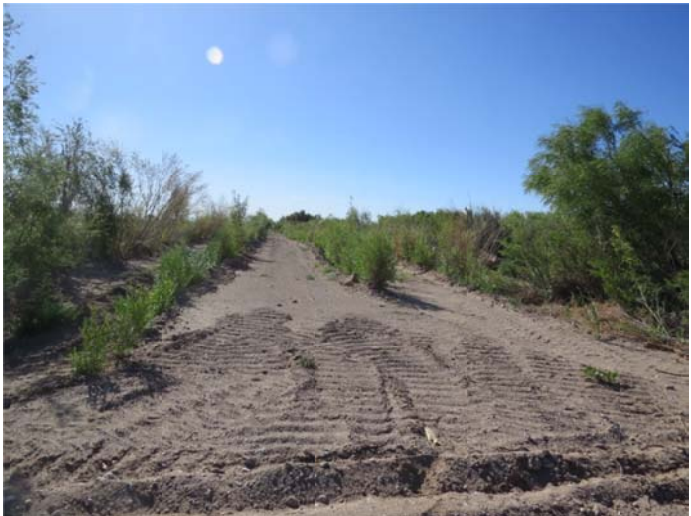
1. Number: Thurman I_02_05212019

2. Date: 21 May 2019	
3. Compass direction taken: Degrees: 280° Cardinal/intercardinal: West	
4. Coordinates (decimal degrees): Latitude: 32.682914 Longitude: -107.176401	
5. Photographer name: Charles Britt	
Description: Coyote willow transplants downstream of Thurman I site

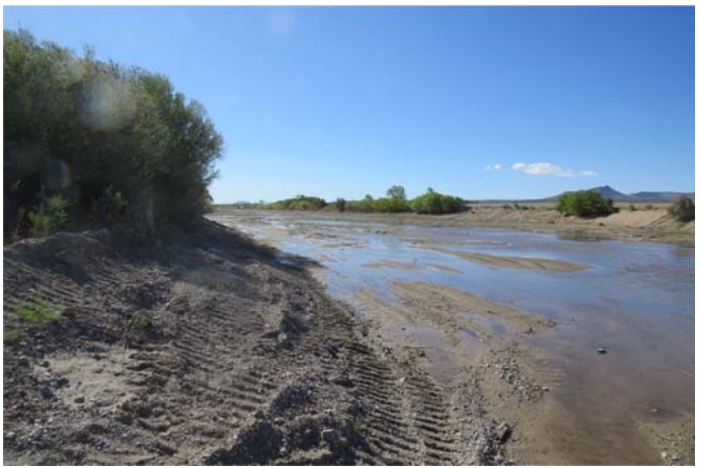
1. Number: Thurman I_05_05212019

2. Date: 21 May 2019	
3. Compass direction taken: Degrees: 120° Cardinal/intercardinal: East-southeast	
4. Coordinates (decimal degrees): Latitude: 32.682726 Longitude: -107.176812	
5. Photographer name: Charles Britt	
Description: Island removal downstream at Thurman I

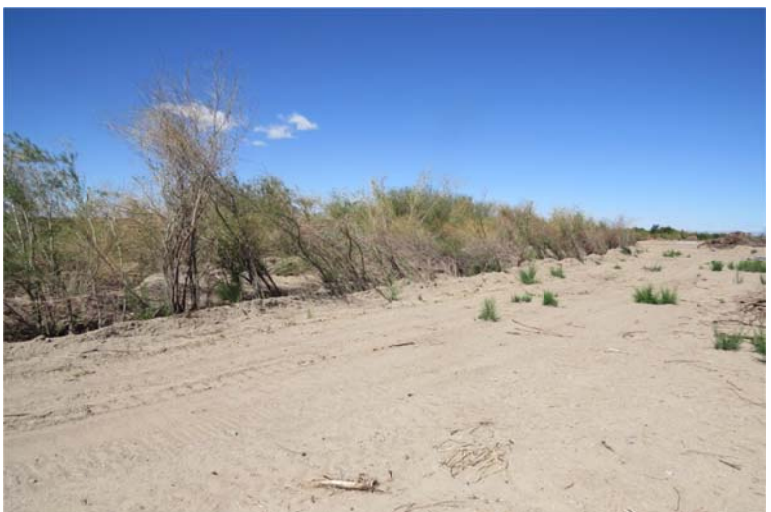
1. Number: Thurman II_04_05212019

2. Date: 21 May 2019	
3. Compass direction taken: Degrees: 270° Cardinal/intercardinal: West	
4. Coordinates (decimal degrees): Latitude: 32.684666 Longitude: -107.18089	
5. Photographer name: Charles Britt	
Description: Initiating transplants of willows at Thurman II

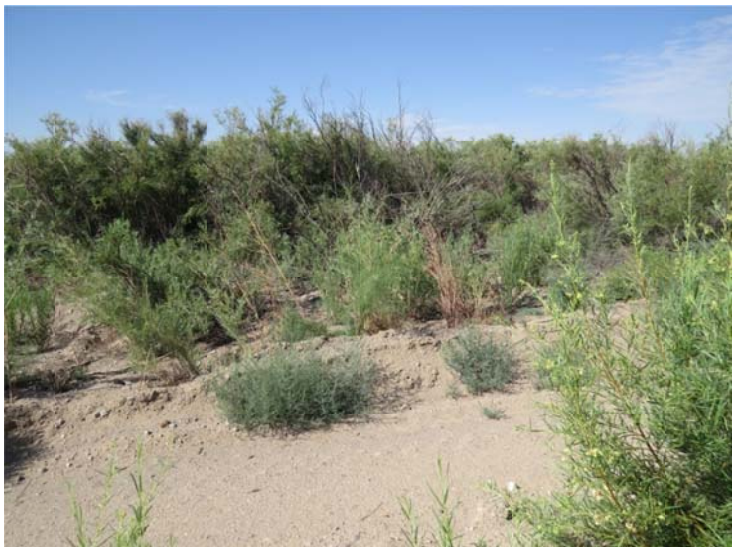
1. Number: Thurman I_03_07182019

2. Date: 18 July 2019	
3. Compass direction taken: Degrees: 190° Cardinal/intercardinal: South	
4. Coordinates (decimal degrees): Latitude: 32.682644 Longitude: -107.175328	
5. Photographer name: Charles Britt	
Description: Downstream coyote willow transplants at Thurman I.

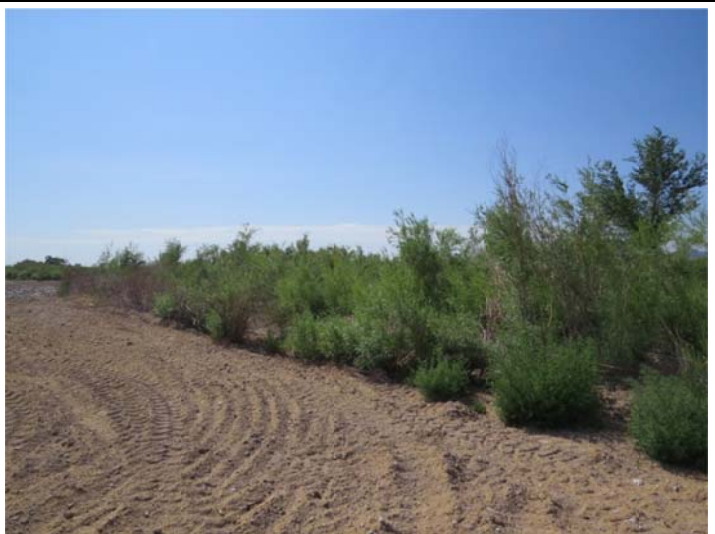
1. Number: Thurman II_01_07182019

2. Date: 18 July 2019	
3. Compass direction taken: Degrees: 30° Cardinal/intercardinal: North-northeast	
4. Coordinates (decimal degrees): Latitude: 32.684833 Longitude: -107.183784	
5. Photographer name: Charles Britt	
Description: Upstream coyote willow transplants at Thurman I.

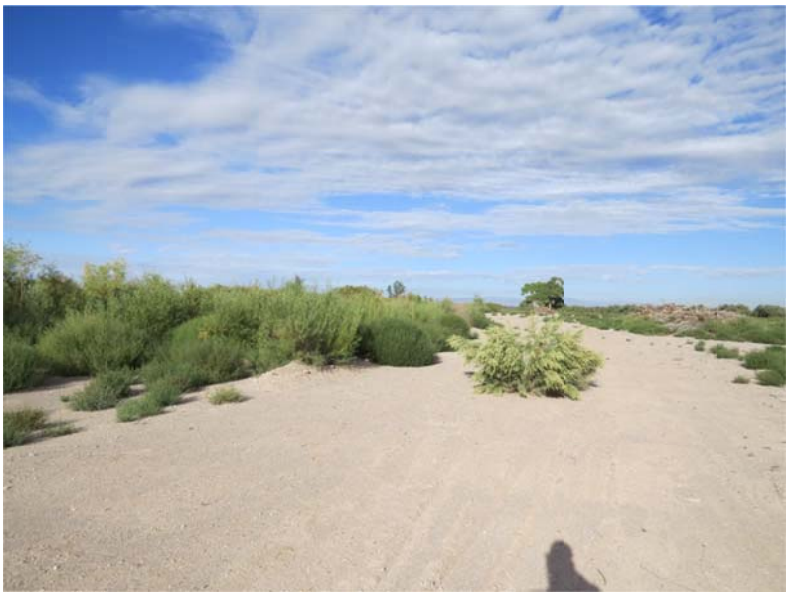
<p>1. Number: Thurman I_05_10142019</p>

<p>2. Date: 14 October 2019</p>	
<p>3. Compass direction taken: Degrees: 275° Cardinal/intercardinal: West</p>	
<p>4. Coordinates (decimal degrees): Latitude: 32.684368 Longitude: -107.180925</p>	
<p>5. Photographer name: Charles Britt Description: Southern transplants at Thurman I.</p>

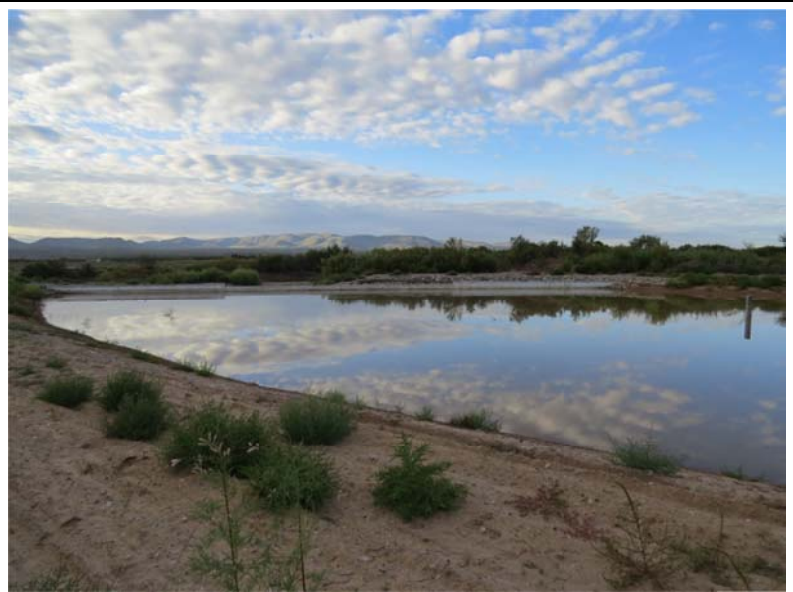
<p>1. Number: Thurman II_01_10142019</p>

<p>2. Date: 14 October 2019</p>	
<p>3. Compass direction taken: Degrees: 200° Cardinal/intercardinal: South-southwest</p>	
<p>4. Coordinates (decimal degrees): Latitude: 32.683879 Longitude: -107.176403</p>	
<p>5. Photographer name: Charles Britt Description: Sediment Trap at Thurman II.</p>

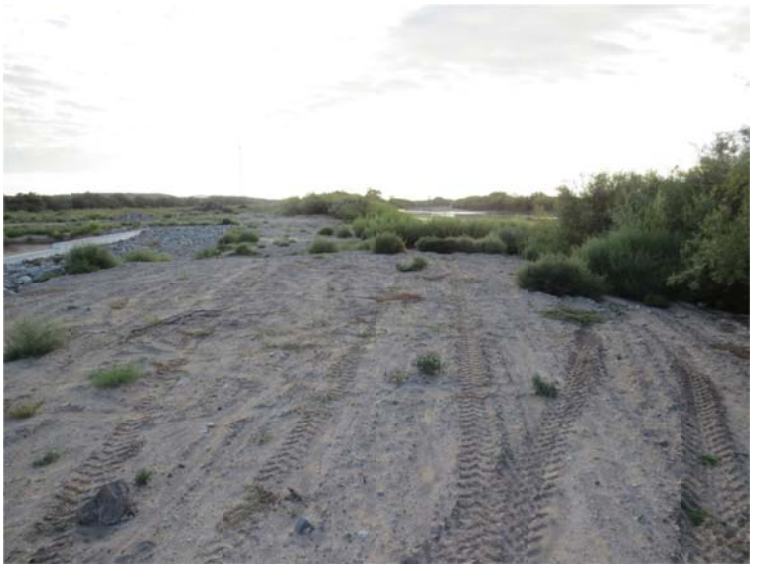
1. Number: Thurman II_05_10142019

2. Date: 14 October 2019	
3. Compass direction taken: Degrees: 110° Cardinal/intercardinal: East-southeast	
4. Coordinates (decimal degrees): Latitude: 32.683325 Longitude: -107.177167	
5. Photographer name: Charles Britt	
Description: Area between the Thurman II sediment trap and the Rio Grande River.

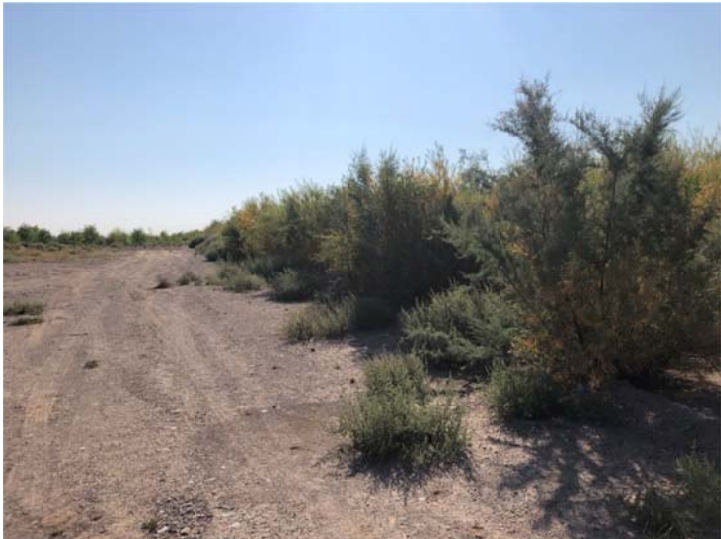
1. Number: Thurman I_03_100920

2. Date: 9 October 2020	
3. Compass direction taken: Degrees: 110 Cardinal/intercardinal: East-southeast	
4. Coordinates (decimal degrees): Latitude: 32.683616 Longitude: -107.178028	
5. Photographer name: Charles Britt	
Description: Coyote willow transplants upstream of Thurman I site

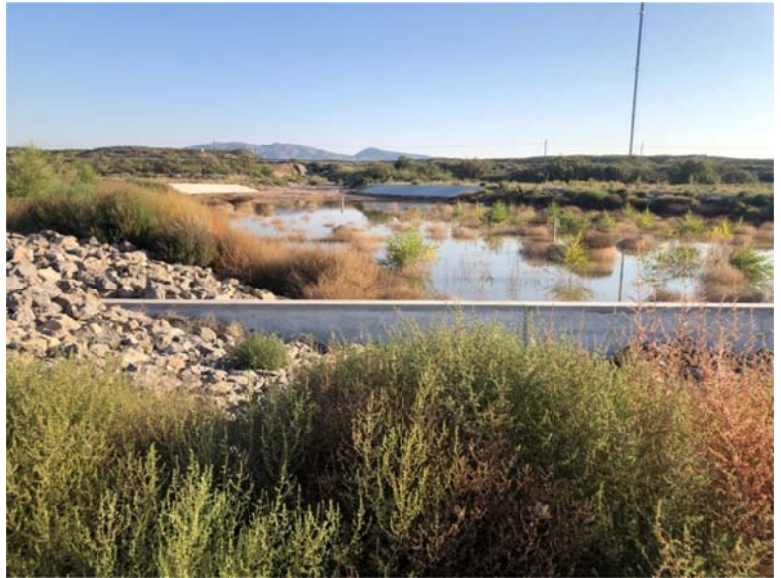
1. Number: Thurman I_01_10092020

2. Date: 9 October 2020	
3. Compass direction taken: Degrees: 35° Cardinal/intercardinal: Northeast	
4. Coordinates (decimal degrees): Latitude: 32.683155 Longitude: -107.177078	
5. Photographer name: Charles Britt Basin retaining water at Thurman I

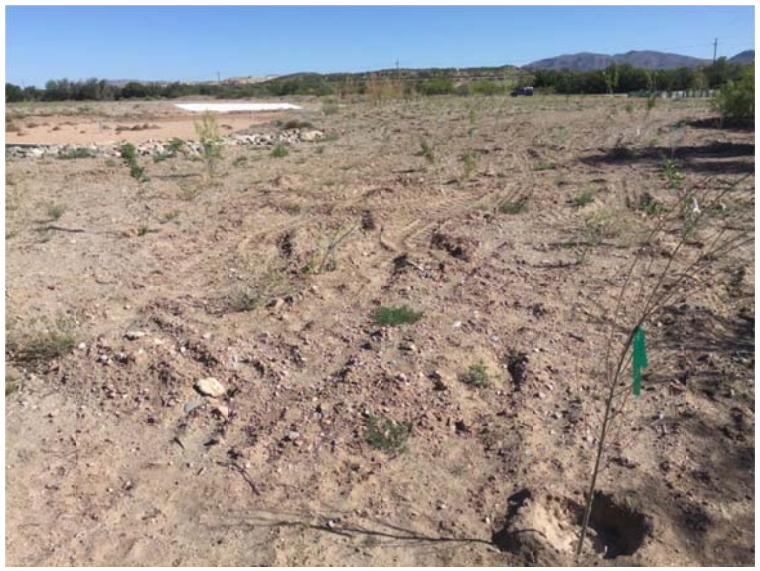
1. Number: Thurman I_04_04212020

2. Date: 21 April 2020	
3. Compass direction taken: Degrees: 0° Cardinal/intercardinal: North	
4. Coordinates (decimal degrees): Latitude: 36.682897 Longitude: -107.176336	
5. Photographer name: Charles Britt Description: Plantings along the eastern side of the arroyo from the confluence

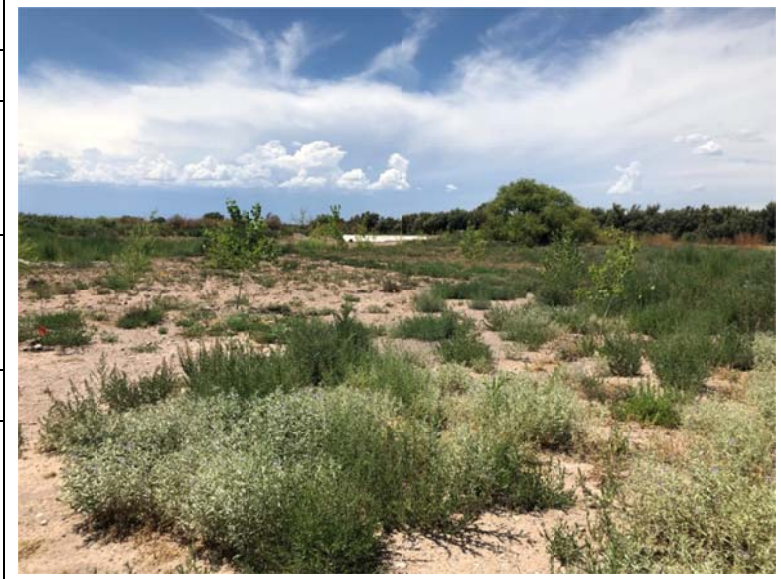
1. Number: Thurman II_04_07212020

2. Date: 21 July 2020	
3. Compass direction taken: Degrees: 350° Cardinal/intercardinal: North	
4. Coordinates (decimal degrees): Latitude: 32.683065 Longitude: -107.17602	
5. Photographer name: Charles Britt	
Description: Downstream plantings at Thurman II

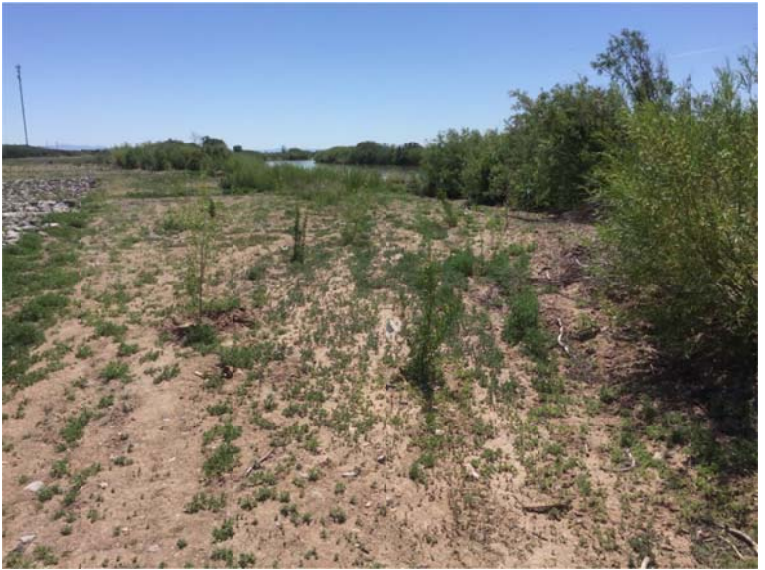
1. Number: Thurman II_04_04212020

2. Date: 21 April 2020	
3. Compass direction taken: Degrees: 95° Cardinal/intercardinal: East	
4. Coordinates (decimal degrees): Latitude: 32.683065 Longitude: -107.17602	
5. Photographer name: Charles Britt	
Description: Thurman II confluences plantings

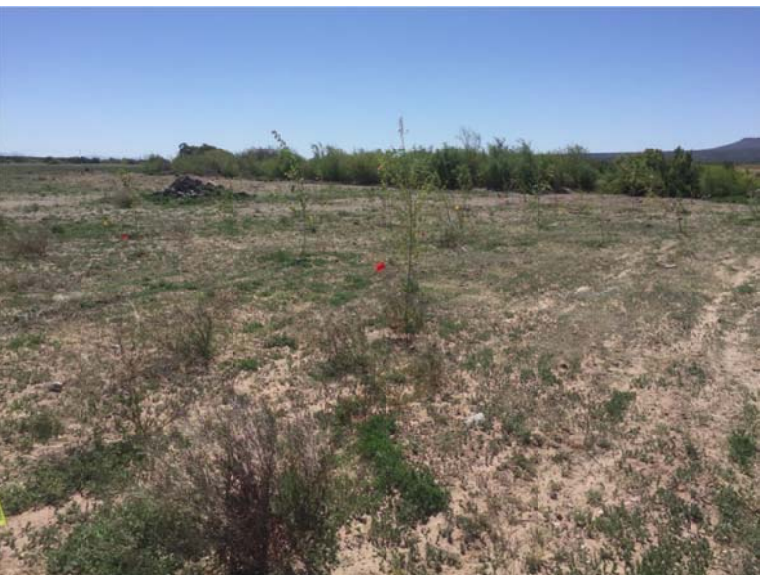
1. Number: Thurman II_02_04212020

2. Date: 21 April 2020	
3. Compass direction taken: Degrees: 120° Cardinal/intercardinal: East-southeast	
4. Coordinates (decimal degrees): Latitude: 32.684888 Longitude: -107.182676	
5. Photographer name: Charles Britt	
Description: View of mixed Goodding's willows, cottonwoods, and long stem shrubs planted at Thurman II

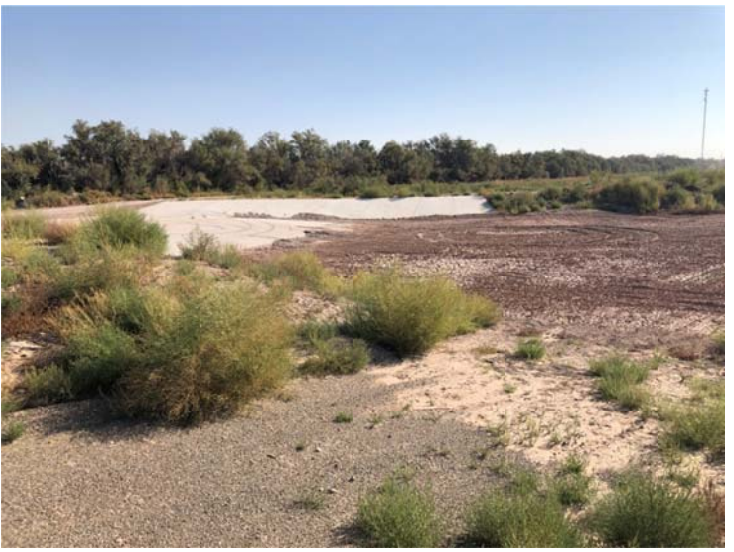
1. Number: Thurman II_01_10092020

2. Date: 9 October 2020	
3. Compass direction taken: Degrees: 80° Cardinal/intercardinal: East	
4. Coordinates (decimal degrees): Latitude: 32.685662 Longitude: -107.183815	
5. Photographer name: Charles Britt	
Description: Thurman II upper basin

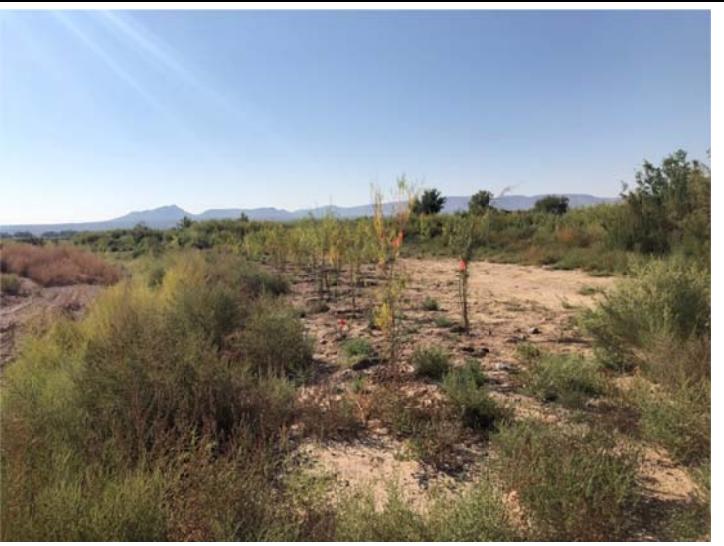
1. Number: Thurman II_03_10092020

2. Date: 9 October 2020	
3. Compass direction taken: Degrees: 155° Cardinal/intercardinal: South-southeast	
4. Coordinates (decimal degrees): Latitude: 32.685492 Longitude: -107.183747	
5. Photographer name: Charles Britt	
Description: Upstream coyote willow plantings at Thurman II

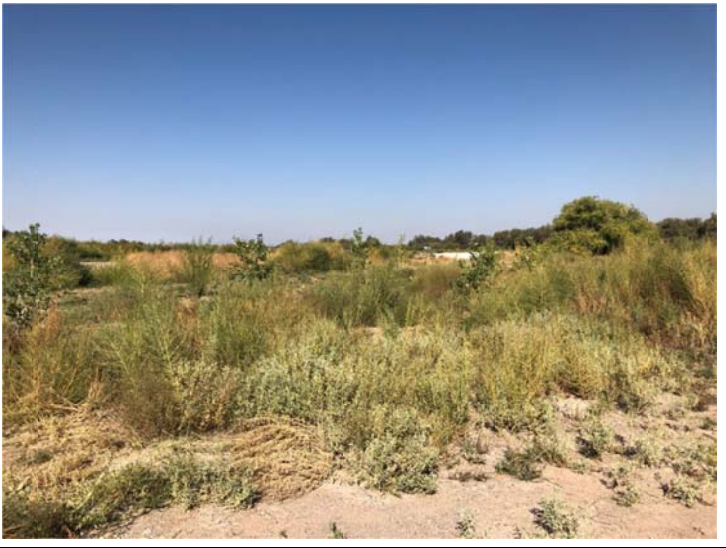
1. Number: Thurman II_08_10092020

2. Date: 9 October 2020	
3. Compass direction taken: Degrees: 285° Cardinal/intercardinal: West-northwest	
4. Coordinates (decimal degrees): Latitude: 32.68489 Longitude: -107.182047	
5. Photographer name: Charles Britt	
Description: Downstream coyote willow plantings at Thurman II
