Berino East and West Site Restoration Final Monitoring Report

Berino East and West Restoration Final Monitoring Report

IBM09D0011 Task Order IBM14T0011

SWCA Project No. 30236

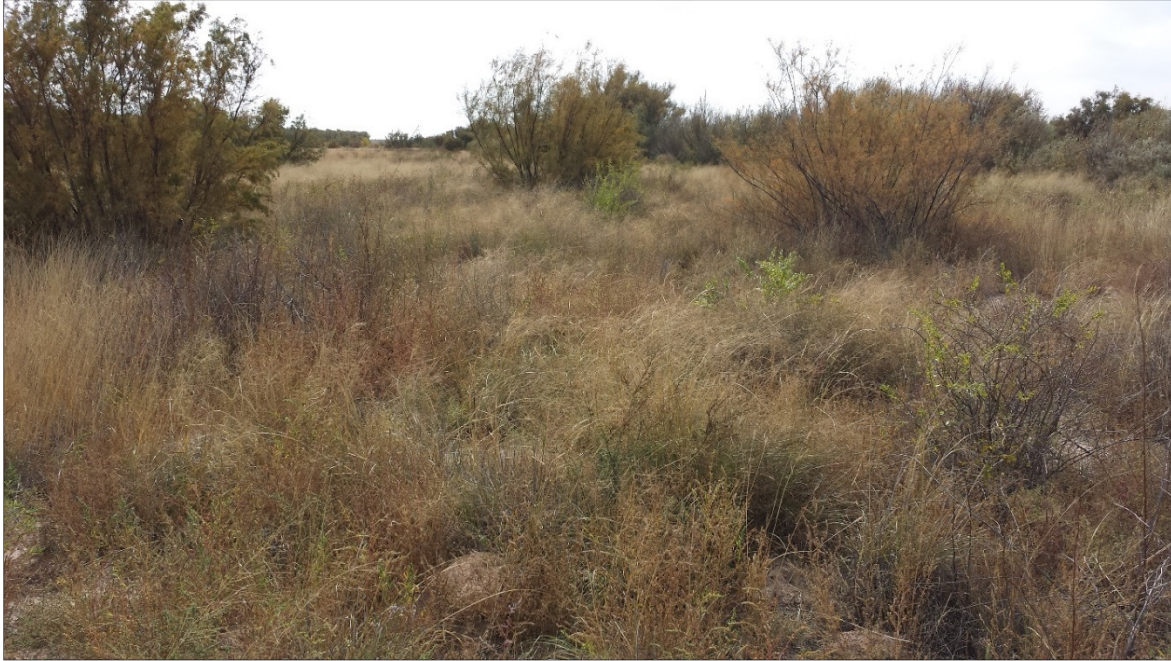
Historically the Berino East site has been mowed, limiting the height and cover of woody vegetation and maintaining intact native grassland communities. Mowing was discontinued in 2011, allowing both native and non-native shrub and tree species to colonize the area (Figure 2.1).

Figure 2.1. Overview of Berino East before restoration.

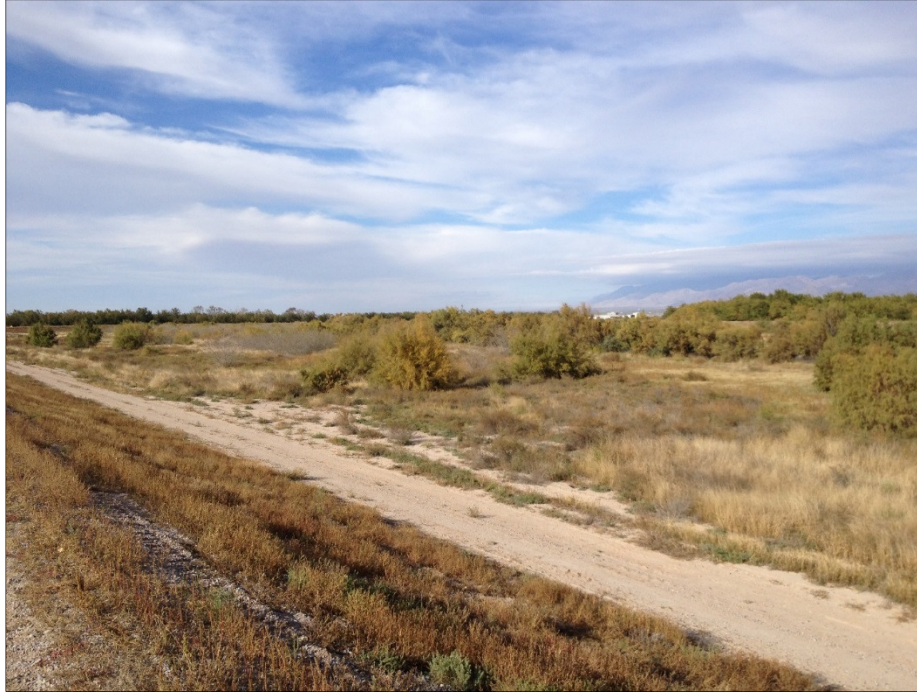
The Berino West project area was dominated by large saltcedar stands with very few willow patches intermixed (Figure 2.2). The floodplain overstory is different from the Berino East site, as it includes a mixture of screwbean mesquite (*Prosopis pubescens*) and saltcedar. The understory consists of inland saltgrass swales and patches of alkali sacaton intermixed with non-natives such as Russian thistle, saltcedar, Bermudagrass, and slim amaranth (*Amaranthus hybridus*) (see Table 2.1). Like the Berino East site, the majority of the invasive herbaceous weeds are found along the two-track roads that have been created by OHV use. Wildlife observed in the area included gophers (mounds), doves, red-tailed hawk, herons (Ardeidae), sparrows (Passeridae), Say's phoebe (*Sayornis saya*), rabbits (Leporidae), and coyotes, and mockingbirds (Mimidae).

Figure 2.2. Overview of Berino West before restoration.

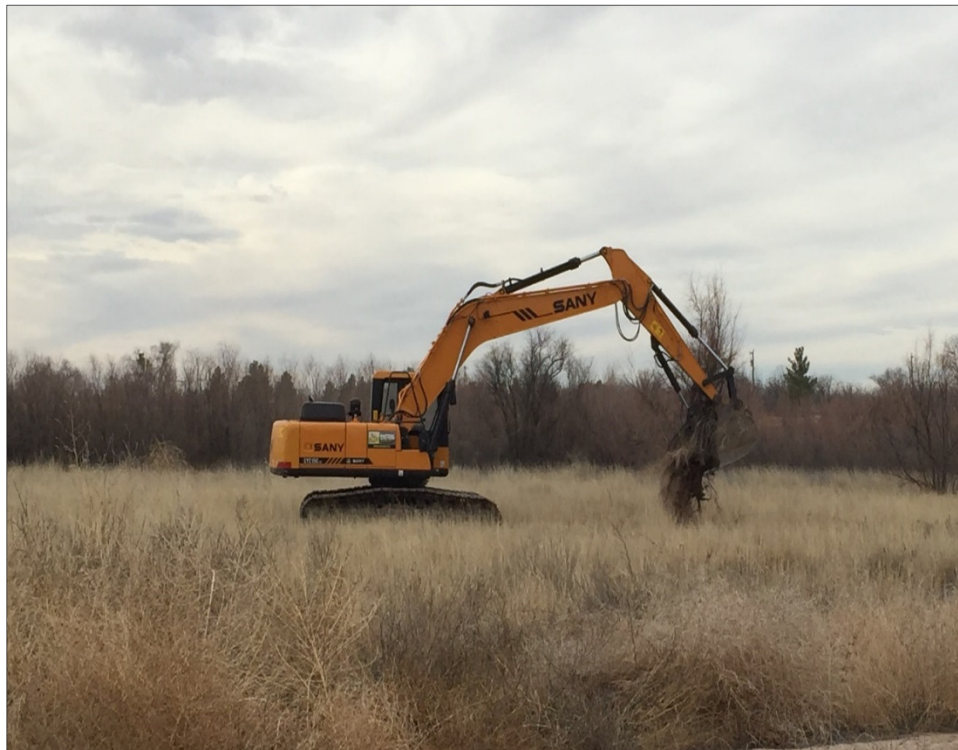
Figure 3.1. Saltcedar being extracted from the Berino East site.

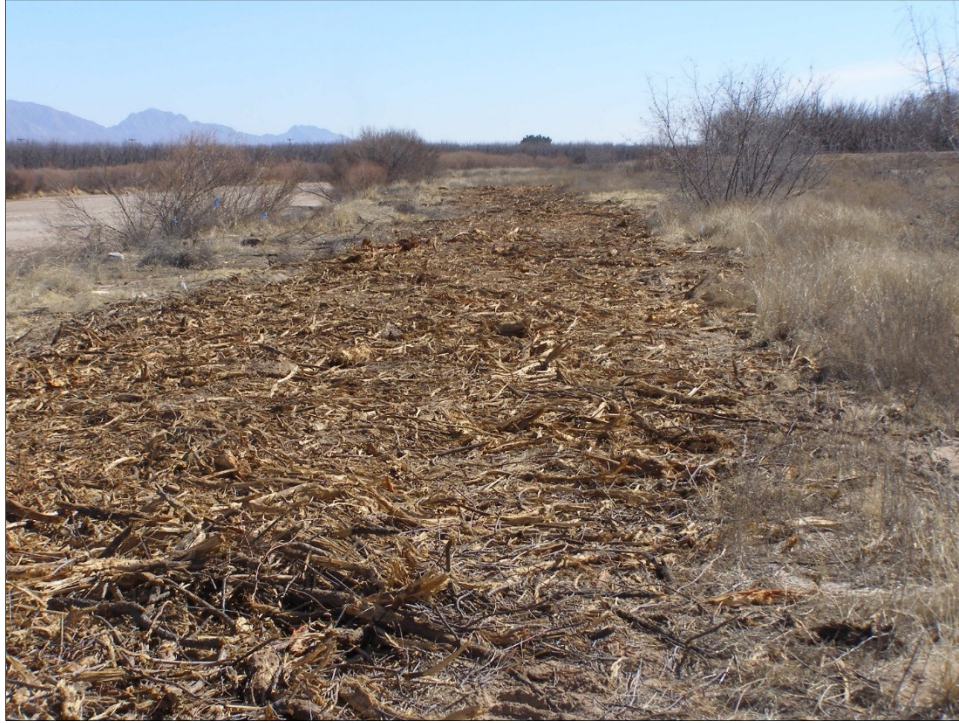
Large saltcedar trees and other non-natives were removed from the site using an excavator that grabs the trees and pulls out the associated root crown (Figure 3.1). Once the trees were removed they were spread and masticated on-site. Mastication involves the shredding of plant material into coarse fragments and is a faster and more cost-effective way of dealing with the woody material. Masticating the woody material also adds needed organic cover to the soil surface. As an added benefit, the masticated material was spread on existing two-track OHV trails to discourage the continued driving through the restoration site (Figure 3.2)

Figure 3.2. Masticated material covers an existing two-track OHV road.

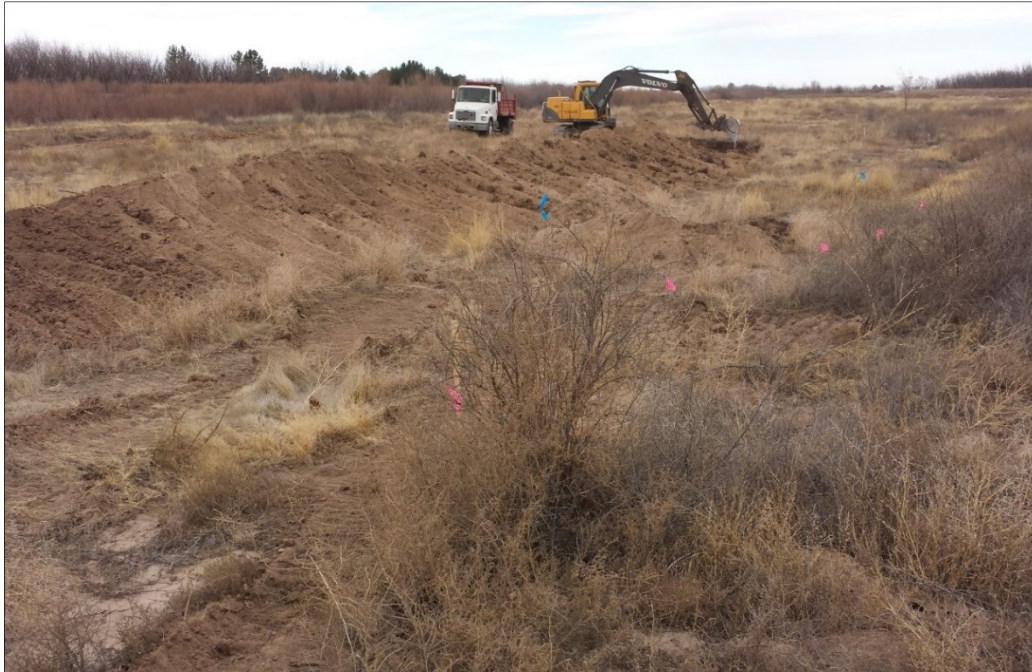
Figure 3.3. A swale is excavated by removing the top several feet of soil to lower the soil surface elevation. Removed topsoil is trucked to spread on nearby roads. Note native wolfberry shrubs flagged to avoid damage or disturbance (Main Swale, Berino East).

- Swales should be excavated prior to delivery of planting material to aid planning and speed planting. This would also allow more accurate determination of groundwater levels.

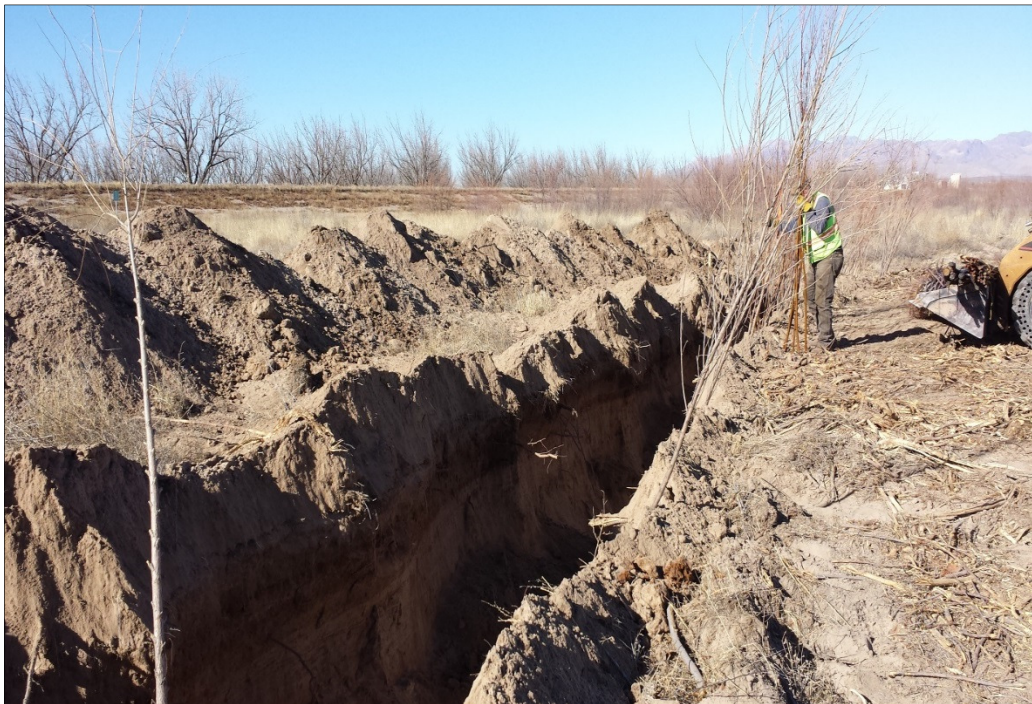
Figure 3.4. Planting willows into an excavated trench in a swale habitat (North Swale, Berino West).

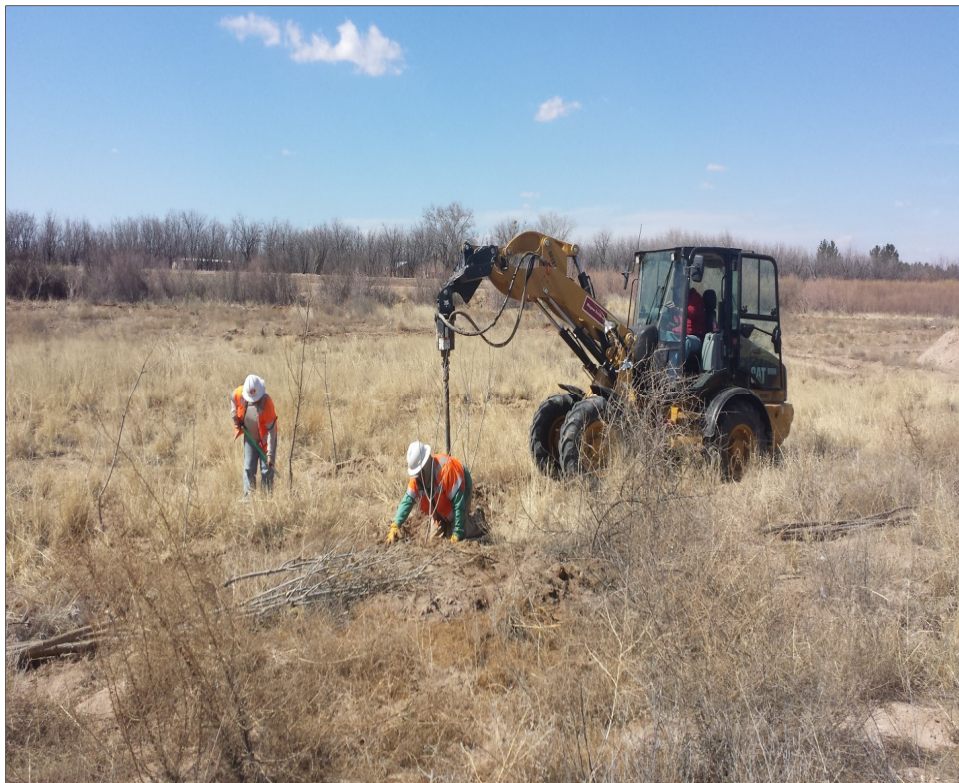
Figure 3.5. Restoration crew planting cottonwood poles into intact native grassland using a frontloader-mounted auger (Grassland Auger Area, Berino East).

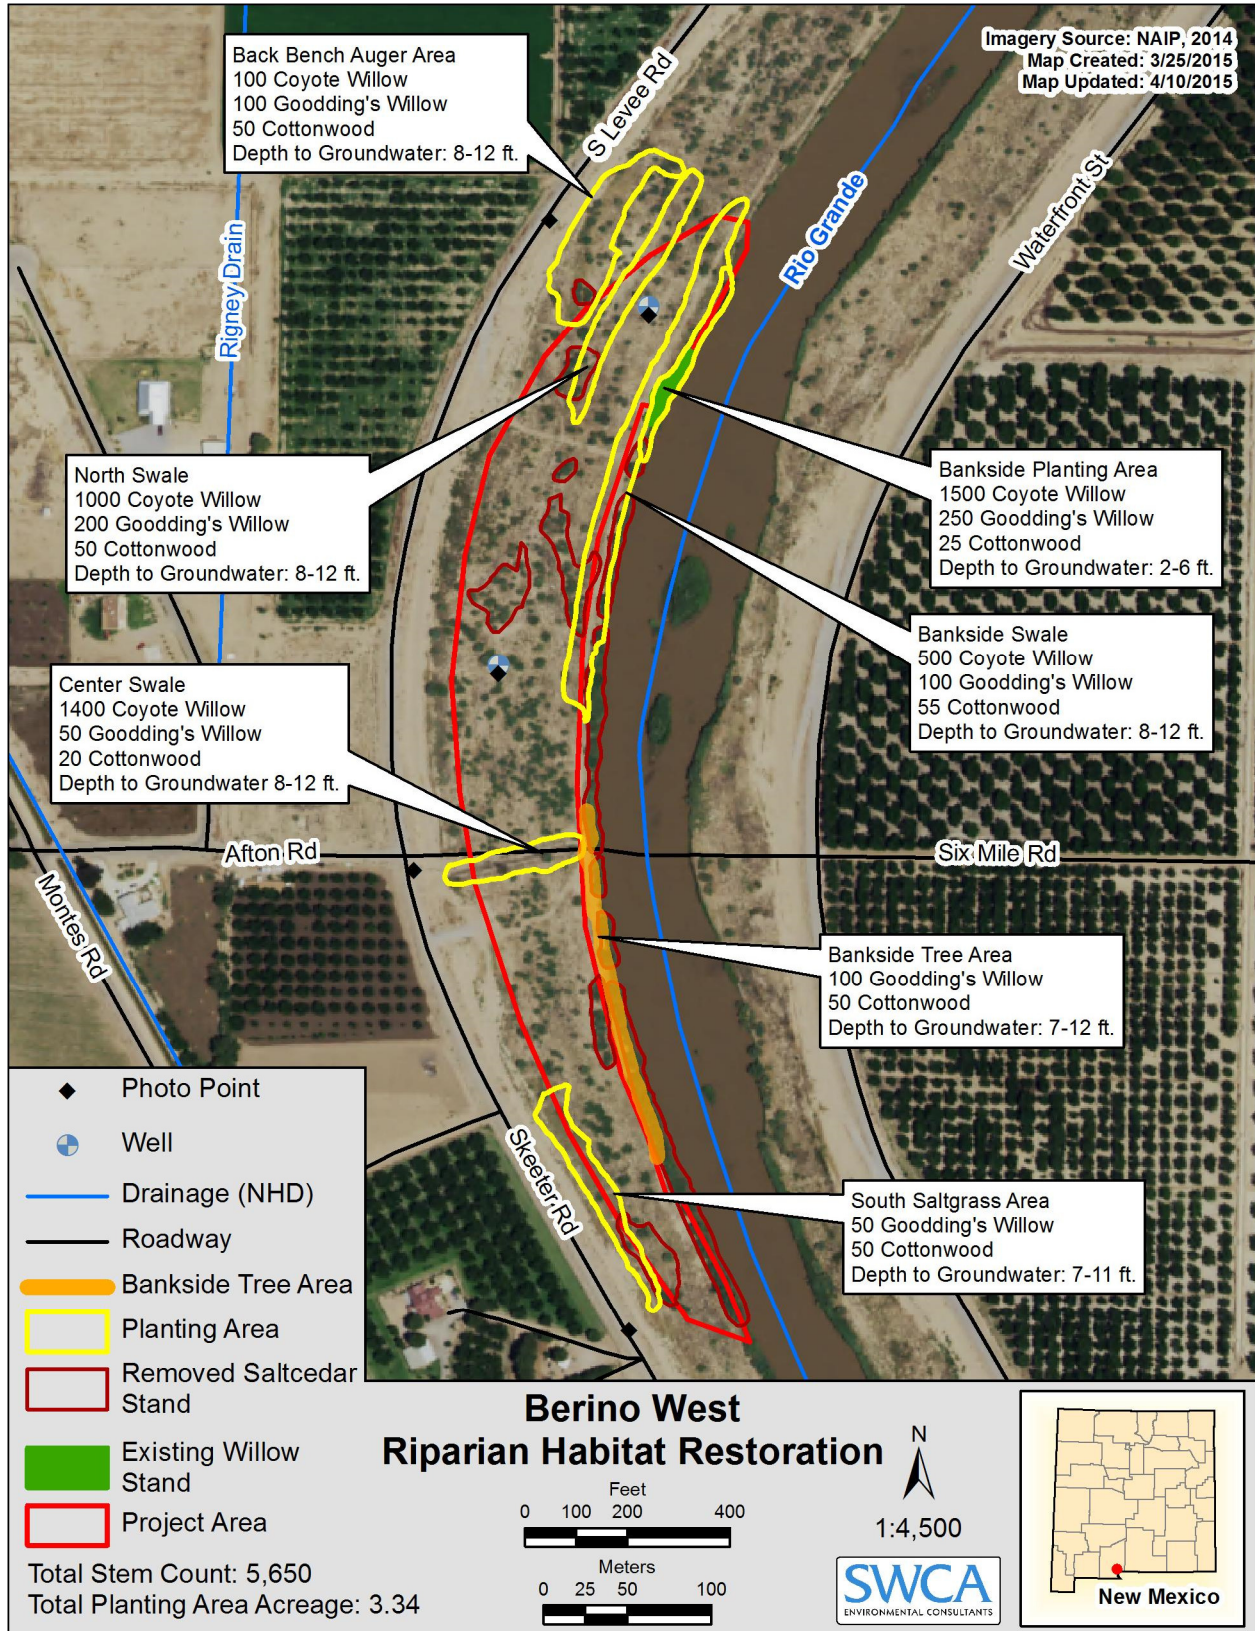
For more detailed information about survival rates in each planting area seen in Figure 4.1, please see the Qualitative Monitoring Field Sheets in Appendix A. Berino West had more than 3 acres of plantings implemented and were situated along banks and in swales where invasive saltcedar had been removed.

Figure 4.1. Overview of the planted areas at the Berino West site.

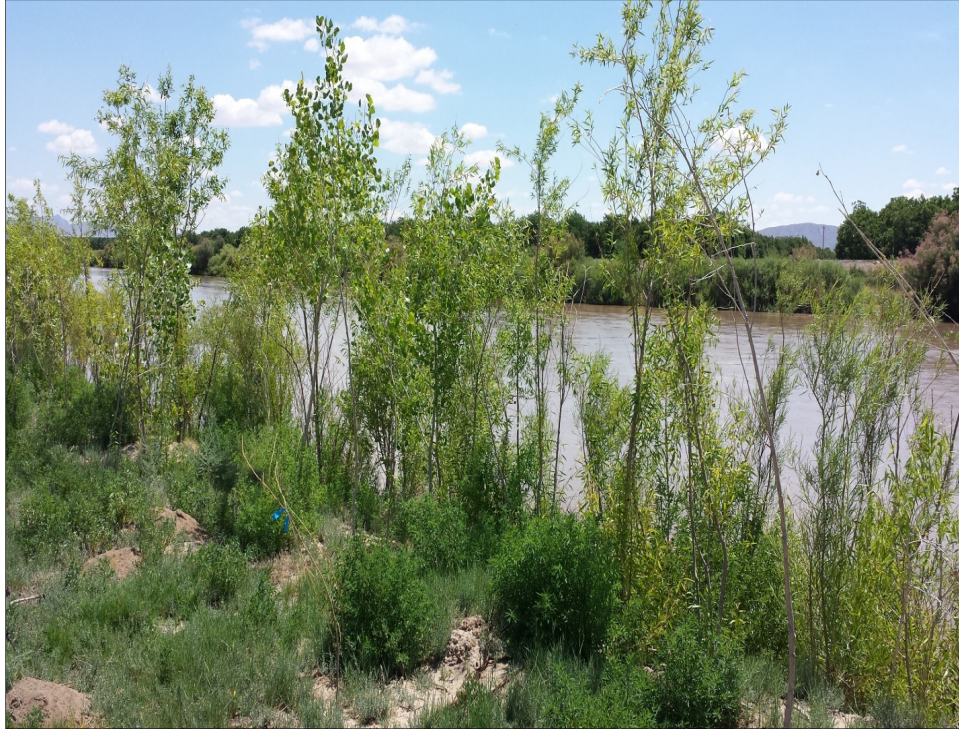
In the north half of the site, the Back Bench Auger Area was planted with a mixture of Goodding's willow and cottonwood poles. More than one stem was planted per hole to maximize survival rates in this large auger planting area. The North Swale was excavated into an existing slight depression with a high water table and planted with a mix of willow and cottonwood. The Bankside Planting Area was constructed using an auger to take advantage of the shallowest groundwater depth (2–6 feet) in the project area. It links existing stands of willow together to form a continuous riparian bank habitat. The Bankside Swale extends inland from the bankside planting area in discontinuous patches that were determined by the location of suitable groundwater. All of these areas show vigorous growth as of June 2015 (Figure 4.2).

Figure 4.2. Berino West Bankside Planting Area, June 16, 2015.

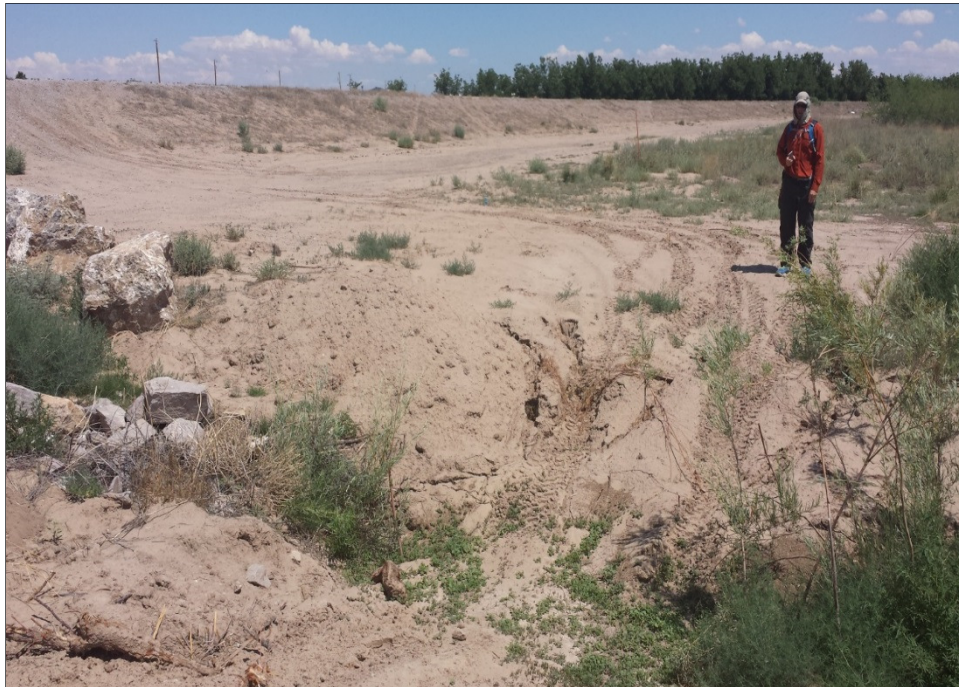
In the southern half of the site, the Center Swale was excavated from an existing old irrigation drain to create a deep willow swale. Although groundwater appeared adequate at the time of planting, trees in the east third of this planting area had high mortality during April and May 2015, indicating that depth to groundwater probably increased in this area during this time. This excavation was also intended to preclude off-road driving through the north half of the project site, but traffic has continued by running over some of the plantings and creating a new road through the swale (Figure 4.3).

Figure 4.3. Off-road driving has continued over and through a constructed swale (Center Swale, Berino West).

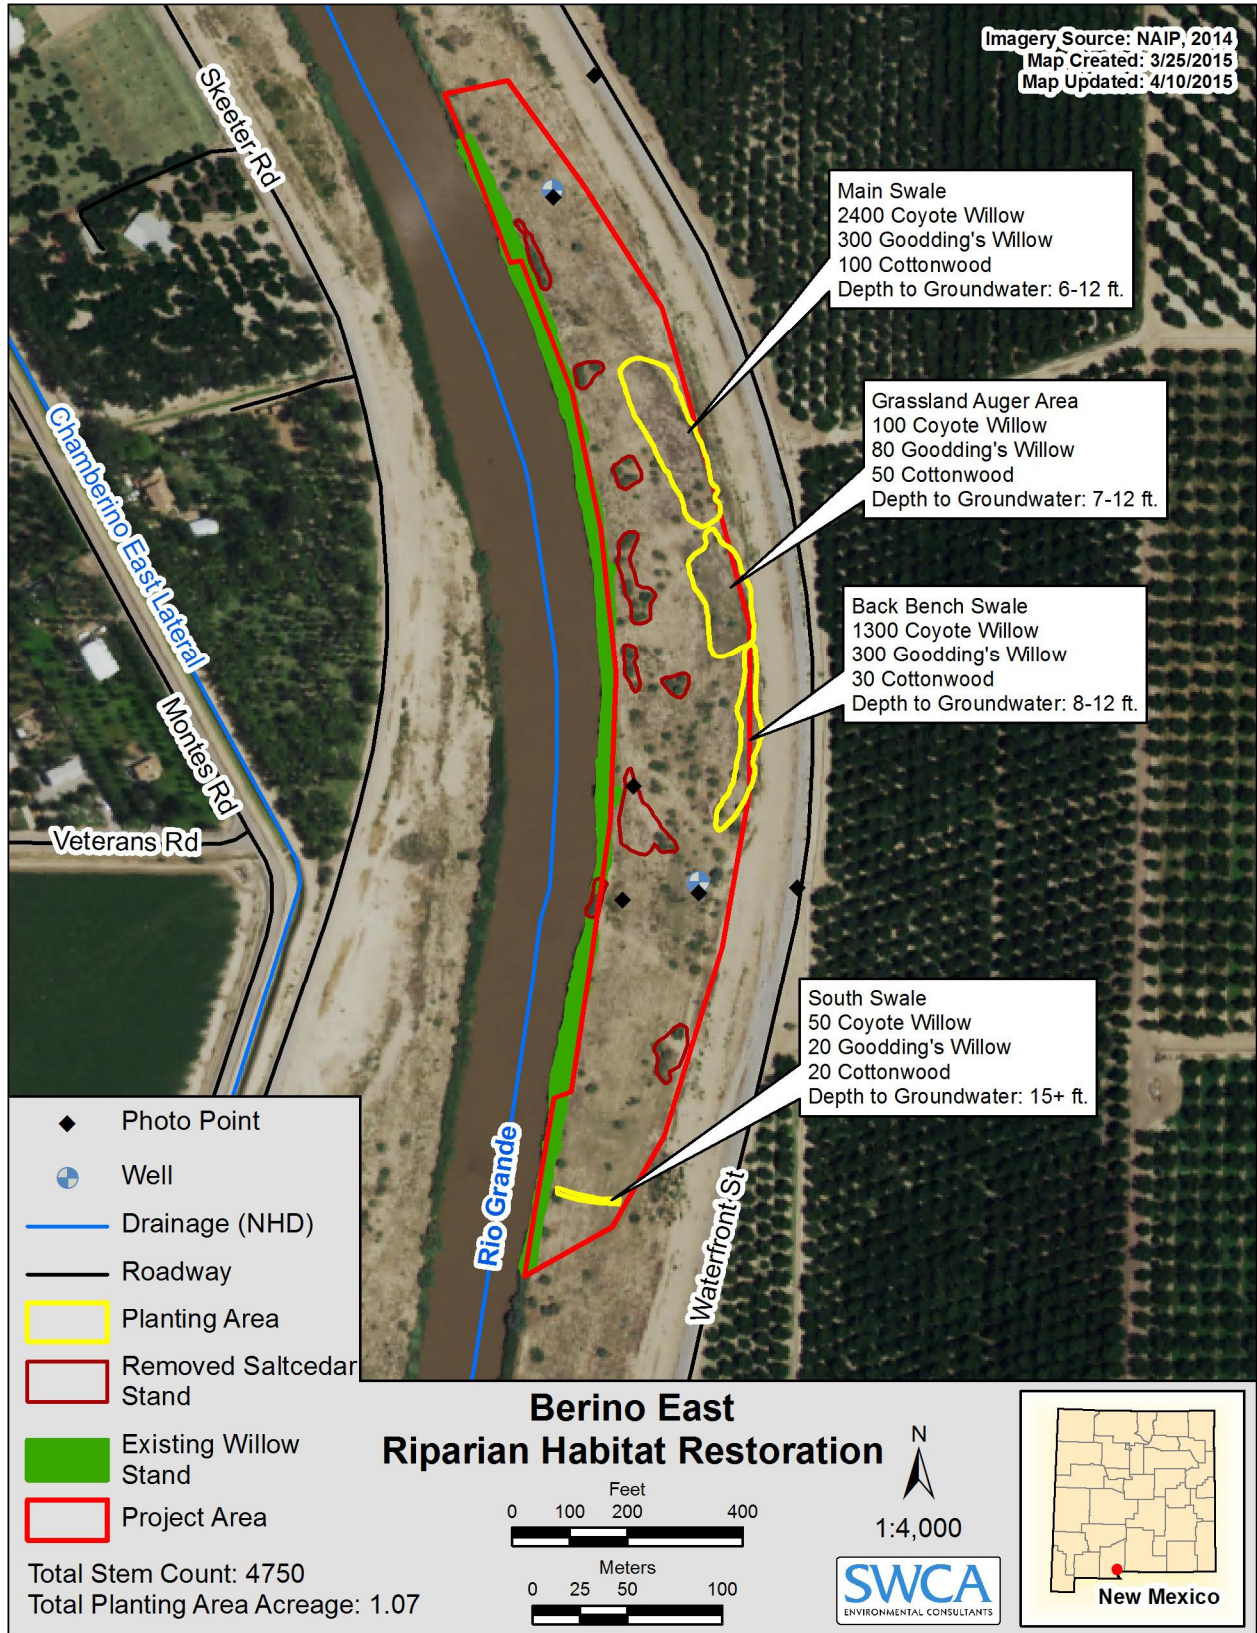
For detailed information about survival rates in each planting area, please see the Qualitative Monitoring Field Sheets attached in Appendix A. At Berino East, shallow soil moisture was not encountered near the stream banks but instead was located near the back of the floodplain bench. Due to the difficulty in locating suitable planting areas, only a little over 1 acre of habitat was created (Figure 4.4).

Figure 4.4. Overview of the planted areas at the Berino East site.

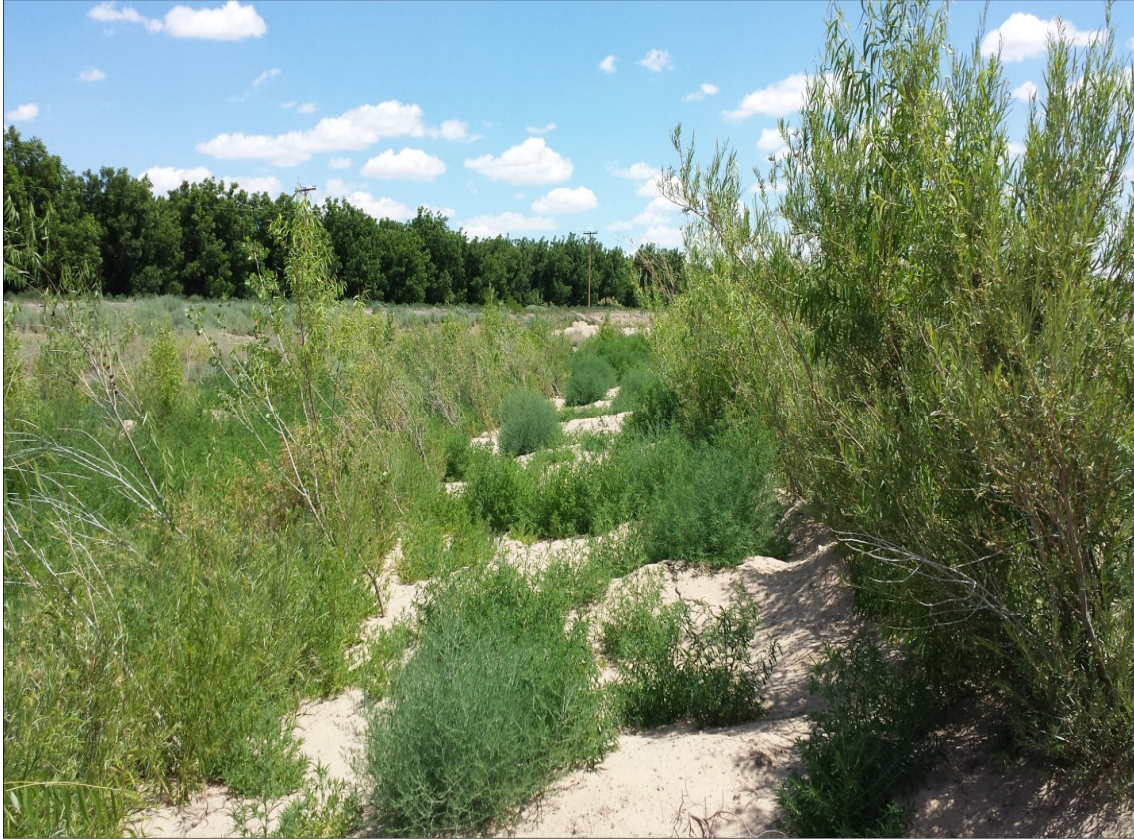
The Main Swale in Berino East was constructed by excavating several feet from a low-lying weed-filled area while avoiding nearby intact native grasslands and shrublands (see Figure 3.3). More than 2,800 trees were densely planted in this area to take advantage of the relatively shallow groundwater (6 to 12 feet) and this area is now growing vigorously and has saturated soil conditions (Figure 4.5). The Grassland Auger Area was constructed to continue to utilize the shallow depth to groundwater without disturbing the native grasses. Survival was lower in this area than surrounding areas, indicating that either holes were not augered deep enough or trees were not planted deep enough (see Section 5, Conclusions). The Back Bench Swale was trenched 8 to 12 feet to groundwater to continue creating willow habitat. The South Swale was an attempt to reach groundwater in another planting location, and while a few trees were planted into groundwater, much of this area appears to have depths to groundwater in excess of 15 feet. Survival of planted areas in Berino East is generally good to excellent, except for the Grassland Auger Area.

Figure 4.5. Vigorous growth of willow and cottonwood poles planted in the Main Swale at the Berino East site.

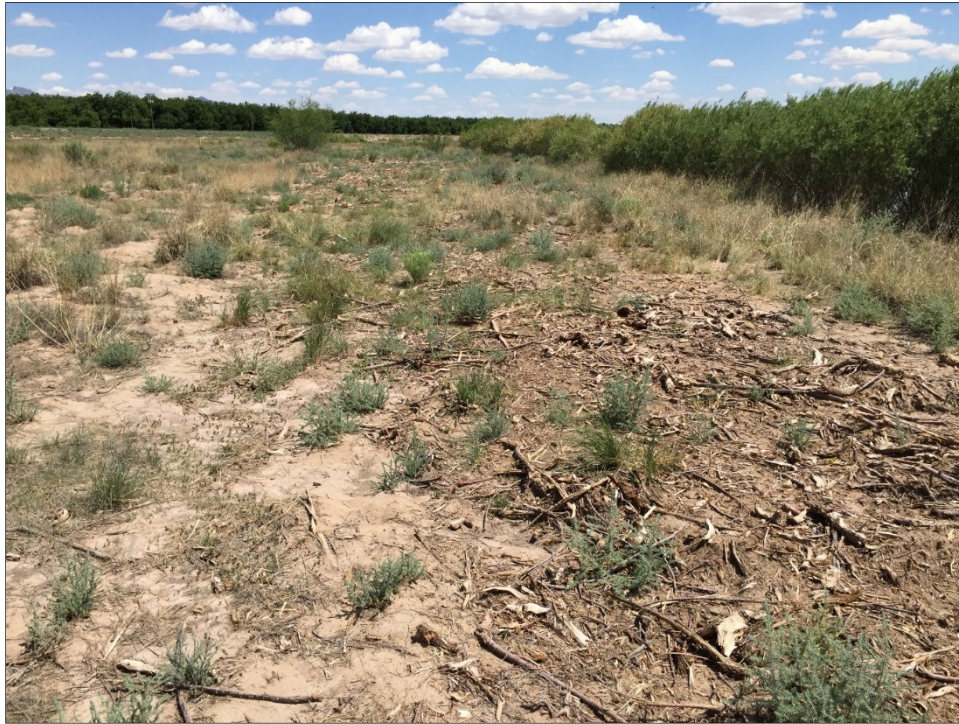
Machine operators were instructed to avoid flagged areas of native grasslands and shrubland areas to reduce unnecessary damage to existing habitats (e.g., see Figure 3.3). Nonetheless, some roads were created and/or used to remove saltcedar and to auger holes or excavate soil for restoration plantings. As of June 2015 these areas are recovering well, with damaged shrubs (e.g., Torrey wolfberry [*Lycium torreyi*]) vigorously leafed out and buried grasses (e.g., sand dropseed) emerging through masticated material and excavated soil (Figure 4.6).

Figure 4.6. Masticated road recolonizing with native species (June 2015).

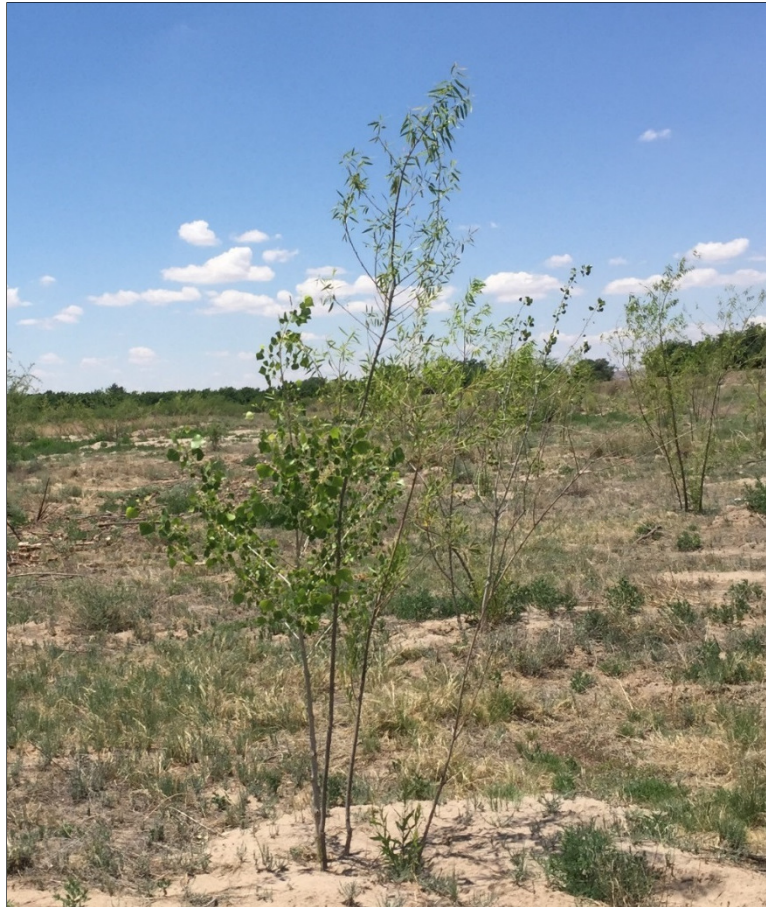
A small (less than 5%) proportion of dead trees was found intermixed with thriving poles, indicating that groundwater levels were not the culprit. While the cause of mortality for any individual tree cannot be determined with certainty, it is possible that some of these trees were not

planted deep enough to reach groundwater. While every effort was made to ensure adequate soil moisture before planting, some tree poles had very large stem bases that may have prevented them from being pushed deep enough to establish a connection with the saturated zone. Auger areas were planted with more than one stem/hole in order to ensure that at least one stem survived (Figure 4.7).

Figure 4.7. Auger plantings with more than 1 stem per hole.

- Poles with large “butts” should be sawed off to create sharp ends to push into holes with collapsing soils.
- Longstem potted shrubs may be helped by a program of watering until soil moisture increases with river flows in June. Installing watering tubes and dry water (absorbent gel) during planting may also be helpful. Watering tubes would need to be filled once a month during the dry season prior to irrigation. Alternatively, since these shrubs are potted they could be planted once the irrigation season begins and the soil moisture increases, however, this would result in additional costs for time and mobilization.
