Final Mitigation Report for Riparian Habitat Compensatory Mitigation for Thurman I and II Sediment Basins

United States Section

International Boundary and Water Commission

February 2021

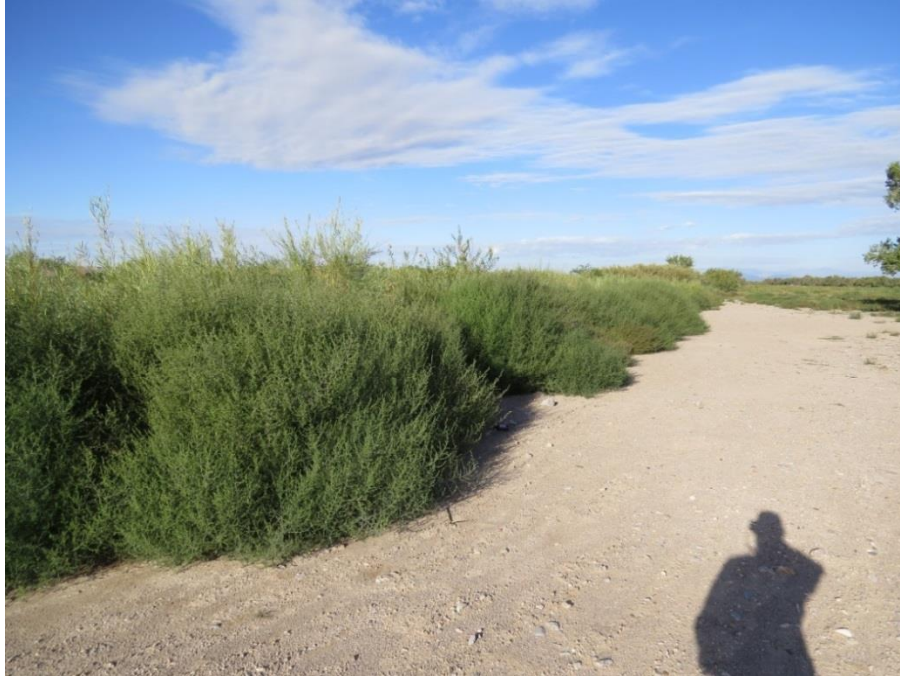
Upstream coyote willow transplants at Thurman I Arroyo with some kochia established (14 October 2019).

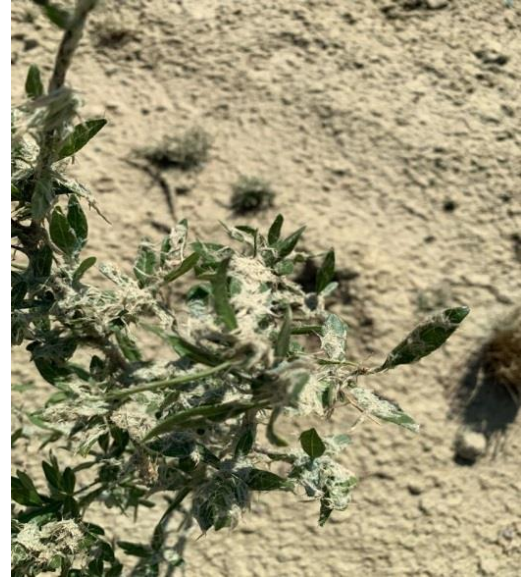
Seeding (approximately 1.3 acres) in areas disturbed by planting and areas where mastication was spread was conducted in April 2020 once planting was complete (Figure 4). The seed mixture included Indian ricegrass (*Oryzopsis hymenoides*), inland saltgrass (*Distichlis spicata*), plains bristlegrass (*Setaria leucopila*), sand dropseed (*Sporobolus cryptandrus*), and blue gama (*Bouteloua gracilis*). In addition, the contractor who constructed the sediment basins tilled and hydro mulched the site (over our seeding area) late June 2020. However, the equipment used for seeding and watering the grass damaged some of the trees and planting areas. Hydroseed was also found sprayed across some of the plantings.

Hydroseeding on planted species at Thurman I (26 June 2020).

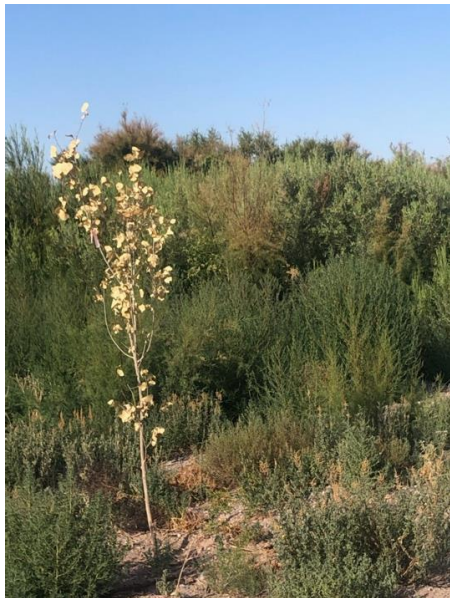
Thurman I cottonwood potentially damaged by overspraying from adjacent area (14 August 2020).

In July 2020, large areas adjacent to the site had been mowed down and appeared to have been sprayed causing some drift into the planted area. Trash and vehicle activity on the site began in April 2020 and continued through September; in August damage from ATVs was noted on the site.

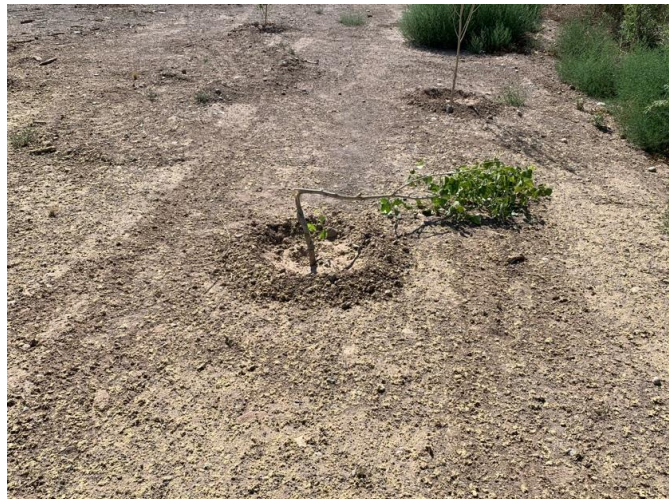
Seeding (approximately 1.2 acres) in areas disturbed by planting and areas where mastication was spread was conducted in April 2020 once planting was complete (Figure 5). In addition, the contractor who constructed the sediment basins tilled and hydro mulched the site (over our seeding area) late June 2020. Some damage to planting was noted from the construction contractor watering the hydroseed.

Damage from hydroseed watering (26 June 2020).

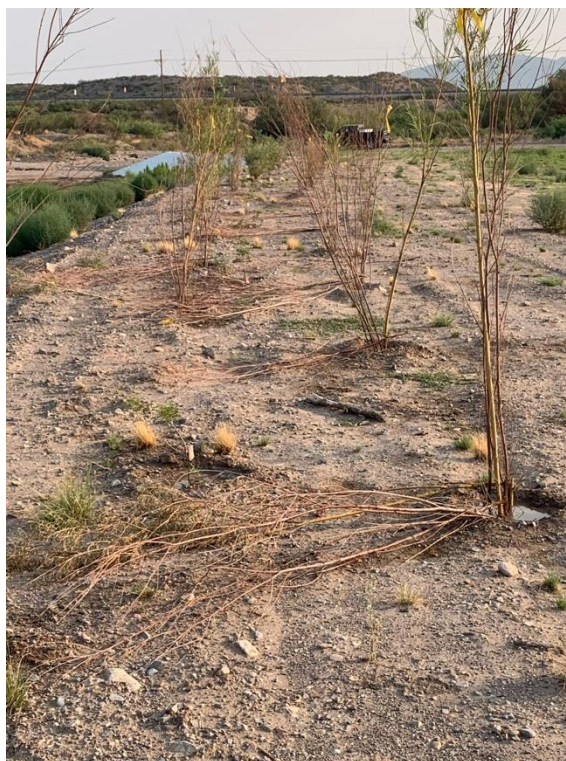
Broken coyote willows at Thurman (21 August 2020).

As noted at several restoration sites, including the Thurman sites, human activity can often have detrimental effects on plant survivorship. Damage at the Thurman I site included: three Goodding's willows, four coyote willows, one cottonwood, and two New Mexico olives. Less damage was noted at Thurman II where two Goodding's willows and one false indigo were damaged along with several shrubs that were run over but not snapped. Although a few signs were posted at each restoration site, they did not deter activity in the area. If possible, large signs, or more of them, posted along the restoration area noting the activity in the area may better inform the public and prevent future disturbance.

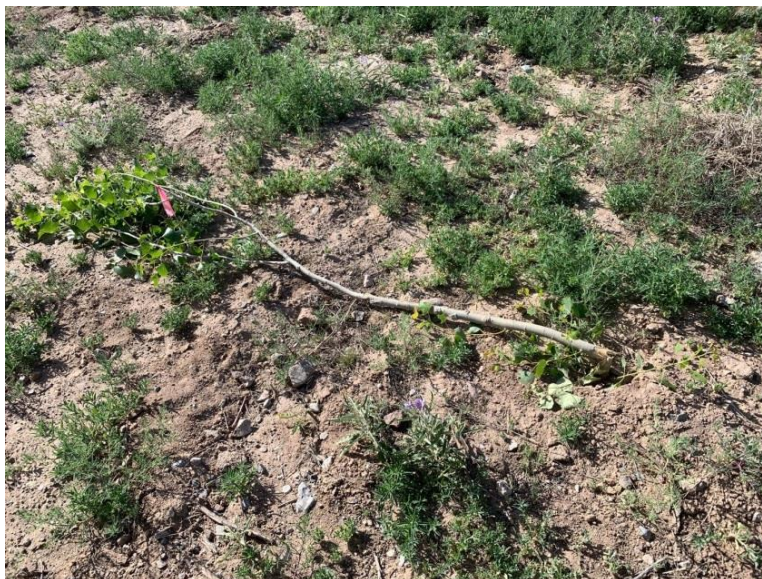
Cottonwood damaged by activity at the Thurman sites
(15 May 2020).

The restoration sites along the RGCP have always been subject to impacts from human activities. Adding large expanses of concrete areas with the sediment basins provided a very attractive area for ATV users. Increased traffic at the sites resulted in damage to some plantings as well as increased trash deposited at the sites.

Coordination with construction activities plays a vital role in not only the success of the restoration efforts, but also the ability to monitor the restoration progress. Having the construction area well defined on the ground prior to any transplanting or planting will prevent interference with the construction activities. In addition we recommend that plantings should be initiated after the construction activities are complete.
