Final Report on the Ten-Year Implementation of the “Record of Decision on River Management Alternatives for the Rio Grande Canalization Project”: 2009 to 2019

International Boundary and Water Commission, U.S. Section

June 17, 2019

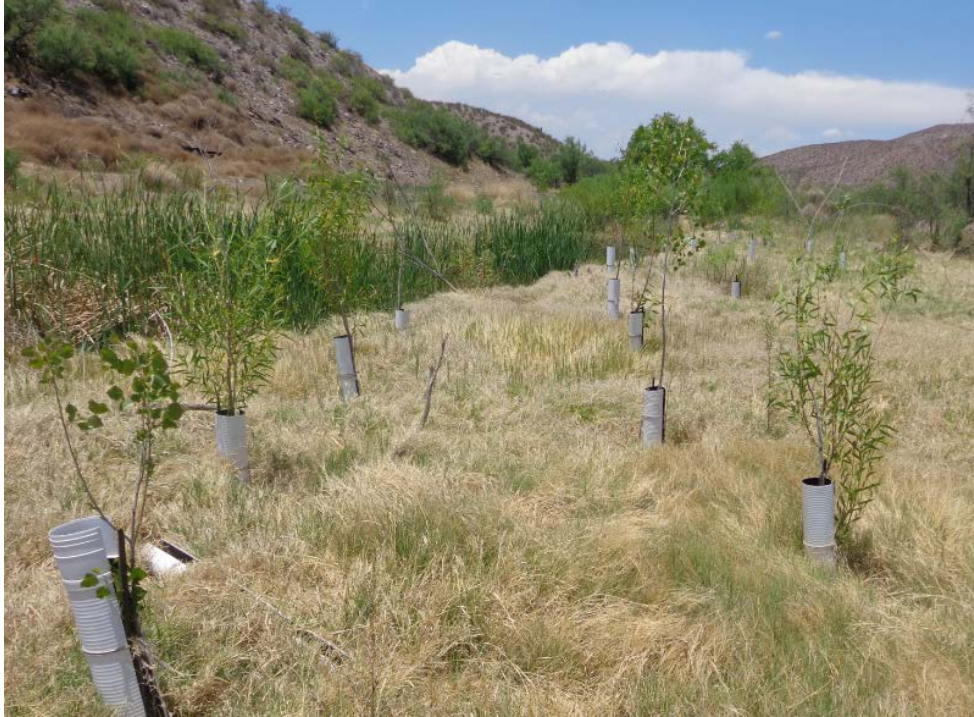
Figure 7 Gooddings willows and cottonwoods along Broad Canyon Arroyo, June 2018

In 2016, USFWS removed the remaining saltcedar along Broad Canyon Arroyo that had not been removed in 2011 due to a cuckoo observation. In 2017, USFWS planted nearly 8,000 coyote willows along the arroyo and over 1,000 Gooddings willows and cottonwoods. Except for a small section at the base of the arroyo at the confluence of the Rio Grande, these trees had exceptional survival rates (see Figure 7). The area along the arroyo has high potential for cuckoo and flycatcher habitat.

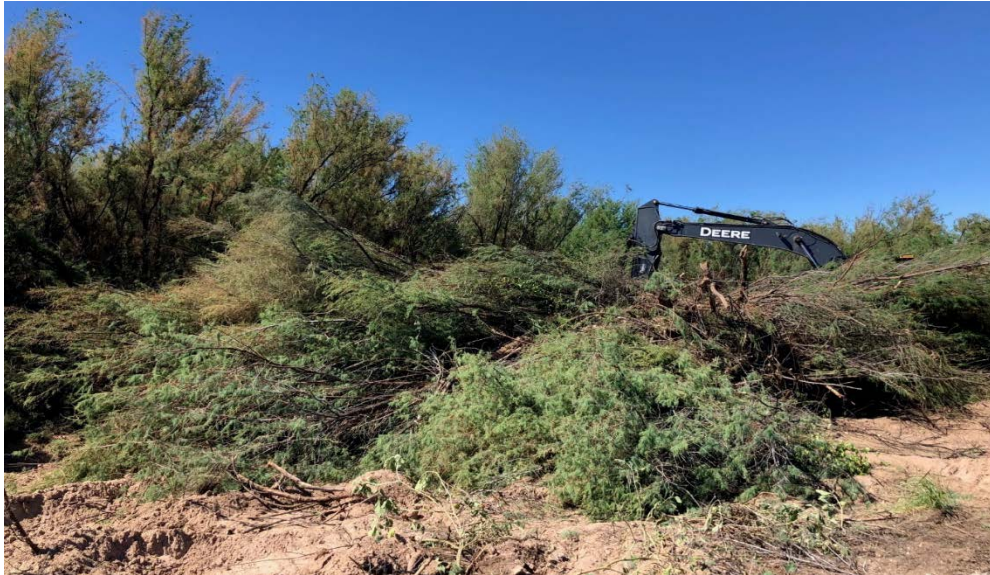
Figure 8 USFWS saltcedar removal at Rincon Siphon A site, September 2018

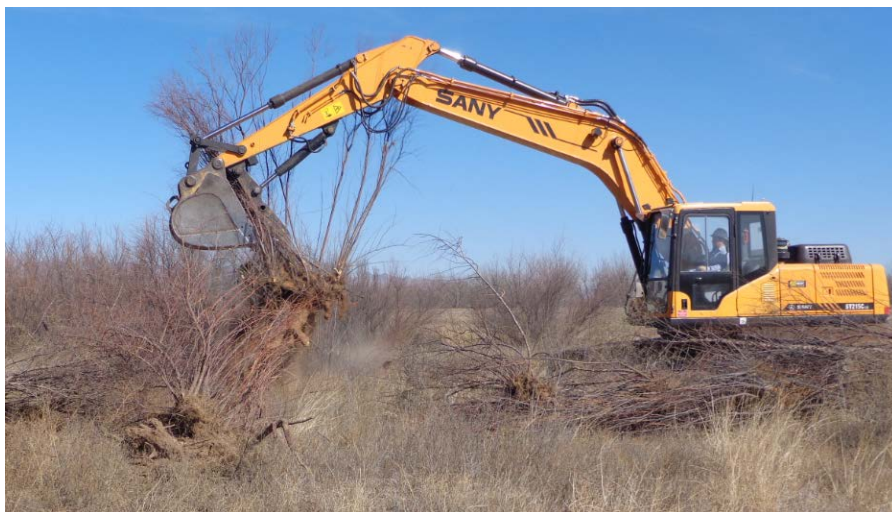
Figure 9 USIBWC contractors excavate saltcedar at Berino West Restoration Site, January 2015

In August 2014, USIBWC awarded Task Order IBM14T0011 to MWH for the implementation of Berino East and West Restoration Sites. MWH, as proposed, subcontracted the restoration work to SWCA. Saltcedar removal and floodplain excavation was subcontracted to Restoration Solutions (see Figure 9). SWCA and team excavated swales that would provide better drainage and localized groundwater conditions for plantings. SWCA and team planted more than 10,000 trees and more than 1,000 longstem shrubs. The trees had overall survival rate of 90% while the shrubs had overall survival rate of less than 10%. SWCA's work is documented in their final monitoring report (SWCA 2015). The low survival rate of shrubs led USIBWC to mandate replantings for mortality rates higher than 15% in subsequent contracts.

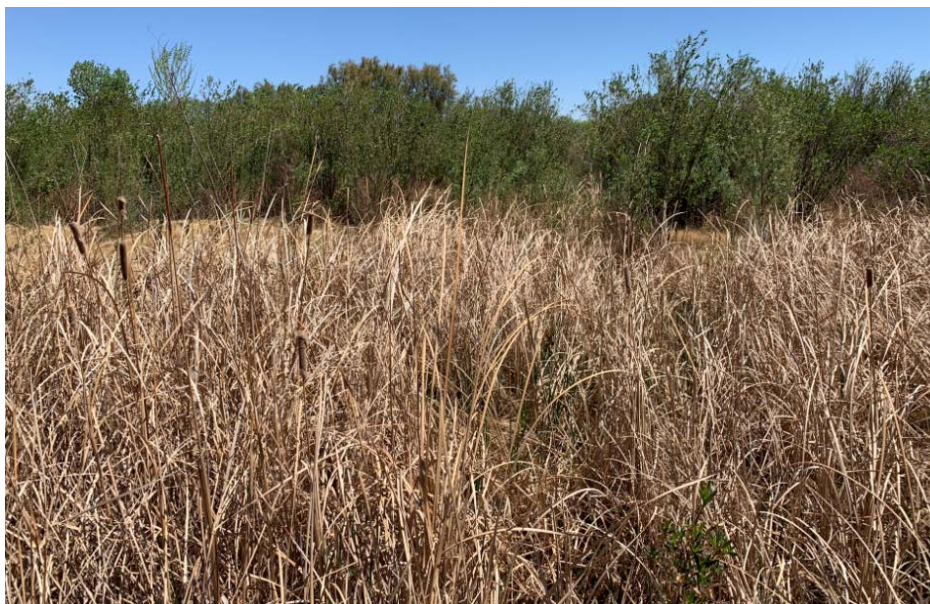
Figure 10 Yeso West has developed a large area of cattails in the middle of the site, April 2019

USIBWC conducted site monitoring at Yeso West in April 2019. The site has salt concentrations on the soil surface, with minimal coyote willows that survived. However, the site has abundant baccharus and is showing signs of possible wetland conditions, including a large portion of the middle of the site covered in cattail (see Figure 10). USIBWC will continue to monitor the Yeso West site to see if the remaining willows persist through strong monsoon flows and other site conditions.

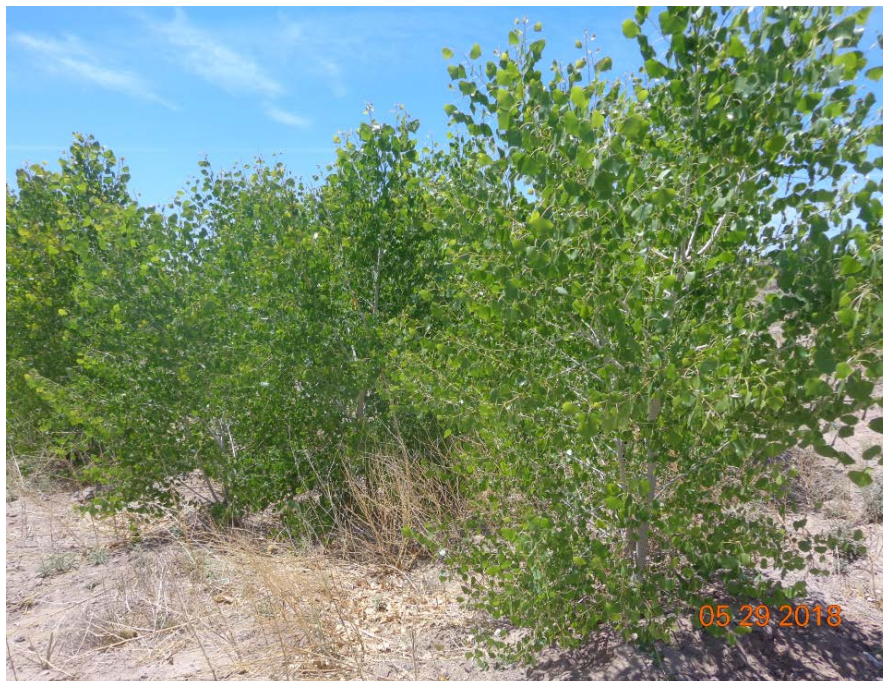
Figure 11 Thriving cottonwoods at the north end of Yeso East, May 2018

GSRC/SWCA's other two sites (Yeso East and Jaralosa) are old river meanders that were cut off when the Rio Grande Canalization Project was constructed in the late 1930s. EBID constructed a check structure at Yeso East in April and May 2019, and the site is slated to receive irrigation water in summer 2019. Both sites target riparian woodlands which should benefit the cuckoo. Contractors excavated large swales at both sites. In September 2017, contractors planted longstem shrubs at Crow Canyon C, Yeso East and Jaralosa, and in March 2018, contractors planted about 300 more cottonwoods and Gooddings willows to make up for those species that had died above 15% in the previous year across all four sites. Contractors also planted grass and wildflower seeds in summer 2017. The northern part of Yeso East has thriving cottonwoods with near 100% survival rates (see Figure 11). GSRC/SWCA's work is documented in their final report (GSRC and SWCA 2018).

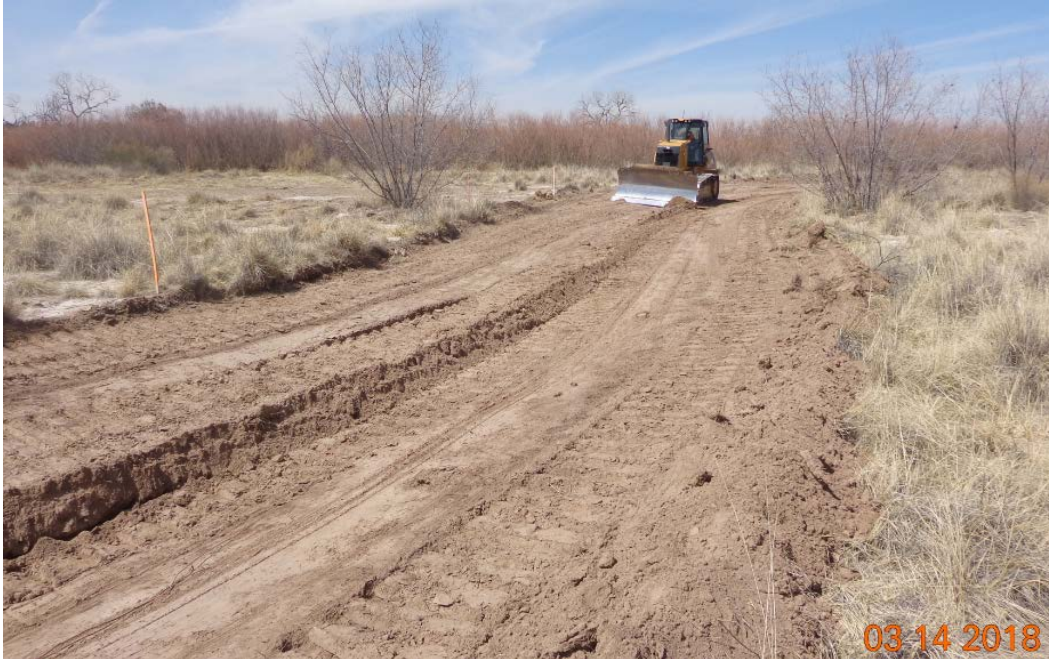
Figure 12 Excavation of swales at Country Club East by USIBWC Contractor IDEALS-AGEISS, March 2018

Country Club East is targeting riparian woodland and riparian forest. The original 2009 Conceptual Restoration Plan called for two bank cuts which would allow high flows (at 3,500 cfs) to enter into the site in order to establish river-floodplain connectivity. IDEALS developed an excavation plan to create four bank cuts instead of two, and these are connected by a series of “swales” and “ponds” (see Figure 12). Drainage channels connect larger excavated open areas where IDEALS planted cottonwoods. Under normal and low flows, the site will not inundate but the excavated open areas will create better localized groundwater conditions for the plantings. Country Club East may eventually benefit both flycatchers and cuckoos. IDEALS installed gages at each of the bank cuts to include water levels in the monitoring events, in order to ensure that the bank cuts were adequate but not too low.

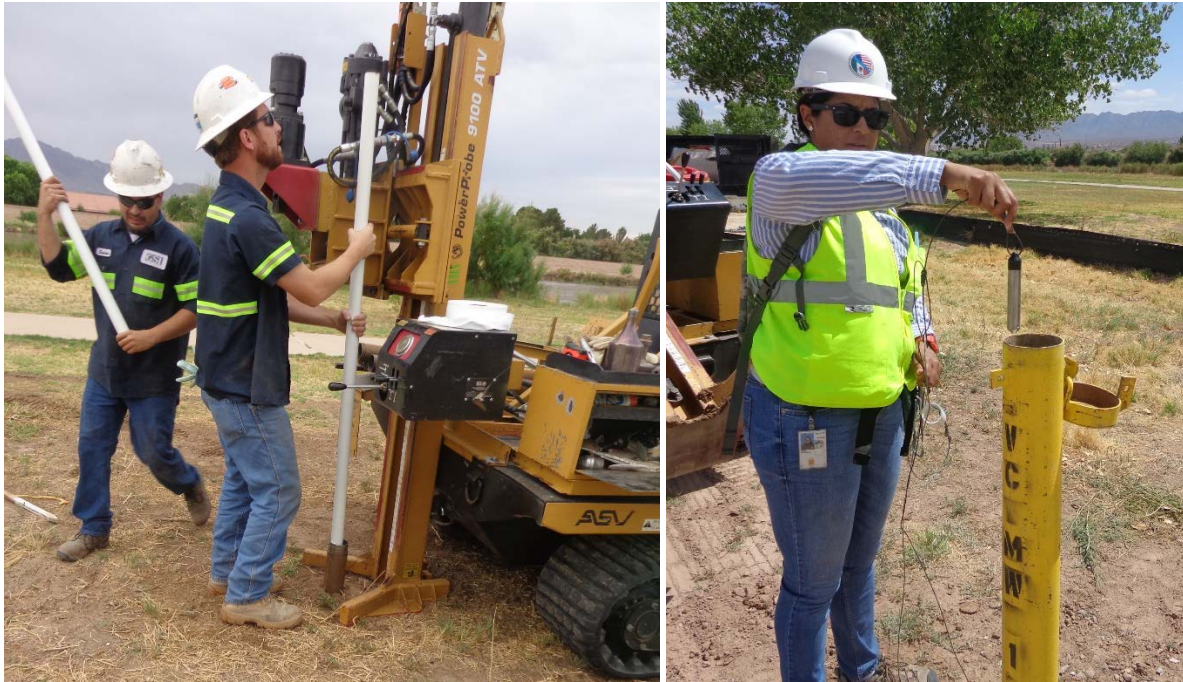
Figure 17 Drilling and installing a groundwater monitoring well at Valley Creek in July 2014 (Left); USIBWC's Nereida Cora deploying an automated logger in the new well (right)

Beginning in 2014, USIBWC had to trouble-shoot some of the wells. For example, cabling HDR used to deploy the sondes began to corrode, breaking in some wells, leading to the sonde falling to the bottom of the well. USIBWC switched the cabling to a vinyl-coated galvanized steel of more threads to withstand corrosion effects. In addition, USIBWC replaced the locks to tamper-resistant locks. In summer 2014, the wells at the Selden Point Bar wells were vandalized, with locks broken and the sonde at this site stolen. USIBWC submitted a report to the Dona Ana County Sheriff for this stolen property in 2015. Some of the wells collapsed or became obstructed. Prior to their contract being completed, HDR reconstructed four wells, but additional wells collapsed due to the unconsolidated sediment of the floodplain.

In September 2017, USIBWC awarded a contract to EGC, Inc. under IBM17C0007 to assess and repair the damaged monitoring wells. In December of 2018, USIBWC contractors EGC conducted a well assessment and recommended rehabilitation of 21 wells and redrilling of 9 wells. In February and March of 2018, EGC rehabbed 20 wells and redrilled 8 wells that were obstructed or destroyed. Rehabilitation included removal of accumulated sediment, root cutting, retrieval of lost sondes, and repainting well names. In September 2018, USIBWC issued a modification to EGC's contract to redrill four additional wells. EGC conducted the fieldwork in November 2018. EGC submitted a draft version of the final report for the well rehabilitation and reconstruction in late December 2018 during the partial government shutdown, and USIBWC reviewed the report in March 2019. USIBWC survey crew surveyed the last 4 wells in April 2019, and EGC finalized their report in April 2019 (EGC 2019).

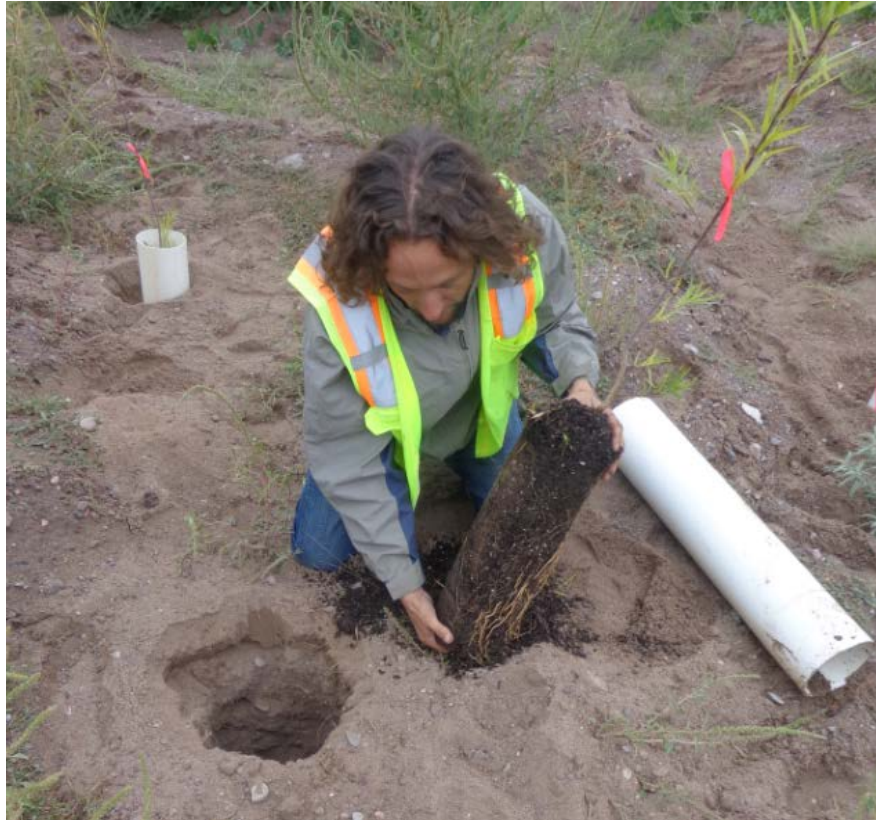
Figure 18 Shrubs planted from extra tall pots at the Yeso East site, September 2017

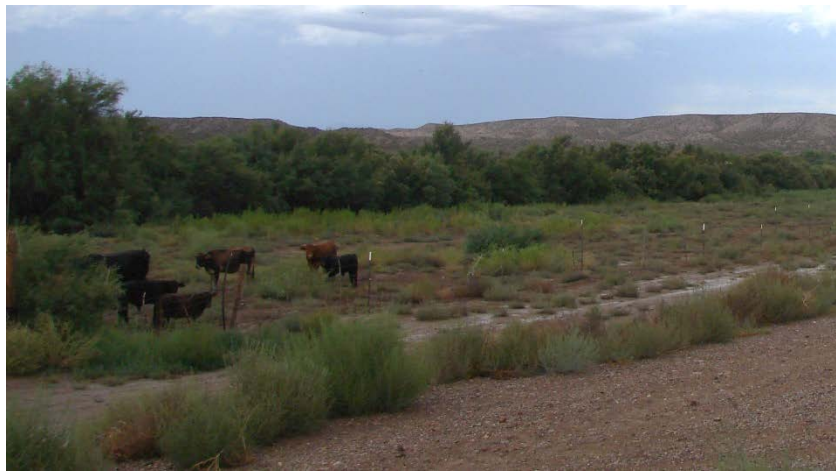
Figure 34 After grazing leases were phased out, grazing occurred without a lease in some cases, such as here near the Doña Ana and Sierra County line, August 2012

In general, the ban on grazing was generally complied with by USIBWC and grazing proponents. There were some locations that continued grazing despite having no lease (see Figure 34). However, due to staffing issues and competing priorities, the Boundary and Realty Office was limited on its enforcement actions for violations on grazing leases.

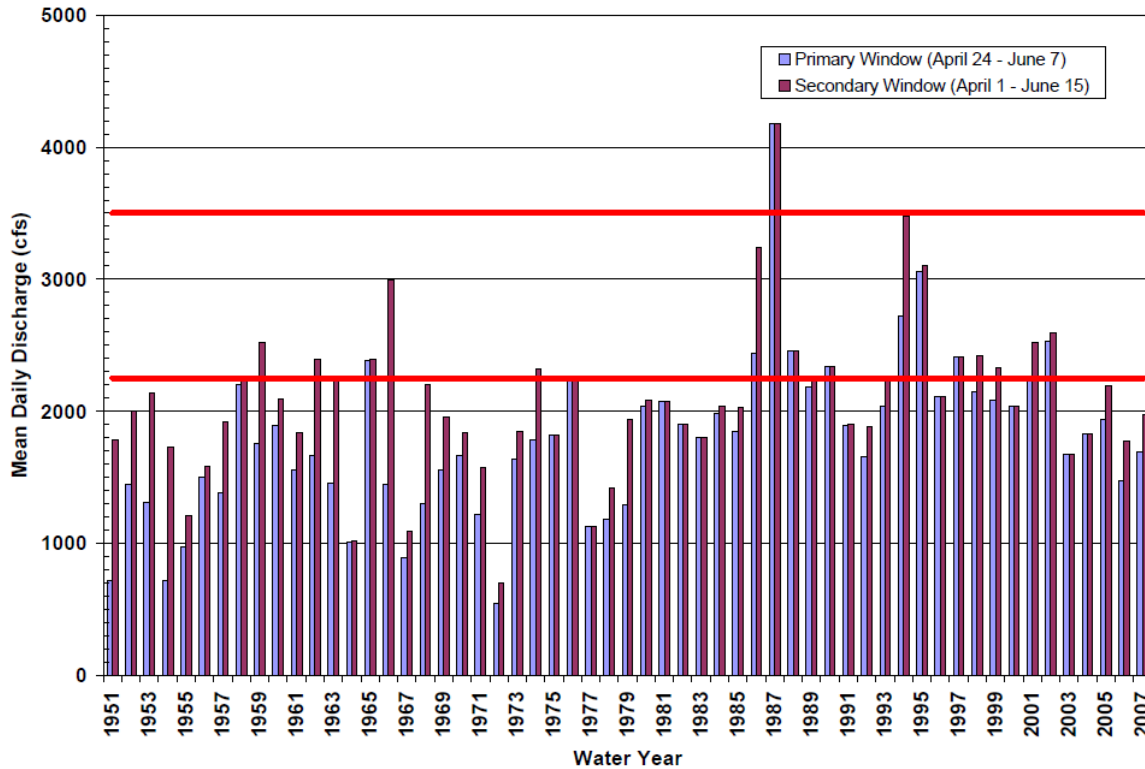
Figure 35 Maximum mean daily flow release from Caballo Dam in the primary and secondary target restoration release windows during the period from water years 1951 through 2007 (from USACE 2009)

Environmental flows were evaluated in a 2008 Technical Memo (Paramatrix 2008), which recommended the season of early spring to promote recruitment of native riparian vegetation. Environmental flows were also evaluated in the 2009 Conceptual Restoration Plan (USACE 2009), where a range of restoration flows from 2,250 cfs to 3,500 cfs was discussed. The lower target flow of 2,250 cfs was reached or exceeding during the primary window of April 24 to June 7 in 11 of the 57 years analyzed (1951 to 2007), see Figure 35.

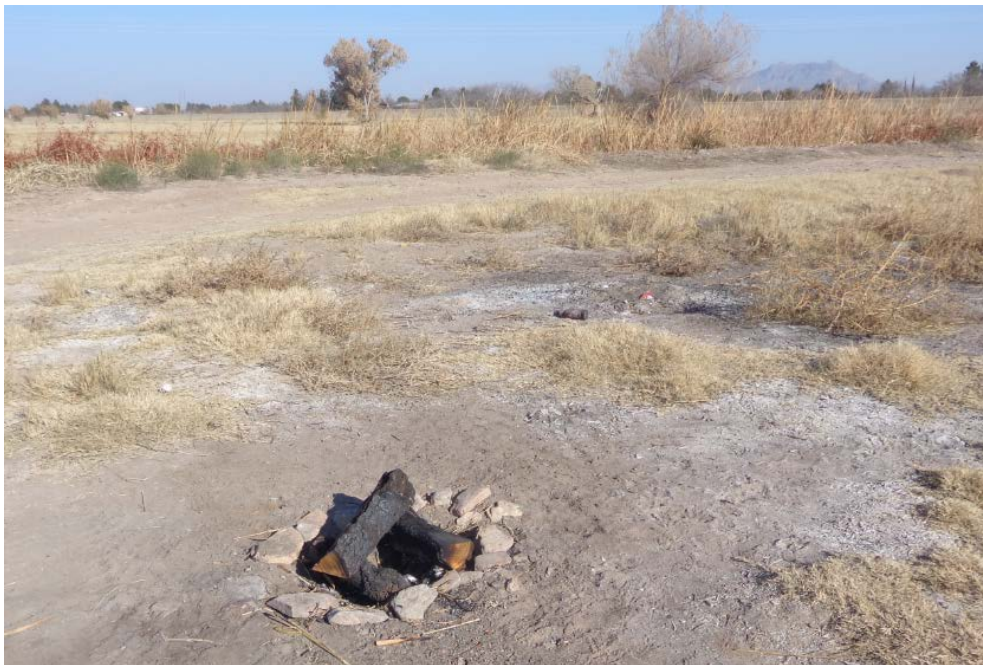
Figure 39 Campfire near the location of the brushfire at Leasburg Extension Lateral WW8 Restoration Site, December 2017

In December 2017, USFWS reported a fire had occurred at the Leasburg Extension Lateral Wasteway #8 Restoration Site in the weeks prior (see Figure 39). USIBWC reconvened internal discussions regarding the enforcement agreements. Public meetings at the Rio Grande Citizens Forum also brought up repeated issues with unauthorized activity and no action from the local law enforcement. USIBWC reconvened meetings with law enforcement entities. In September 2018, USIBWC, the District Attorney, and the Dona Ana County Sheriff signed an agreement for enforcement assistance within RGCP. USIBWC ordered new signs clearly noting authorized and unauthorized activities for various locations. Similar agreements are in the works for City and County of El Paso law enforcement and State of New Mexico and Texas game wardens.

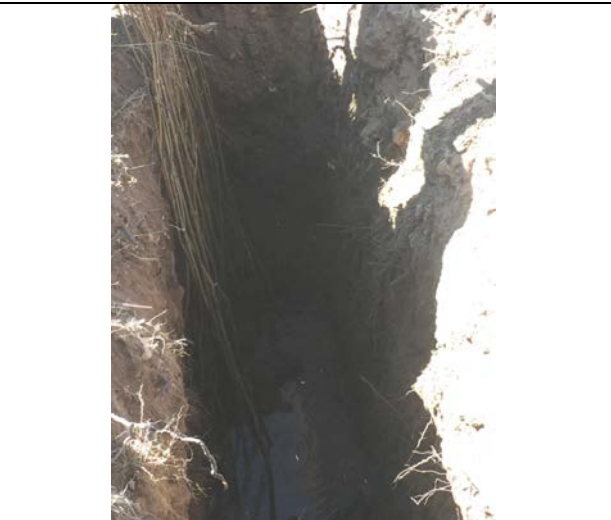
Depth to water during trenching in March 2016 shows favorable groundwater conditions

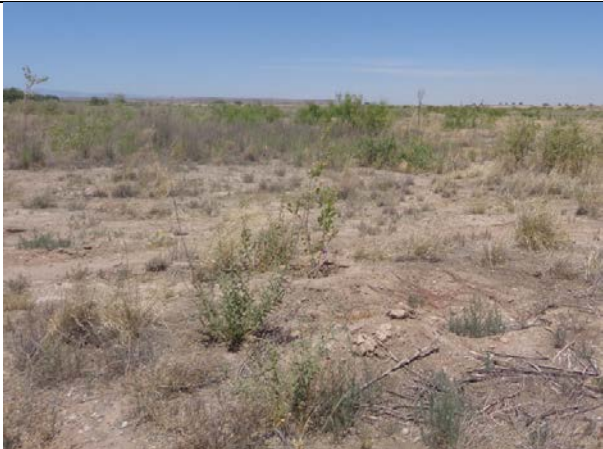
Conditions are harsher at the southern end of the site where plantings are not as vibrant but still surviving. May 2018

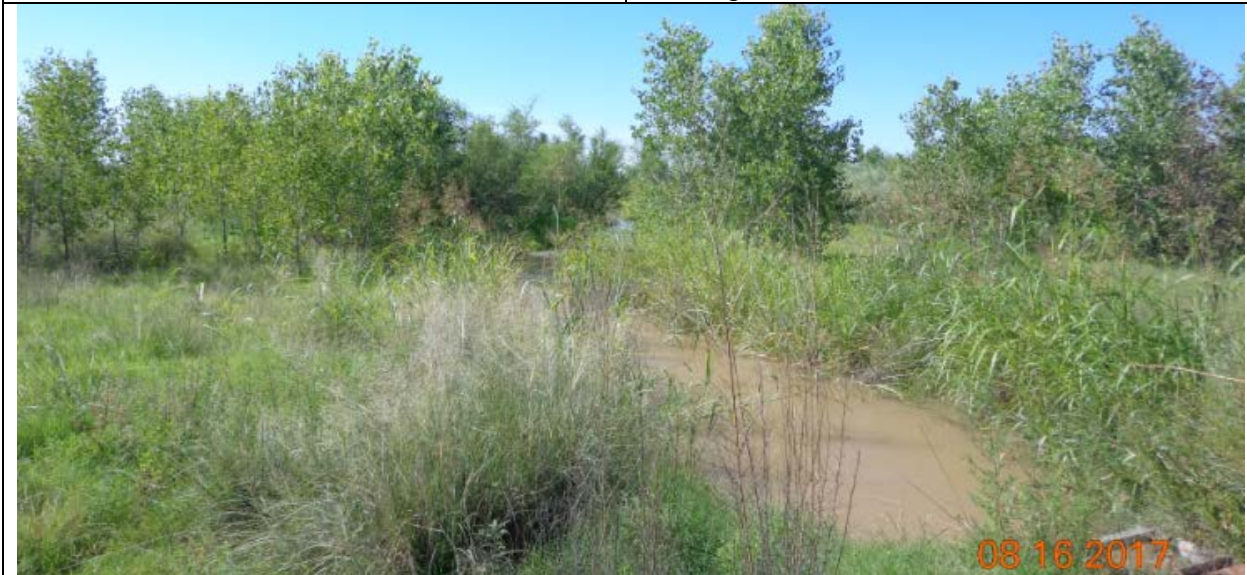
New turnout structure breached and irrigation had to stop. May 2017. Turnout was repaired by EBID in the following month.

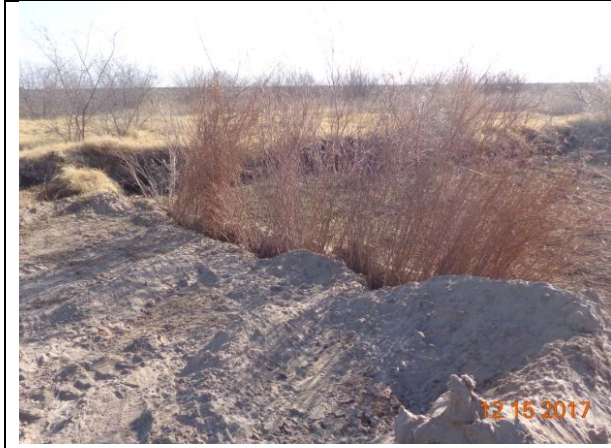
Site visit December 2017 to assess damage from a fire that occurred in October or November 2017.

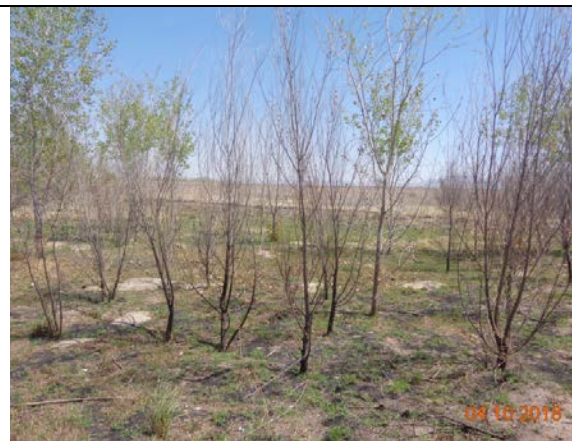
Site visit in April 2018 to assess damage from fires. Trees recovering somewhat from fire damage, April 2018.

Some trees appear to have died during the fire, April 2018.

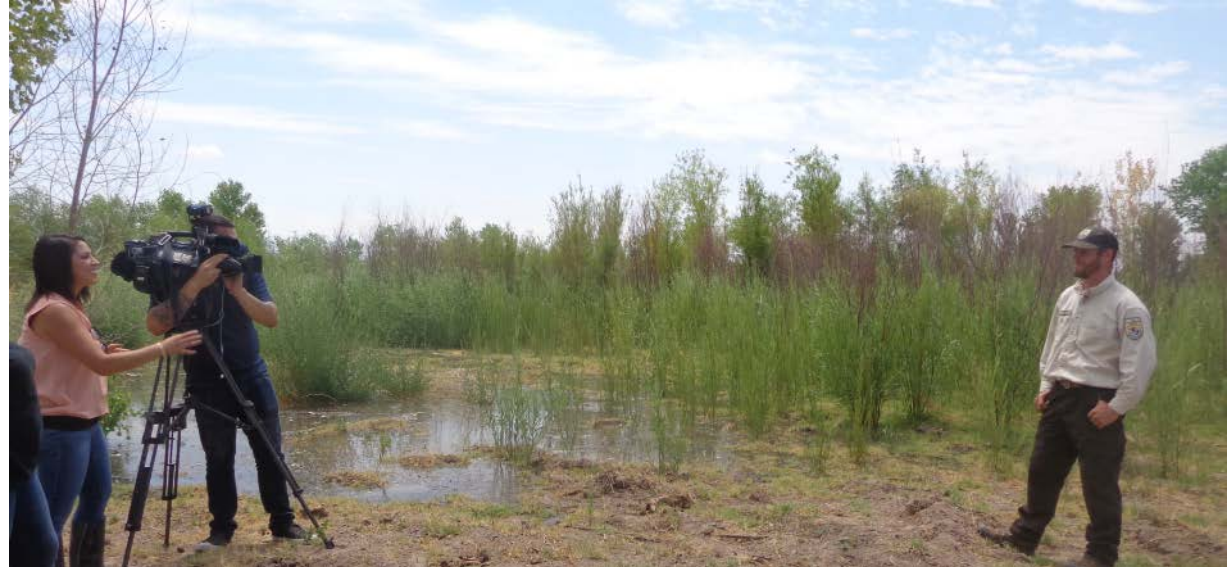
USFWS prepare to fix gopher holes in the irrigation berm to prevent leaks, June 2018

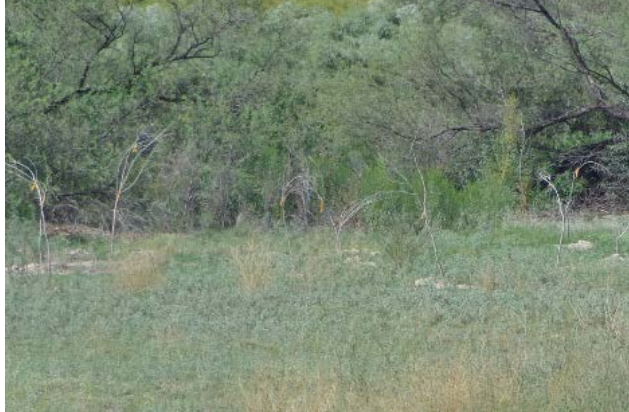
<p>Contractor reported a fire occurred at Sunland Park site in July 2018. Some damage to mature cottonwoods.</p>	<p>Sunland Park had high mortality of cottonwood plantings. August 2018.</p>
