Riparian Habitat Restoration at Four Sites in New Mexico and Texas: Shalem Colony, Vinton A and B, and Valley Creek Restoration Sites

Final Restoration Report
Version: October 2017 to January 2020

Date: **February 28, 2020**

Prepared by: ***IDEALS-AGEISS, LLC***

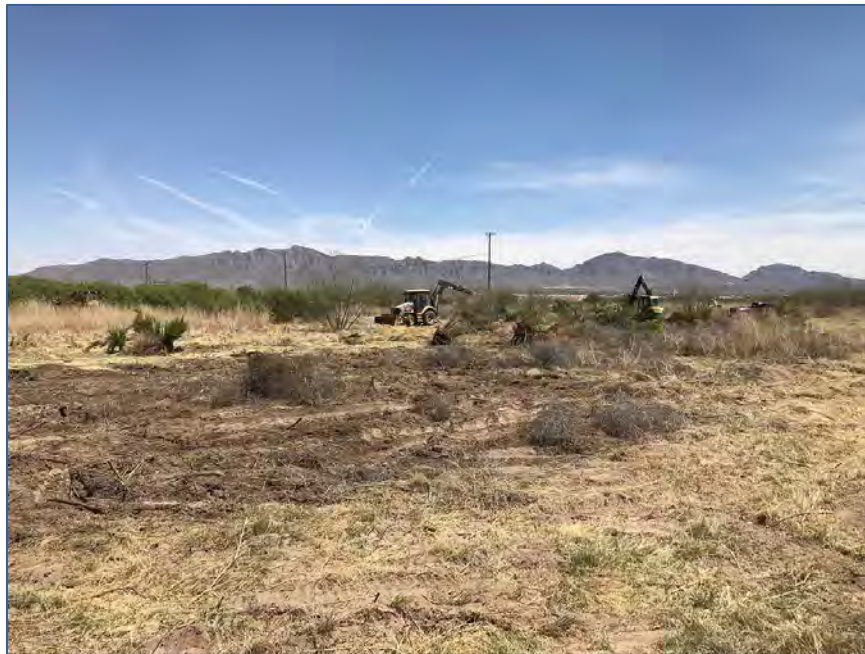
Saltcedar extraction at Vinton B, 24 April 2018

To protect native vegetation identified at the site, vegetation was flagged prior to site preparation. Exotic species were then removed in order to increase the current native habitat. Saltcedar (*Tamarisk spp.*) plants were cut near the base of the plant with a chainsaw, these branches were then run through a wood chipper with the woodchips being dispersed throughout the site. Following removal of the branches and trunks, a backhoe and excavator with a bucket and grappler (clasping thumb) attachment was used to extract the large root masses including the root crown. This removal process was used for saltcedars along the stream bank and throughout the restoration sites within the floodplain. Other low-growing noxious weeds (e.g., Russian thistle [*Salsola tragus*]) were grubbed using a compact skid steer with brush hog

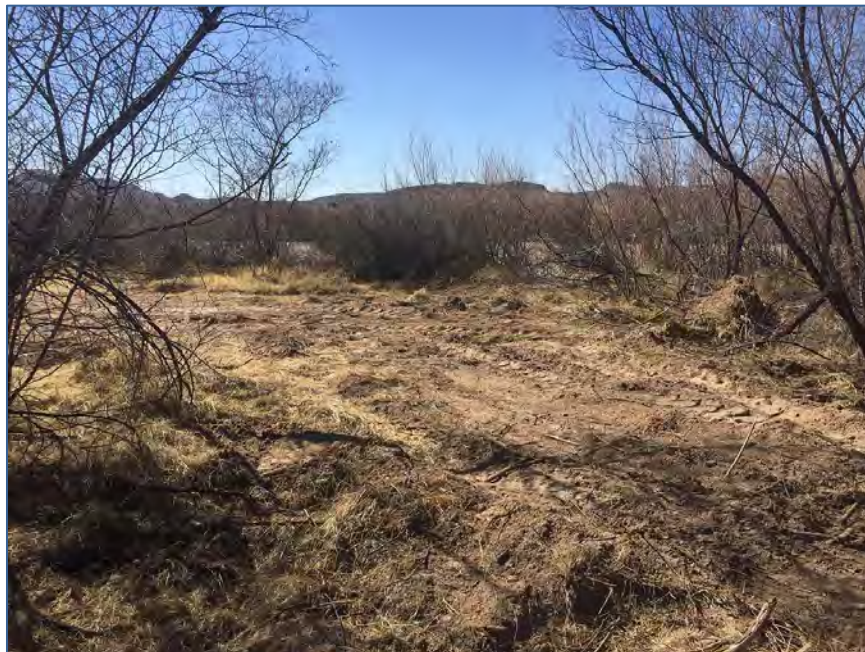
**Shalem Colony restoration site after saltcedar extraction,
23 February 2018**

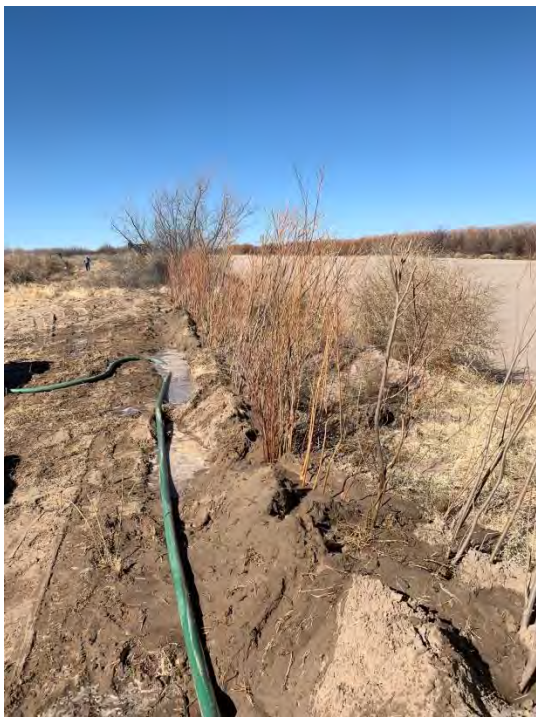
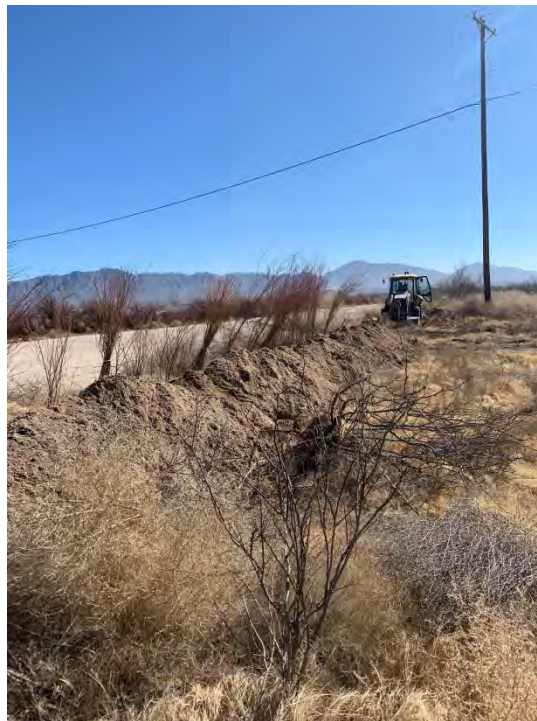
Example of coyote willow transplanting from vegetated islands at the Vinton A site (24 January 2019)

Prior to USIBWC crews removing the island sediment, IDEALS-AGEISS extracted willows from islands designated for removal and transplanted them to the sites. IDEALS-AGEISS crews used a front-end loader to extract clumps of coyote willows with the root balls, approximately 20 stems per bucket load, and placed them in an excavated trench within the floodplain along the riverbank. The trench was dug deep enough such that the root balls would be in contact with groundwater during the winter months when the water table is at its lowest. Once the willows and root balls were placed in the trench, it was then backfilled taking care to not damage newly transplanted willows and to eliminate any voids within the backfill material. Coyote willows from the islands were transplanted from January to March 2018 at the Valley Creek and Vinton B sites and in January 2019 for Shalem and Vinton A sites.

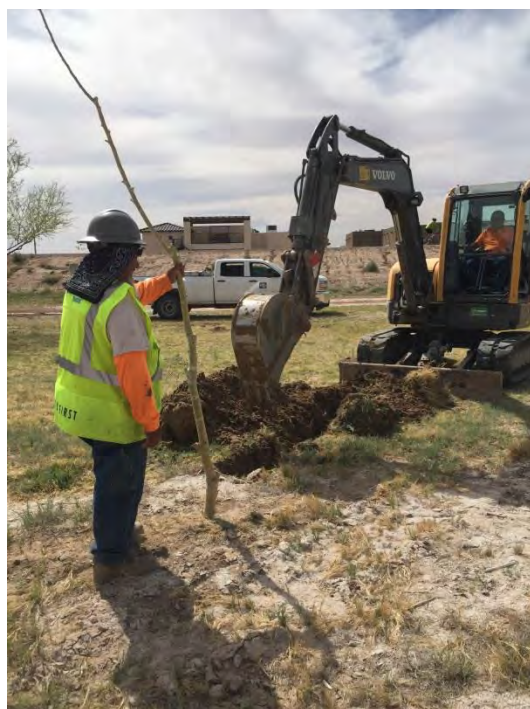
**Cottonwood pole planting, Valley Creek
16 April 2018**

Cottonwood poles and Goodding's willow nurse stock for planting was purchased from Santa Ana Native Plants Bernalillo, New Mexico (cottonwoods) and Hydra Aquatic Albuquerque, New Mexico (Goodding's willows). Cottonwood poles and Goodding's willows were 12- to 16-feet long and approximately 2 to 3 inches in diameter. An auger was used to plant cuttings after the cuttings soaked for approximately 2 weeks. Planting was conducted in late winter/early spring months (February through April). Due to the timing for the transplants, not all sites were planted in the spring of 2018, and the remaining poles were planted winter 2018-2019.

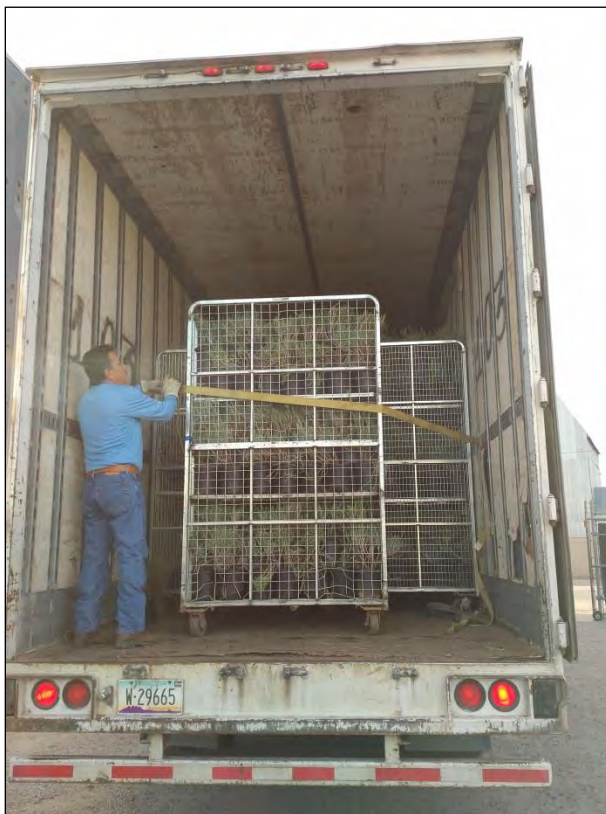
Shrubs for planting at the restoration sites, 25 October 2018

Based on other restoration sites, fall plantings for the long-stem shrubs seem to promote better survivorship; therefore; plantings of these species were moved to late fall 2018. Shrub planting was conducted using an approximate 3-foot auger hole. A 4-inch well around the shrubs was then created to retain additional moisture (Appendix B).

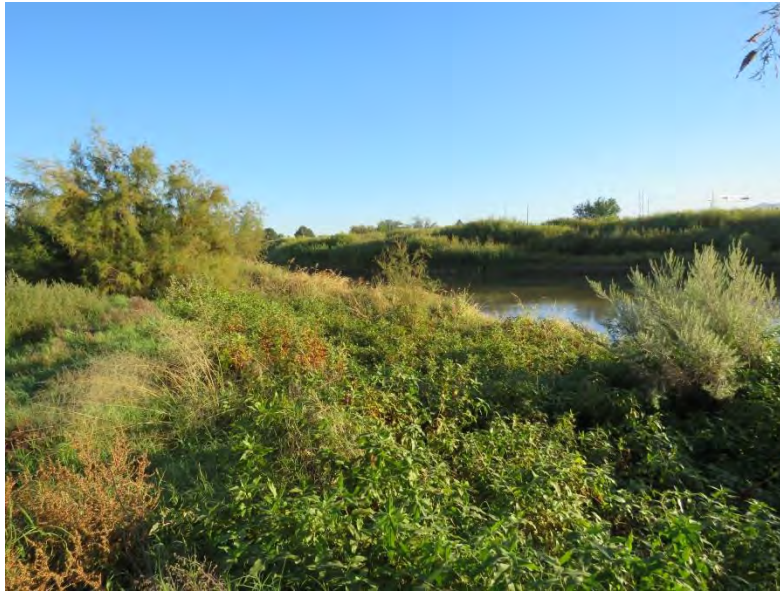
**Vinton B site pre-restoration conditions with saltcedar
along the river bank, 14 November 2017**

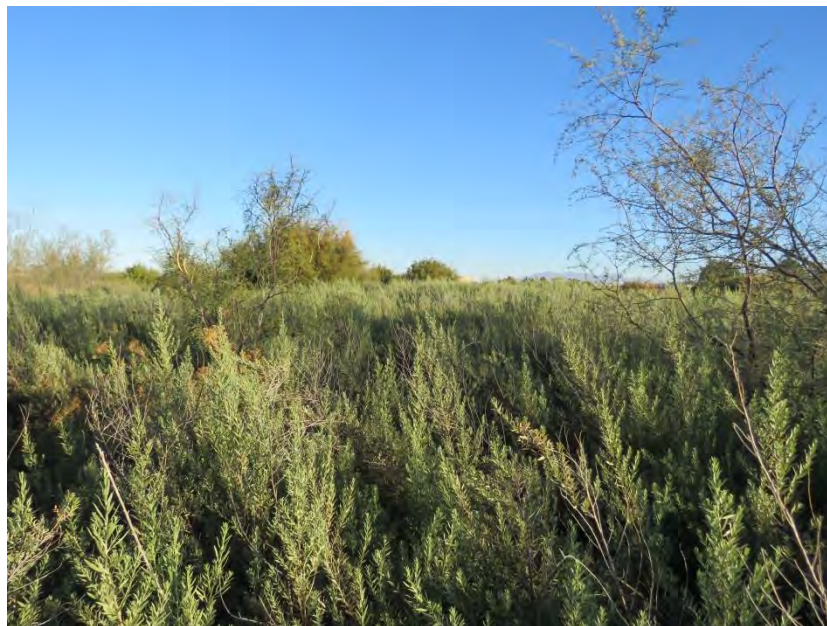
Vinton B site pre-restoration conditions, 14 November 2017

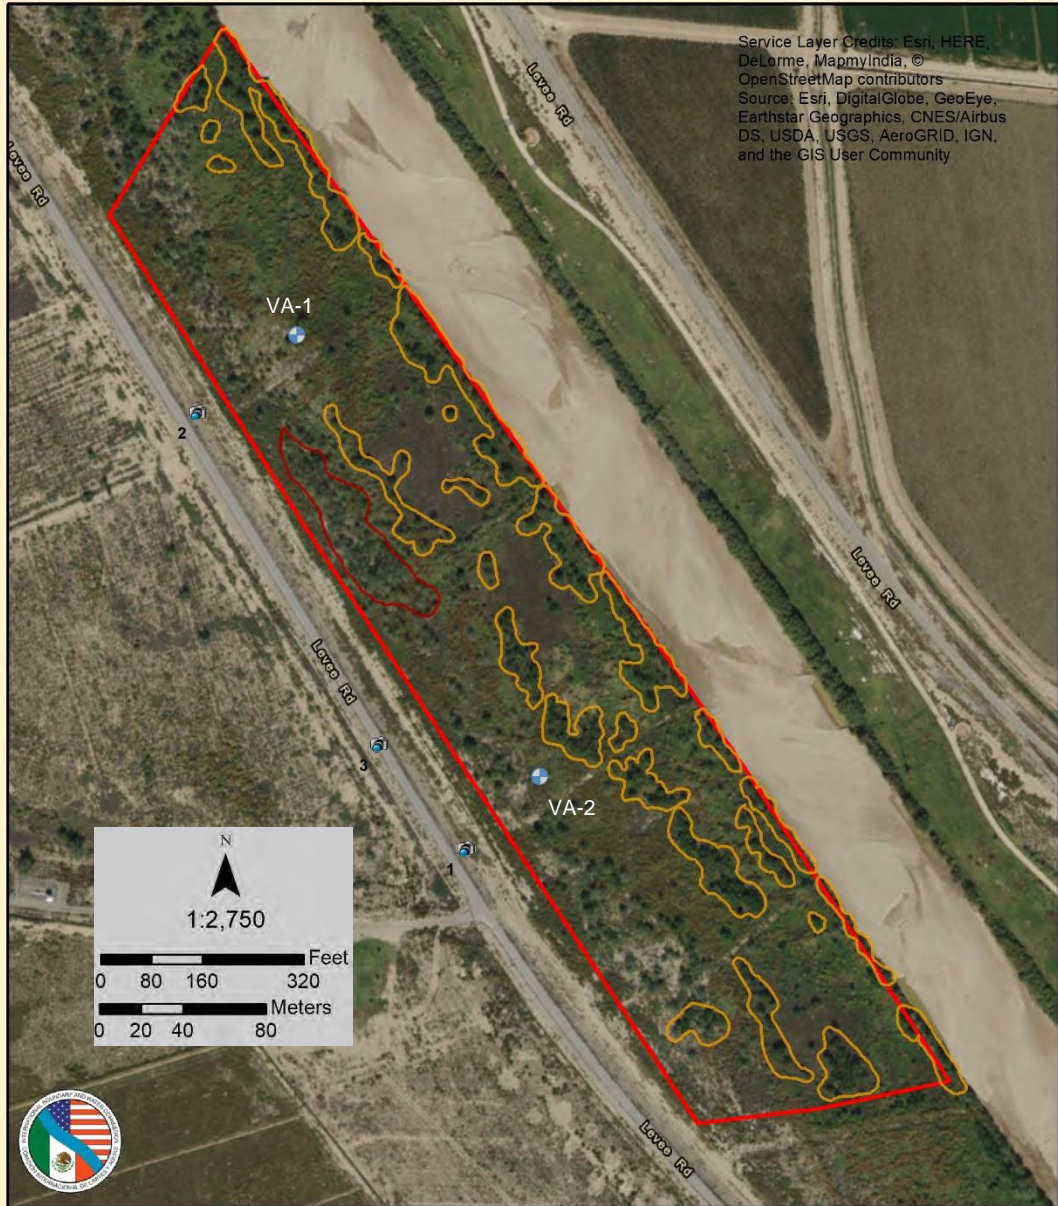
Figure 3-2. Pre-restoration Conditions at the Vinton A Restoration Site

The Agua variant soils found at the Vinton A site are fine sandy loam which is deep and somewhat poorly drained. Clay comprises approximately 4 to 18 percent of the soils type, although some higher clay concentrations were documented in some of the sample horizons (TRC 2010). Salinity at the sites is low. Groundwater levels are highly dependent on water availability in the river and vary considerably at the site with historical records indicating depths that range from 2.6- to 13.7-feet below the surface at Vinton A.

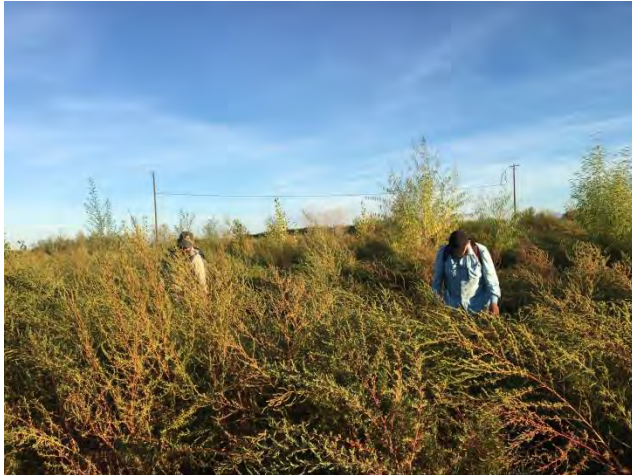
Kochia documented at the Vinton A site in shrub planted areas (17 October 2019)

During the August 2019 monitoring, it was noted that screwbean mesquite continued to dominate the canopy, while salt grass dominated the forb layer (Table 3-3). A dramatic increase in non-native species was seen at the site during both the August and the October 2019 monitoring sessions (Appendix C). Kochia and camelthorn were the predominant species at the site (Table 3-3). The kochia was extremely dense in the areas of the planted long stem shrubs often creating an impenetrable wall.

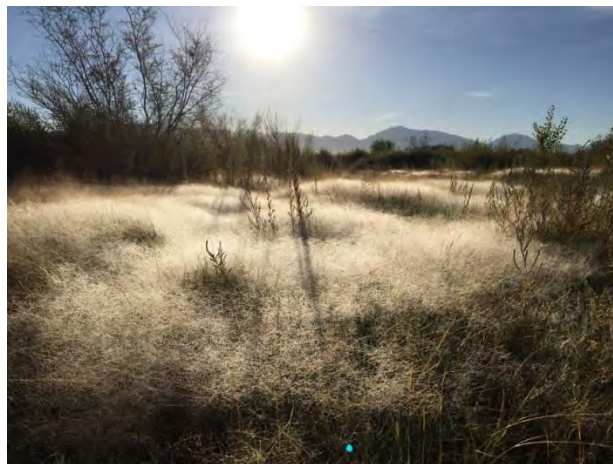
Native grasses growing between the riparian habitat along the river and the kochia stands, 17 October 2019

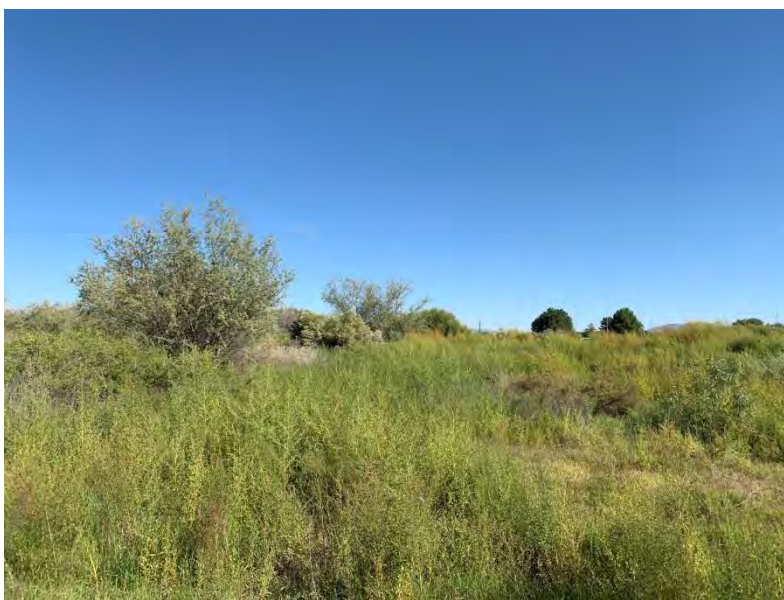
Overview at Vinton B restoration site, 17 October 2019

As of August 2019, a low abundance of saltcedar (20 percent) remained at the Vinton B site and consisted of small re-growth sporadic individuals. August monitoring documented that large screwbean mesquite still occur in moderate abundance (Table 3-3). Like the Vinton A site, kochia and camelthorn have invaded the site, but not in the same density as the Vinton A site. Salt grass and spreading alkaliweed (*Cressa truxillensis*) were the dominant native plants in the shrub and forb layer. In October 2019, non-native species such as Bermuda grass, camelthorn, and kochia still dominated the cover. A diversity of native herb and shrub species was documented throughout the site during October 2019 monitoring (Appendix C).

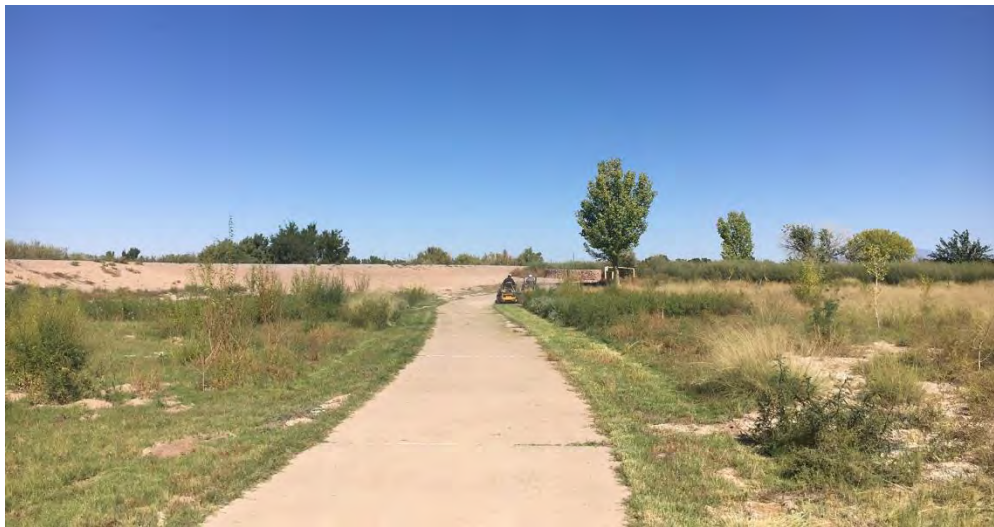
Mowing still occurs at the Valley Creek Restoration site (11 October 2019)

- Continue communication with City of El Paso to ensure long stem shrub plantings, Goodding's willows, and cottonwoods are not damaged by maintenance activities.

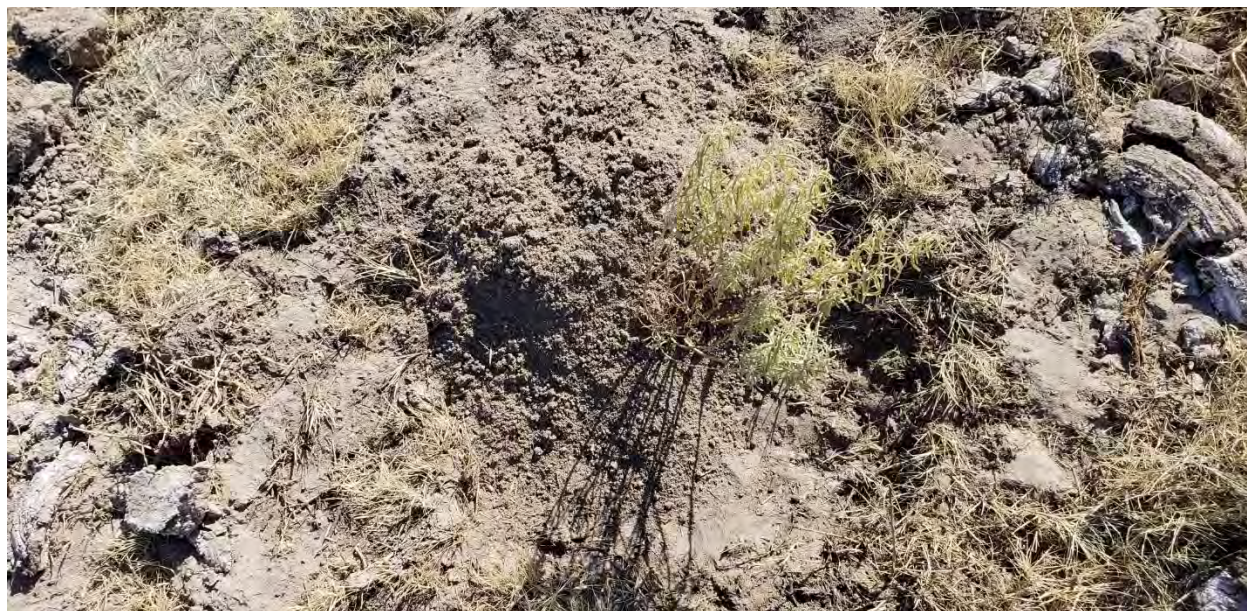
Pocket gopher activity around the long stem shrubs at Valley Creek, 27 November 2018

No recent evidence of herbivory was observed at any of the sites. However, the IDEALS-AGEISS team biologists did observe other instances which had an impact, or the potential to impact, restoration efforts. Pocket gopher activity was pronounced at the Valley Creek, Vinton A, and Vinton B sites. This species can be a serious threat to reforestation and restoration efforts in North America (Engeman and Witmer 2007). Pocket gophers can kill young plants and trees by clipping above ground, girdling trees at the surface, and pruning roots below ground (Witmer and Engeman 2007). No clipped or girdled shrubs were noted during the monitoring sessions; however, potential damage to the root systems of some of the shrubs could have occurred during the spring before other forbs were available for foraging.

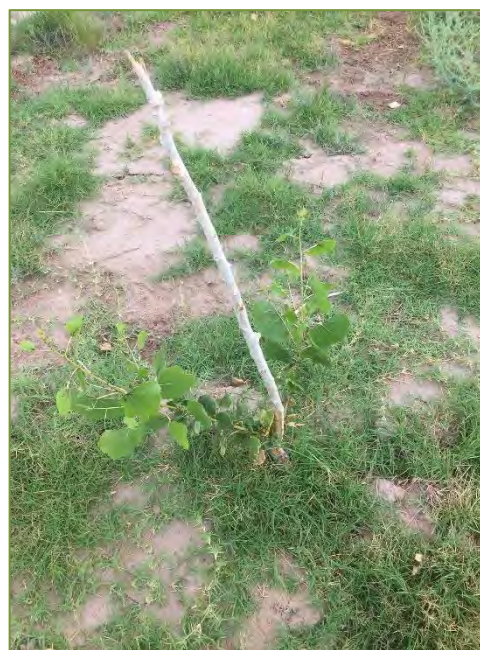
Example of cottonwood regrowth from the base, Valley Creek, 9 August 2018

Many of the cottonwood poles remaining at the sites showed signs of stress although some also showed re-sprouting at the base of the pole. Irrigation peak releases occurred in mid-March and June-July 2018, and an unusually late and minimal monsoon season did not provide much moisture. In addition the majority of the cottonwood poles were planted during the winter 2018-2019 season and irrigation release that year was not until the end of May. Maintenance activities by City of El Paso and vandalism at the Valley Creek site also affected cottonwood survival.

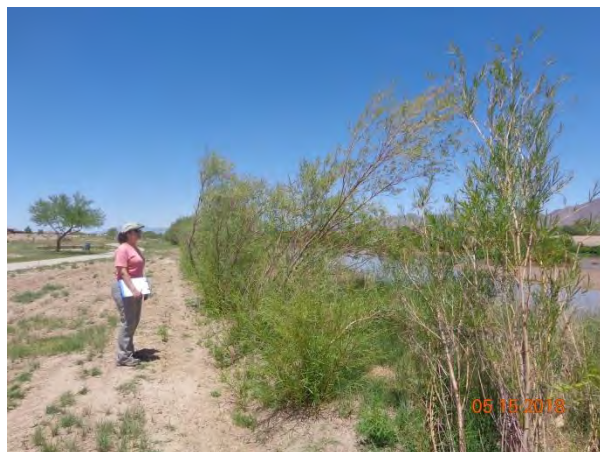
**First year coyote willow transplants at
Valley Creek, 15 May 2018.**

Per the request of the USFWS and stipulations in the 2017 BO, coyote willows were transplanted from islands being removed for channel maintenance. Willows were transplanted to all restoration sites to fill in gaps along the banks where saltcedar extraction occurred. These clumps of willows were difficult to count in every bucket load, so USIBWC and IDEALS-AGEISS determined that an average of 20 willows was contained in each bucket load. Willow transplantation was extremely successful given that mature willows and root balls were transplanted at each site. Kochia was very prominent during the October 2018 and 2019 monitoring periods and was found growing on the edge of the willow transplants towards the restoration site. Survivorship of the transplanted willows was near 100 percent at all the sites and the second year the transplants were difficult to distinguish from the native plants. GPS locations of the transplanted willows enabled biologists to identify the transplanted areas during the 2019 monitoring. Willow sprouts were found during the 2019 monitoring season. Survivorship of the other plant species varied widely between sites. Survivorship estimates documented through the October 2019 monitoring period are noted in the sections below.

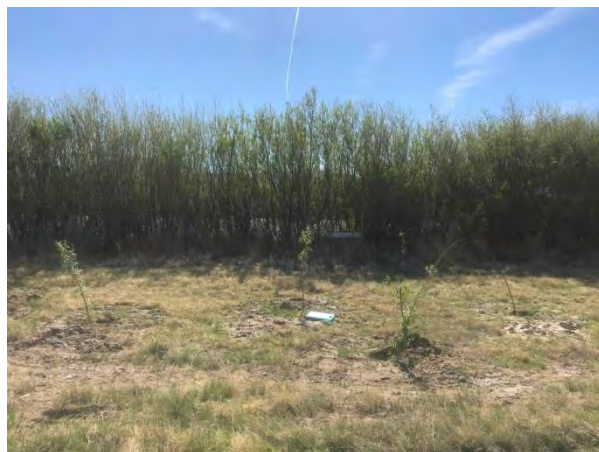
**Second year coyote willow transplants at
Valley Creek, 19 April 2019.**

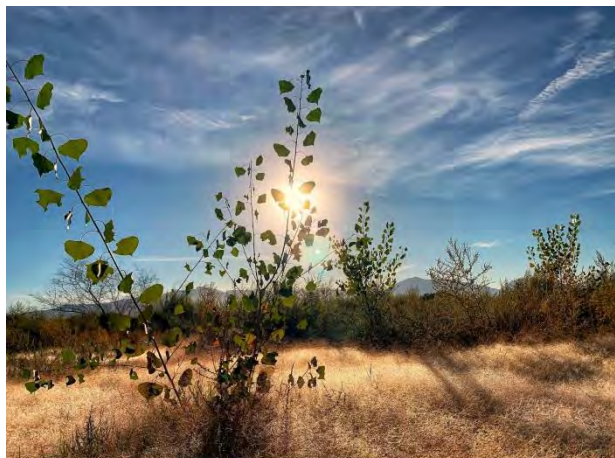
Cottonwoods and salt grass at the Vinton A restoration site, 17 October 2019

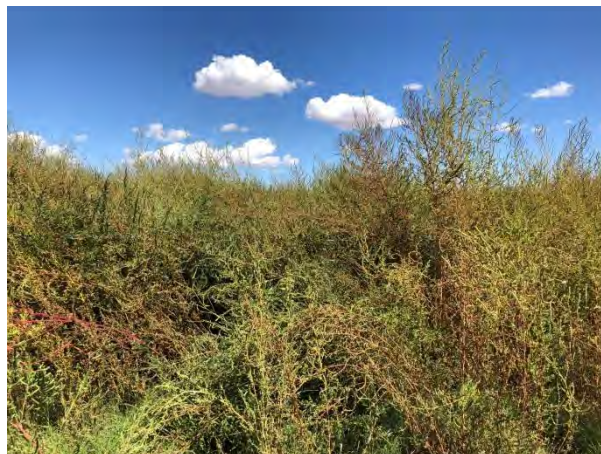
Kochia growing at the Vinton A site, 17 October 2019

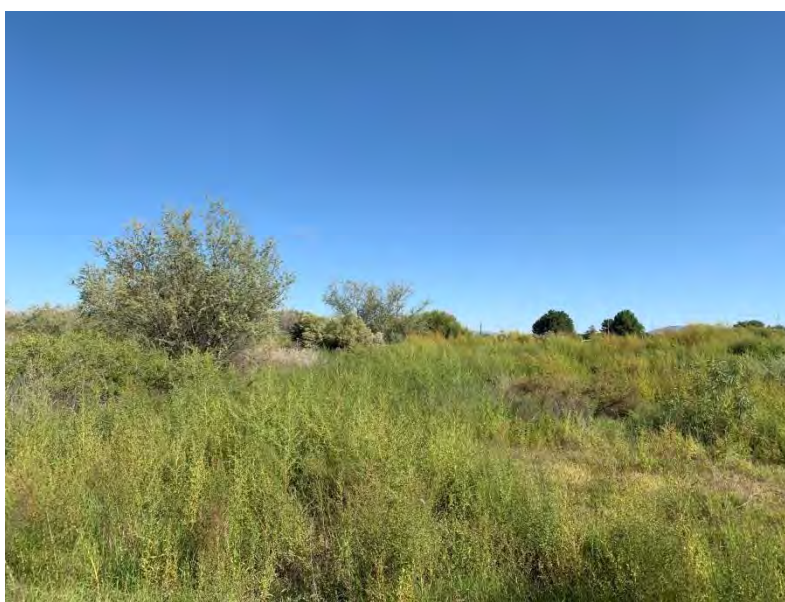
By the October 2018 monitoring event, only about one third of the coyote willows had been transplanted. The remaining plantings for this site occurred during fall 2018 and winter of 2019. Like the Vinton A site, Vinton B had a high density of ground cover dominated by three invasive plants: camelthorn, Bermuda grass, and kochia. Cottonwood and coyote willow pole survival was very low at the site, with several poles not accounted for as no evidence of the plantings remained (Table 3-7). Kochia has invaded several of the planting holes. Four-wing salt bush plantings at the site were thriving during the 2019 monitoring sessions. The majority of the shrubs was flowering during the 2019 season and was well established.

Overview of Vinton B restoration site during the October 2019 monitoring, 17 October 2019

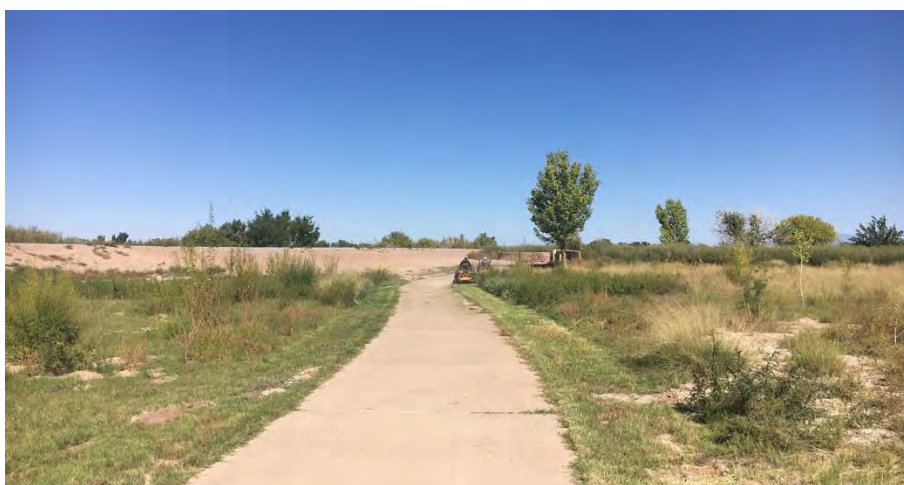
Mowing at Valley Creek site does decrease non-native species but has potential to impact restoration efforts, 3 October 2019

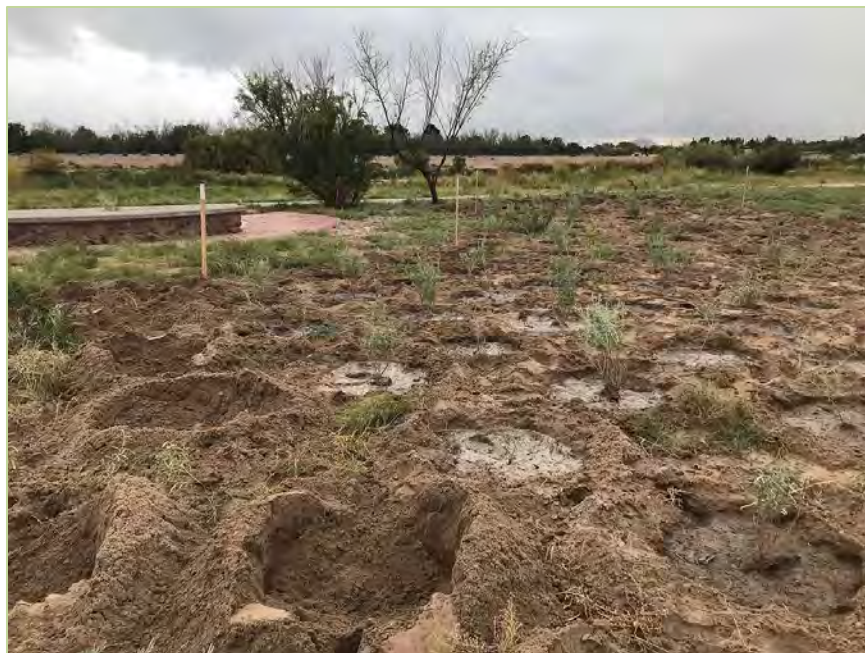
**Long stem shrubs planted at Valley Creek restoration site,
24 October 2018**

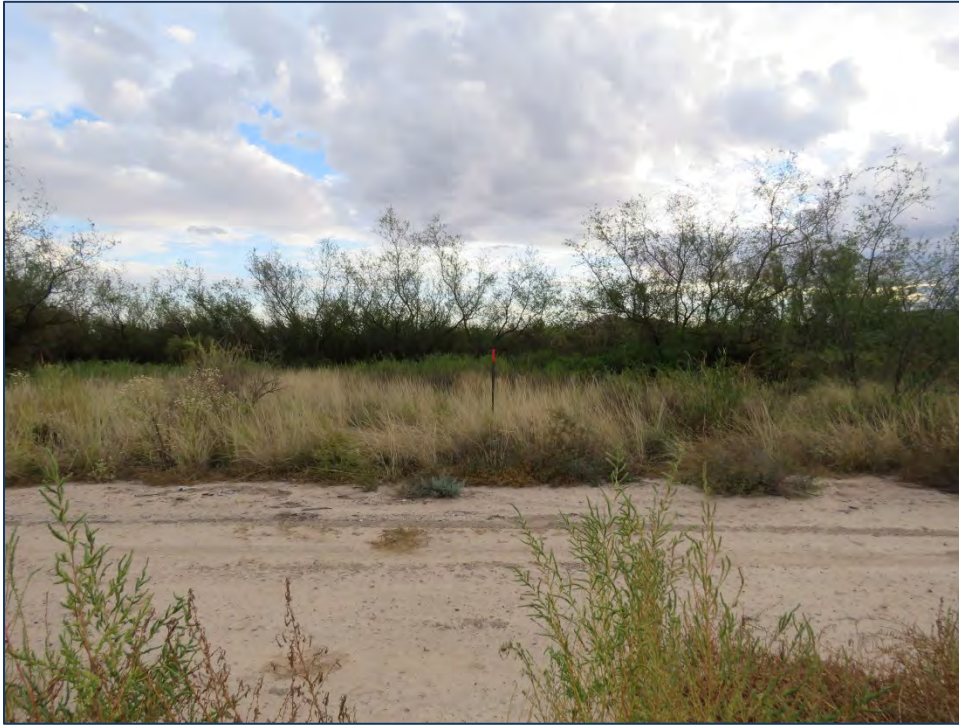
Figure 3-1. Pre-implementation Photo of Shalem Colony at Photo Point 1

Mowing has been discontinued along most of the site since the 1990s, leading to the mature screwbean mesquite (*Prosopis pubescens*) forest (>5 acres) with scattered saltcedar (*Tamarisk spp.*; Figure 3-1). The area has high abundance of large screwbean mesquite forming a large thicket of vegetation. The vegetation on the southern lateral along the bank at this site is bulrush (*Scirpus spp.*) and cattail (*Typha spp.*) in low abundance. The southern portion of the site has riparian vegetation along the river in the form of mixed vegetation dominated by tall screwbean mesquite with coyote willow (*Salix exigua*) and saltcedar (showing the effects of *Diorhabda* infestation). Coyote willow is in moderate abundance and could be developed at the site. False seep willow (*Bacharis salicifolia*) occurs in low abundance. The main exotic species noted during both surveys are saltcedar in moderate abundance and Russian thistle (*Salsola tragus*) in high abundance (Figure 3-2). Most of the saltcedars occurring on this site can be removed without damaging native vegetation.

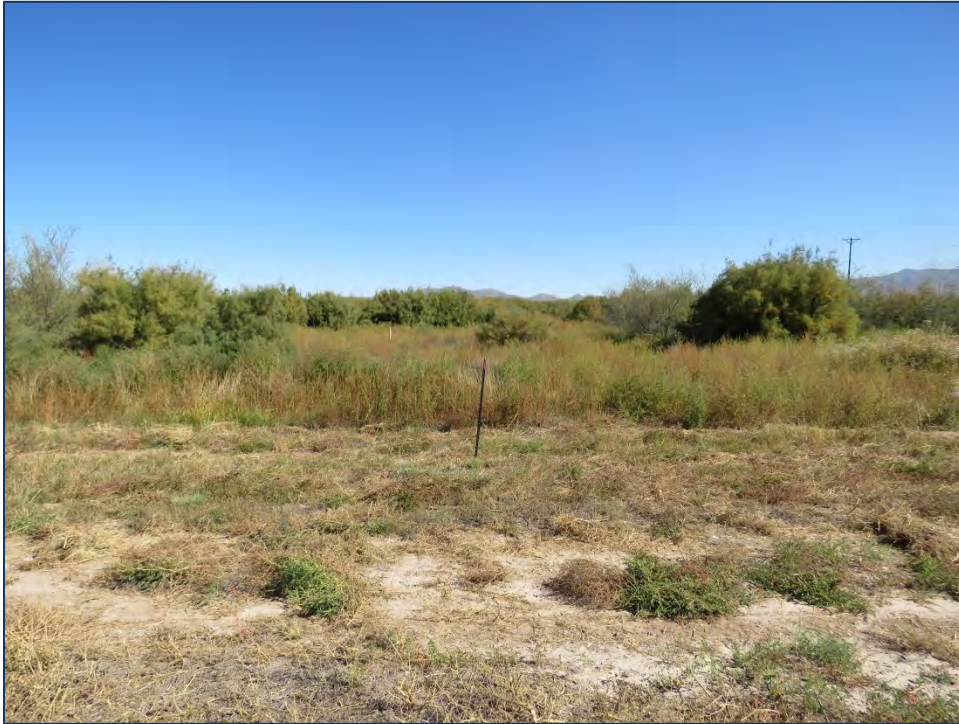
Figure 3-4. Pre-implementation Photo of Vinton A at Photo Point 1

Mowing has been discontinued at the Vinton A site since 2011 and the site is nearly contiguous along the west side of the river with the Vinton B site. Dominant tree and shrub vegetation at the site consists of saltcedar, screwbean mesquite, and four-wing saltbush (*Atriplex canescens*; Figure 3-4). Good stands of mesquite occur sporadically through the site. Smooth pigweed is dense and abundant on the site with wolfberry (*Lycium spp.*) in low to moderate abundance. Saltcedar is present throughout the site in some dense stands and currently shows limited signs of stress from *Diorhabda* (Figure 3-5). Other invasive species on the site include moderate to high abundance of Russian thistle and sporadic Siberian elms (*Ulmus pumila*). The central portion of Vinton A has an area of mixed vegetation that may be adequate for flycatchers within the next few years, although yellow-billed cuckoos (*Coccyzus americanus*) habitat does not currently exist at this site (IDEALS-AGEISS 2016). Vegetation and fauna observed at the Vinton A site are listed in Tables 3-3 and 3-4 respectively. The current distribution of saltcedar and native vegetation is noted in Figure 3-6.

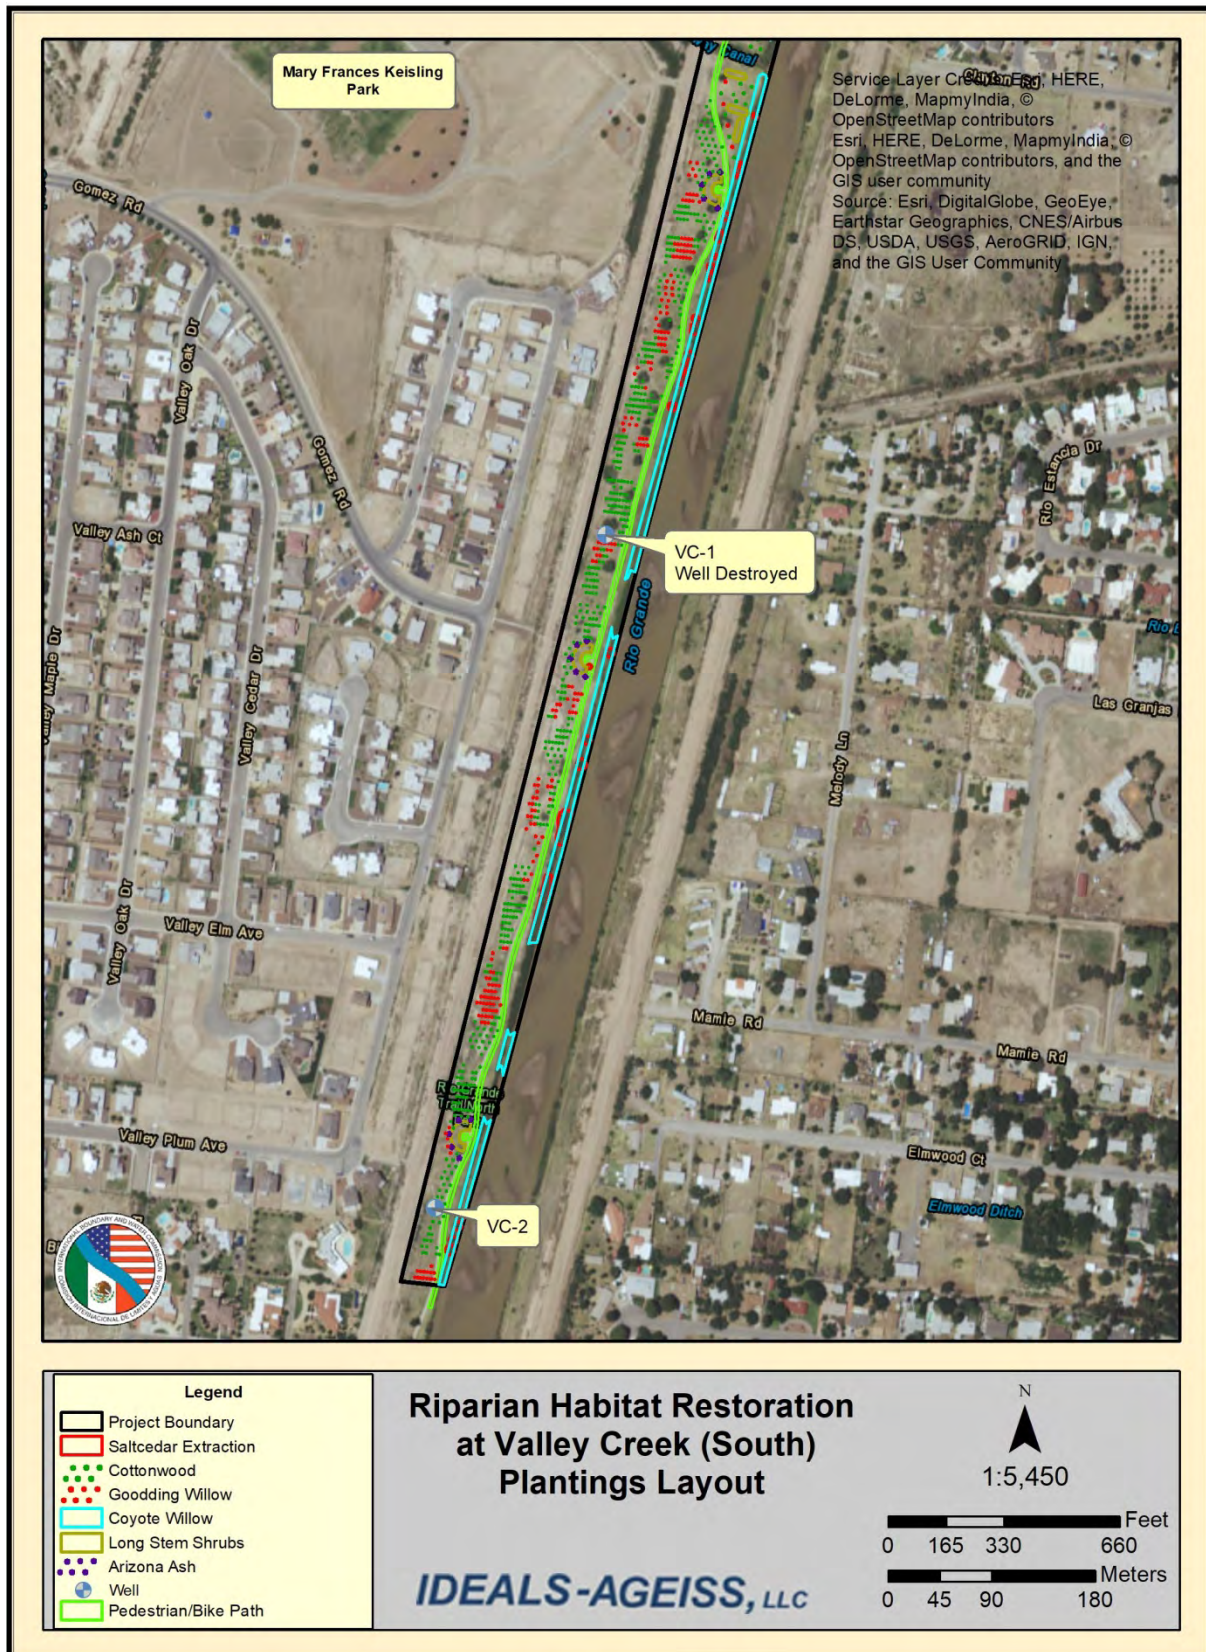
Figure 4-5. Valley Creek South Planting Layout

Longstem shrubs will be concentrated in areas adjacent to the laterals. Goodding's willow and cottonwood trees can be planted with an overall canopy cover of about 30 percent. Shrubs (coyote willow, sumac, seep-willow, etc.) would form scattered patches throughout the area at a high density with some open areas (TRC 2011). The clustering would assist with more uniform mowing areas and provide for a planting layout that would minimize encroachment along the trail path and thus provide a buffer between the trail and plantings. Coyote willow whips will be planted at approximately 100 per acre, Goodding's willow whips at 10 per acre, cottonwood poles at 20 per acre, and longstem riparian shrubs at 160 per acre. Minimal saltcedar extraction is needed on the north end of the site (Figure 4-5). Coyote willows and longstem shrubs will be planted between the river and the walking and bicycle path with a 10-foot buffer between the vegetation and the pathway. Patches of Goodding's willows and cottonwoods will be placed throughout the site (Figures 4-4 and 4-5). Cottonwoods will be distributed amongst the long-stem shrubs where the laterals meet the river. Riverside areas where saltcedar are extracted will be planted with coyote willows. Vegetation will not be planted within 10 feet of monitoring wells to protect their integrity.

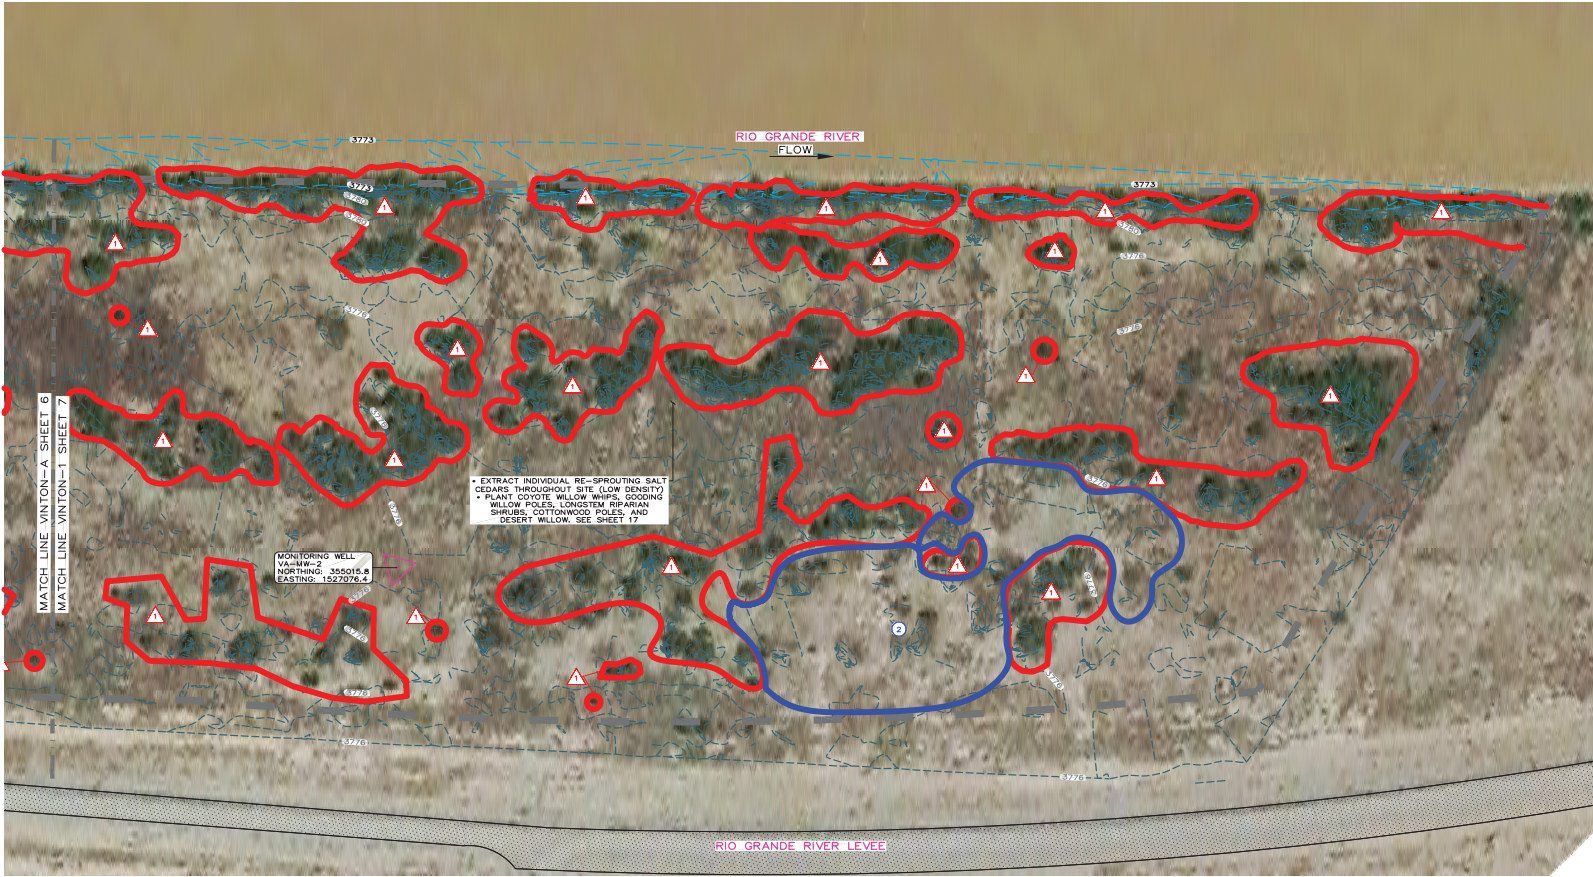
• EXTRACT INDIVIDUAL RE-SPROUTING SALT CEDARS THROUGHOUT SITE (LOW DENSITY)
 • PLANT COYOTE WILLOW WHIPS, GOODING WILLOW POLES, LONGSTEM RIPARIAN SHRUBS, COTTONWOOD POLES, AND DESERT WILLOW. SEE SHEET 17

MONITORING WELL
 VA-14W-2
 NORTHING: 355018.8
 EASTING: 1527076.4

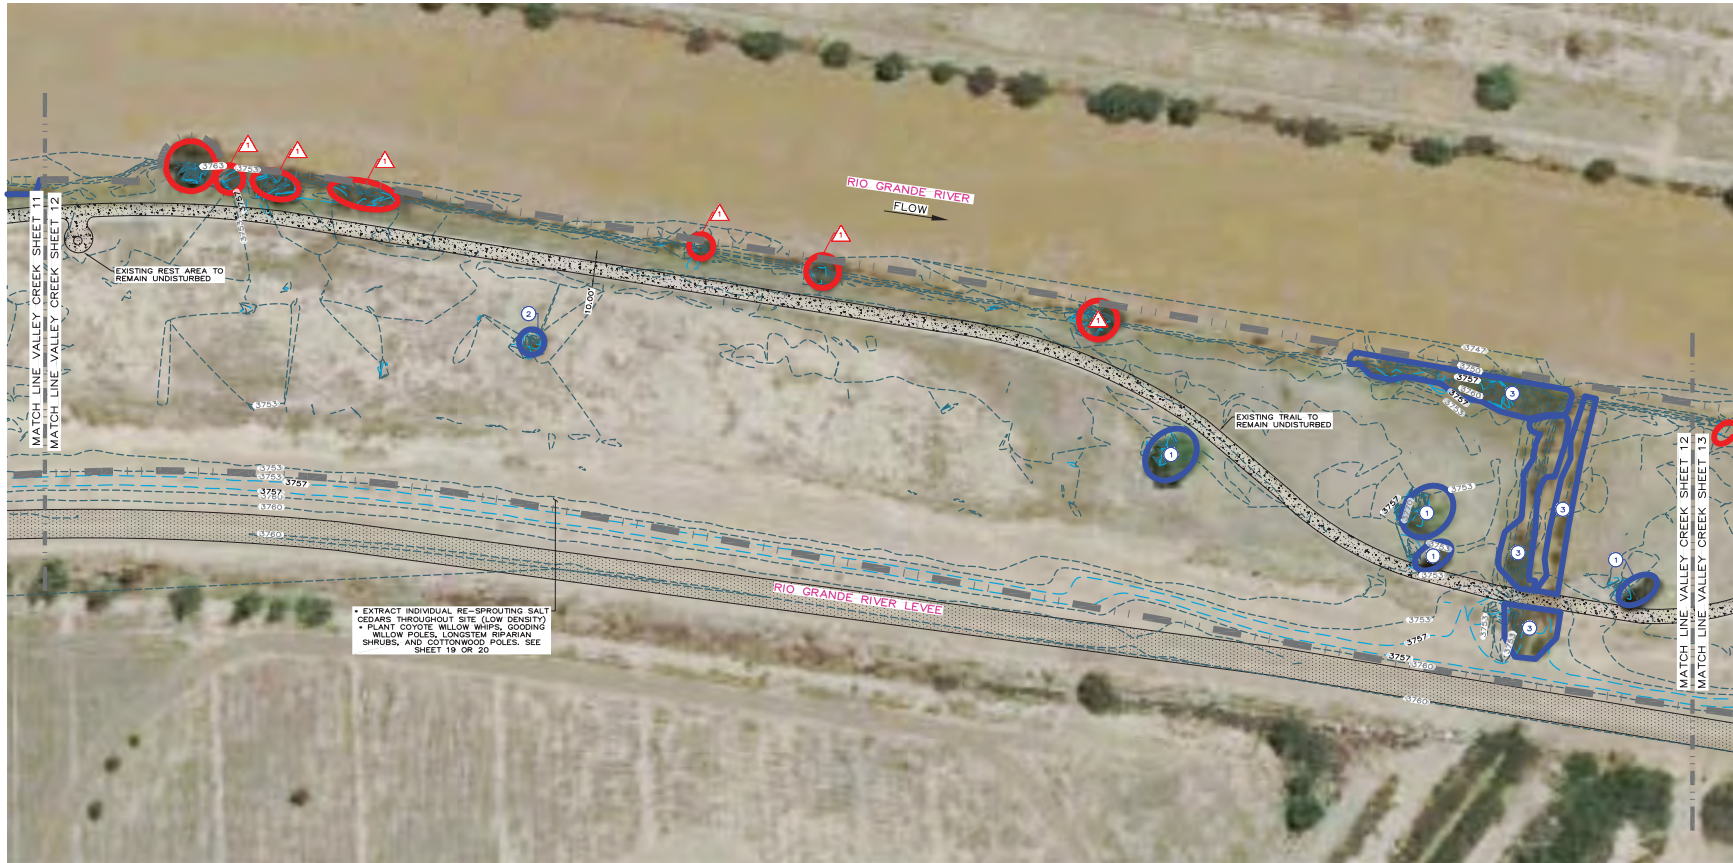
SITE 26 - VALLEY CREEK SITE PLAN

EXTRACT INDIVIDUAL RE-SPROUTING SALT CEDARS THROUGHOUT SITE (LOW DENSITY)
 PLANT COYOTE WILLOW WHIPS, GOODING WILLOW POLES, LONGSTEM RIPARIAN SHRUBS, AND COTTONWOOD POLES. SEE SHEET 19 OF 20

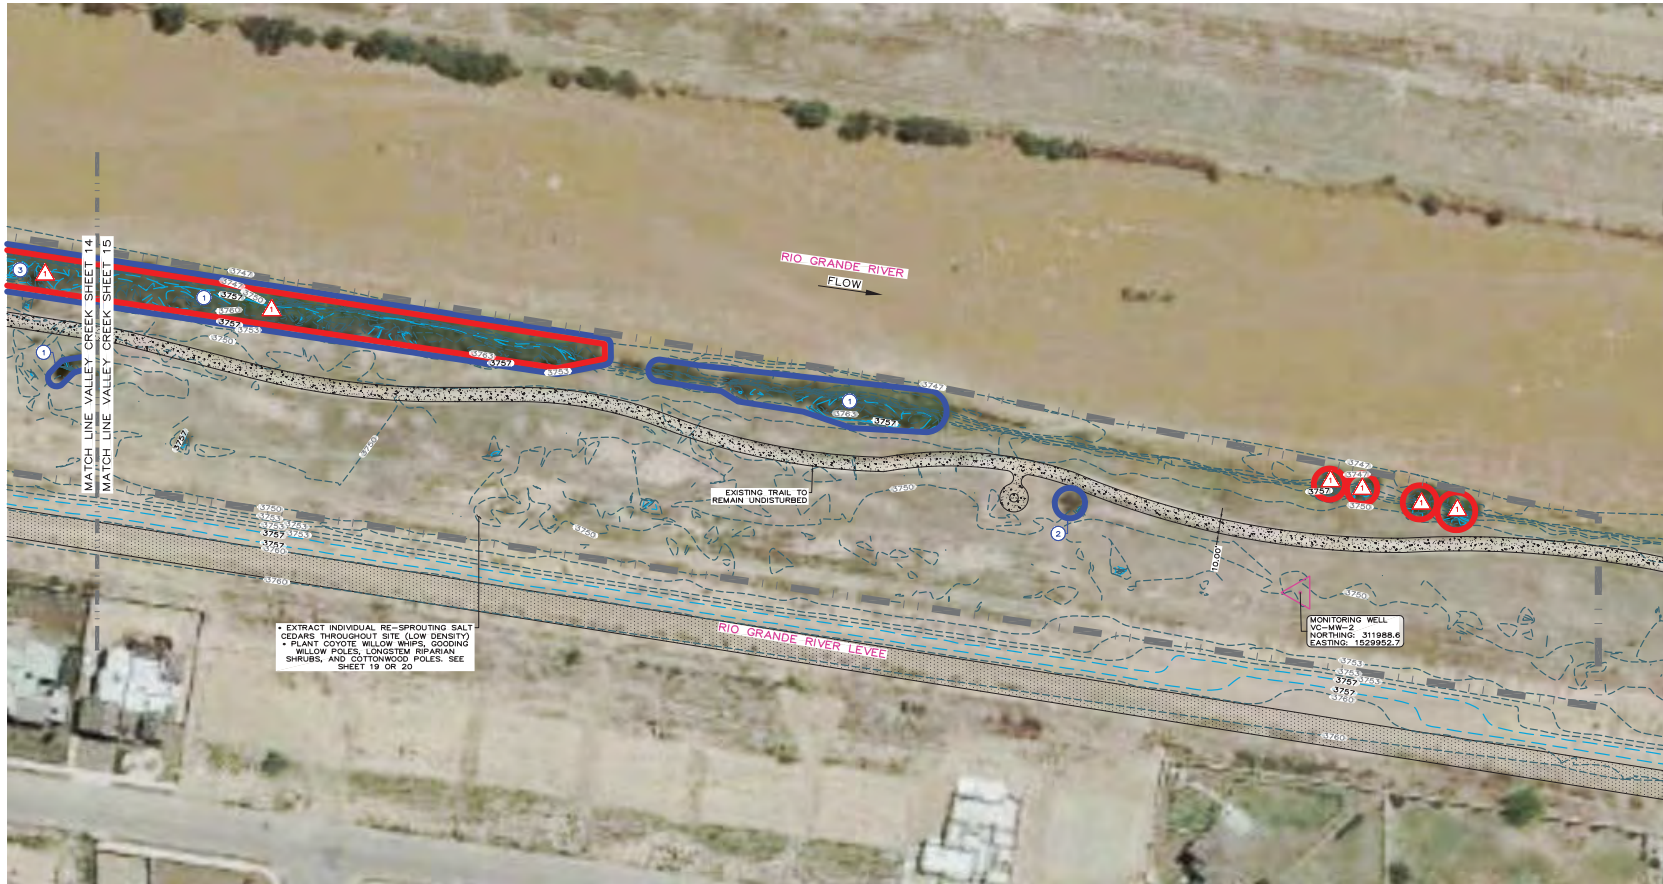
EXTRACT INDIVIDUAL RE-SPROUTING SALT CEDARS THROUGHOUT SITE (LOW DENSITY)
 PLANT COYOTE WILLOW WHIPS, GODDING WILLOW POLES, LONGSTEM RIPARIAN SHRUBS, AND COTTONWOOD POLES. SEE SHEET 19 OR 20

MONITORING WELL
 VC-MW-2
 NORTHING: 311988.6
 EASTING: 152992.7
