Riparian Habitat Restoration at Four Sites in New Mexico and Texas: Shalem Colony, Vinton A and B, and Valley Creek Restoration Sites

Final Restoration Report
Version: October 2017 to January 2020

Date: **February 28, 2020**

Prepared by: ***IDEALS-AGEISS, LLC***

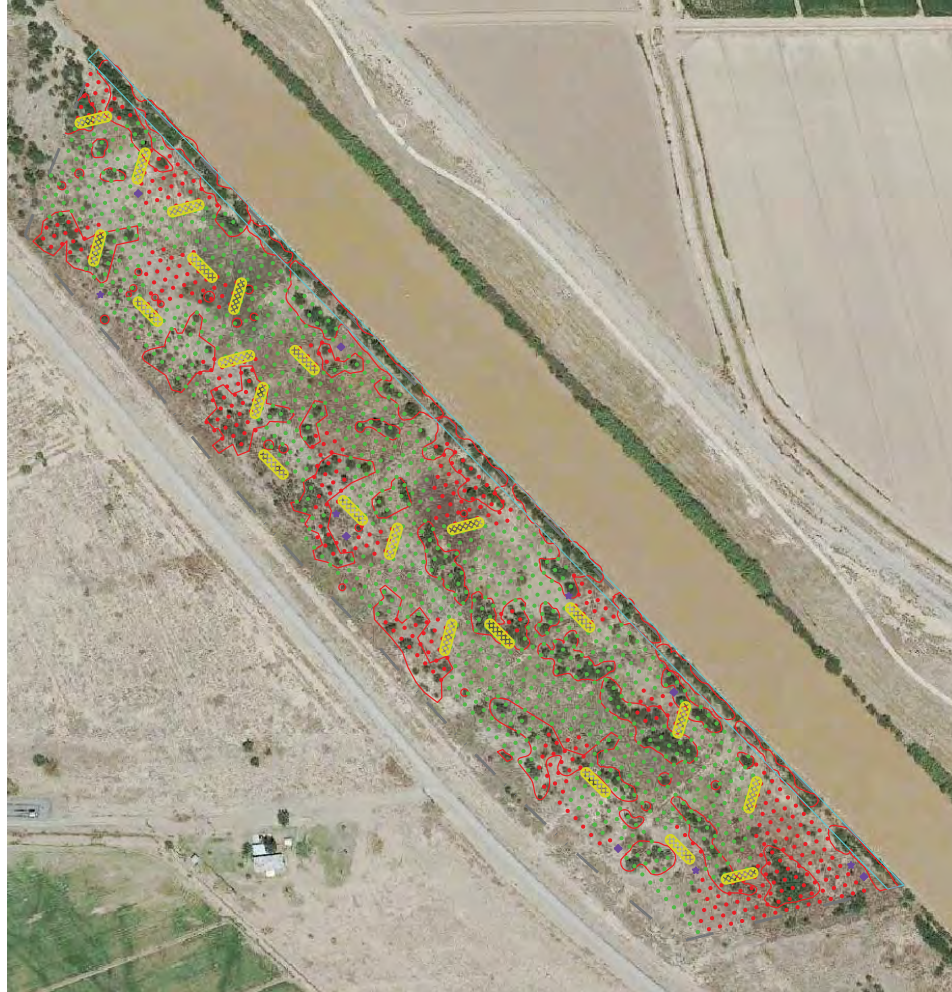
SITE 24 - VINTON A PLANTING MAP

MINIMUM NUMBER OF PLANTINGS AT EACH SITE						
SITE	GRASS AND FORB SEEDING (ACRES)	COYOTE WILLOW WHIPS	GOODING WILLOW POLES	COTTONWOOD POLES	LONGSTEM RIPARIAN SHRUBS	DESERT WILLOW / ARIZONA ASH / SALT CEDAR EXTRACTION (ACRES)
VINTON A	0	2940	441	1029	1470	5/5 ±4.60

NOTE:
 LONGSTEM SHRUBS PLACED PARALLEL TO PEDESTRIAN/BIKE PATH SHALL MAINTAIN 10.00' MINIMUM SEPARATION FROM CONCRETE EDGE.

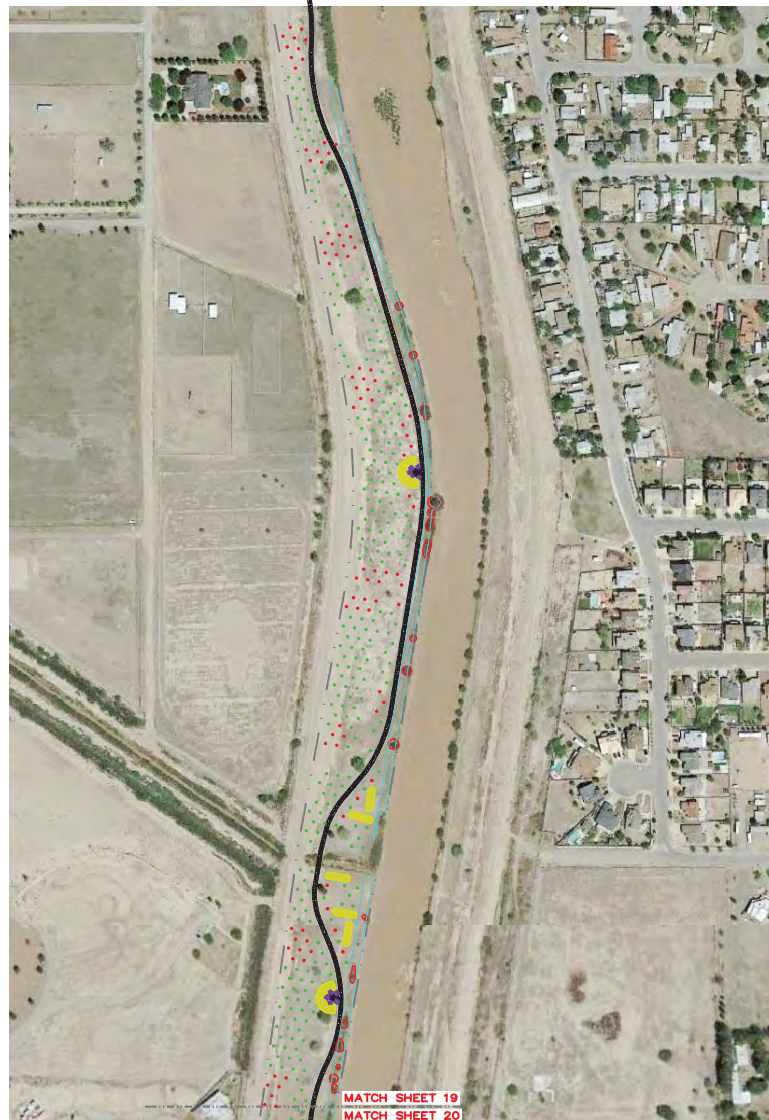
VALLEY CREEK SHEET MAP
 NOT TO SCALE

SITE	MINIMUM NUMBER OF PLANTINGS AT EACH SITE						
	GRASS AND FORB SEEDING (ACRES)	COYOTE WILLOW WIRES	GOODING WILLOW POLES	COTTONWOOD POLES	LONGSTEM RIPARIAN SHRUBS	DESERT WILLOW ARIZONA ASH	SALT CEDAR EXTRACTION (ACRES)
VALLEY CREEK	0	1100	220	440	1000	10/10	±0.61

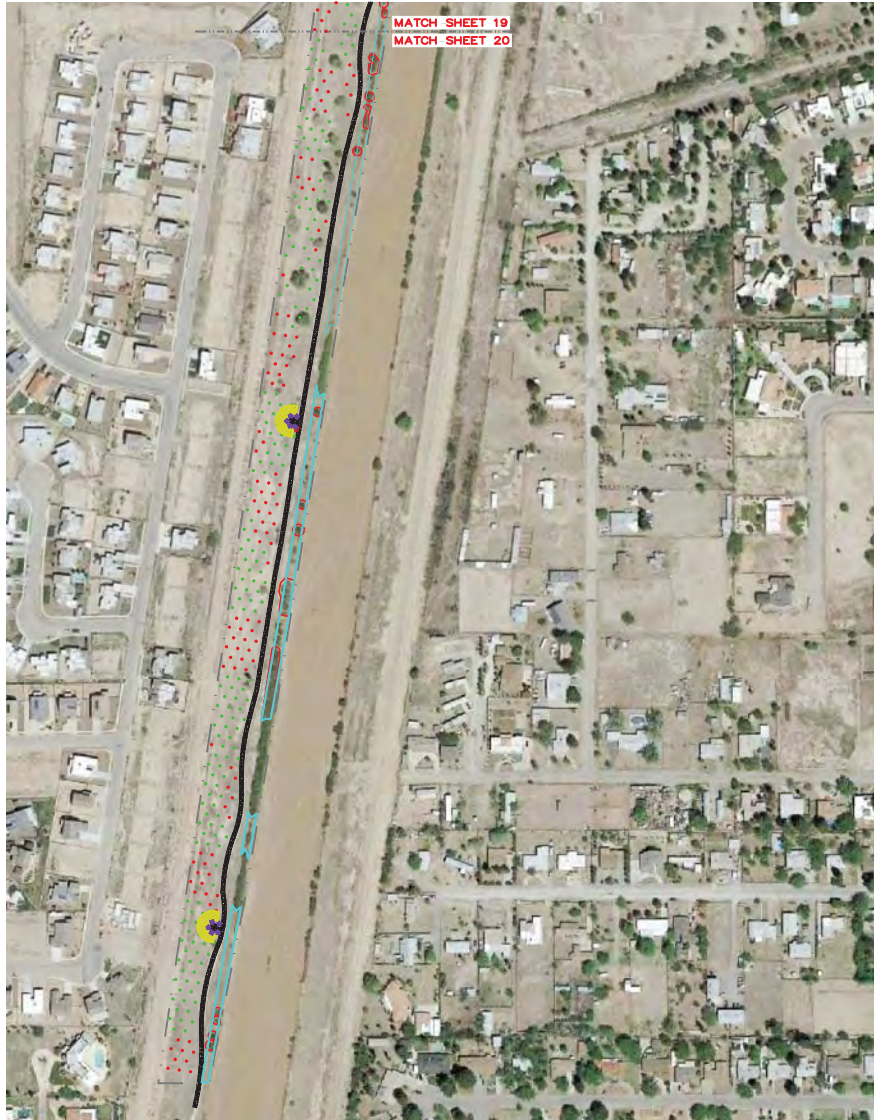
MINIMUM NUMBER OF PLANTINGS AT EACH SITE						
SITE	GRASS AND FORB SEEDING (ACRES)	COYOTE WILLOW WIRES	GOODING WILLOW POLES	COTTONWOOD POLES	LONGSTEM RIPARIAN SHRUBS	DESERT WILLOW / ARIZONA ASH / SALT CEDAR EXTRACTION (ACRES)
VALLEY CREEK	0	1100	220	440	1000	10/10 ±0.61

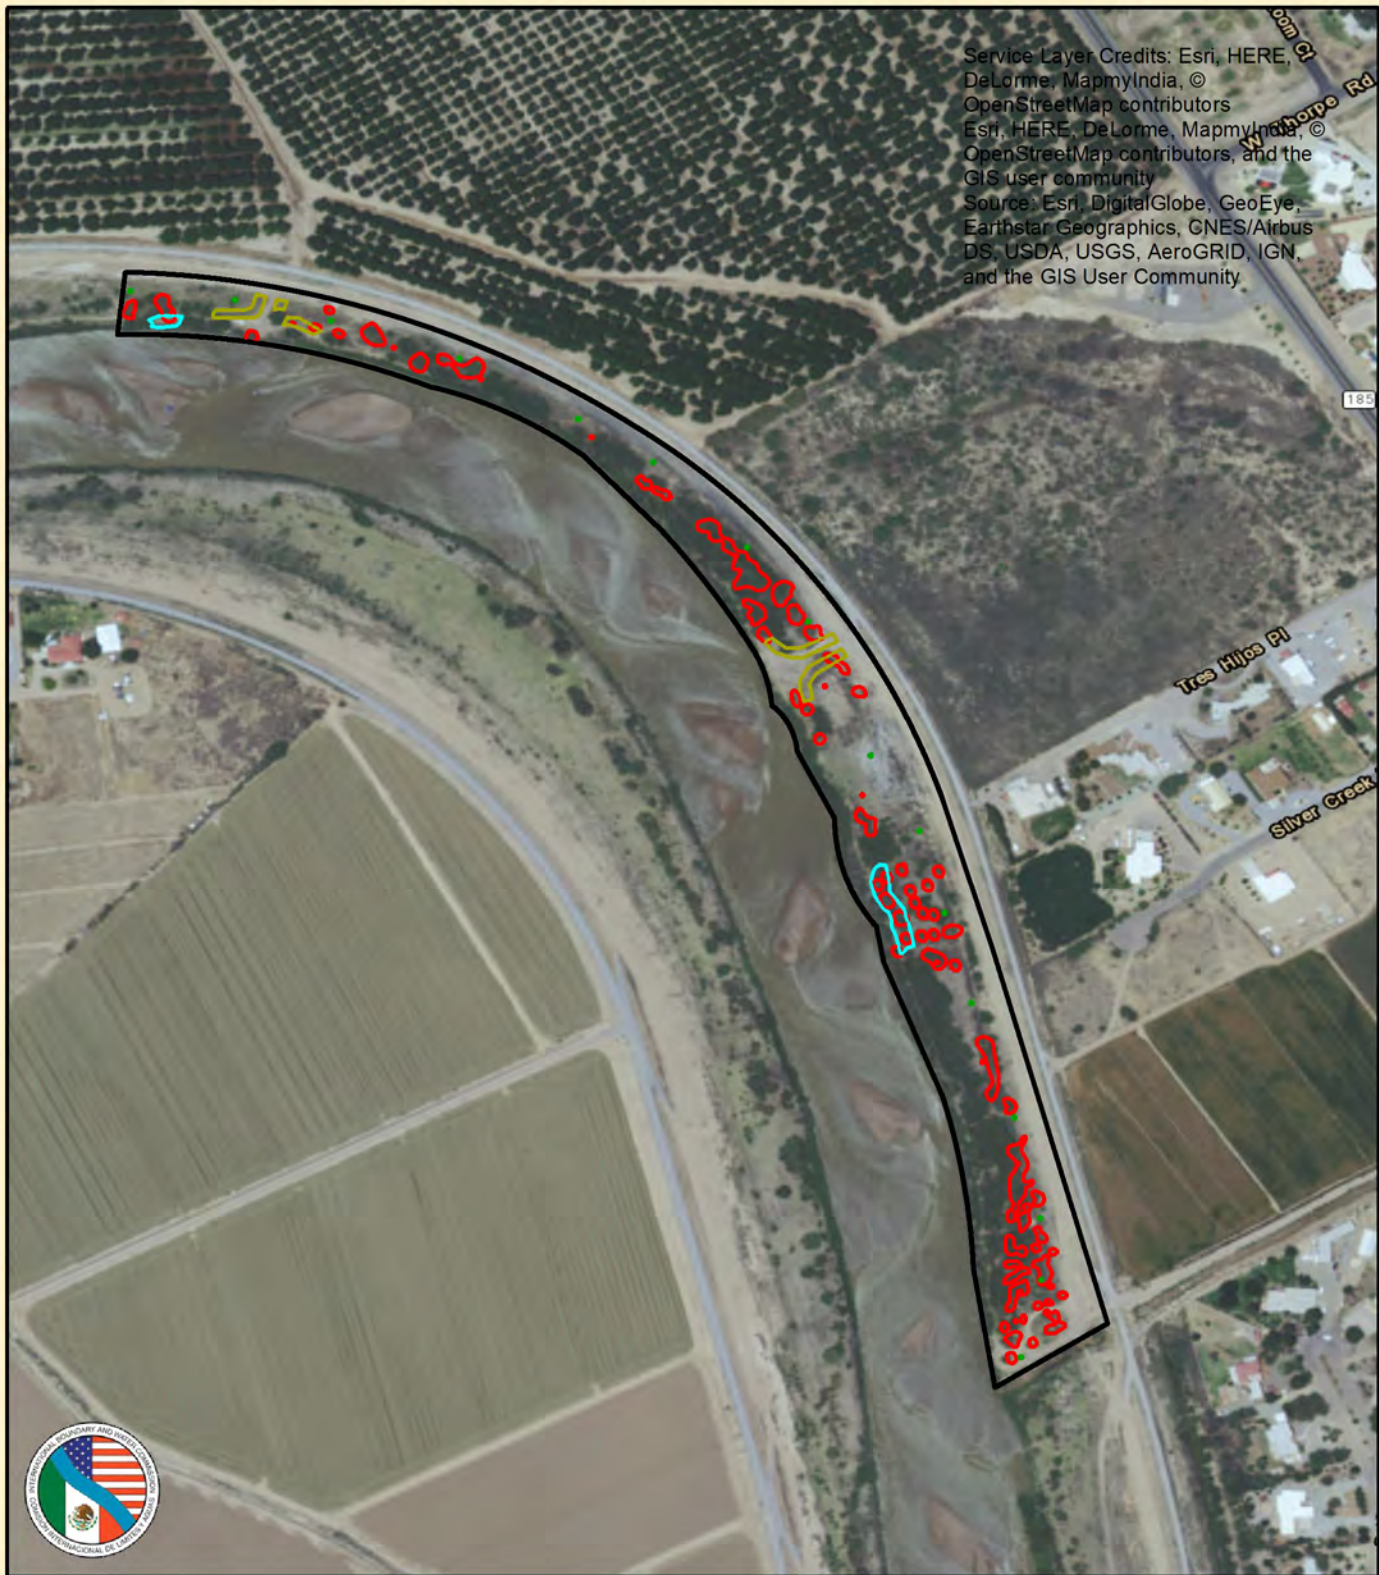
- Project Boundary
- Saltcedar Extraction
- Cottonwood
- Goodding Willow
- Coyote Willow
- Long Stem Shrubs
