Soil Survey Resource Report for Rio Grande Canalization Project River Restoration Implementation Plan

Soil Survey Resource Report for Rio Grande Canalization Implementation Plan August 2010

U.S. International Boundary and Water Commission
4171 N. Mesa
El Paso, Texas 79902

TRC
Austin, Texas

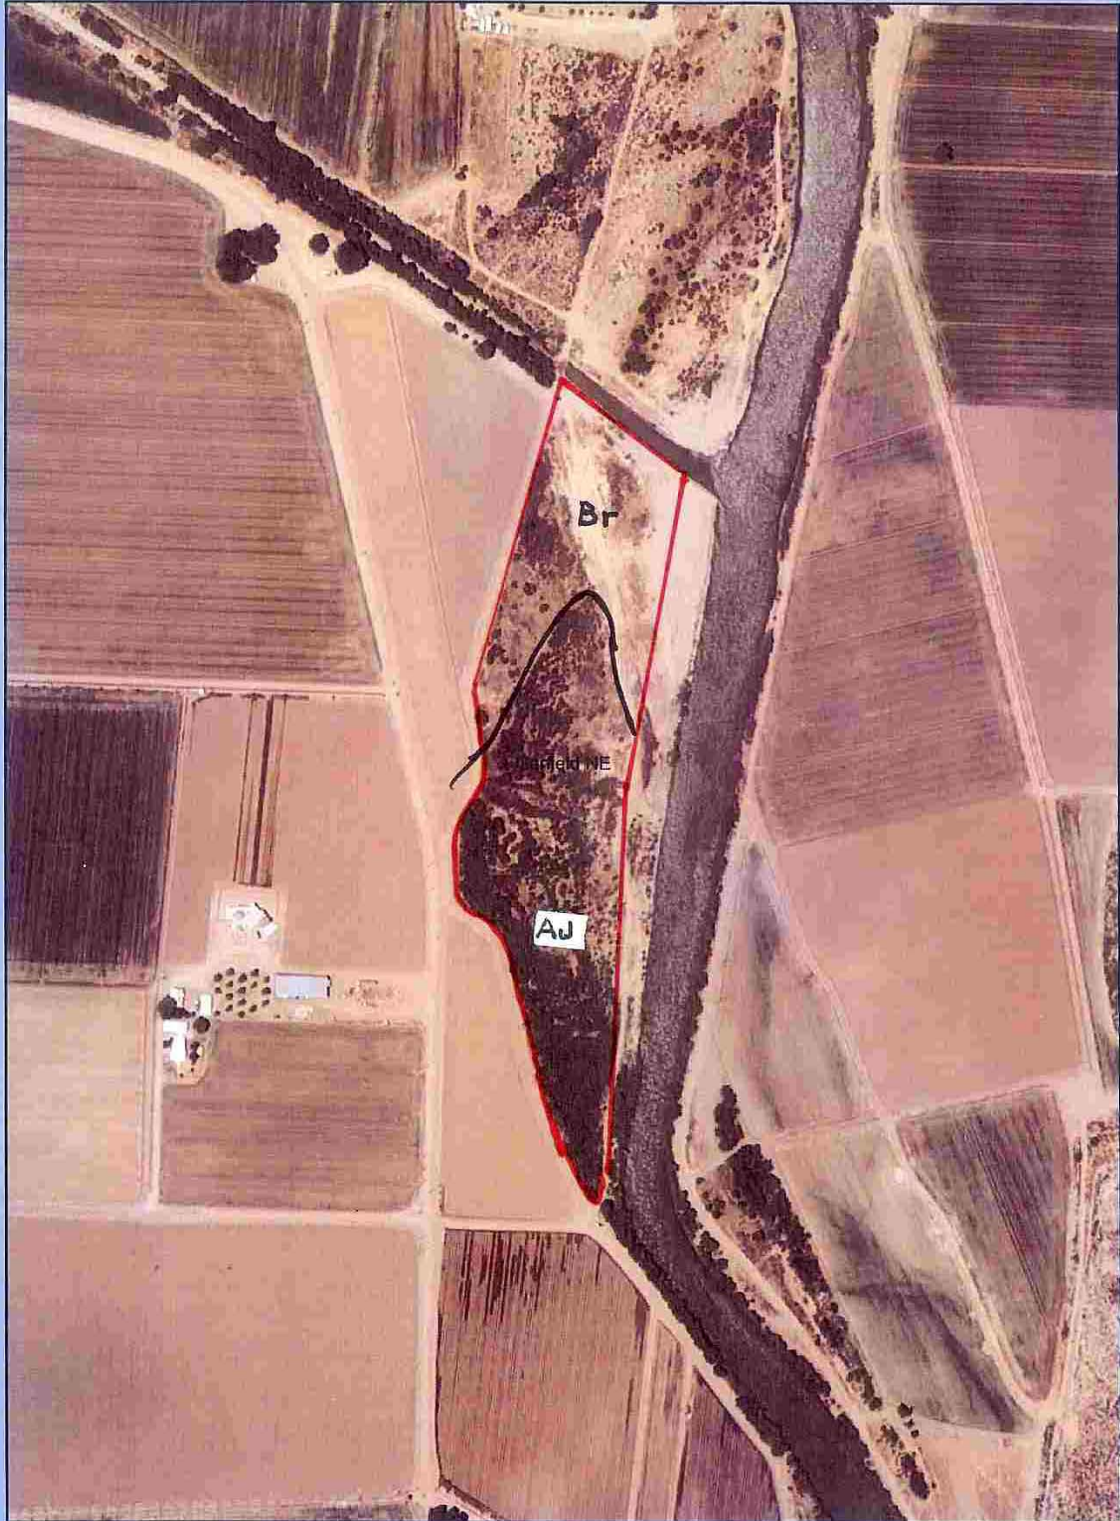
SITE # 1

Garfield NW

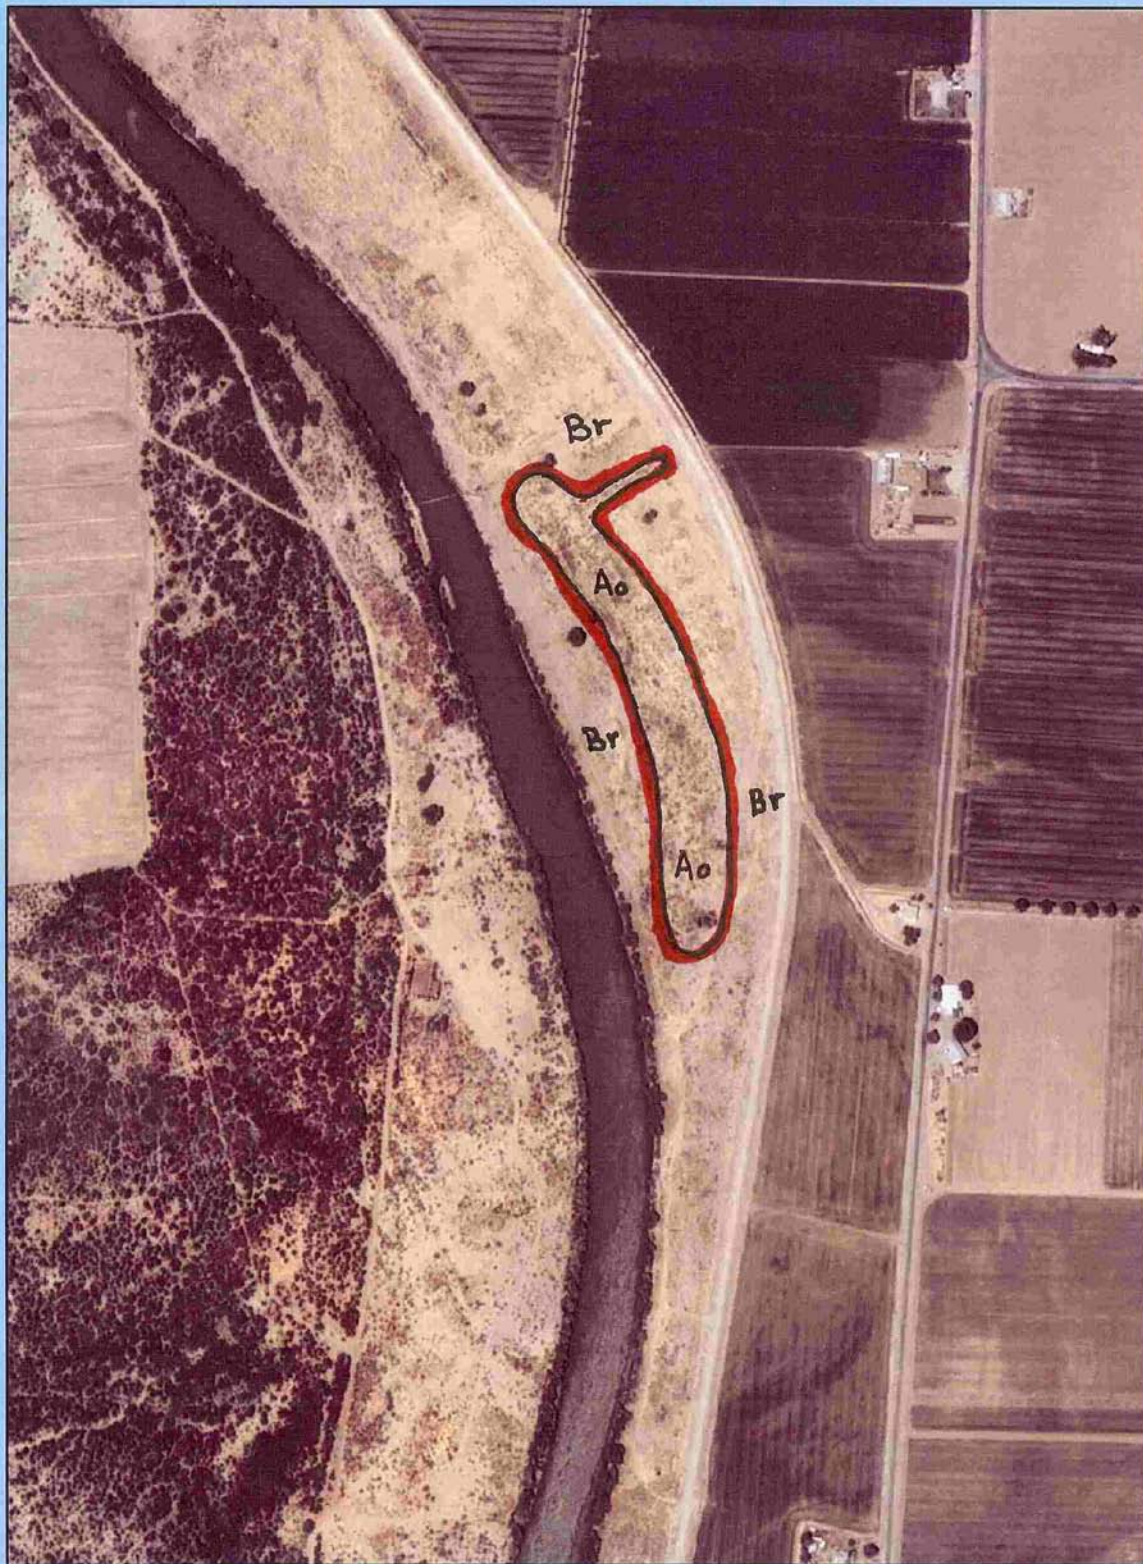
SITE # 2

Arroyo Cuervo NE

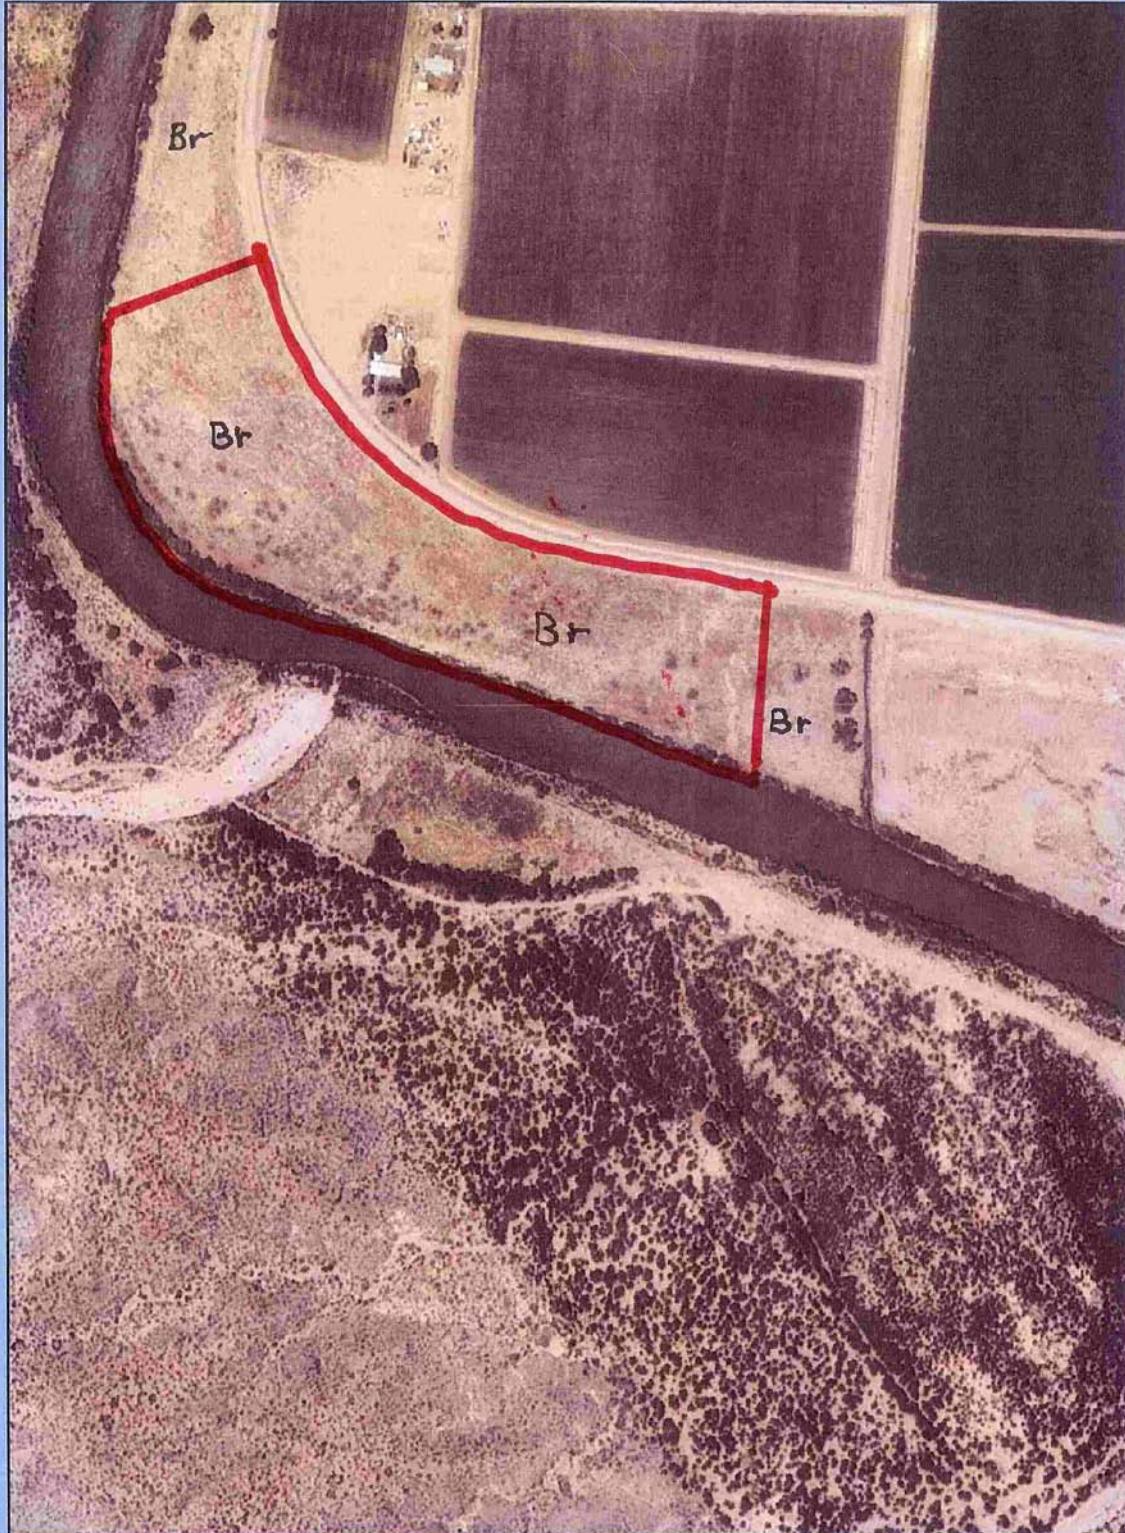
SITE # 3

Arroyo Cuervo NE

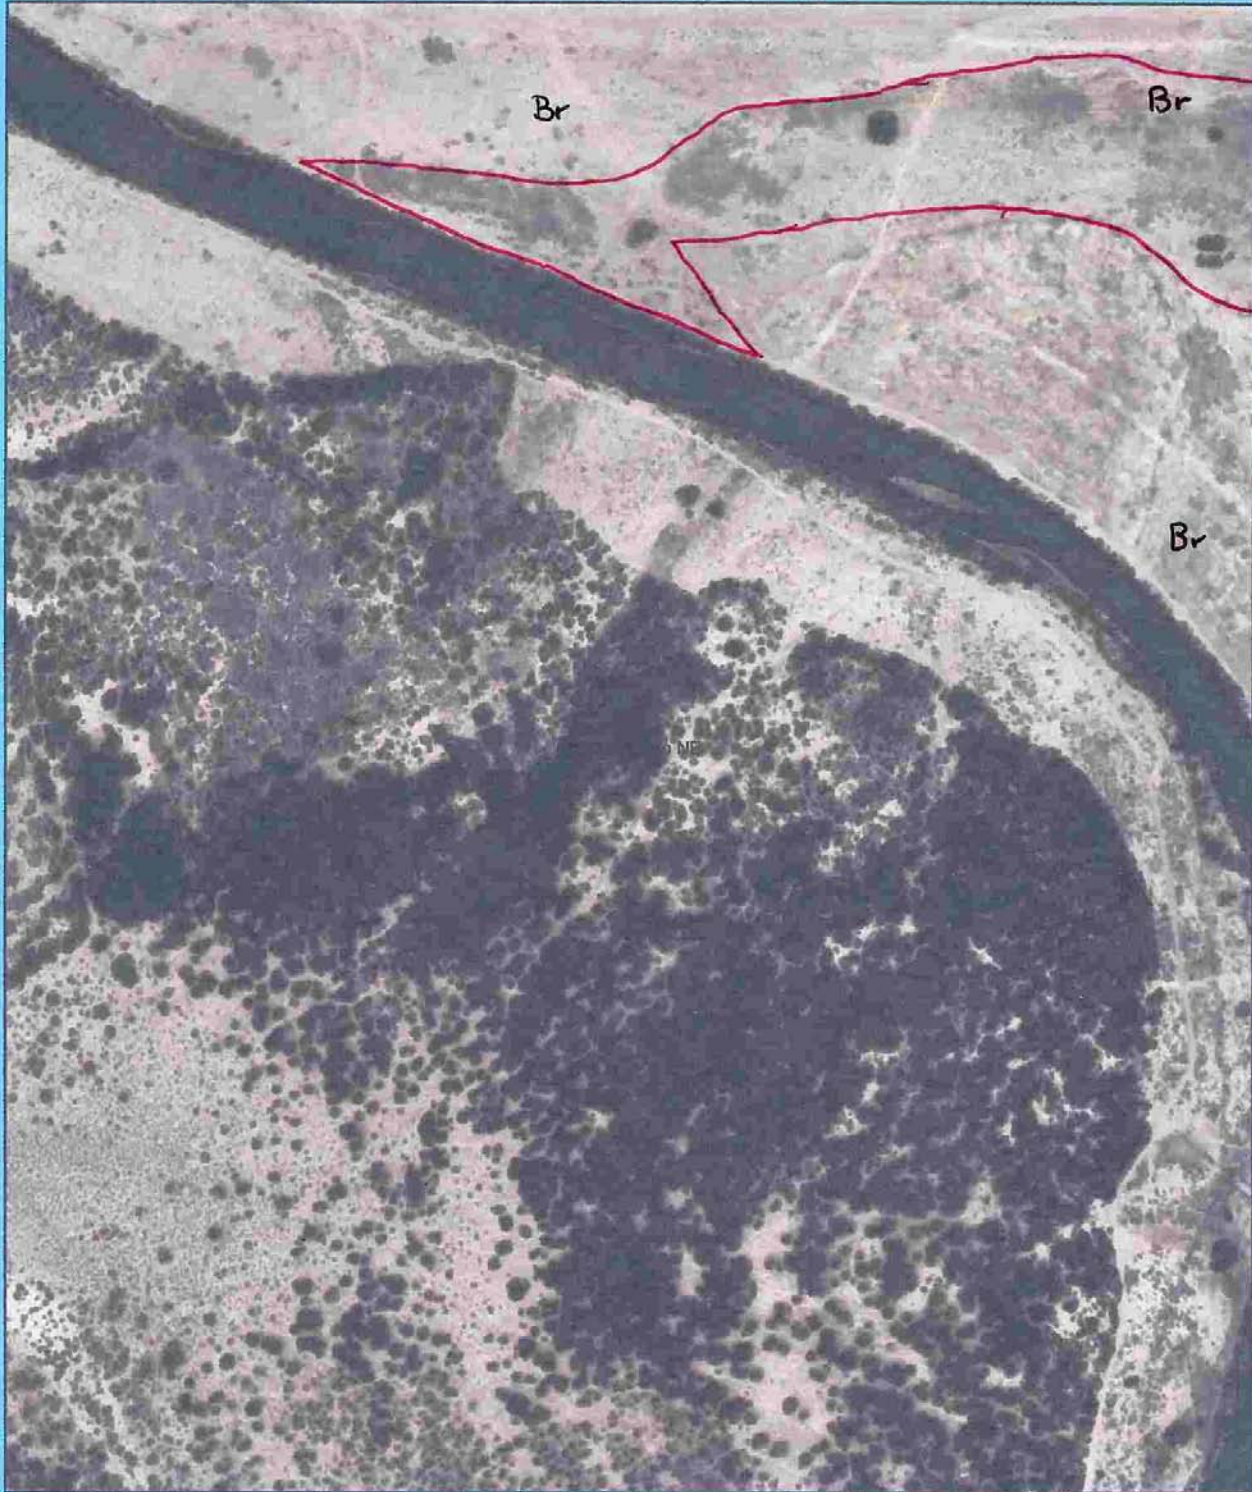
SITE # 6-1

Arroyo Cuervo NE extended

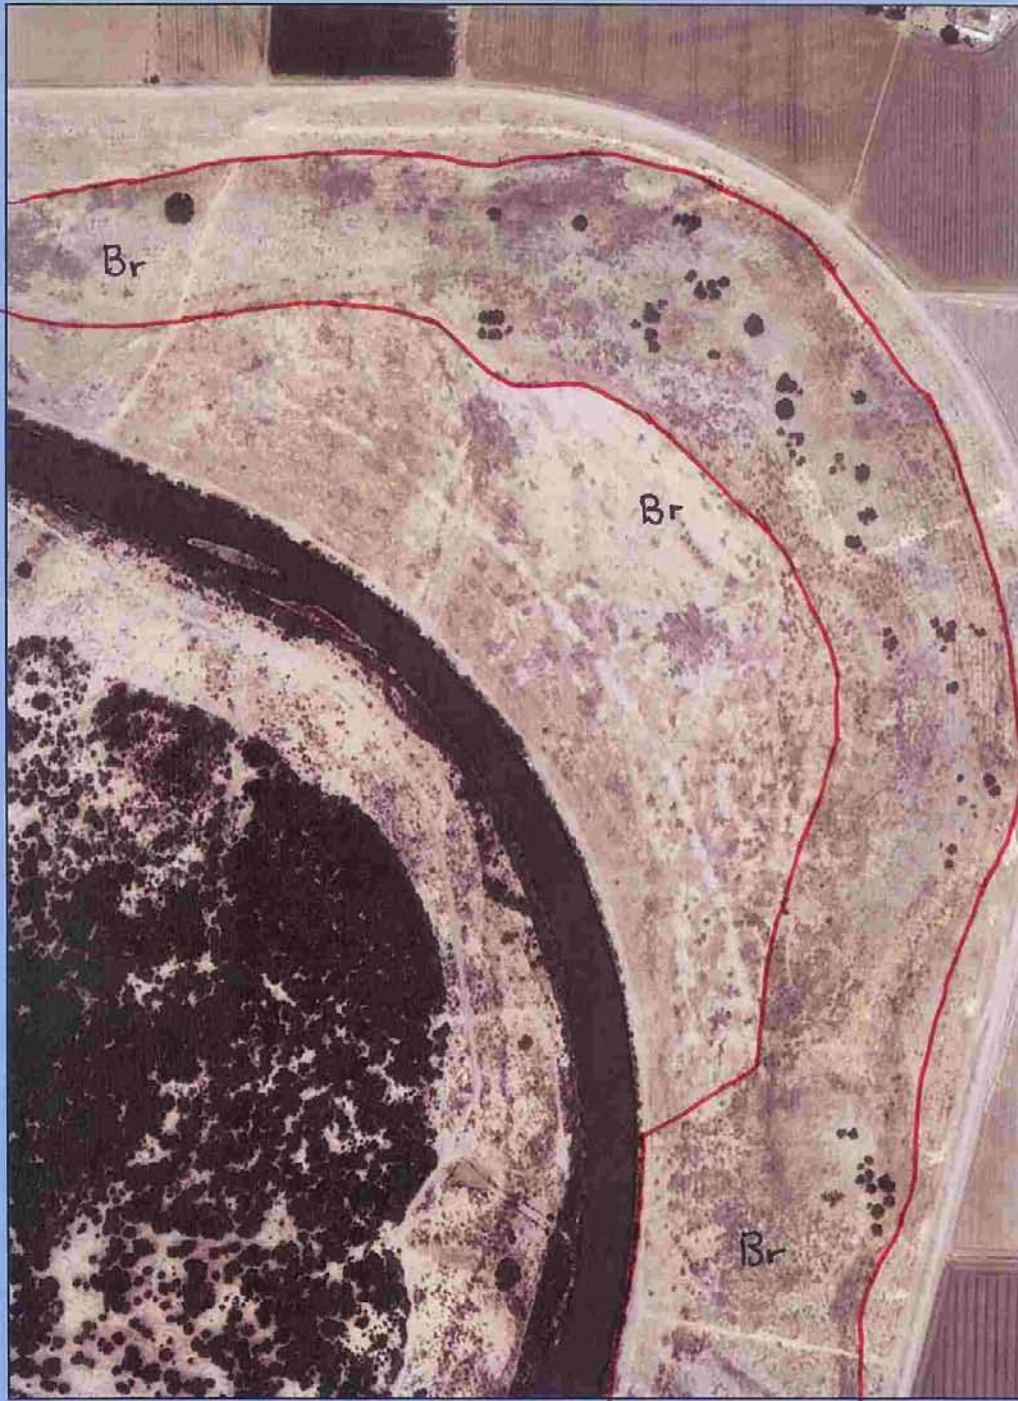
SITE # 6-2

Arroyo Cuervo NE

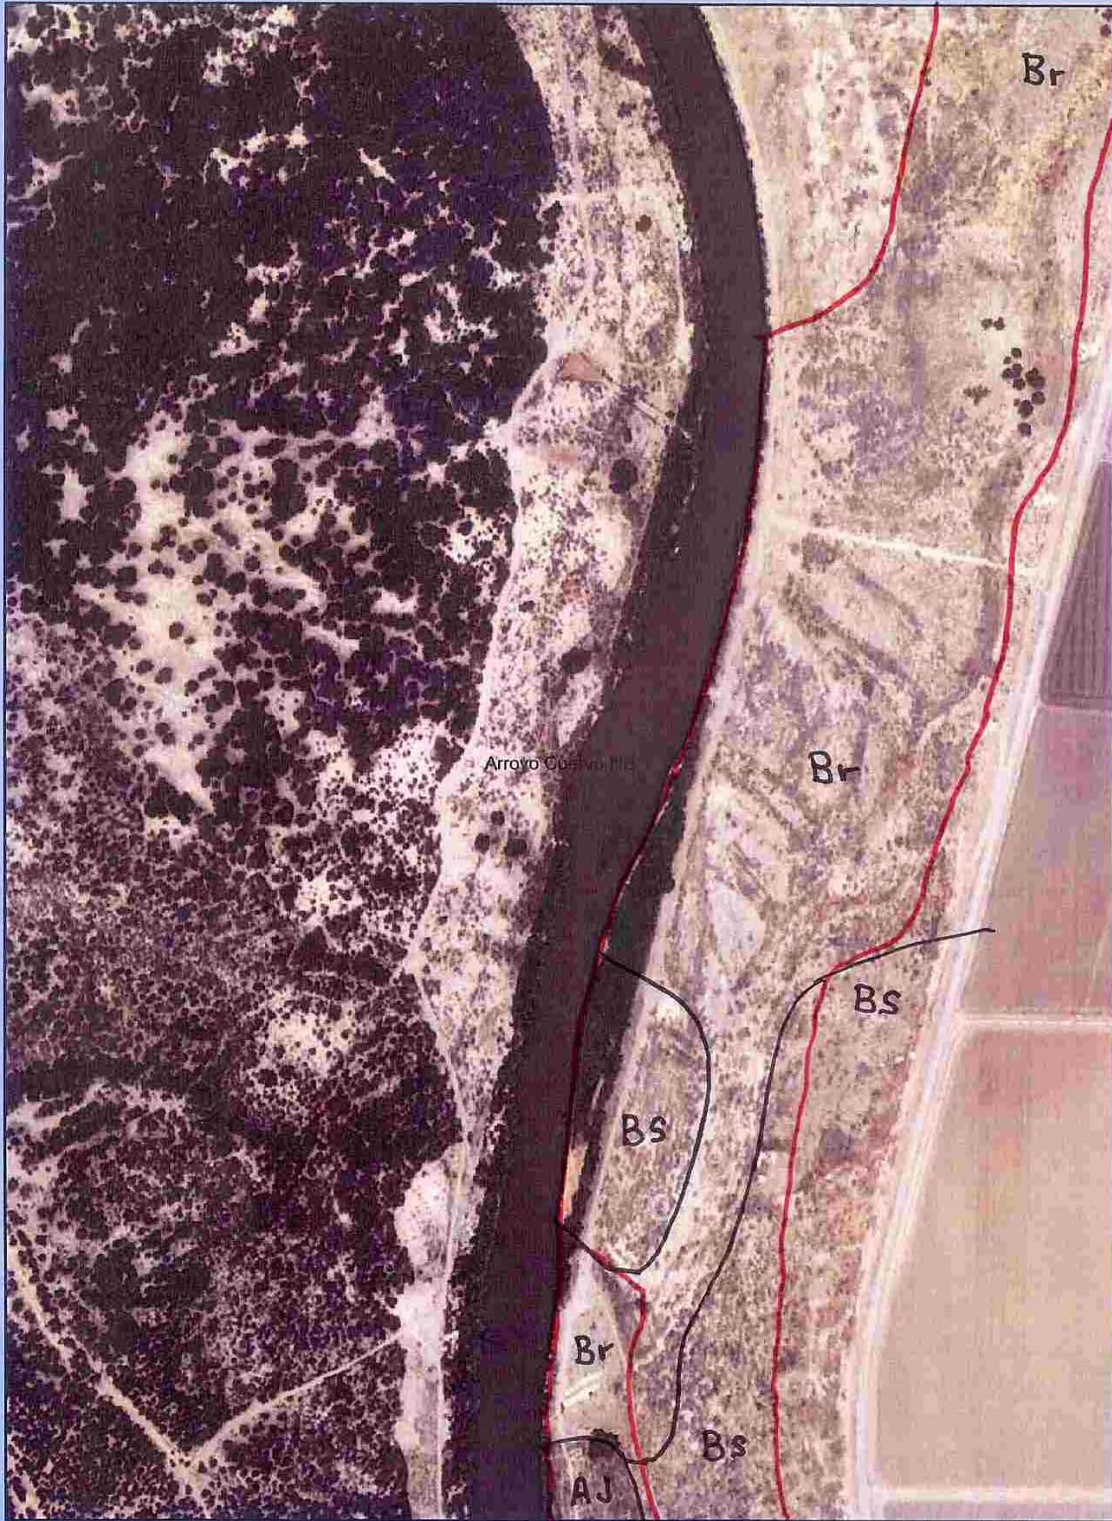
SITE # 6-3

Arroyo Cuervo NE

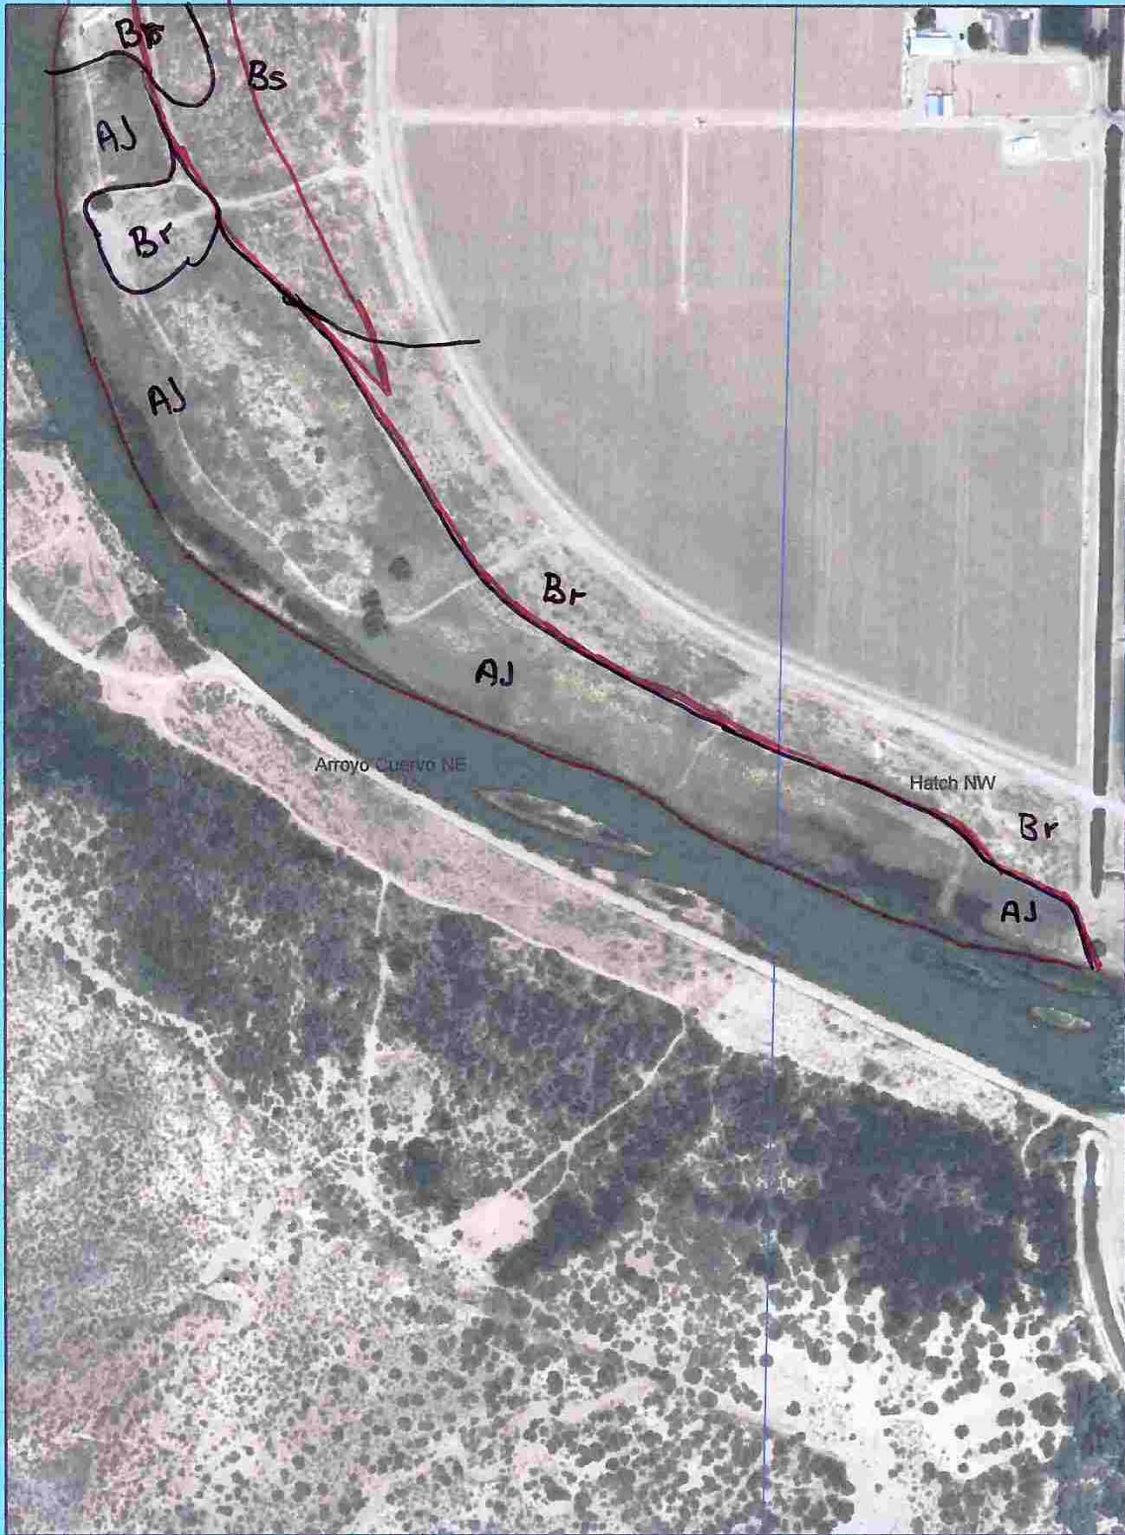
SITE # 7

Arroyo Cuervo NE

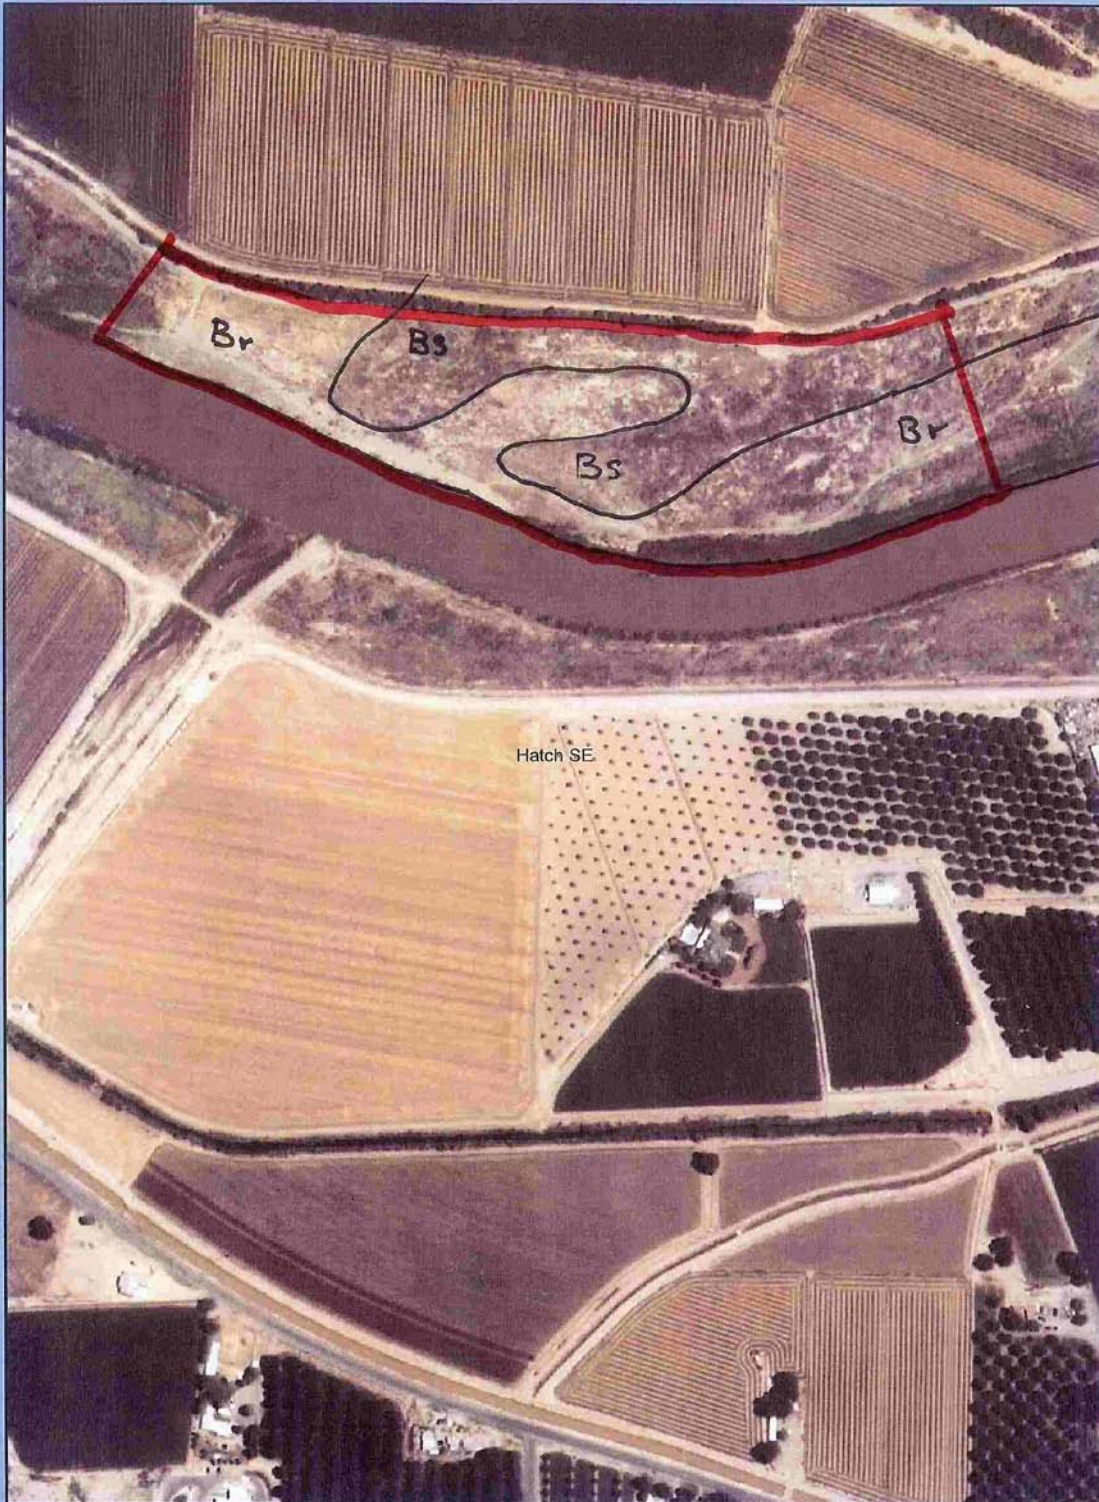
SITE # 8

Hatch SE

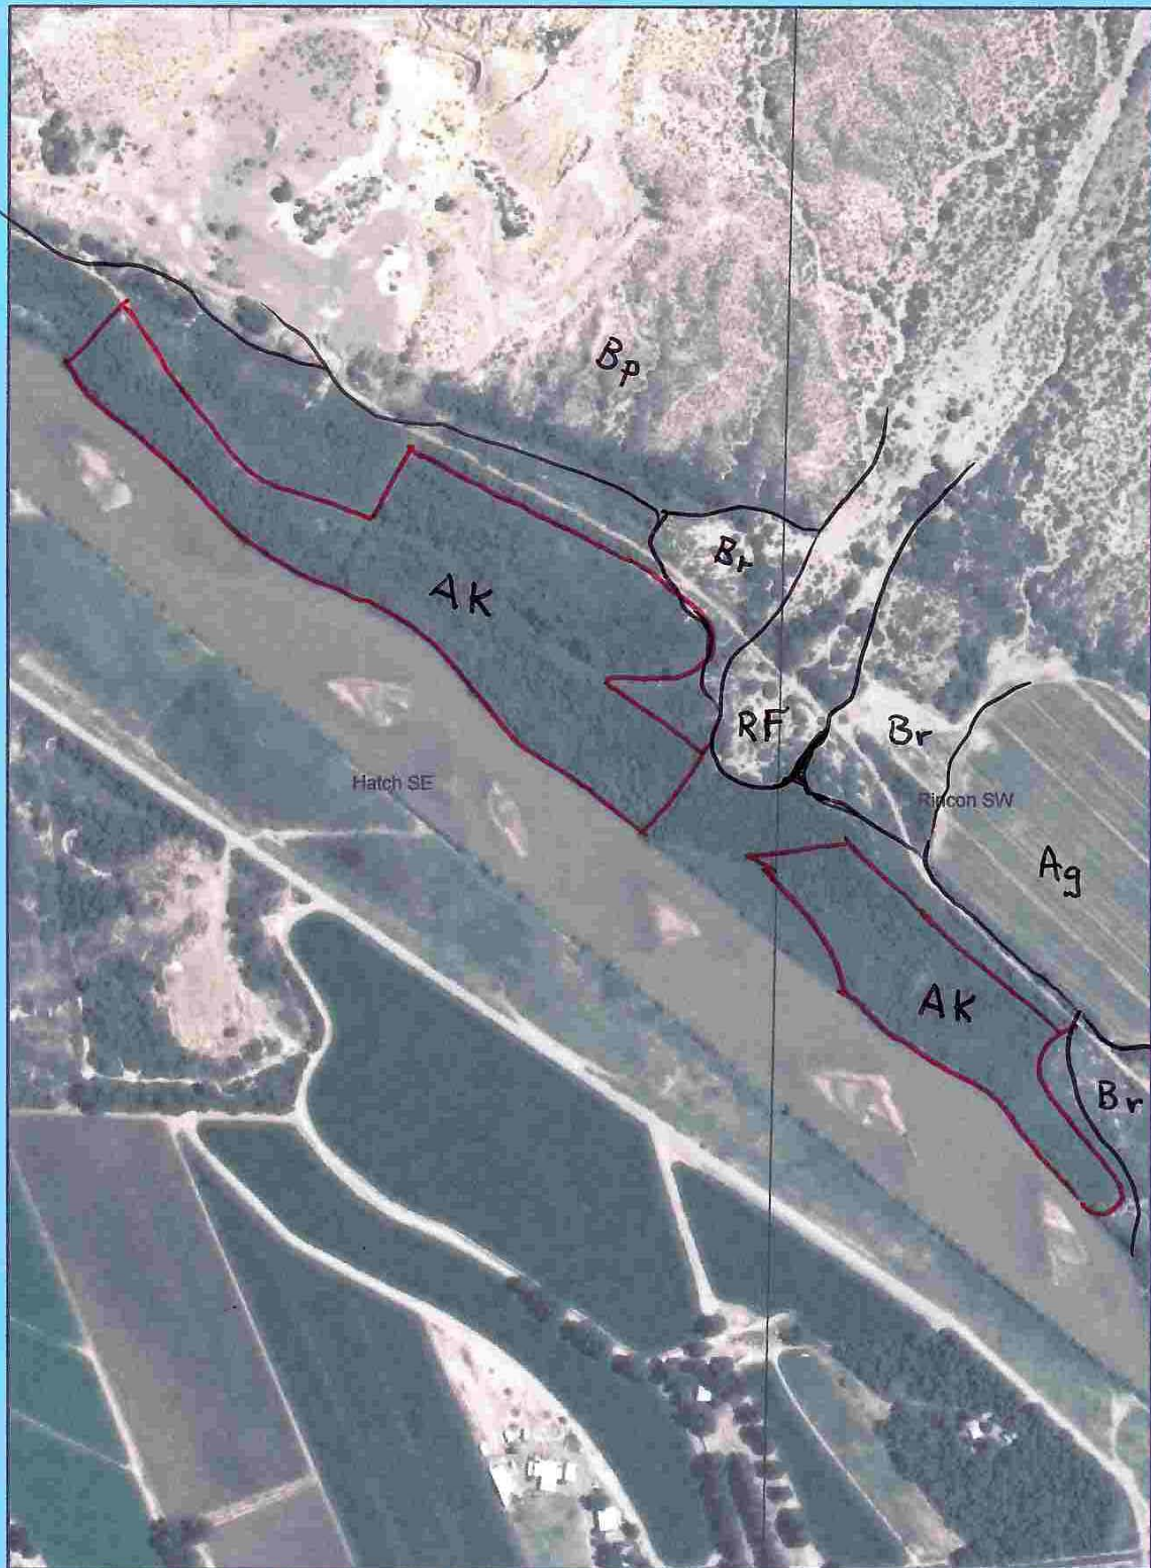
SITE # 9

Hatch SE Rincon SW

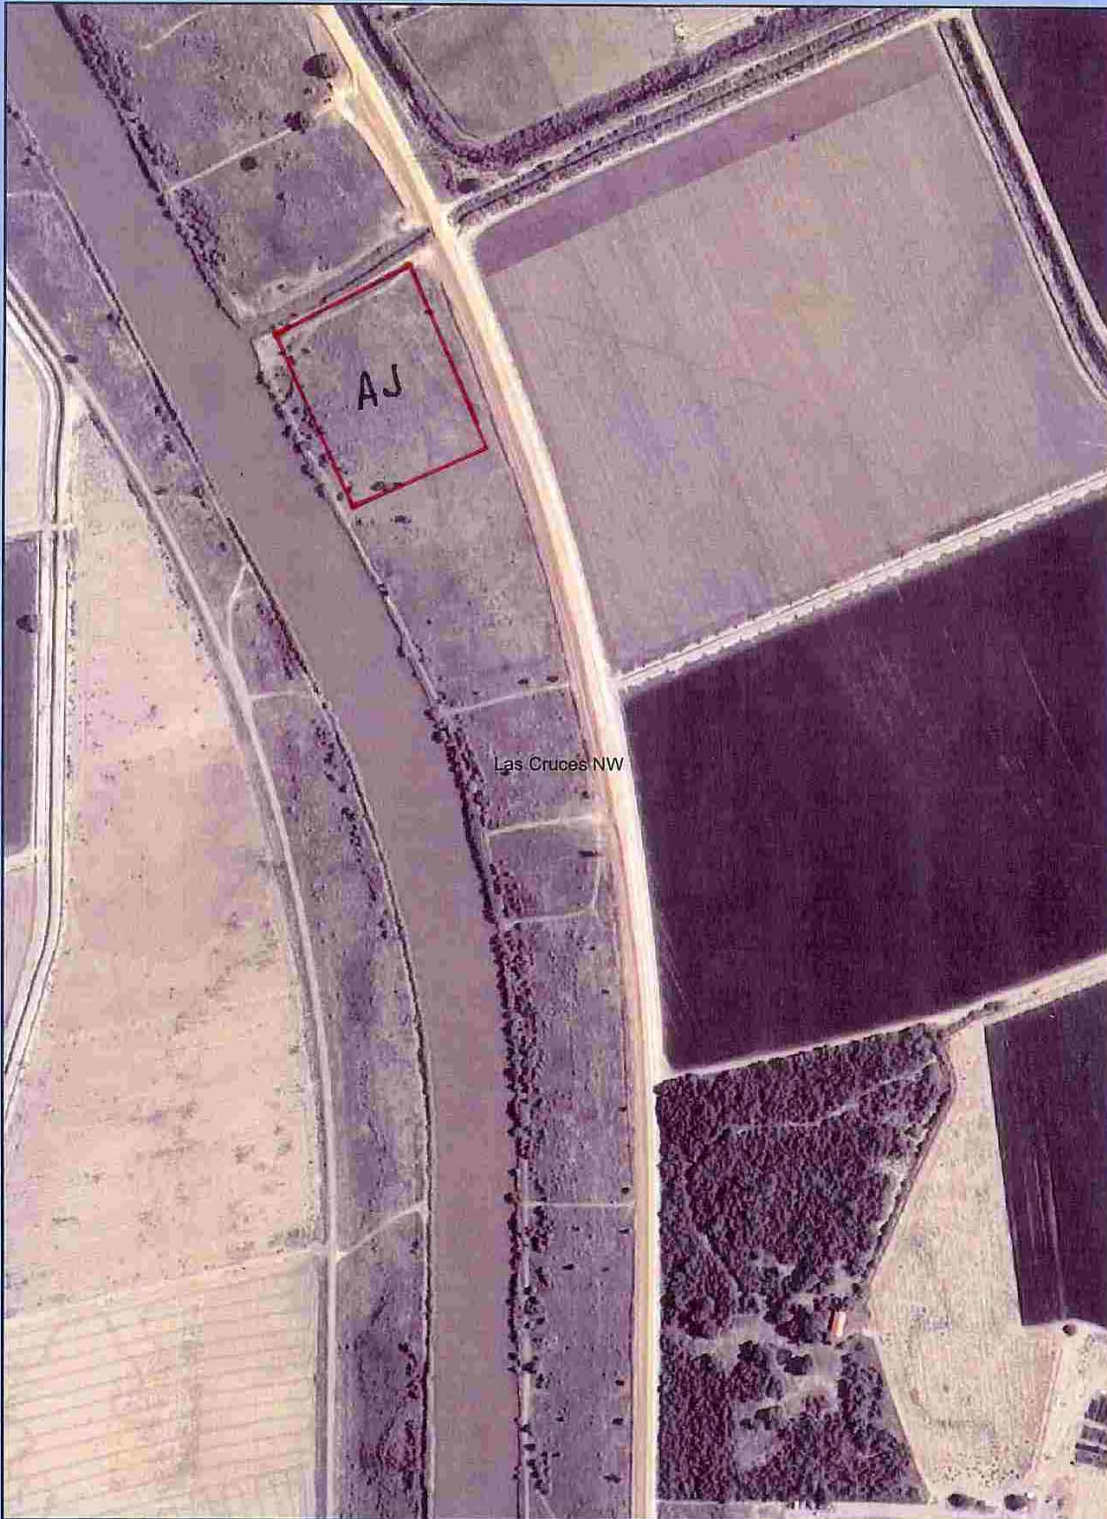
SITE # 18

Las Cruces NW

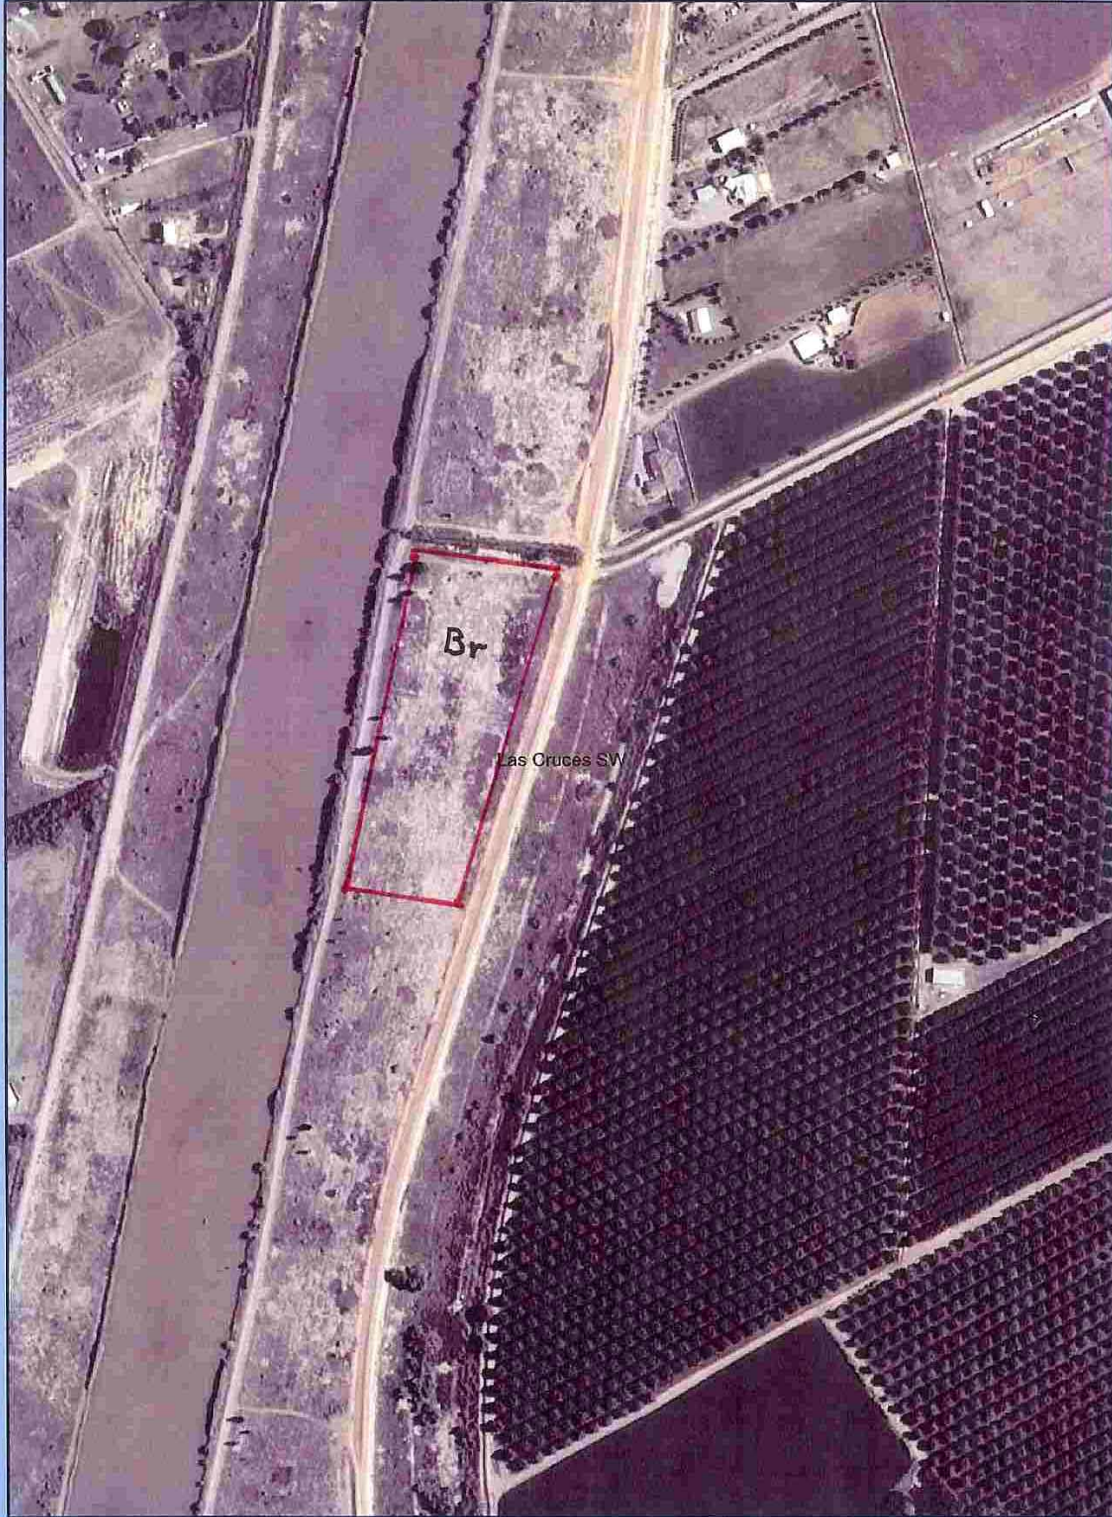
SITE # 19

Las Cruces SW

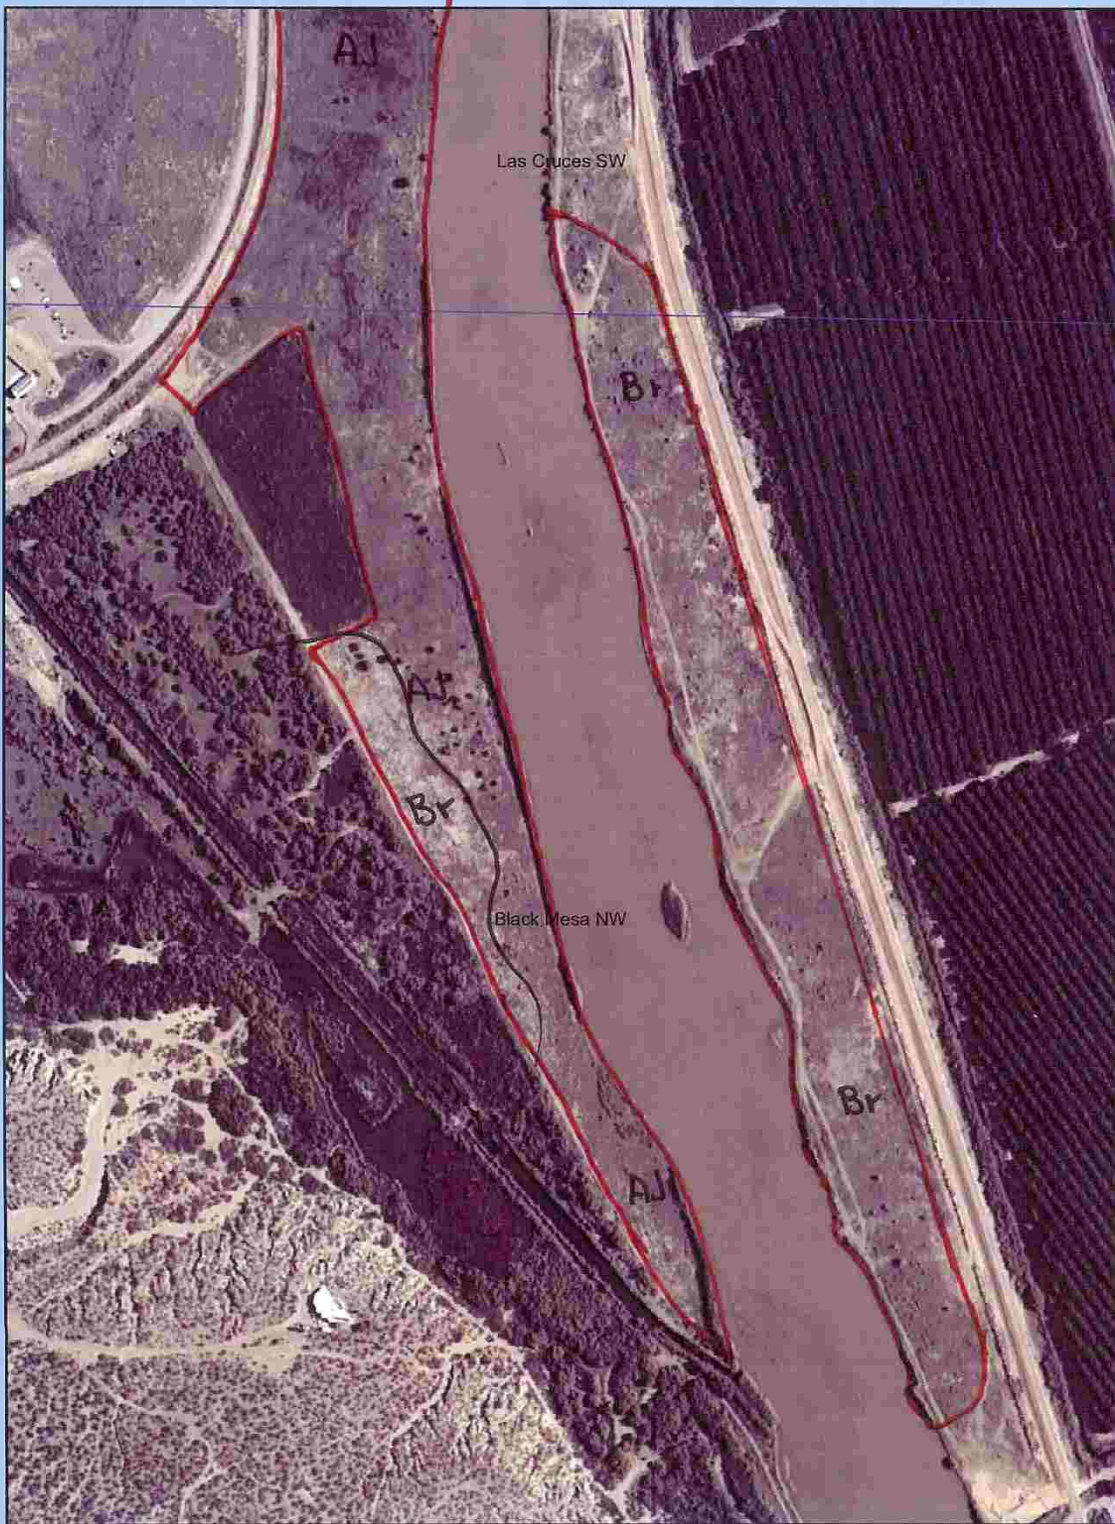
SITE # 21

Las Cruces SW Black Meas NW

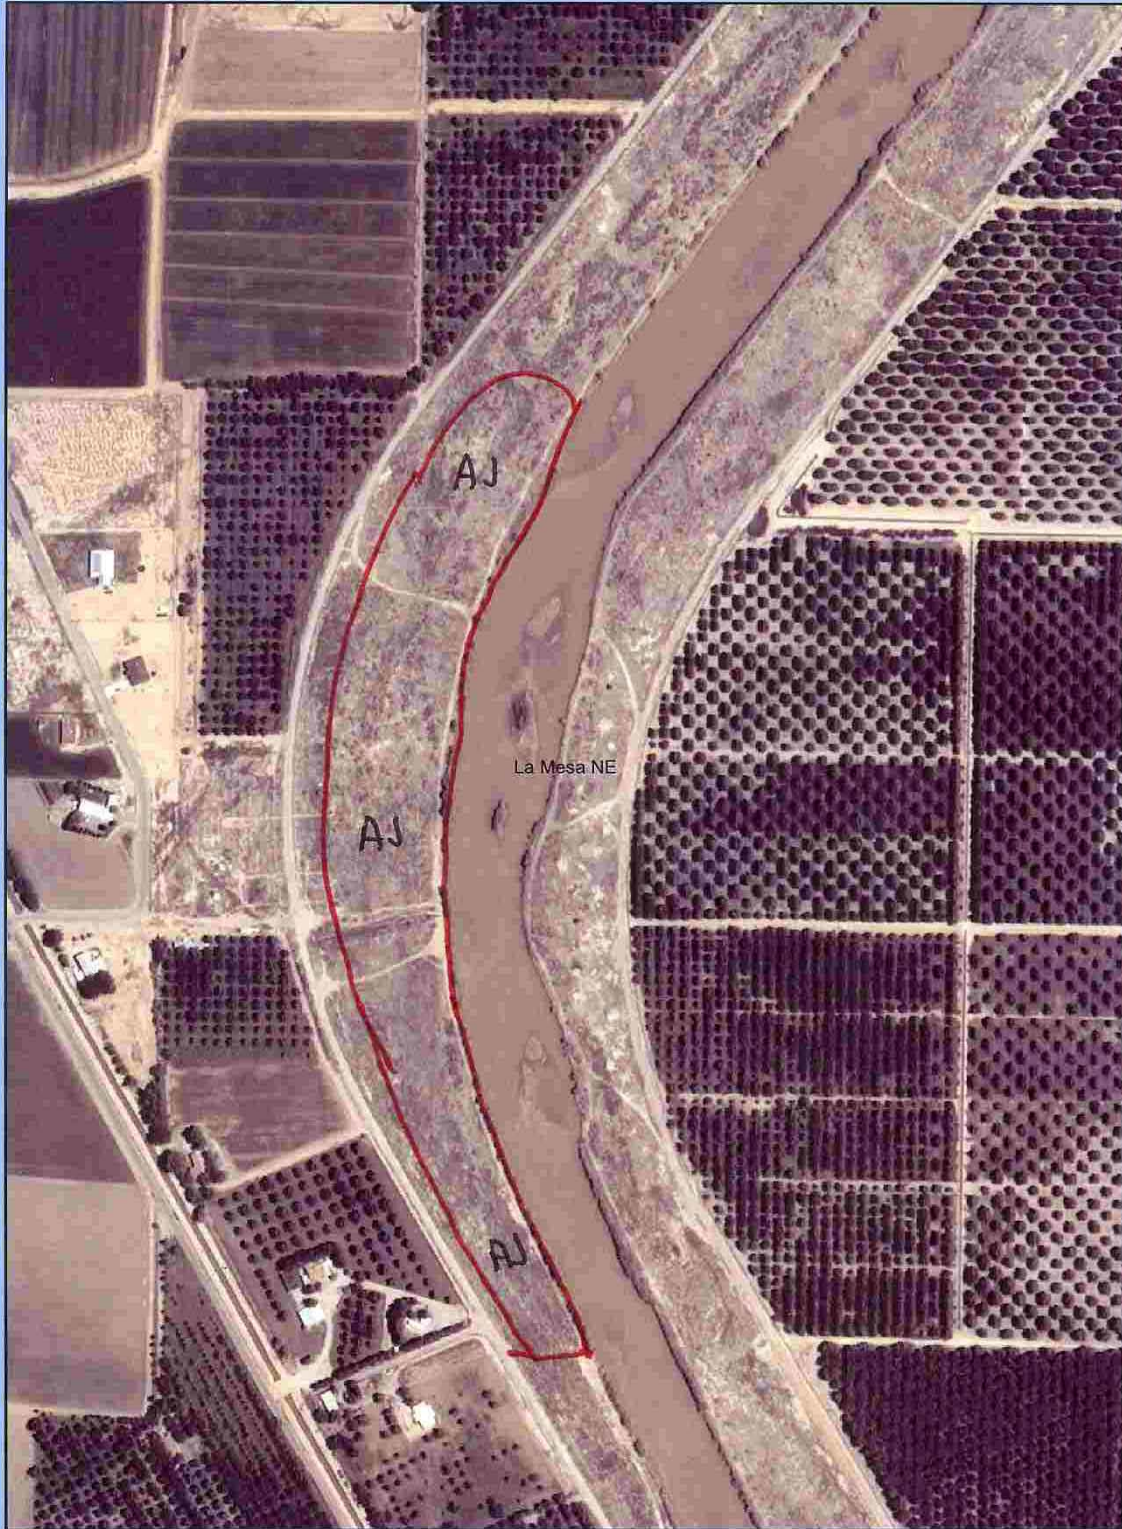
SITE # 22

La Mesa NW
