Soil Survey Resource Report for Rio Grande Canalization Project River Restoration Implementation Plan

Soil Survey Resource Report for Rio Grande Canalization Implementation Plan August 2010

U.S. International Boundary and Water Commission
4171 N. Mesa
El Paso, Texas 79902

TRC
Austin, Texas

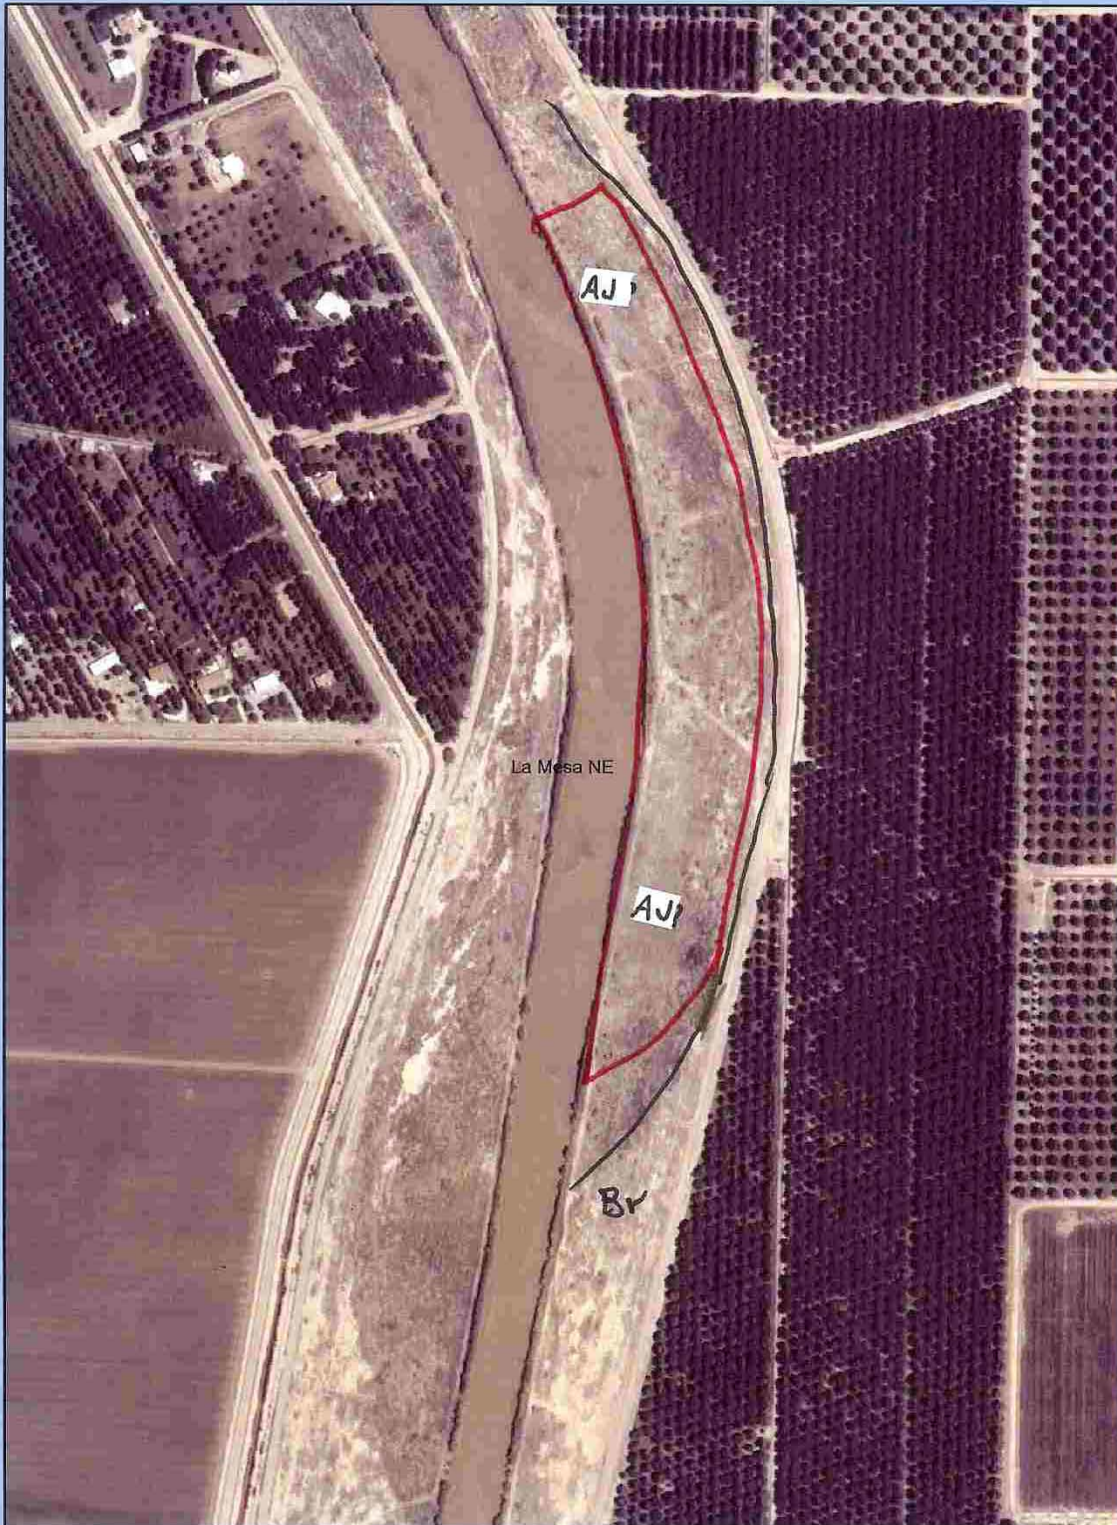
SITE # 23

La Mesa NW

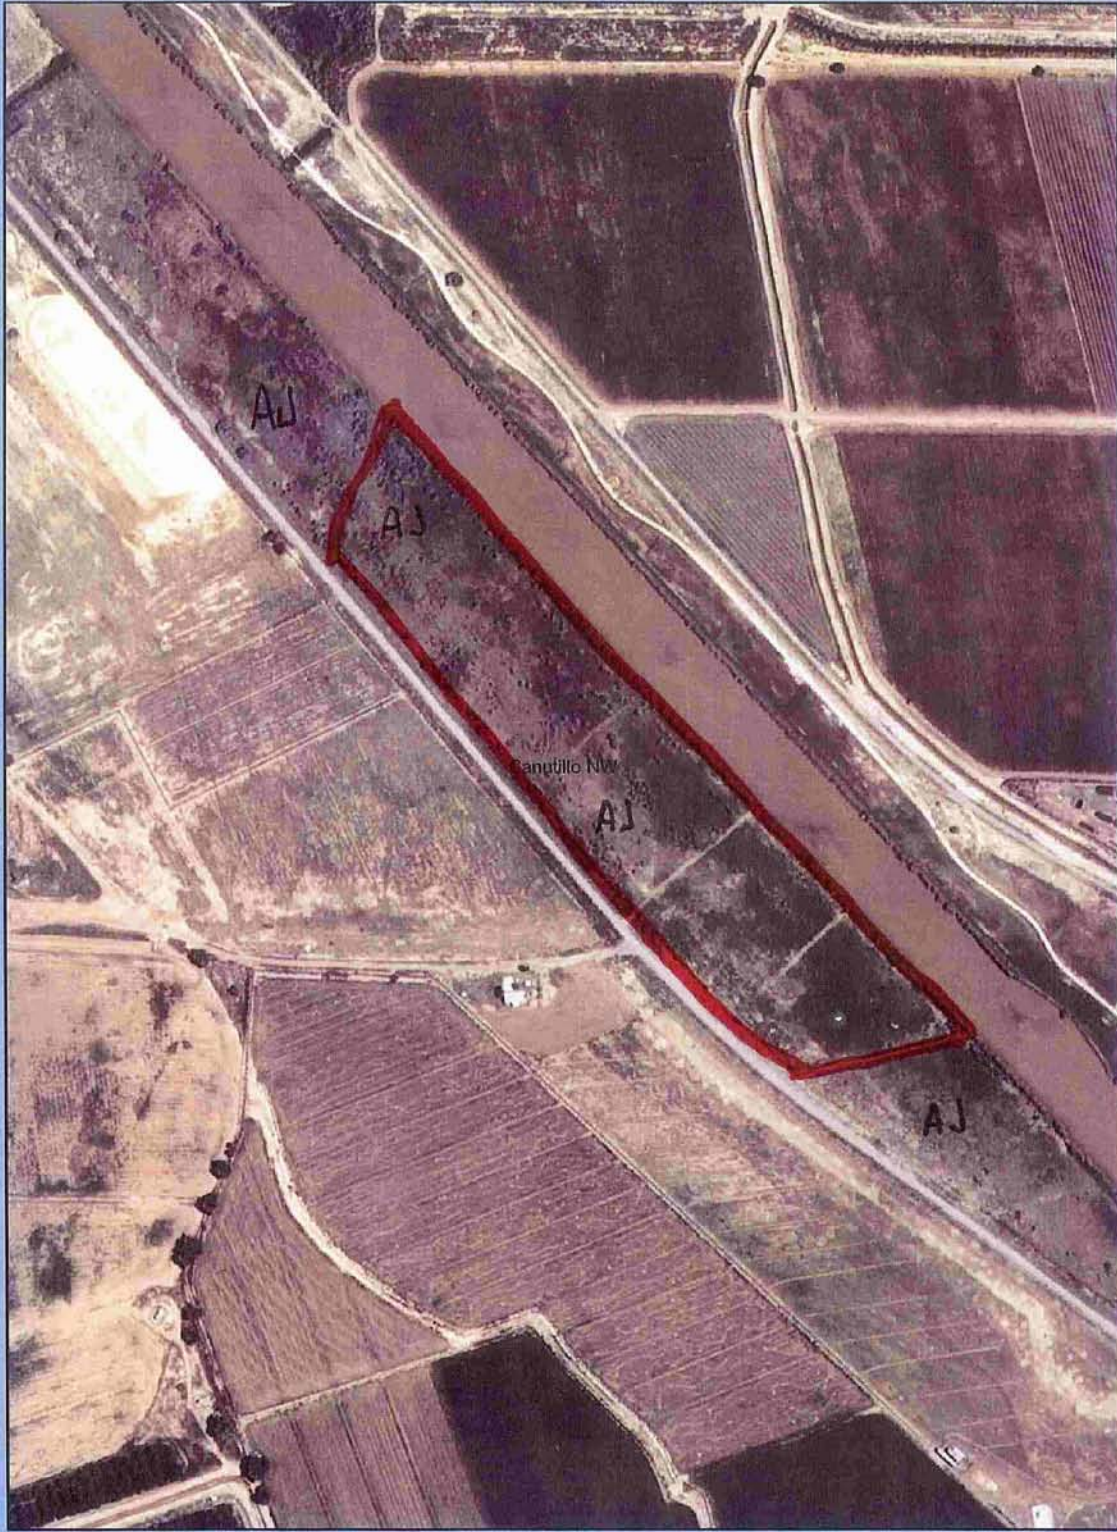
SITE # 24

Canutillo NW

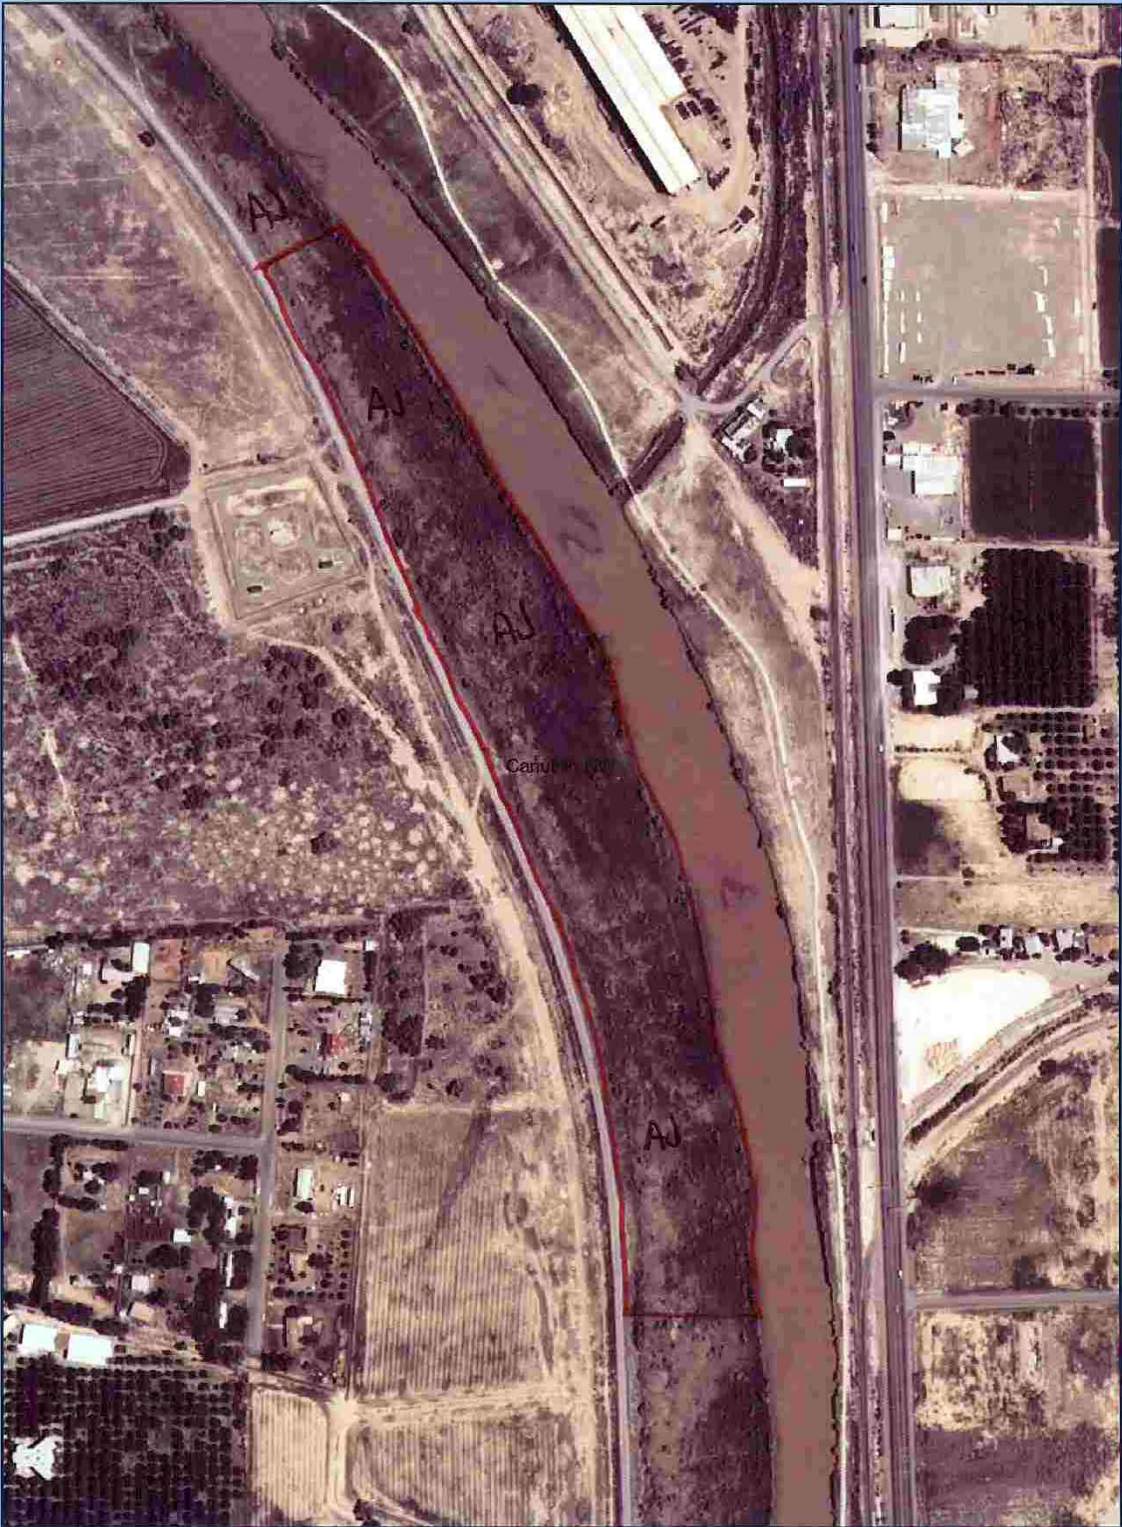
SITE # 25

Canutillo NW

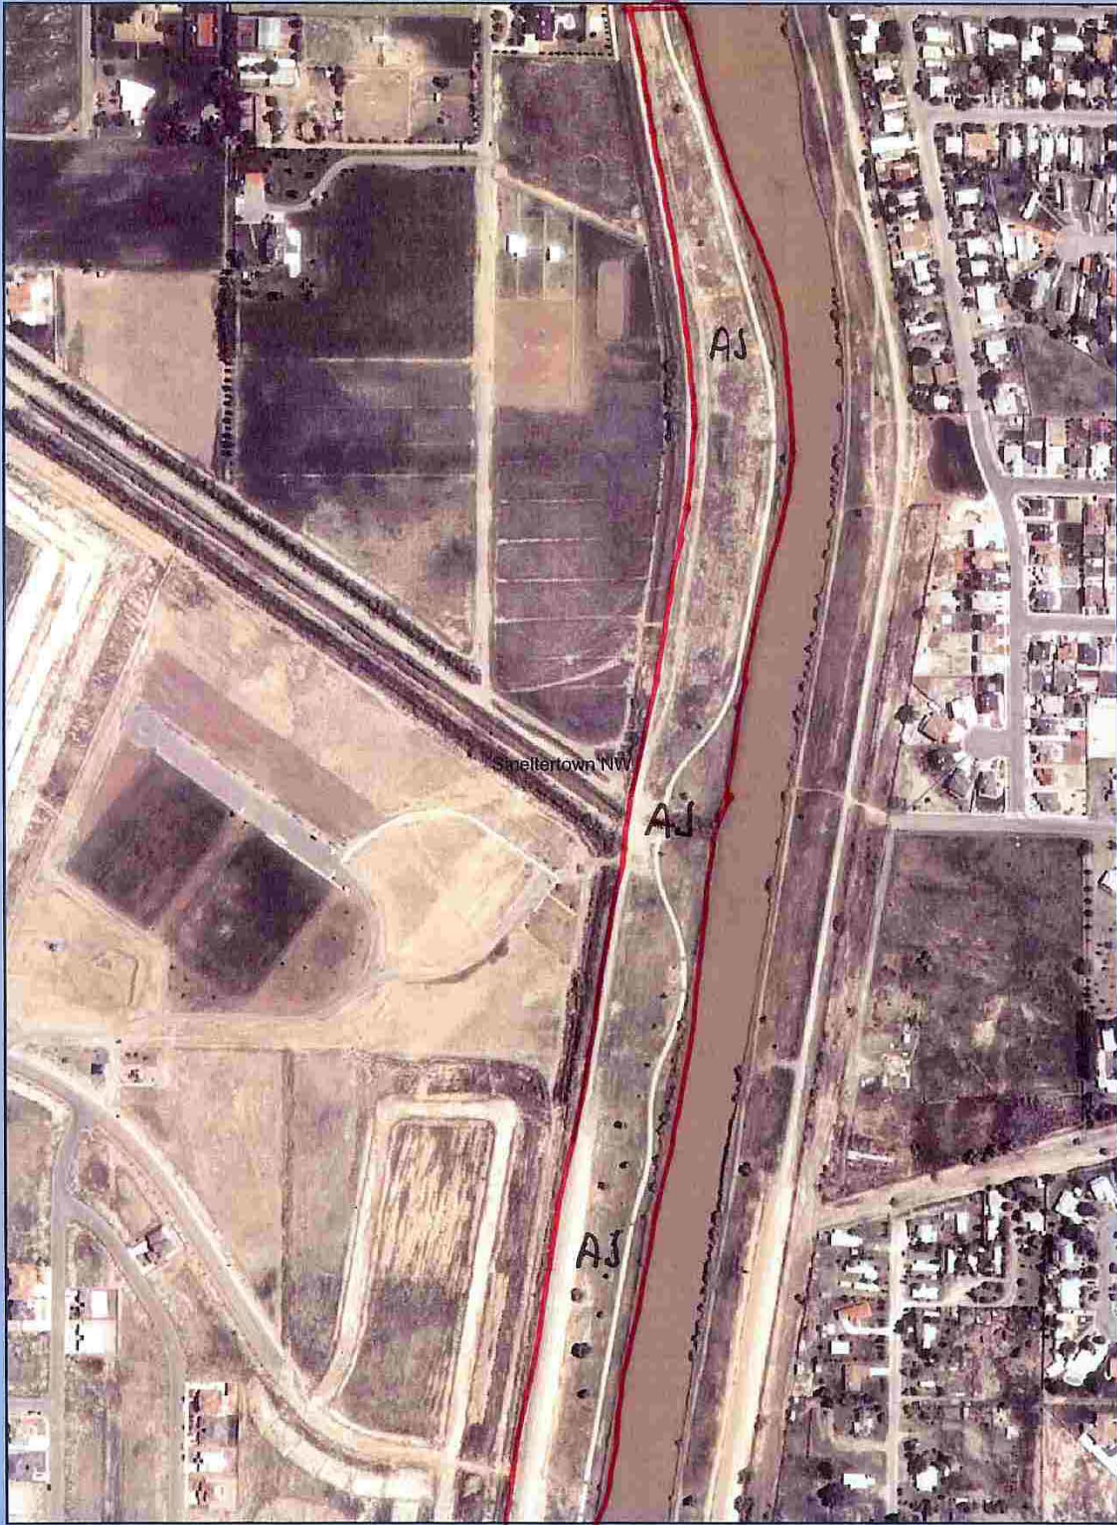
SITE # 26-1

Smelertown NW

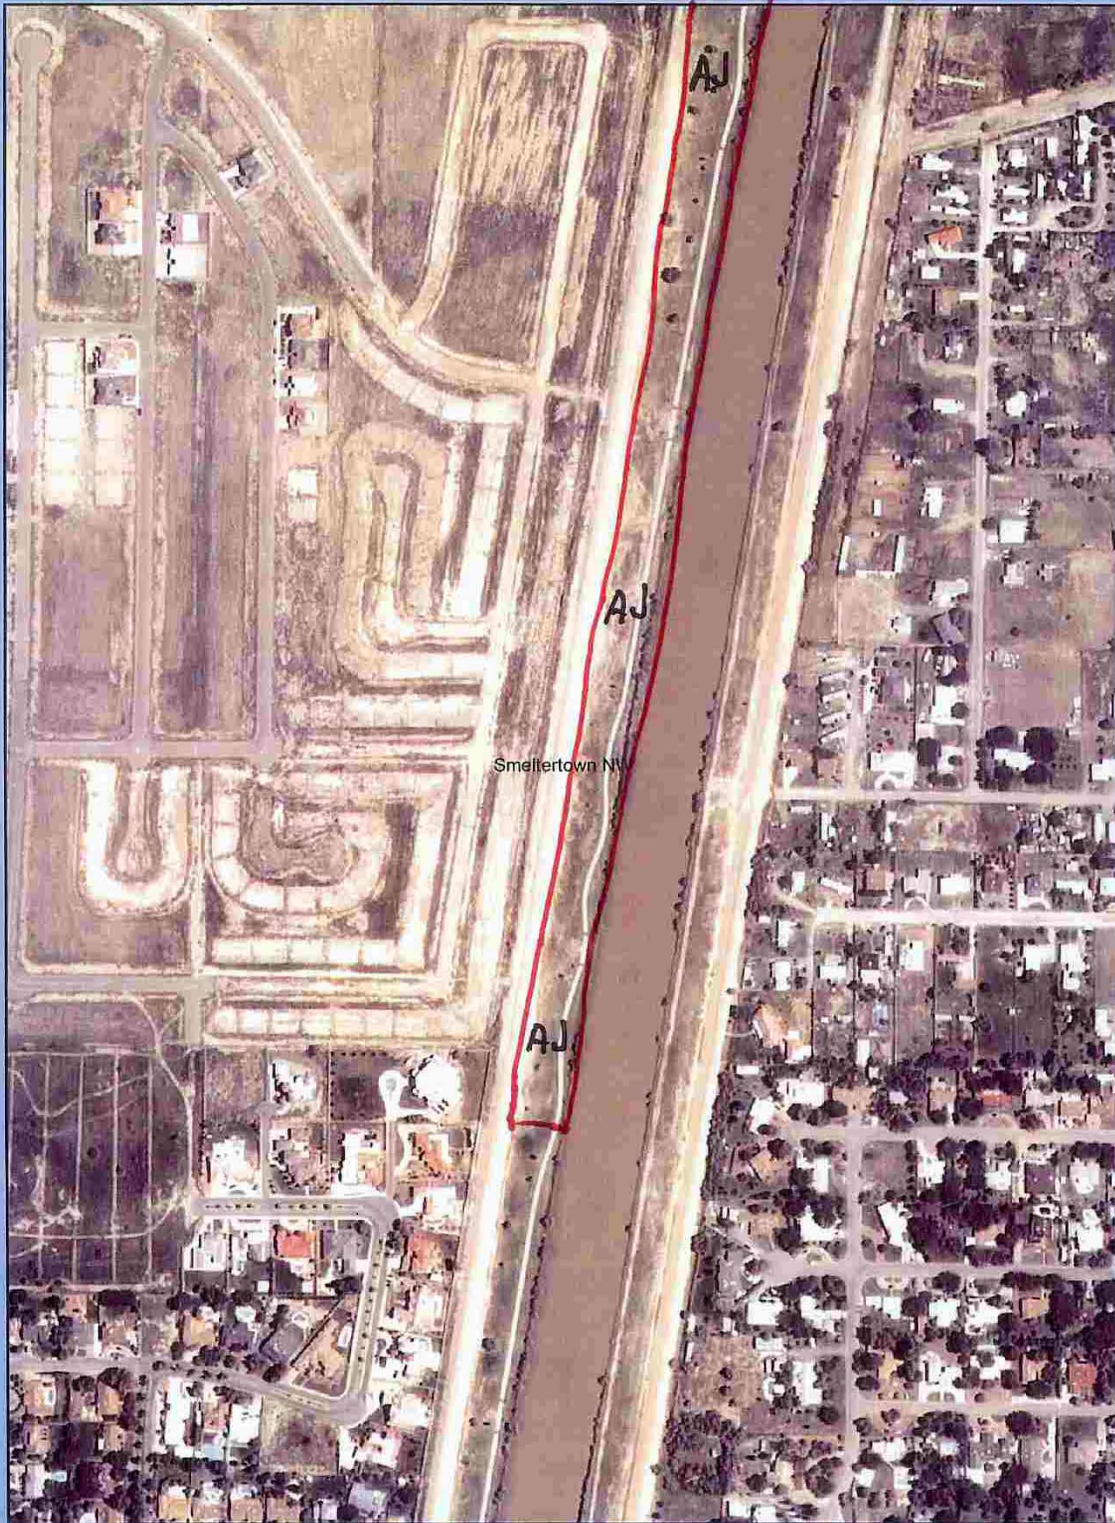
SITE # 26-2

Smelertown NW

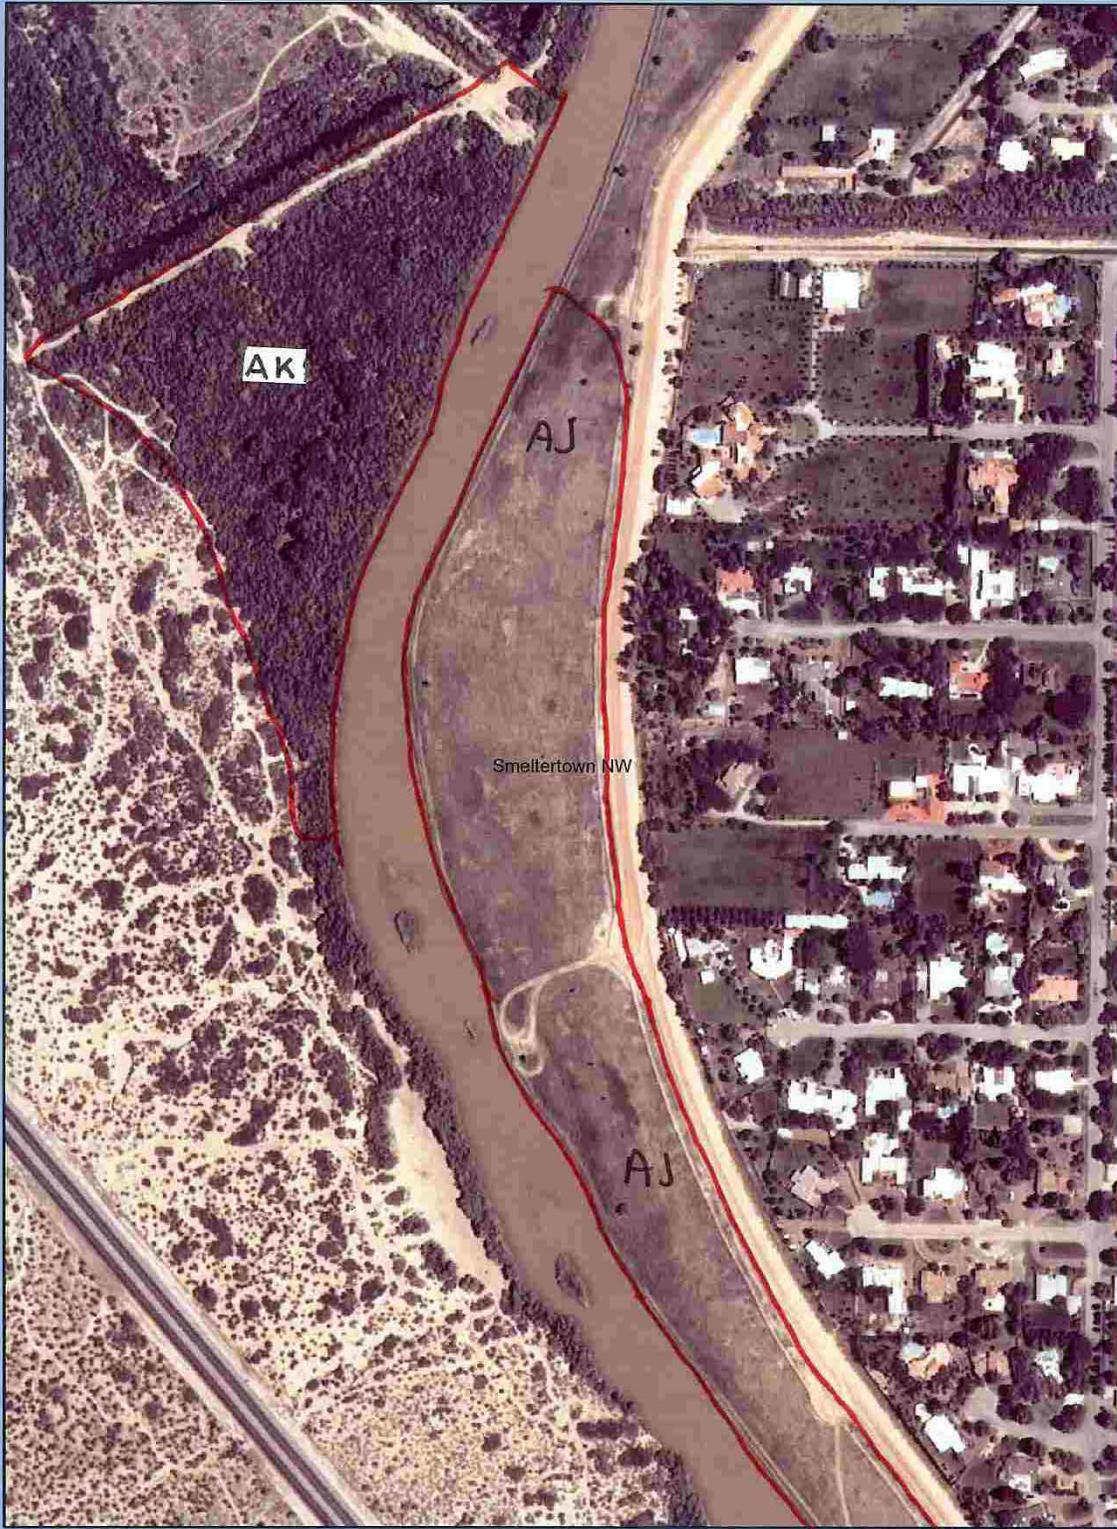
SITE # 28-1

Smelertown NW

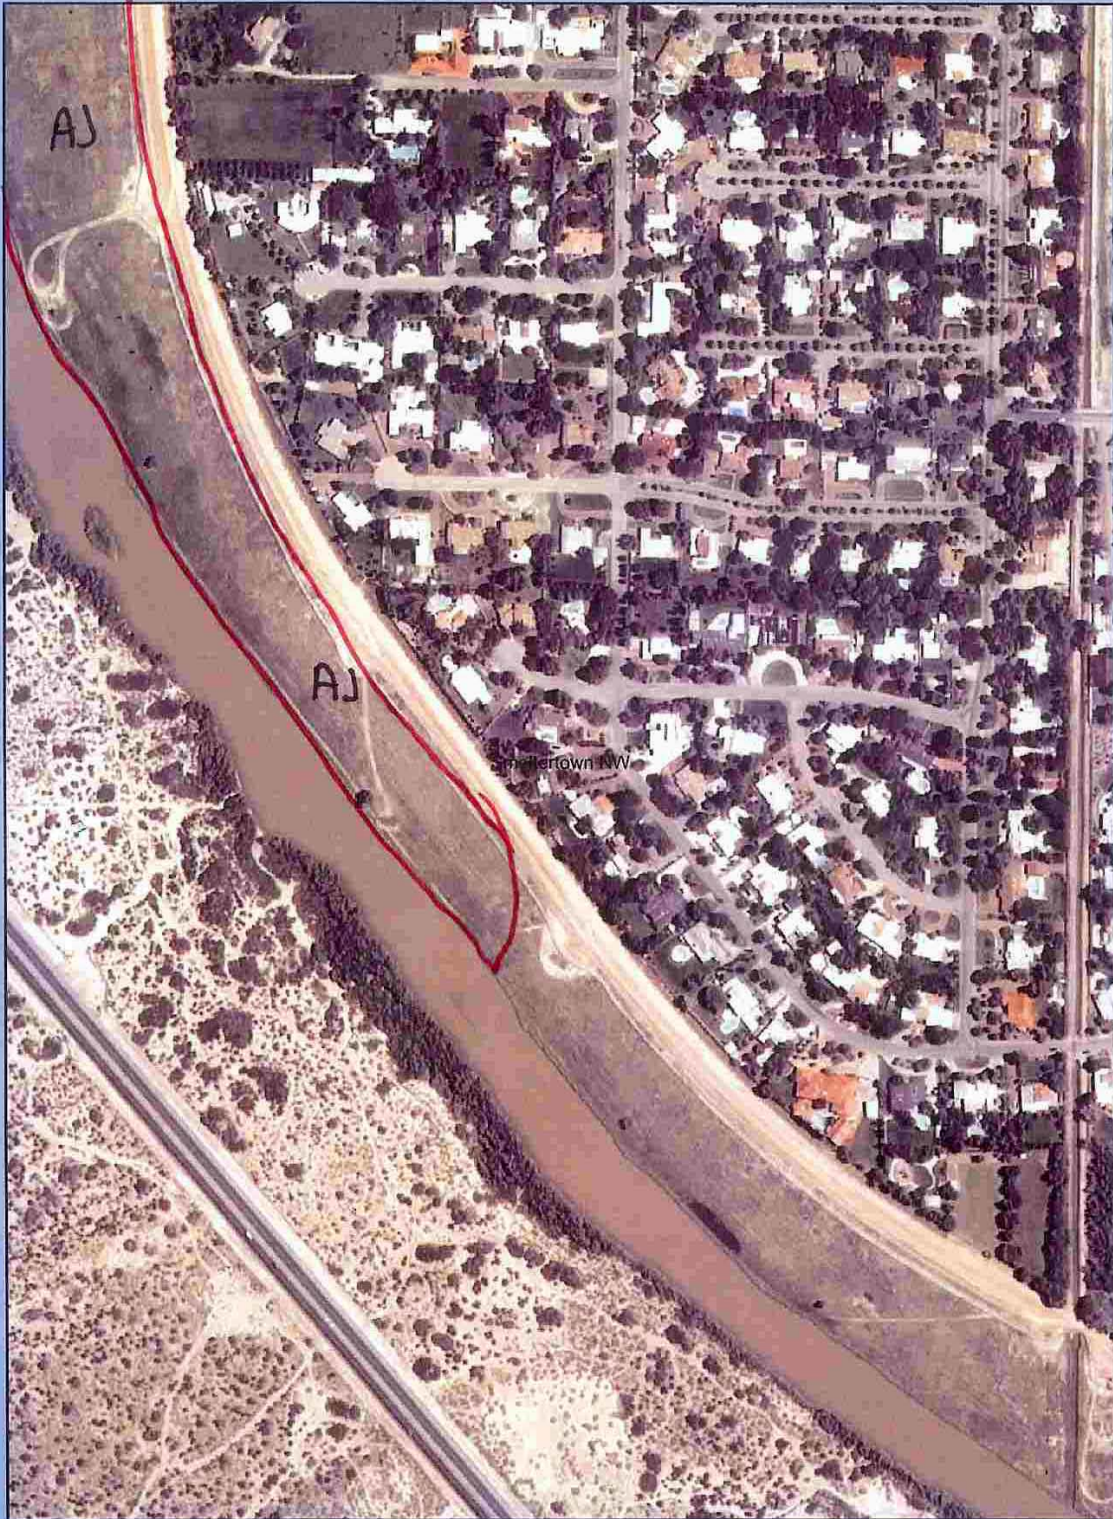
SITE # 28-2

Smelertown NW

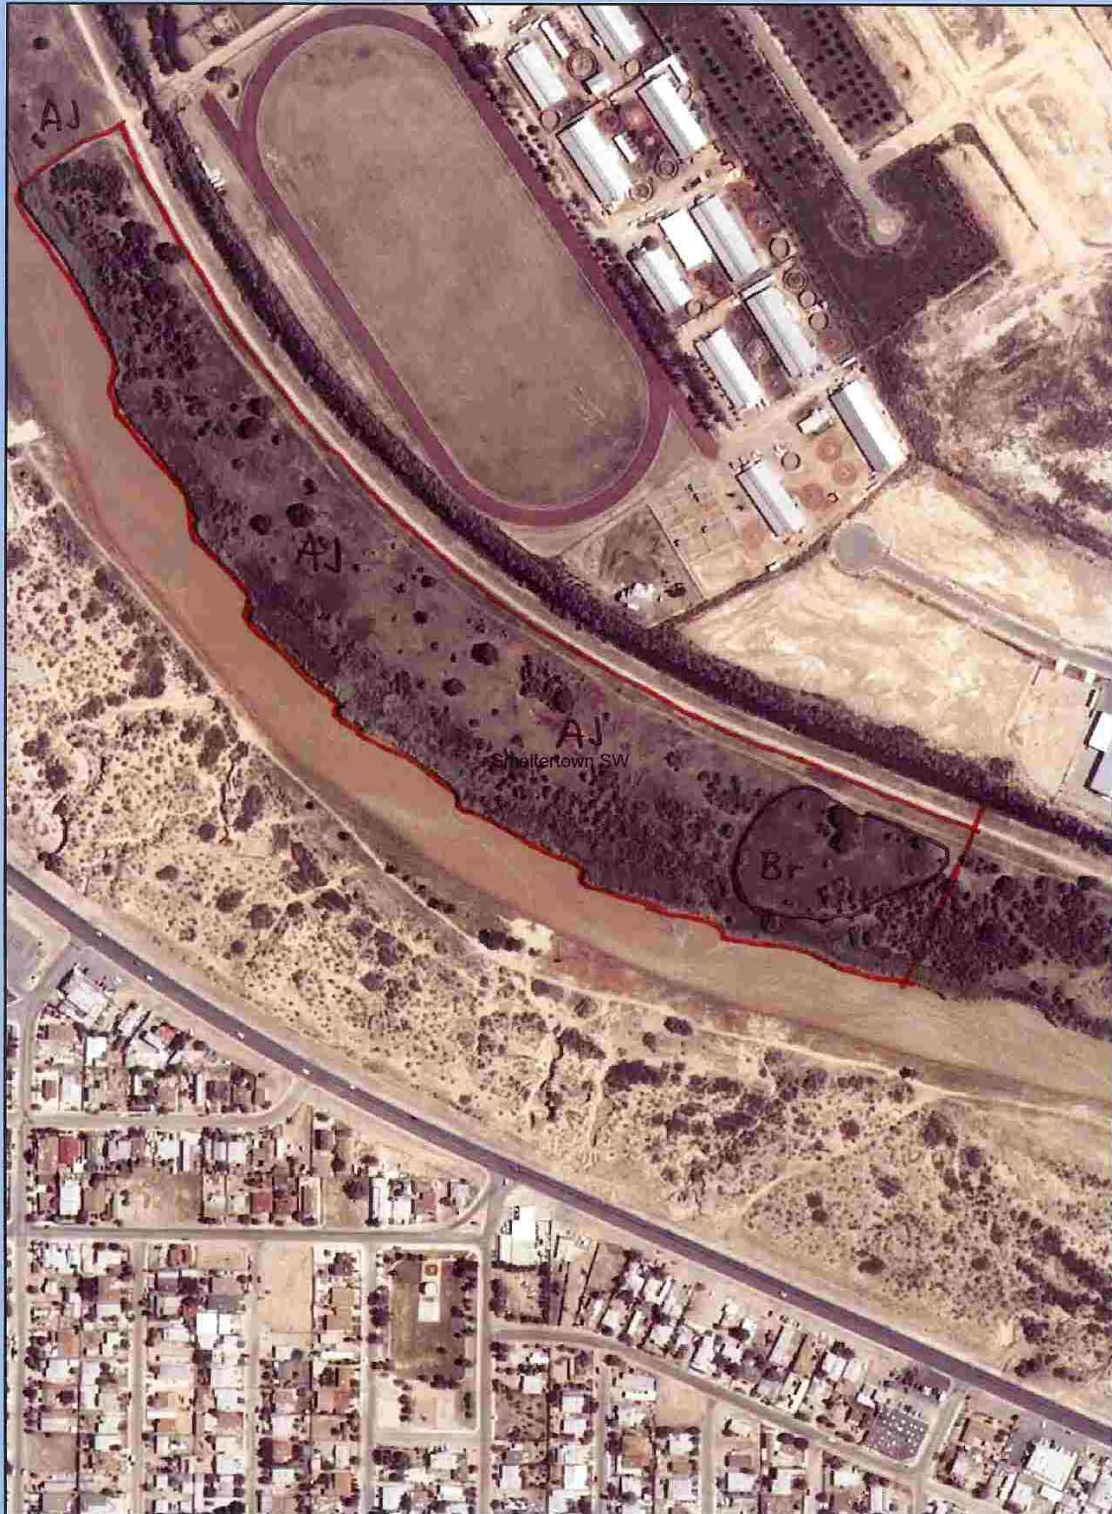
SITE # 29

Smelertown SW

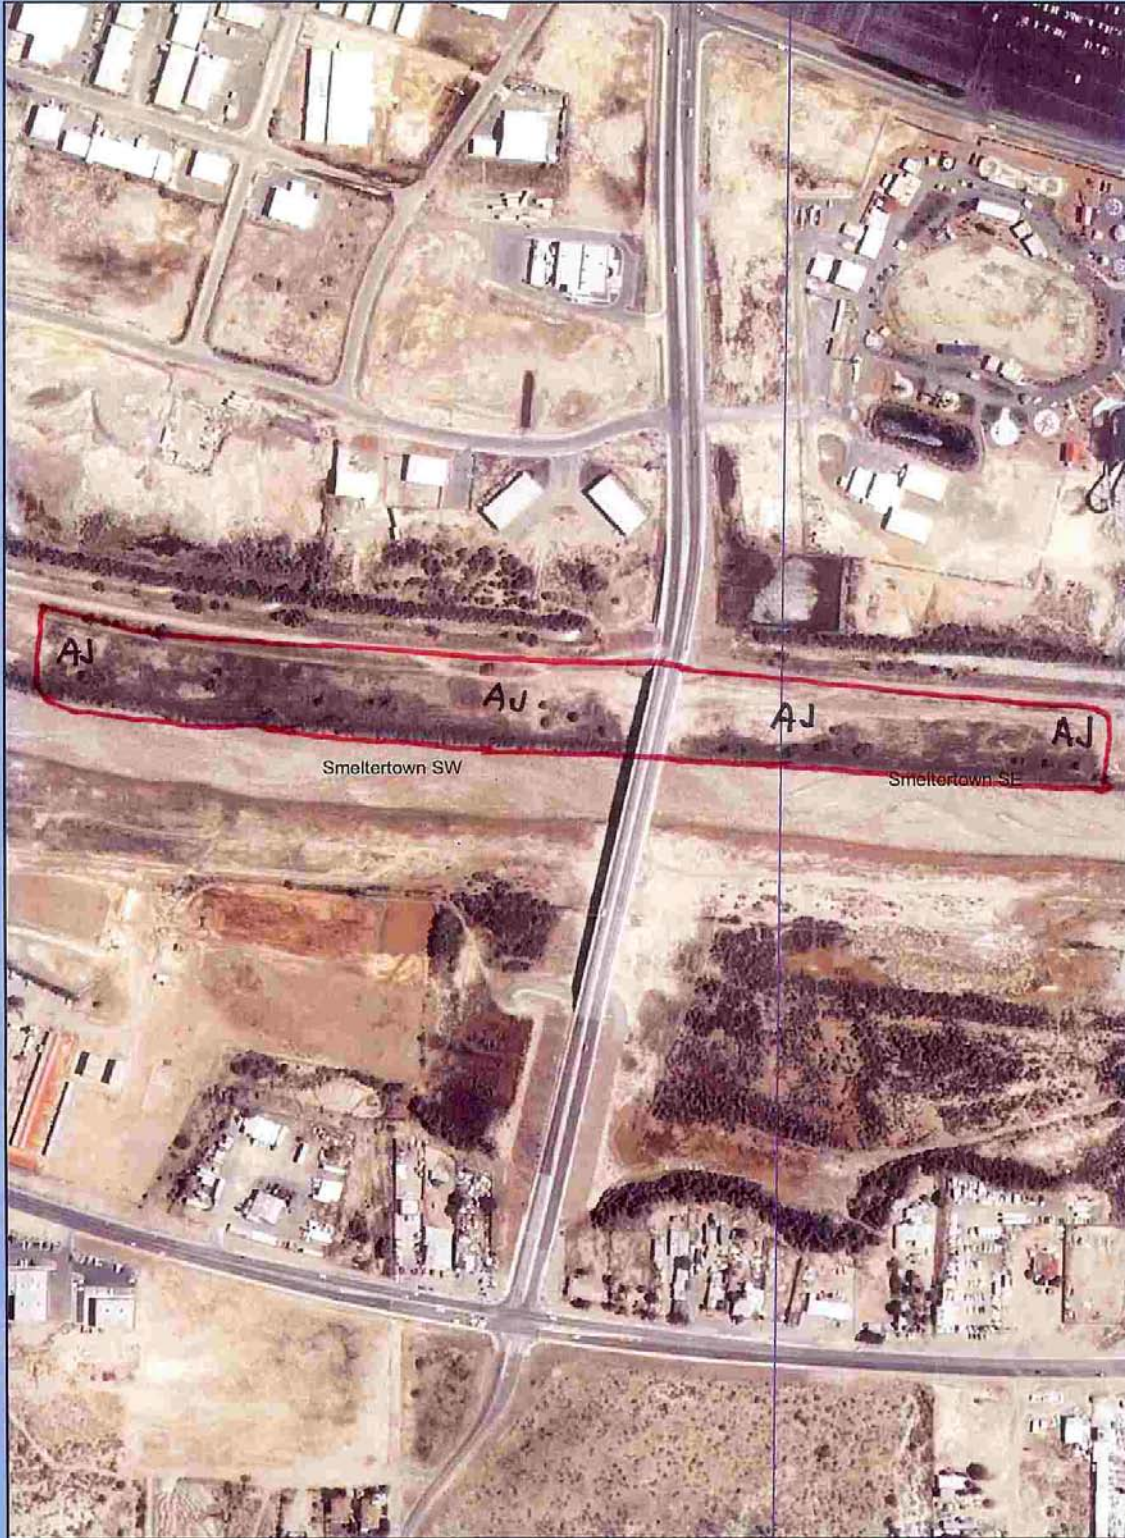
SITE # 30

Smelertown SW
