Riparian Habitat Restoration at Three Sites in New Mexico and Texas: Country Club East, Sunland Park, and Anapra Bridge Restoration Sites

Final Interim Annual Restoration Report

October 2017 to October 2018

IDEALS-AGEISS, LLC

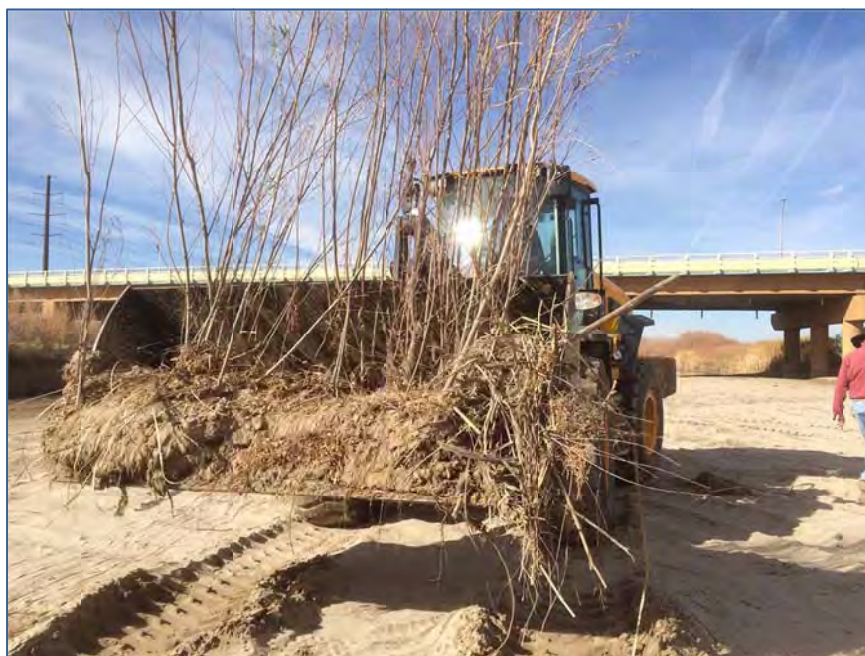
**Removing coyote willows for transplanting at Anapra Bridge,
February 2018**

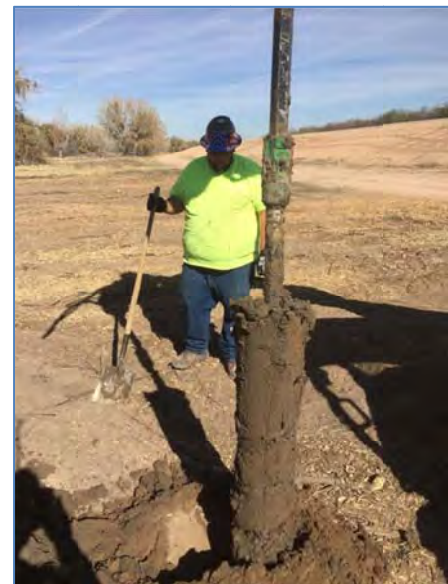
Augering holes for cottonwood pole planting at Sunland Park, 21 March 2018

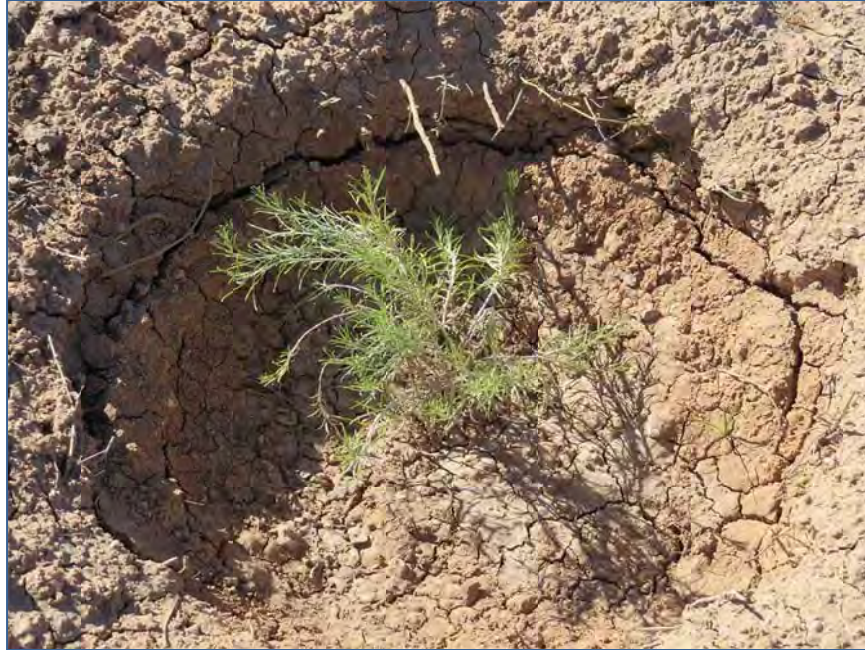
Shrub planting at Anapra Bridge, 15 November 2018

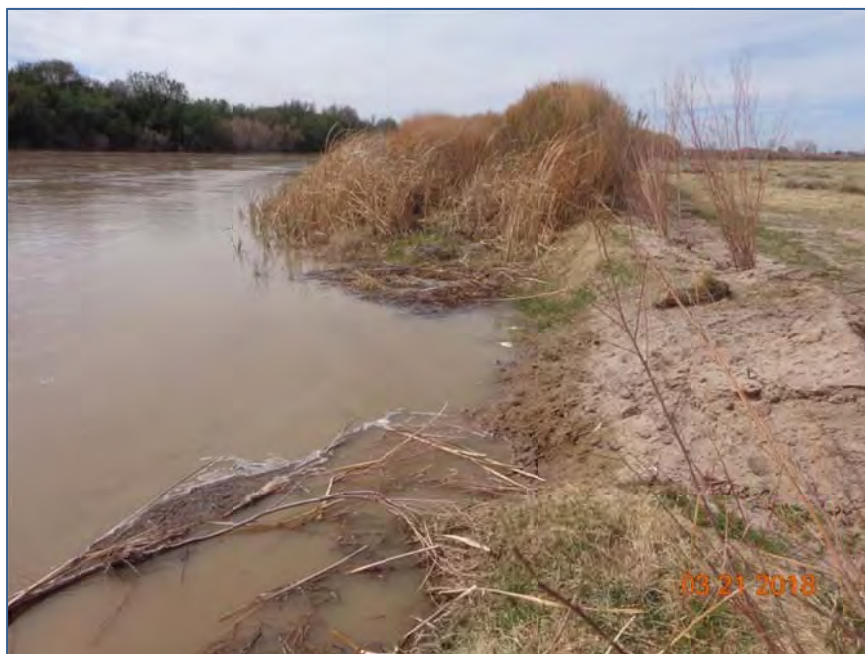
Cut bank area at Country Club East, 21 March 2018

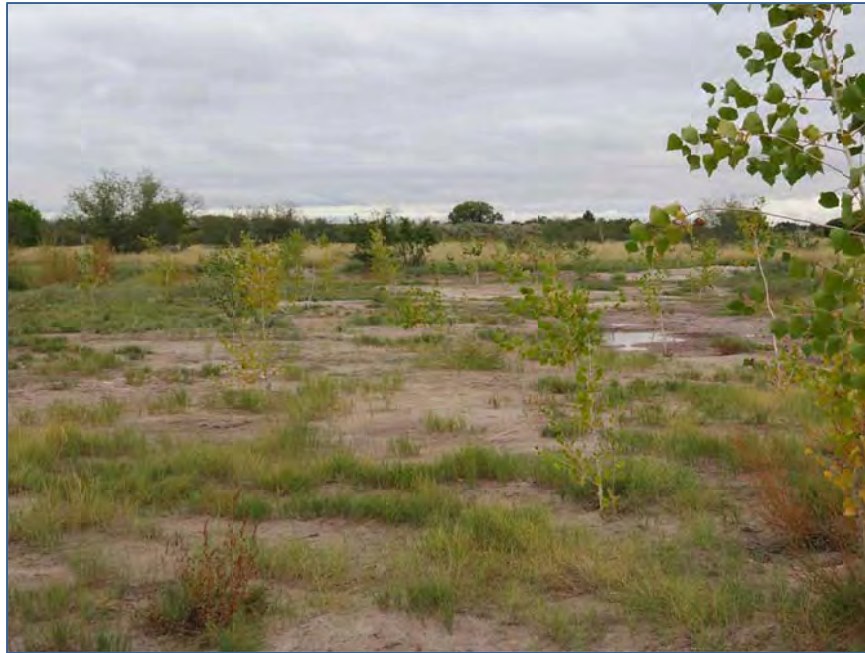
**Cottonwoods planted in the swales at Country Club East,
18 October 2018**
