**USIBWC Riparian Habitat Restoration  
MONITORING NOTES AND PHOTOGRAPHS  
SUMMER 2021**

**U.S. Section International Boundary and Water Commission**

**April 20, 2022**

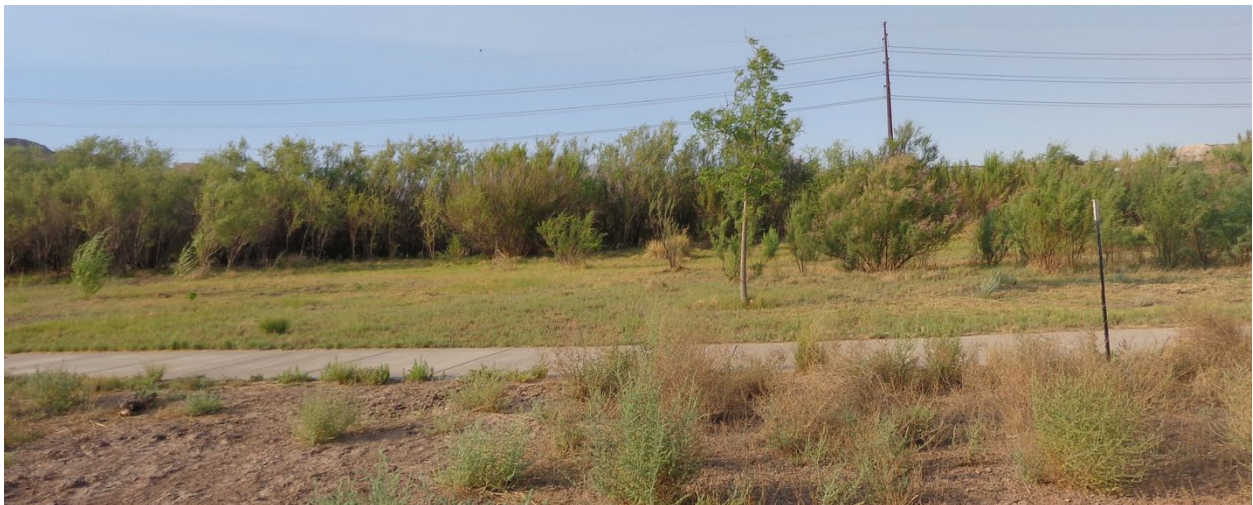
One of IDEALS' photo point T-posts (right). Some saltcedar regrowth. Willows expanding along bank. Plantings are not tall or vigorous except for the ash in the middle that was planted previously by the City of Sunland Park.

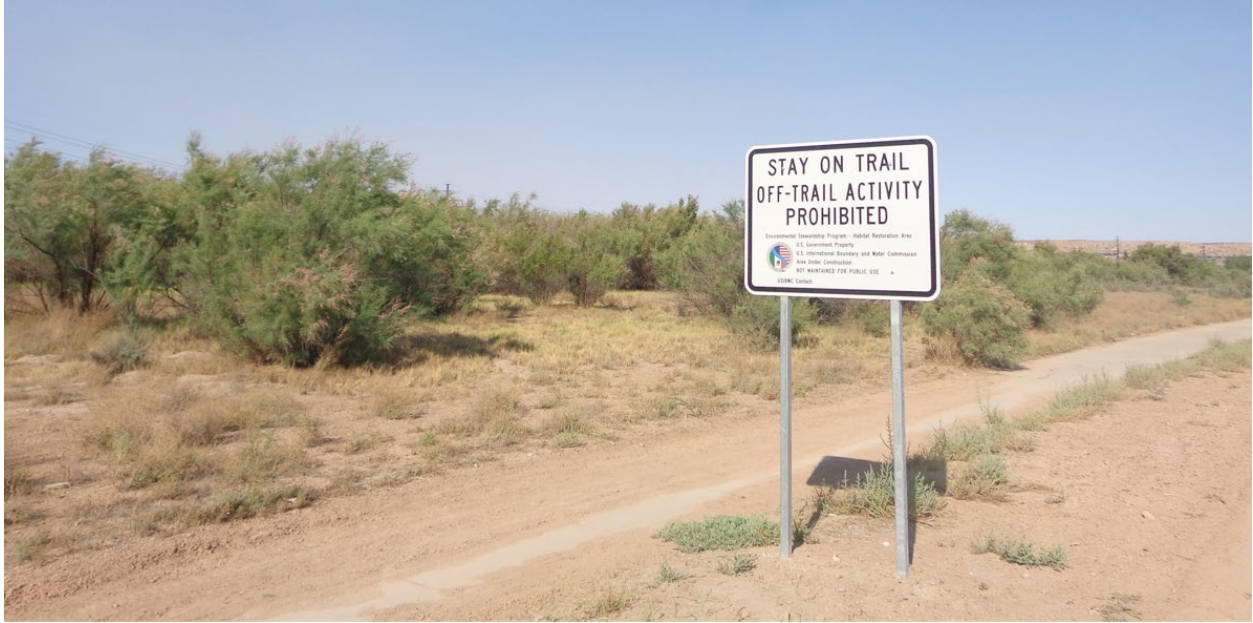
New signs post stay on trail. This sign is at the end of the Anapra site, facing the No Mow Zone outside of the active restoration site, where saltcedar is abundant.

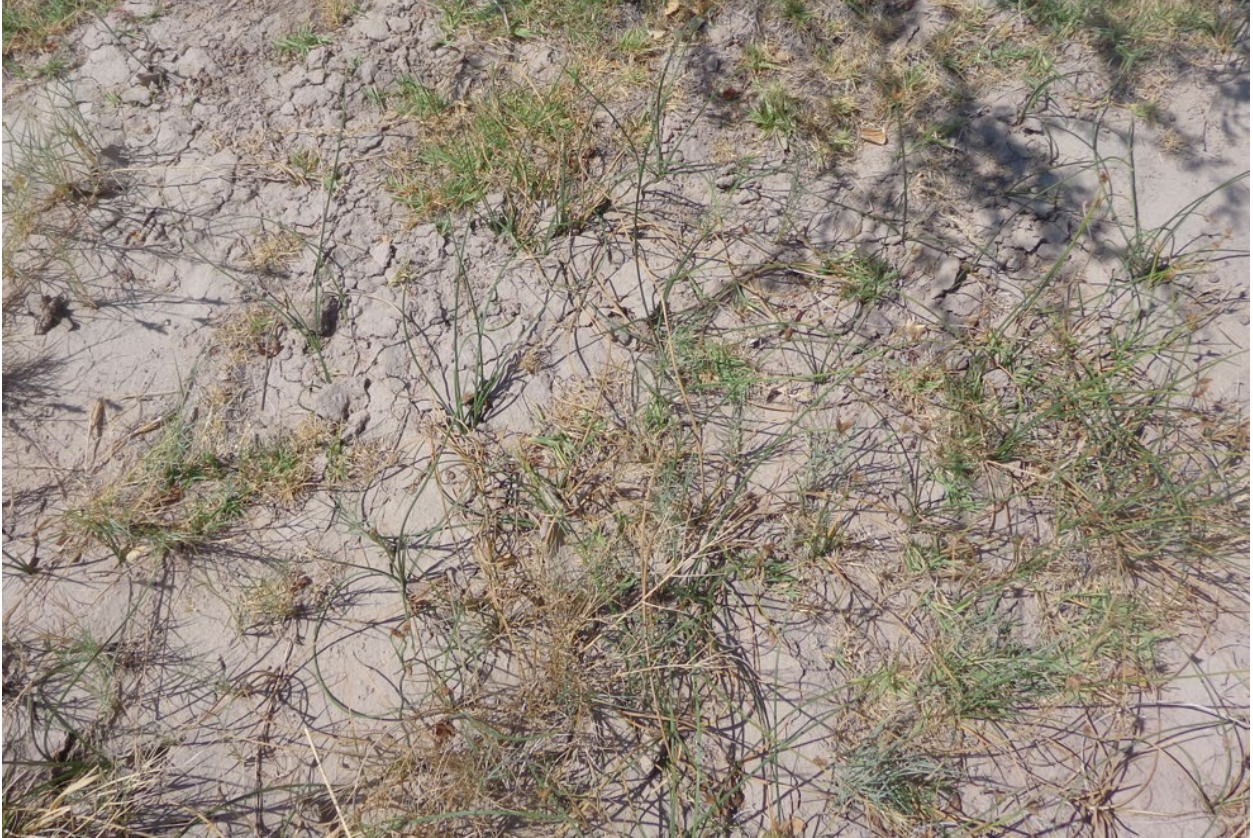
Bullrushes (high water plants) popping up in the construction swales

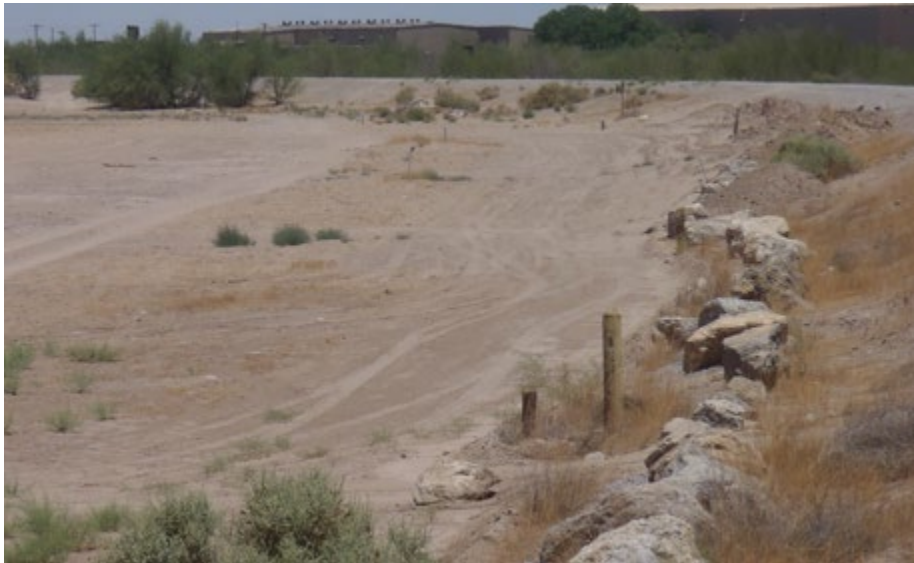
ATV/vehicle tracks up the landside of the west levee past the Vinton Bridge.

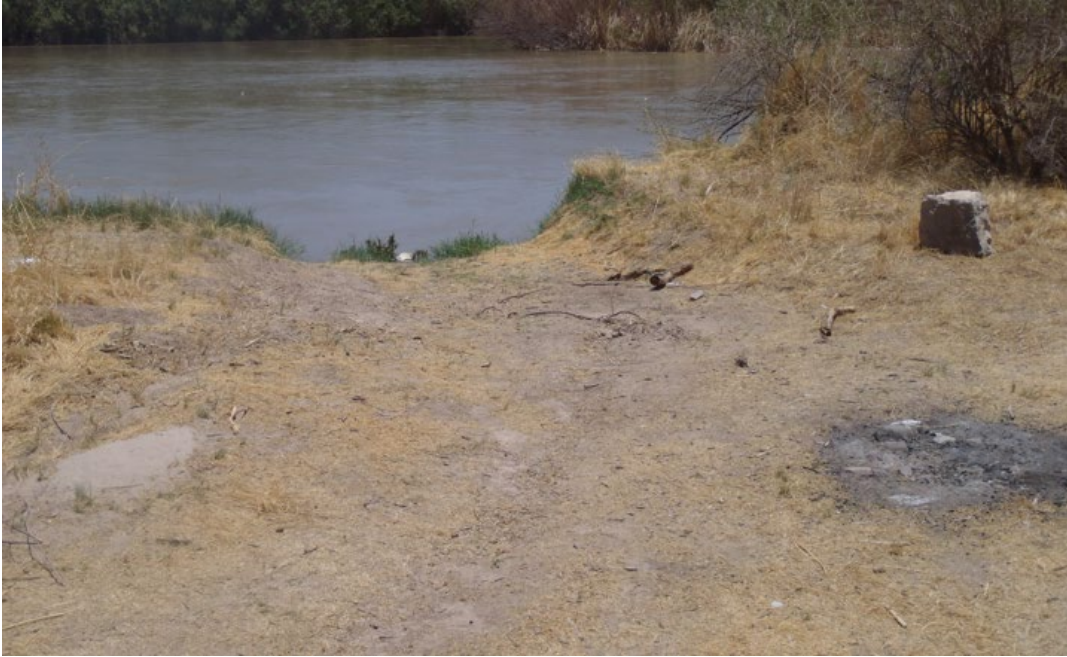
The dirt road led to a makeshift boat ramp and had recent campfire remains and trash.

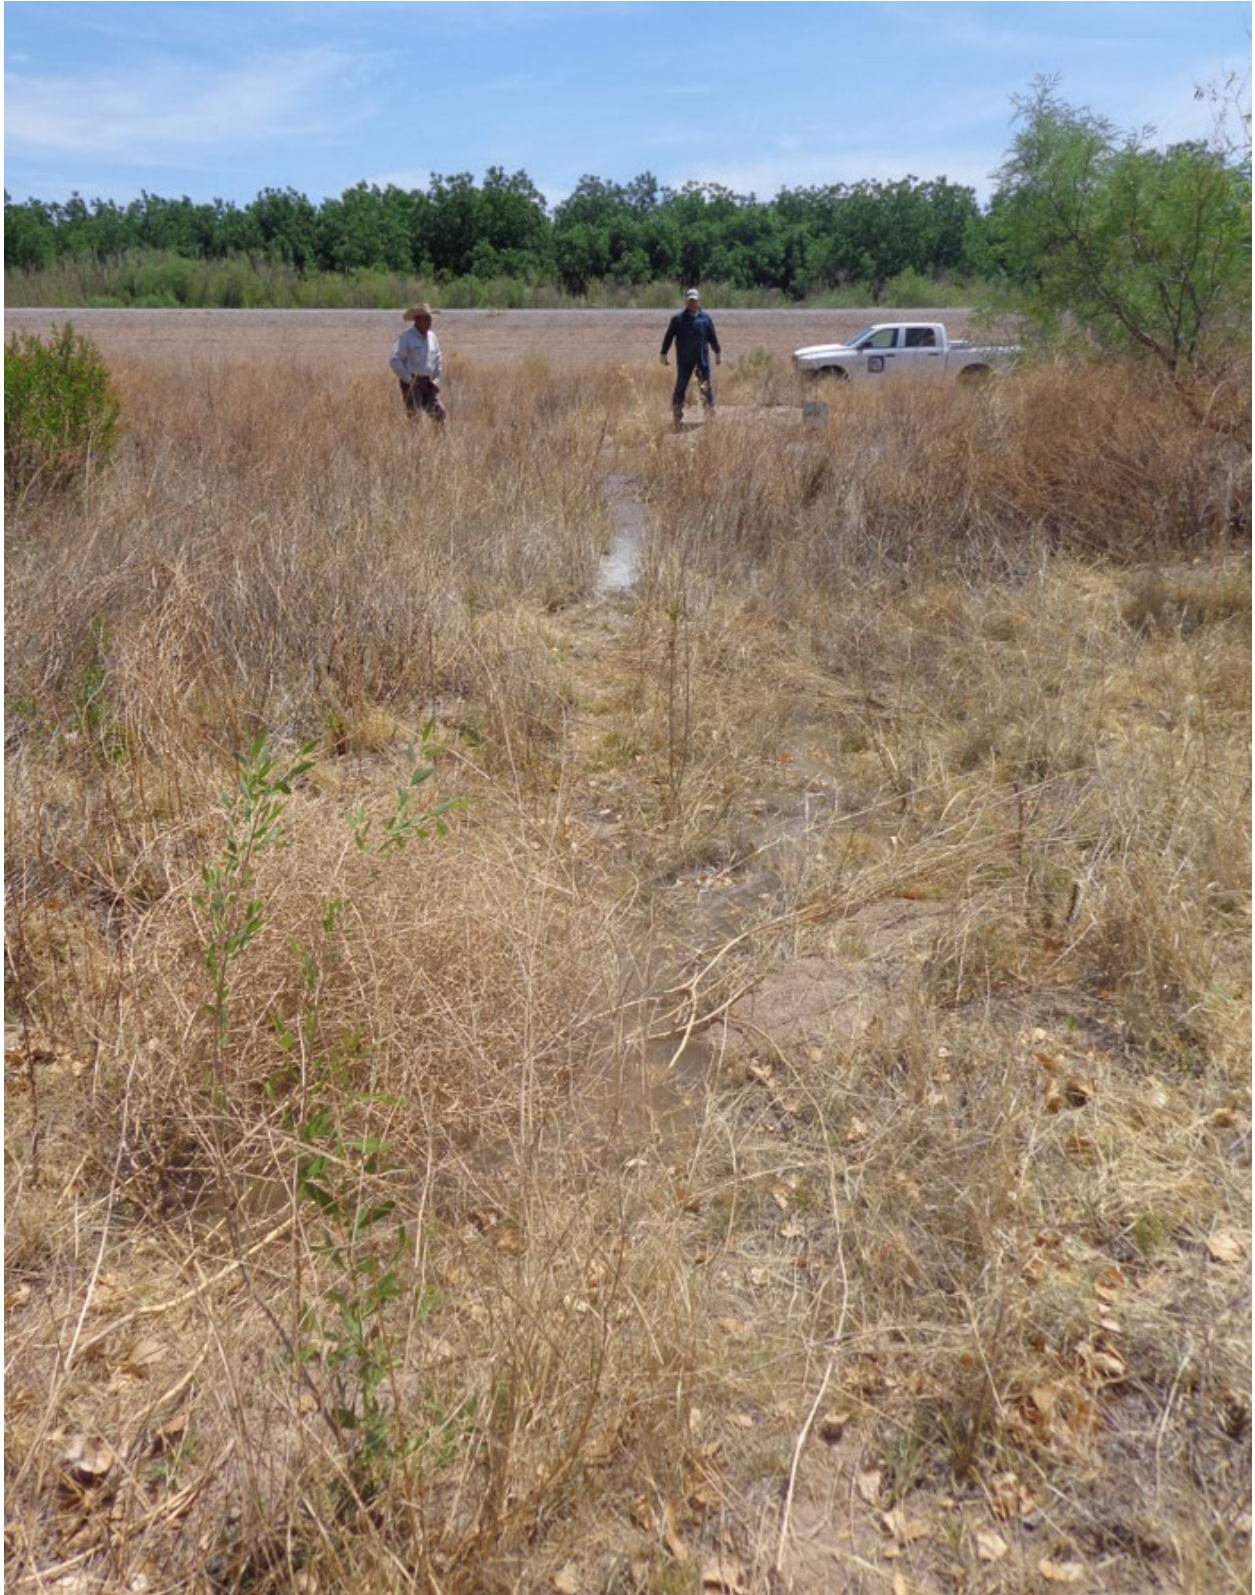
Irrigation water is reaching this small Gooddings willow in Irrigation Cell 2.

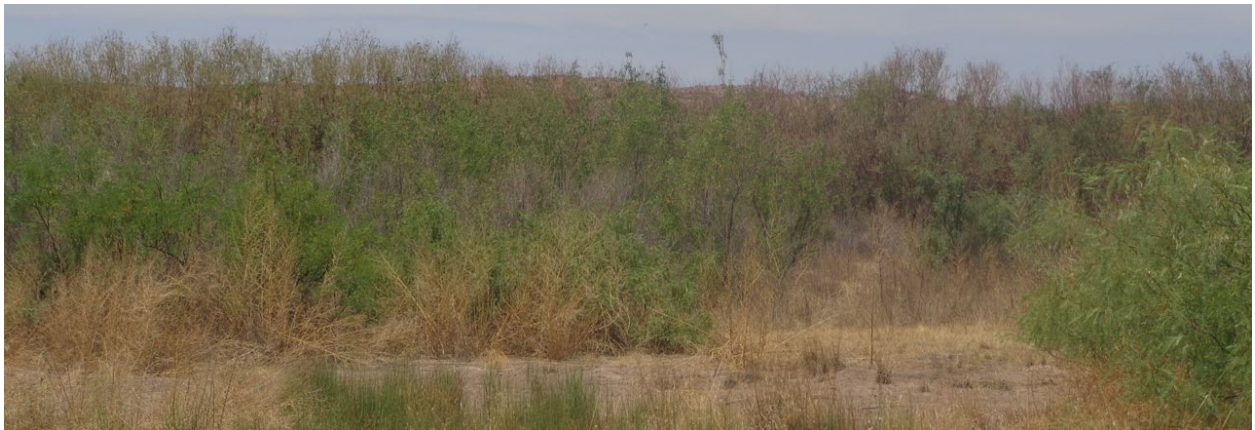
Coyote willows along the bank in the middle of the site appear to be struggling due to lack of water in the river.

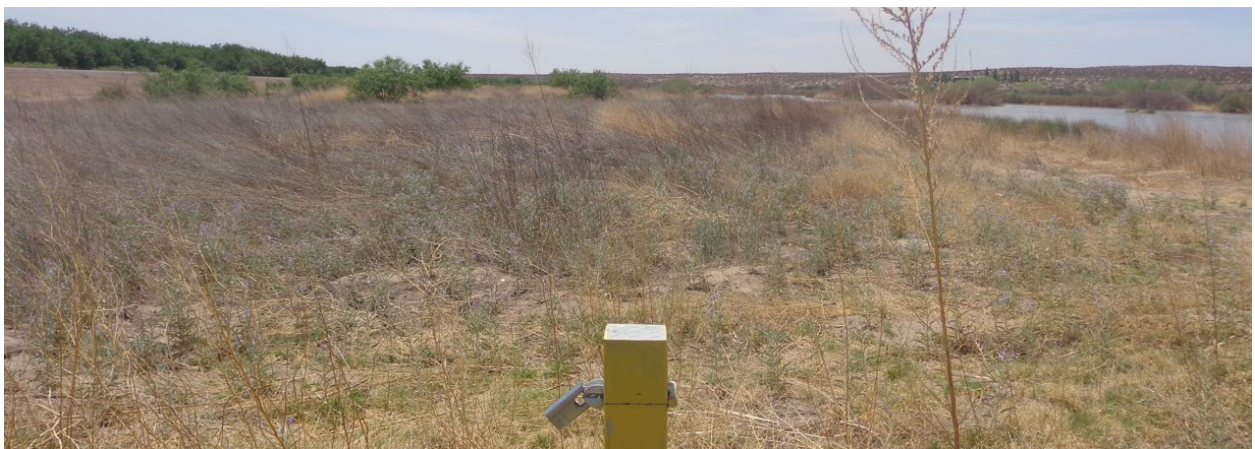
Grasses and shrubs near well 1 (middle of site).

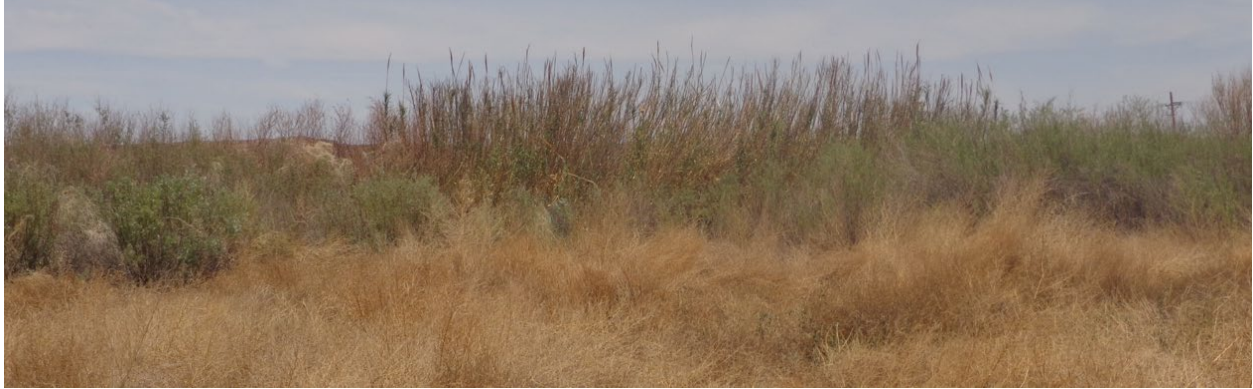
A phragmites stand along the river on the northern end of the site.

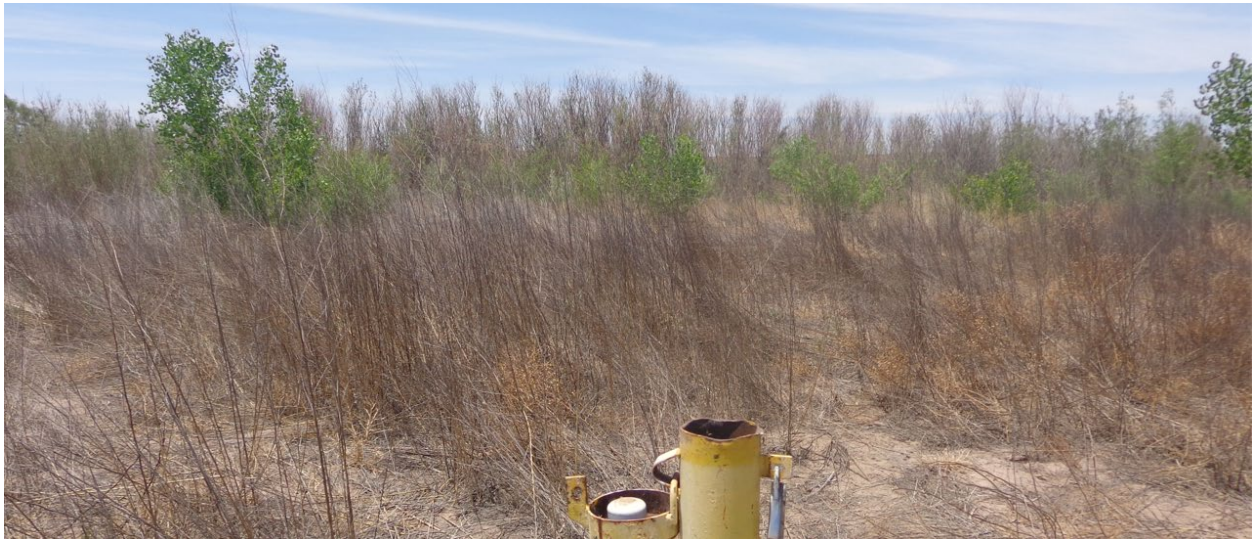
Planted cottonwoods and Gooddings willows thriving near Well 2 at the north end of the site.

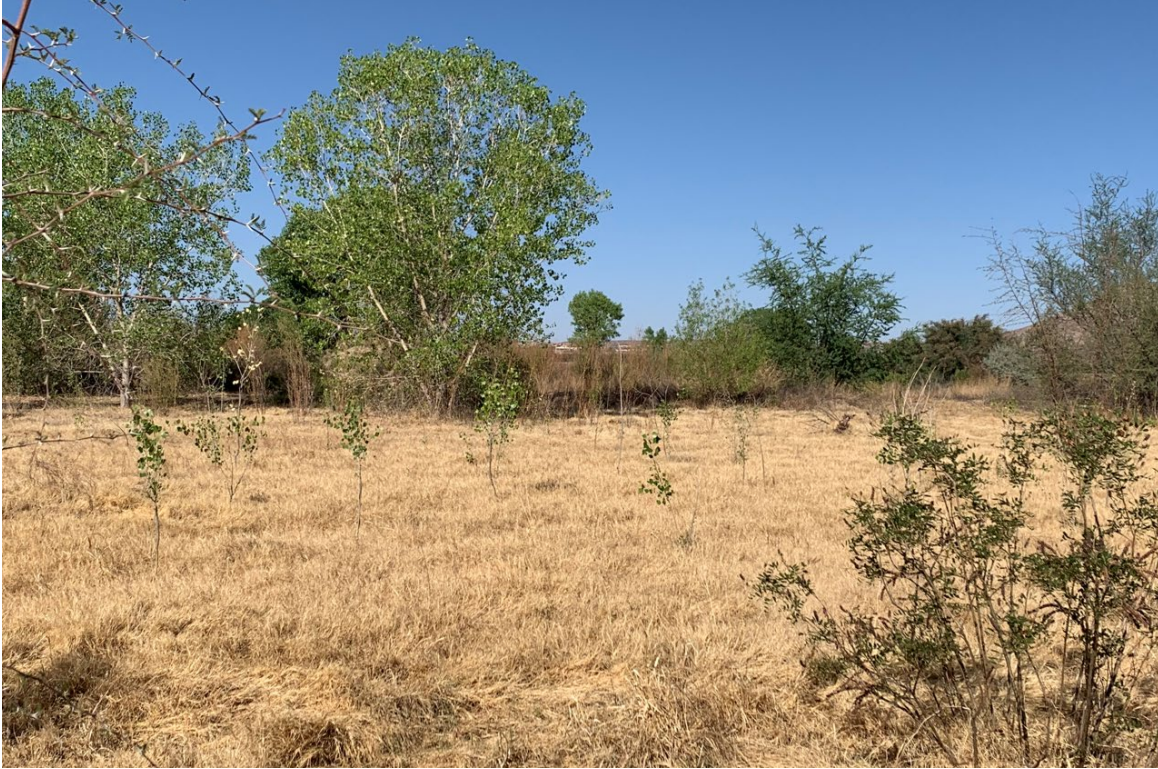
Younger cottonwood plantings amongst older plantings and native brush in the second irrigation cell.

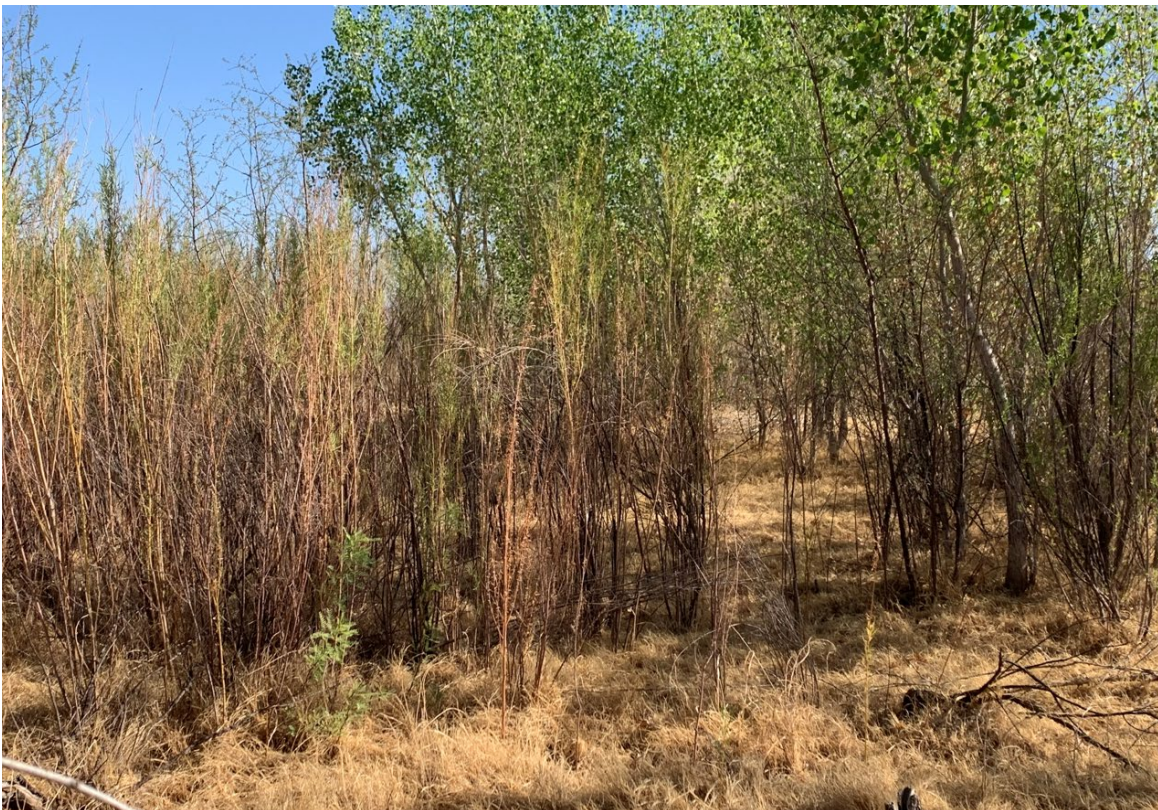
Willows sprouting from offshoot roots after several fires impacted the site. Site is recovering nicely after the fires, with increased density of willows as a result.

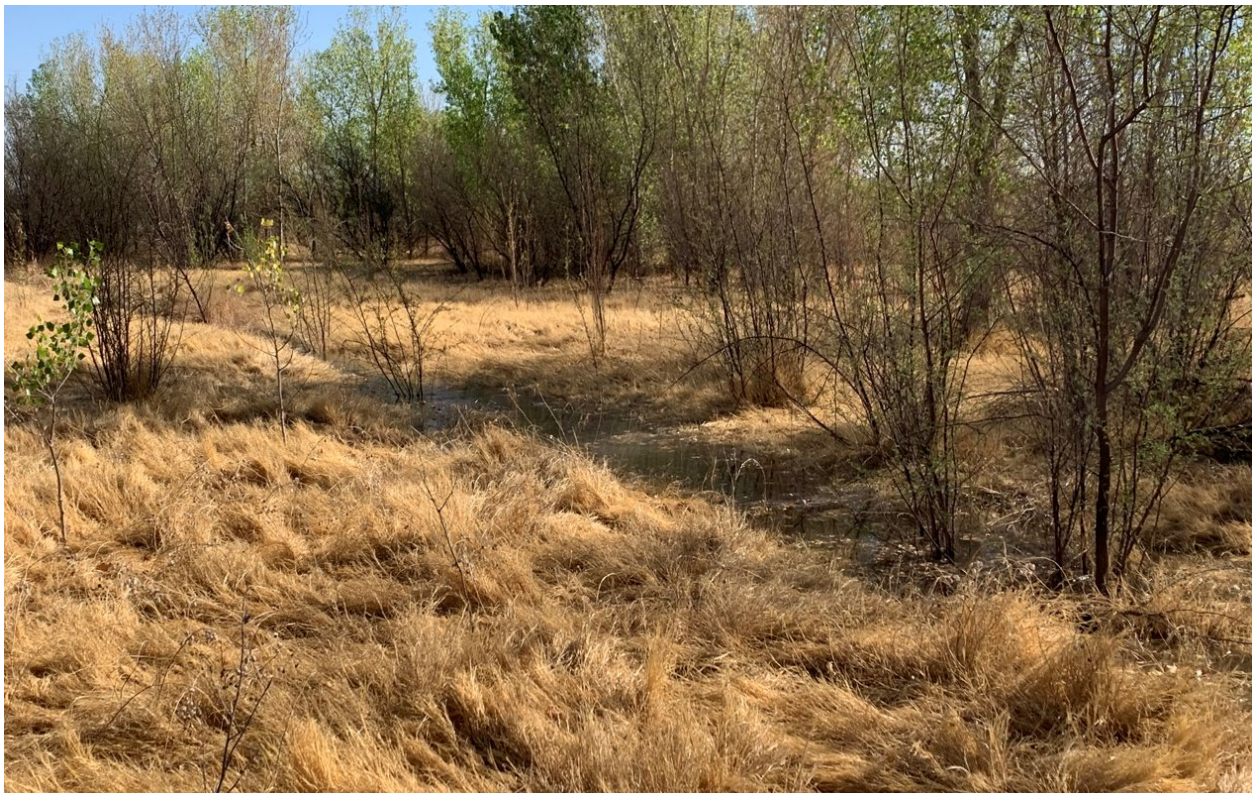
Irrigation water being conveyed through the site via the earthen v-ditch.

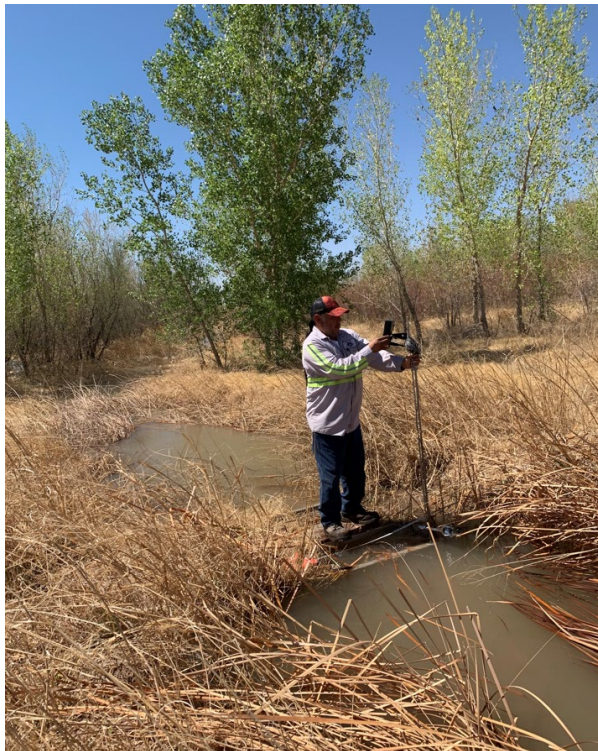
EBID hydrotech measures the flow entering the site in order to calculate the volume of irrigation water received.

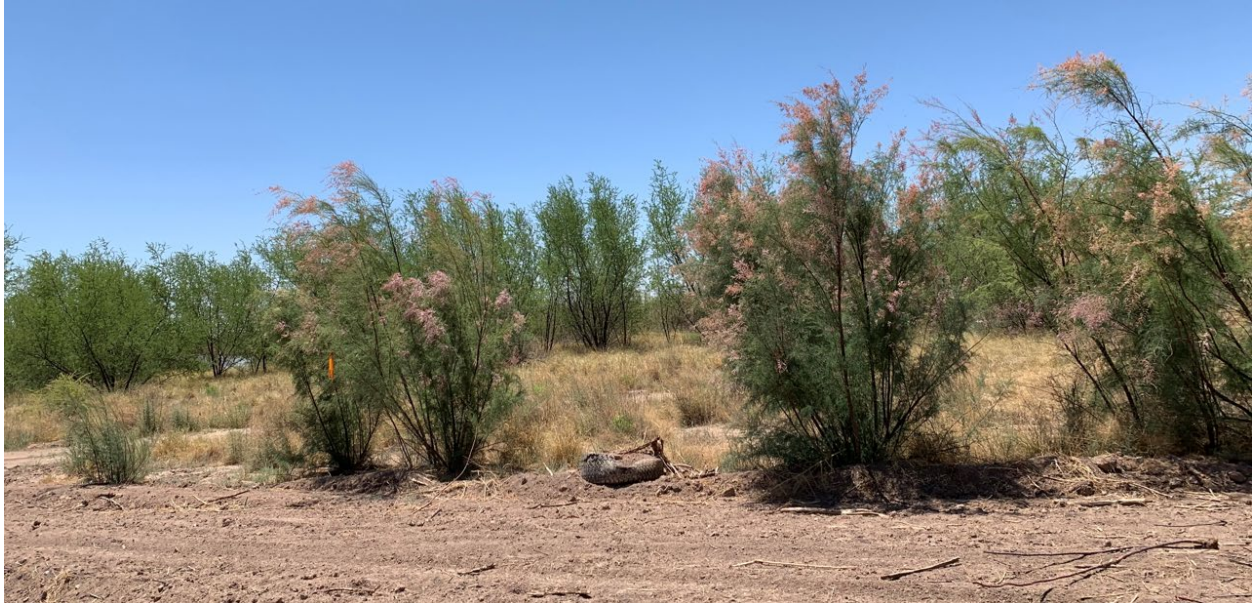
Trash and flowering saltcedar by the road immediately outside of the Shalem Colony site.

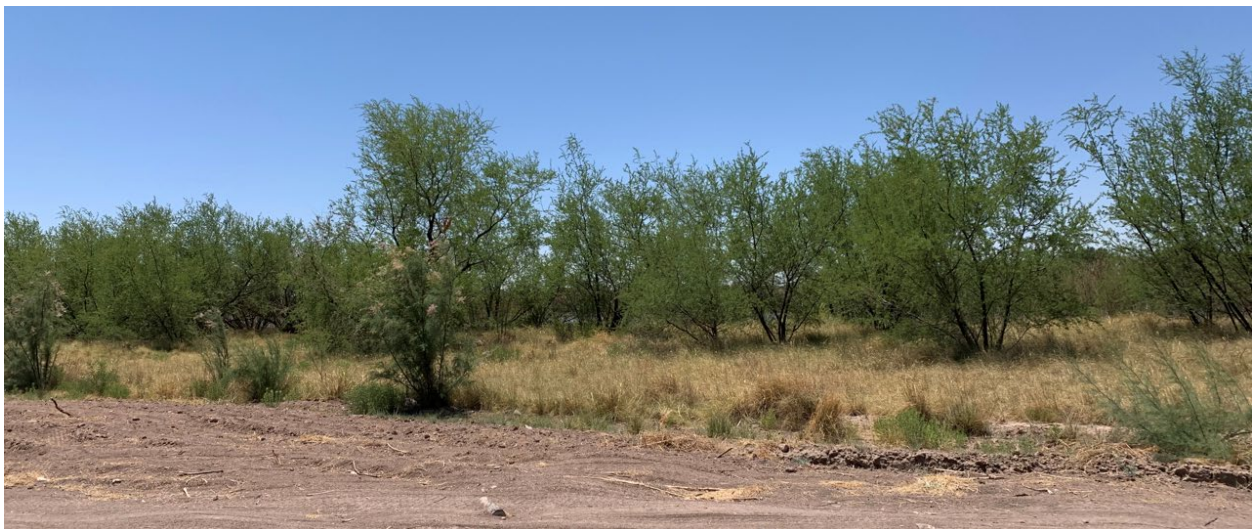
Inside the site, there are some young resprouts of saltcedar along the levee toe road.

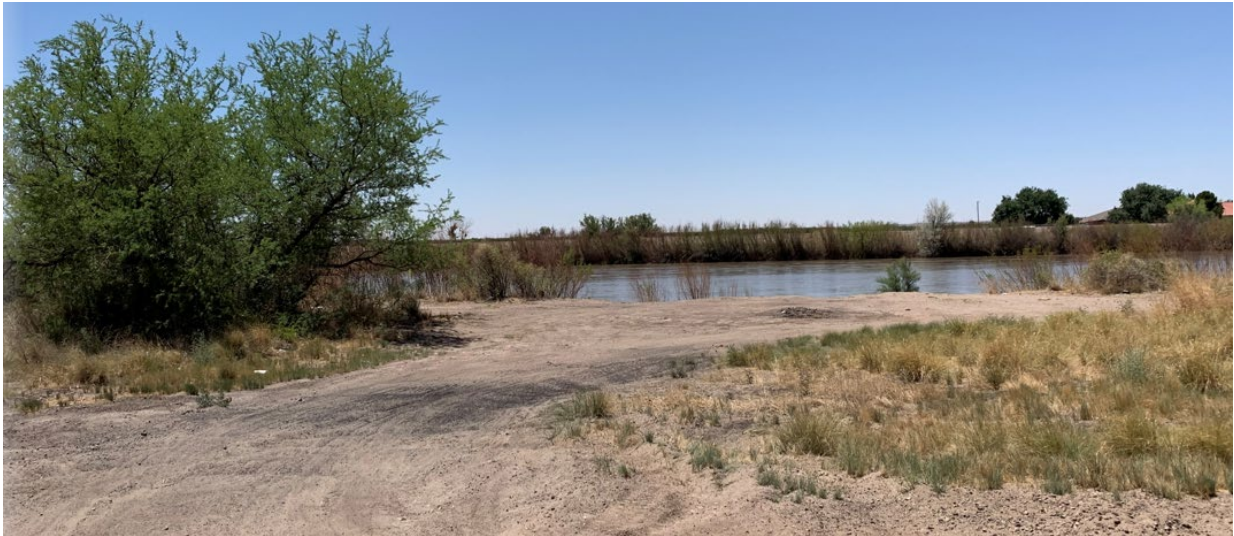
The southern end of the site has campfire evidence and a frequently used dirt road.

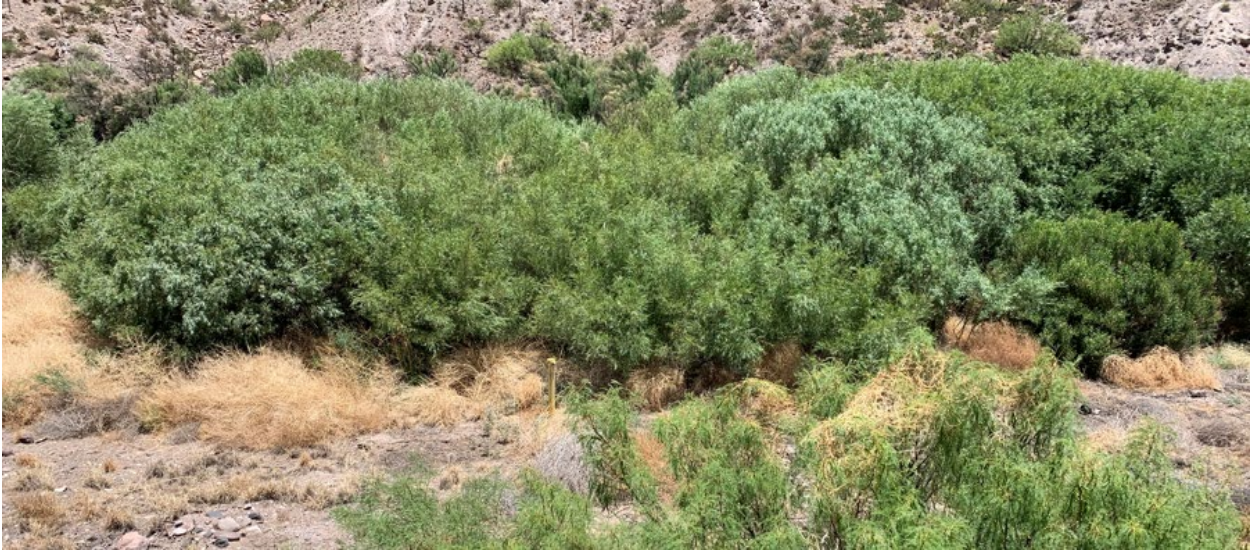
Planted willows along the terrace along the Rio Grande at Well 1 (hills are on opposite bank).

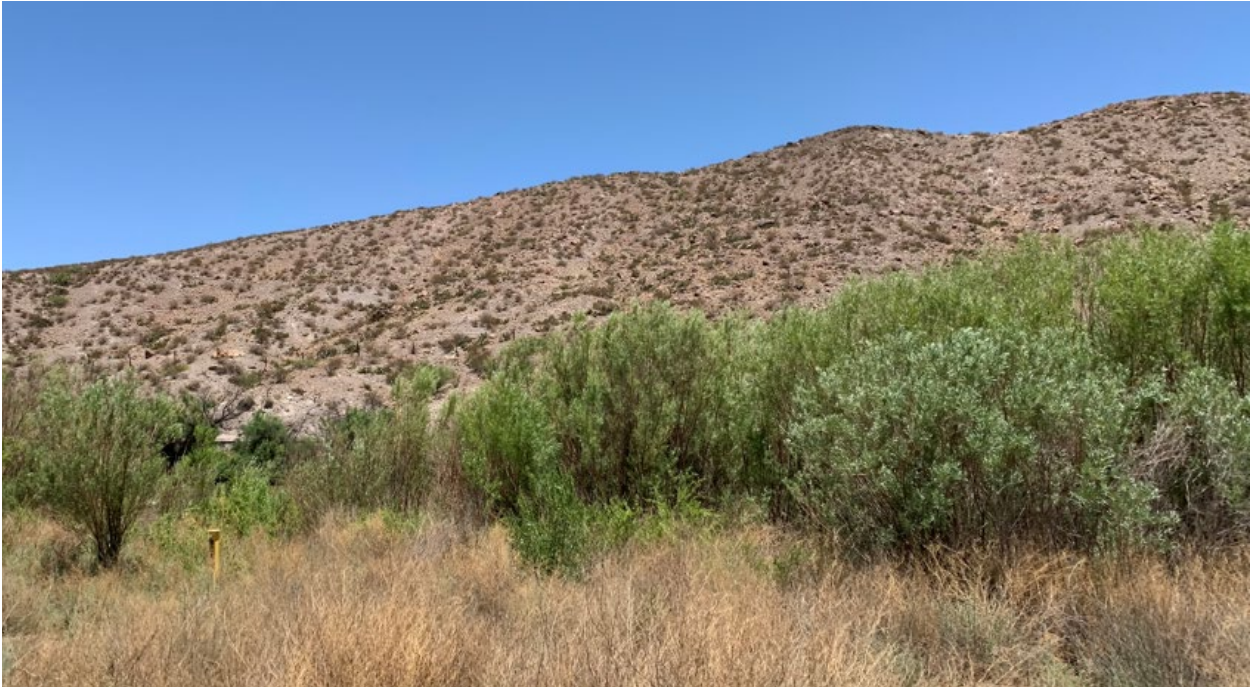
Planted willows along the terrace along the Rio Grande at Well 2 (hills are on opposite bank).

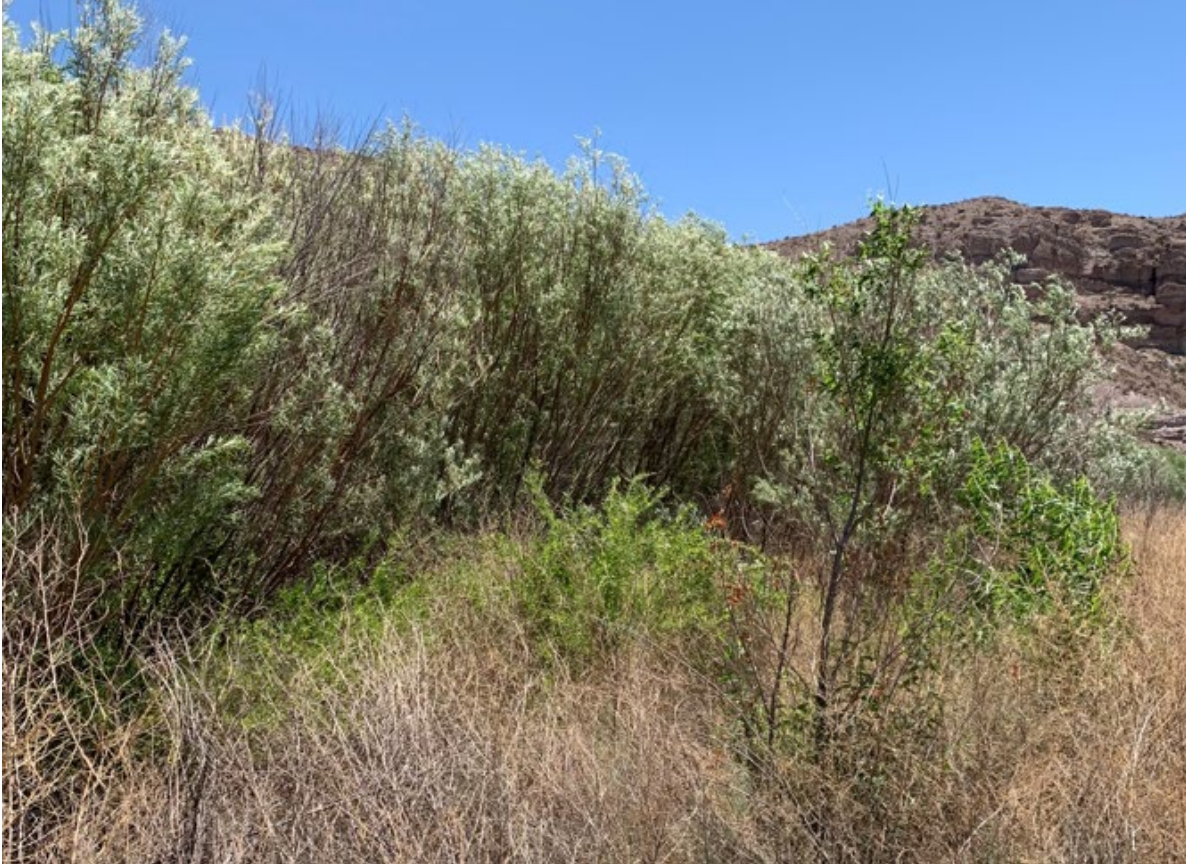
Planted willows along the terrace along the Rio Grande at Well 2 (hills are on opposite bank).

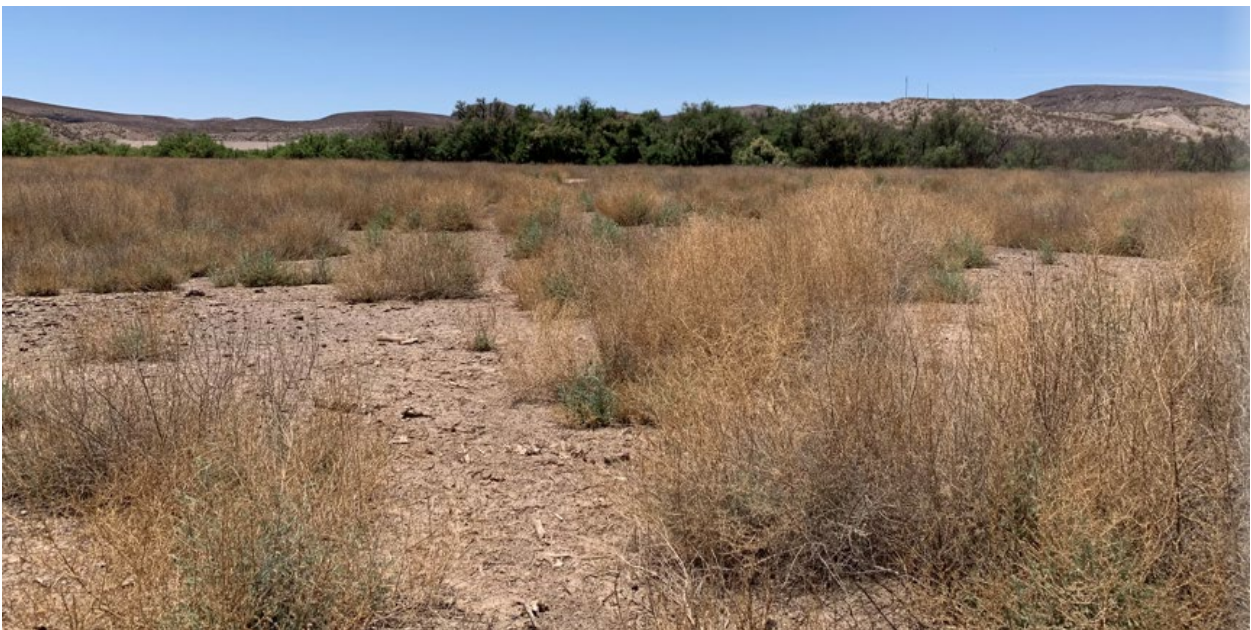
Upland portion of the Broad Canyon Arroyo site is unsuccessful at various restoration efforts. Planted cottonwoods over the years have had 100% mortality likely due to deep groundwater, salinity and clays. Efforts at native seeding have also not been successful.

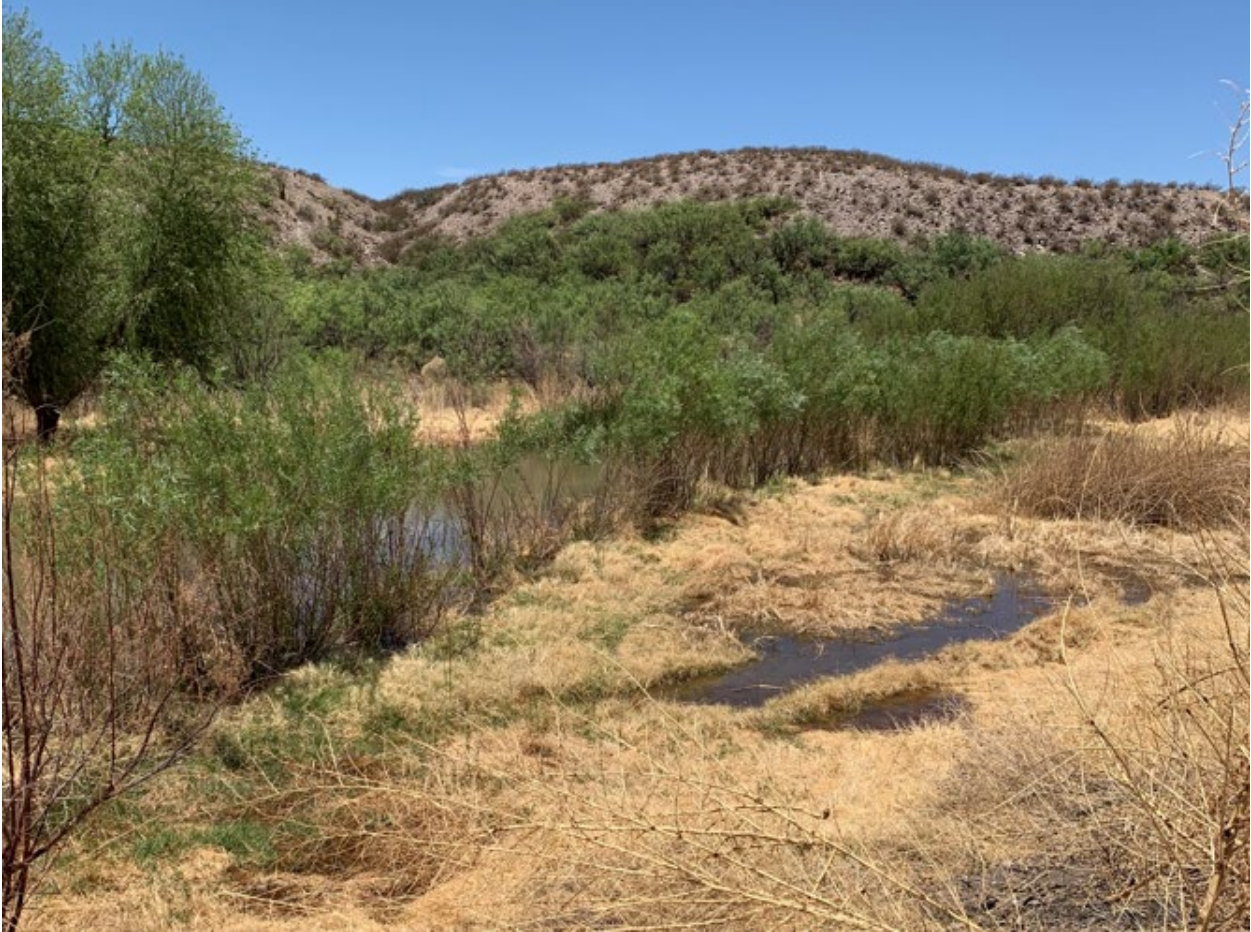
On the flip side, the arroyo portion of this site is highly successful. This photo shows the willows along the arroyo near the mouth, as well as backwater conditions that create wetland conditions.

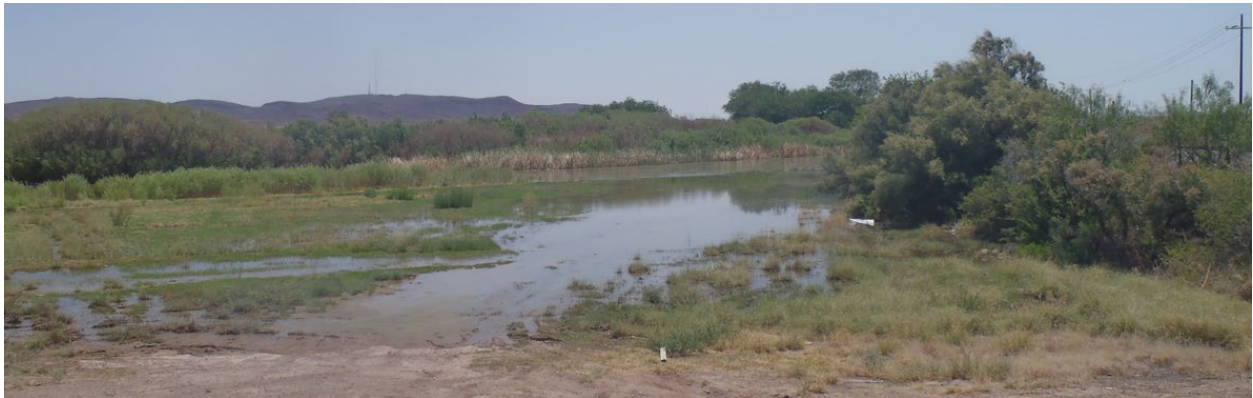
Rincon Siphon D just north of the Rincon Siphon captured overbank flows at the beginning of irrigation season in June 2021.

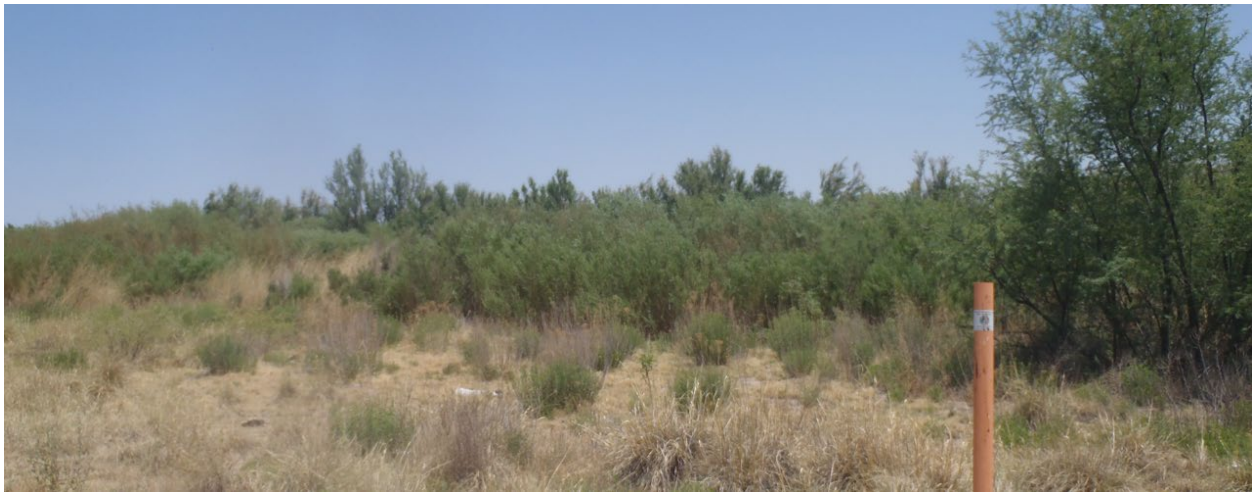
Successful transplanted island willows at the southern end of Rincon Siphon D. There were about 5 rows of willows planted via trenches in 2019. The bankline is where the taller saltcedar is in the background.

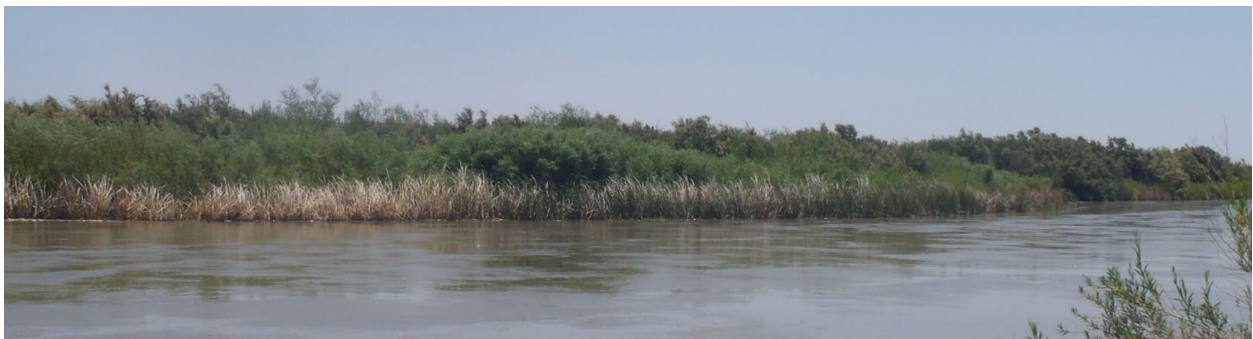
View of delta at Rincon Siphon C where mature willows where flycatchers were breeding were harvested and moved to the opposite bank. This "slimming" of the island delta was a pilot project to see if narrowing island habitat for flycatchers would minimize impacts to the birds.

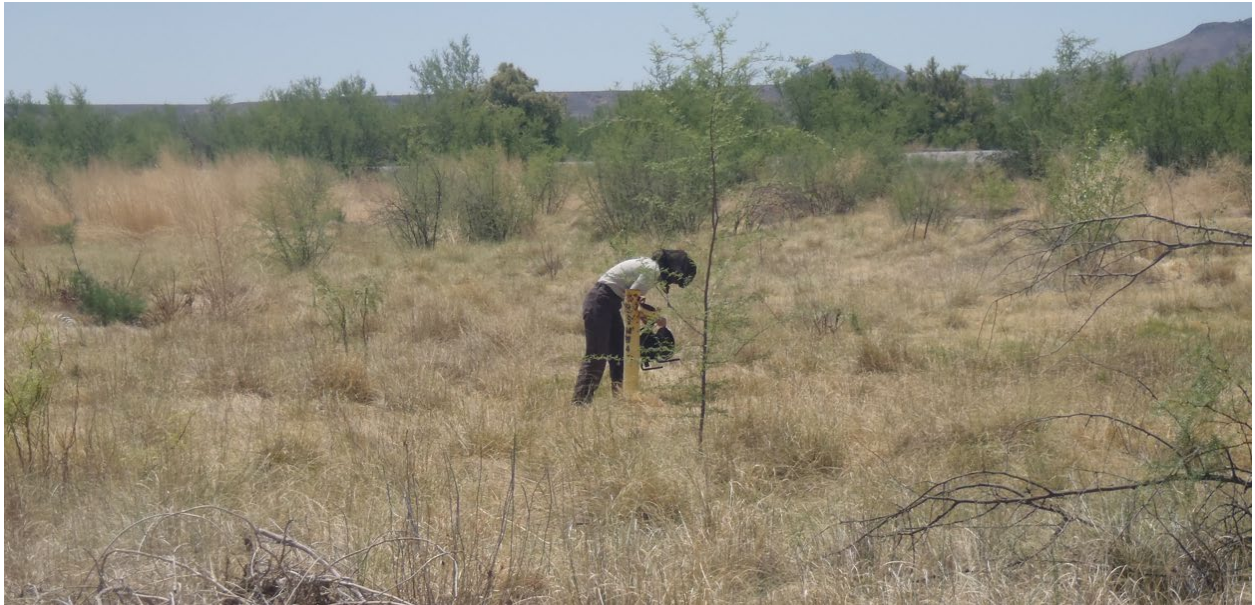
USFWS collecting groundwater levels at Well 4.

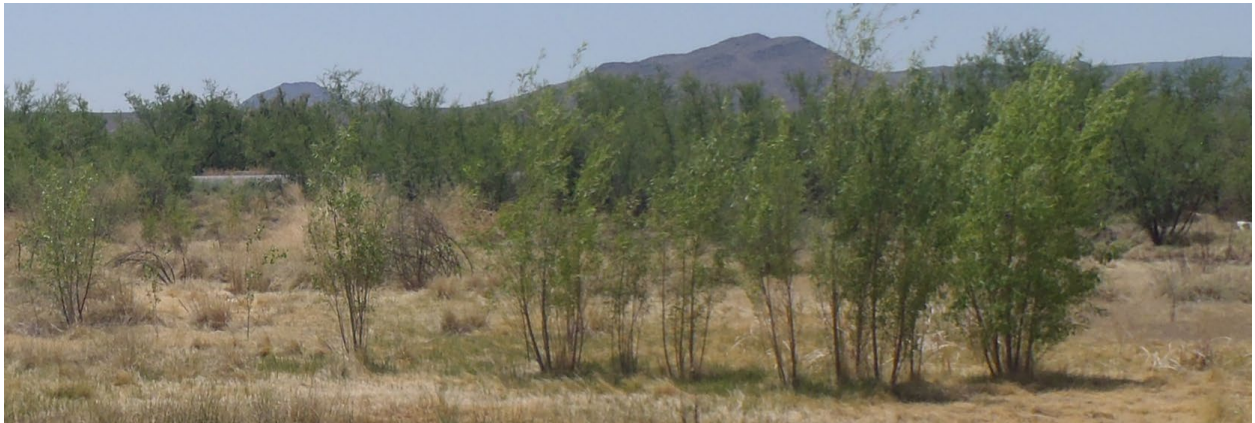
Successful trench plantings at Rincon Siphon D near well 4.

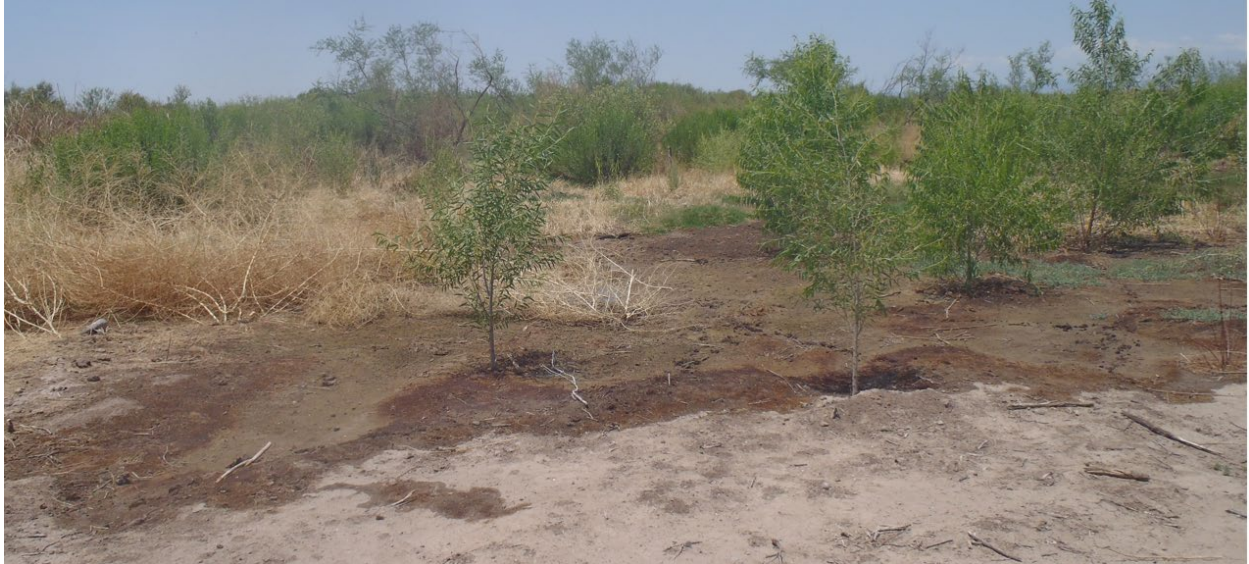
At Rincon Siphon A, the groundwater is so shallow that the ground surface is wet. Here the Gooddings willows are thriving.
