**USIBWC Riparian Habitat Restoration  
MONITORING NOTES AND PHOTOGRAPHS  
SUMMER 2021**

**U.S. Section International Boundary and Water Commission**

**April 20, 2022**

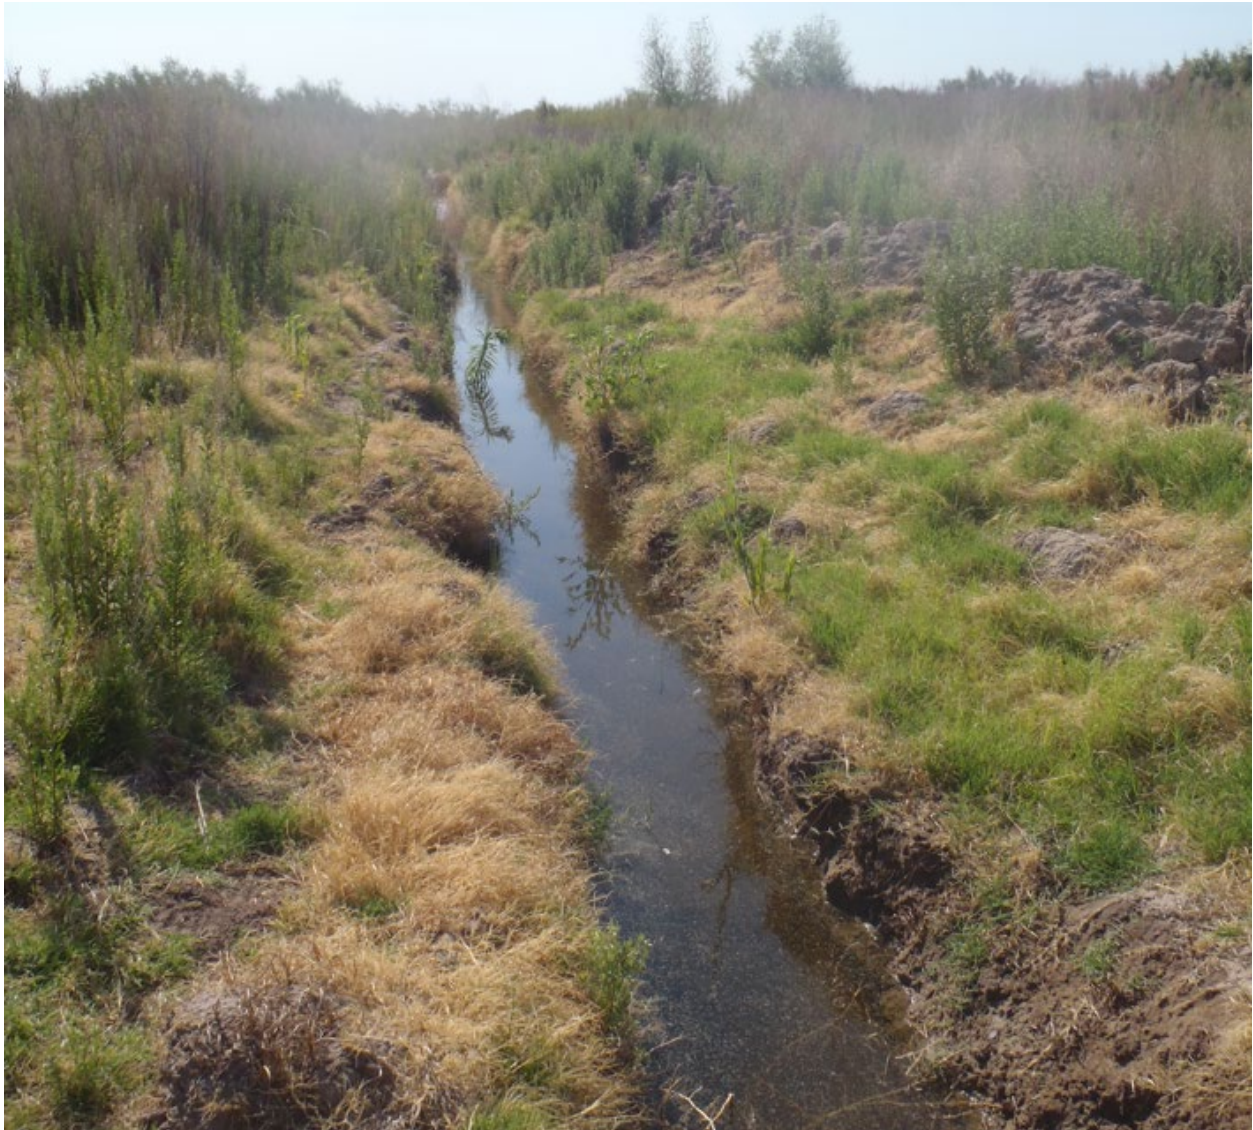
Earthen v-ditch conveying irrigation water from Garfield Canal upstream through the site.

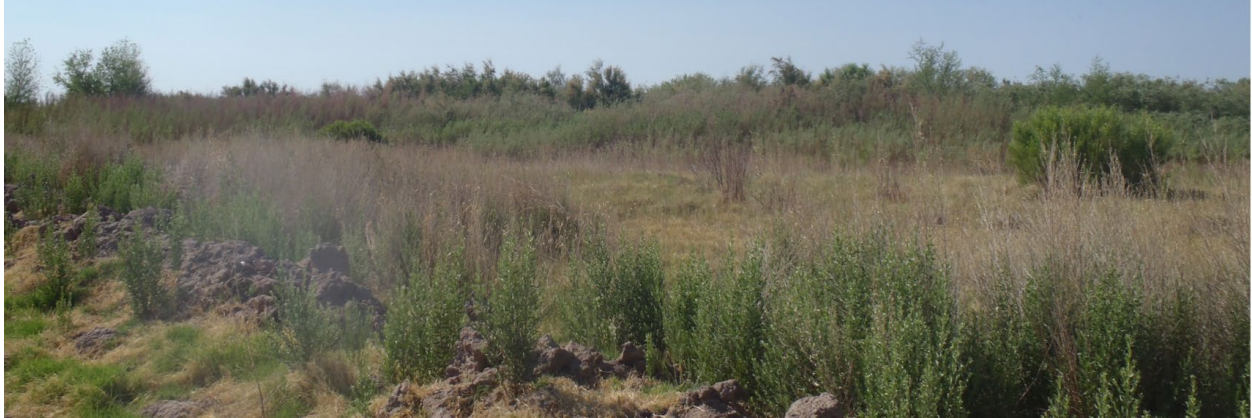
Irrigation v-ditch in the foreground, with the river bank willows in the background. The willows are very dense and provide flycatcher habitat, usually with territories. The willows are coming back after a dry year.

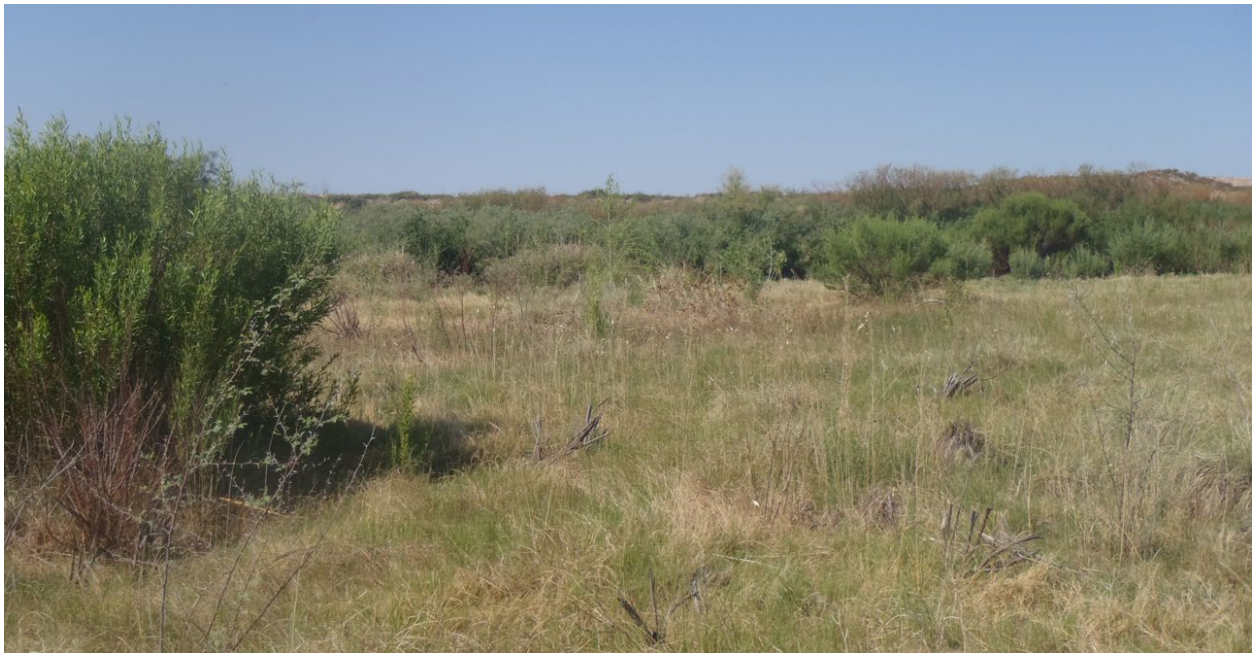
Treated saltcedar among native grasses (foreground), Gooddings willow (left) and several Gooddings and cottonwoods plantings in the floodplain, with native willows along the banks (background).

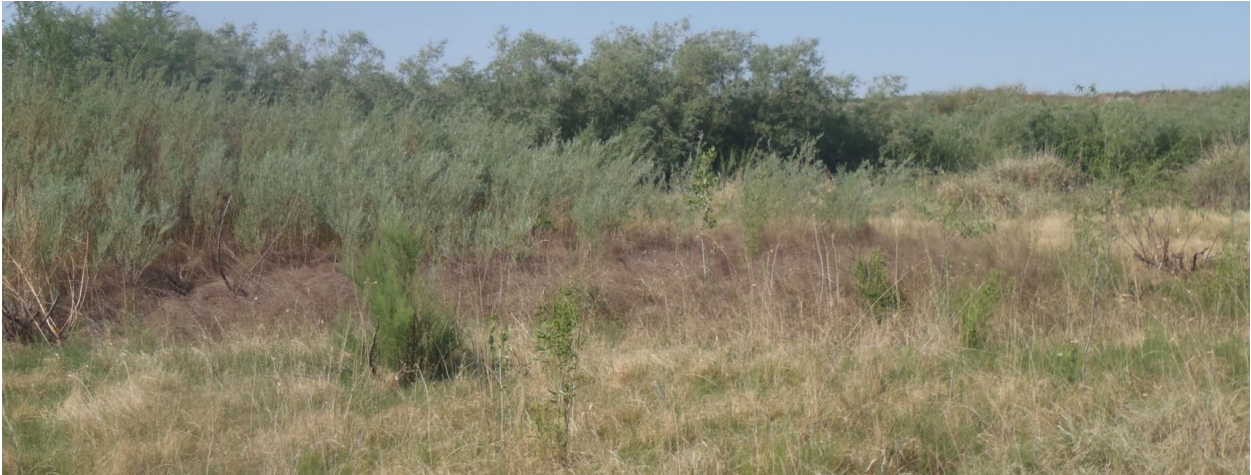
Young Coyote willows are spreading into the floodplain (left, middle). Here there are cottonwood and Gooddings plantings with coyotes growing around them. One treated saltcedar bush is returning but may not survive after treatment.

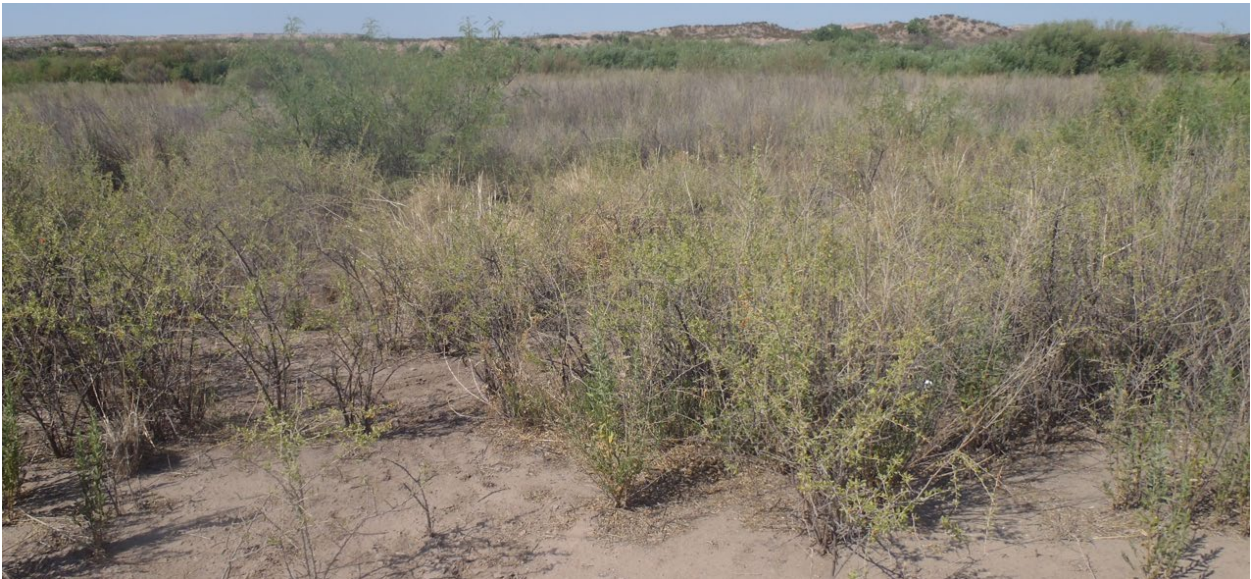
Scrub shrub habitat in the upper portion of the floodplain near the levees, with mesquite, saltbush, baccharus, and sacaton grasses.

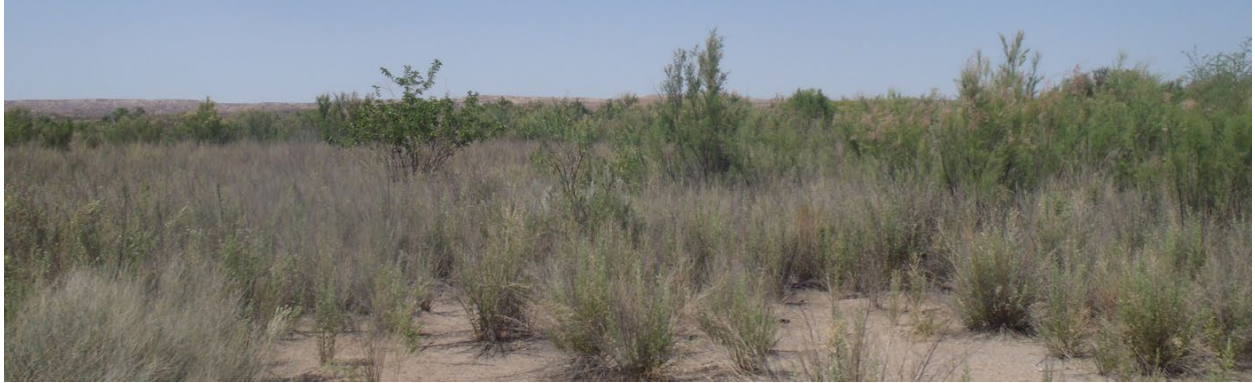
Overview of upland scrub shrub habitat at Well 1, looking north. Flowering saltcedar should be retreated.

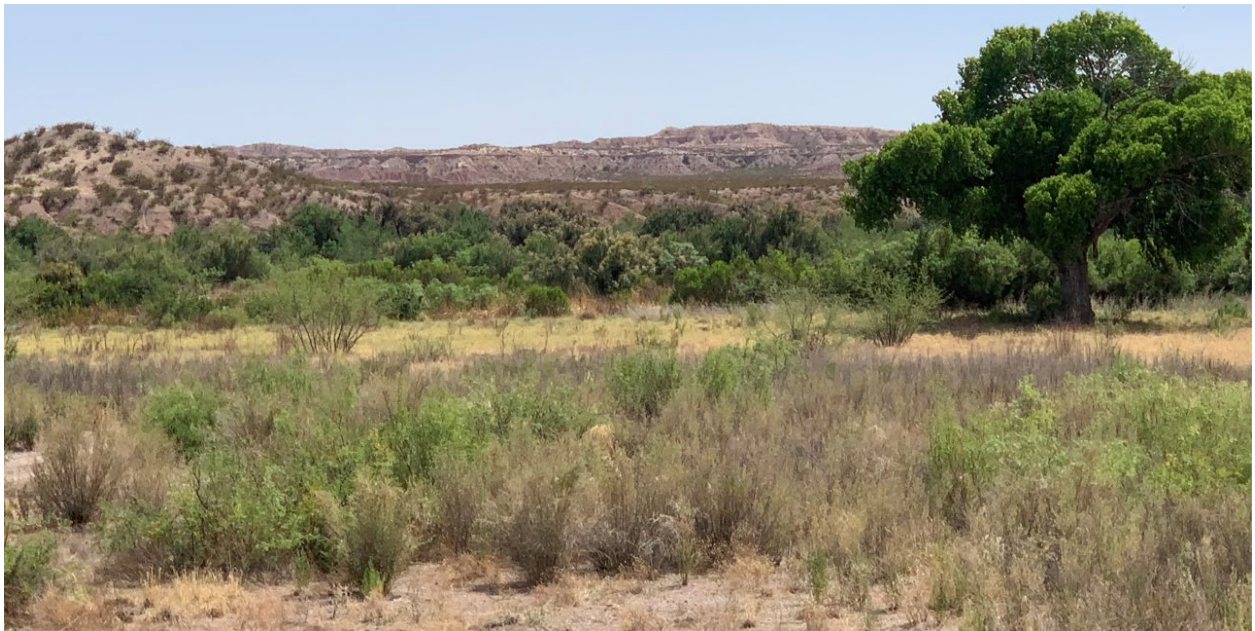
Upland scrub shrub habitat in foreground, transitioning to grassland, transitioning to riparian habitat along the bank (background). Hills are on the opposite bank.

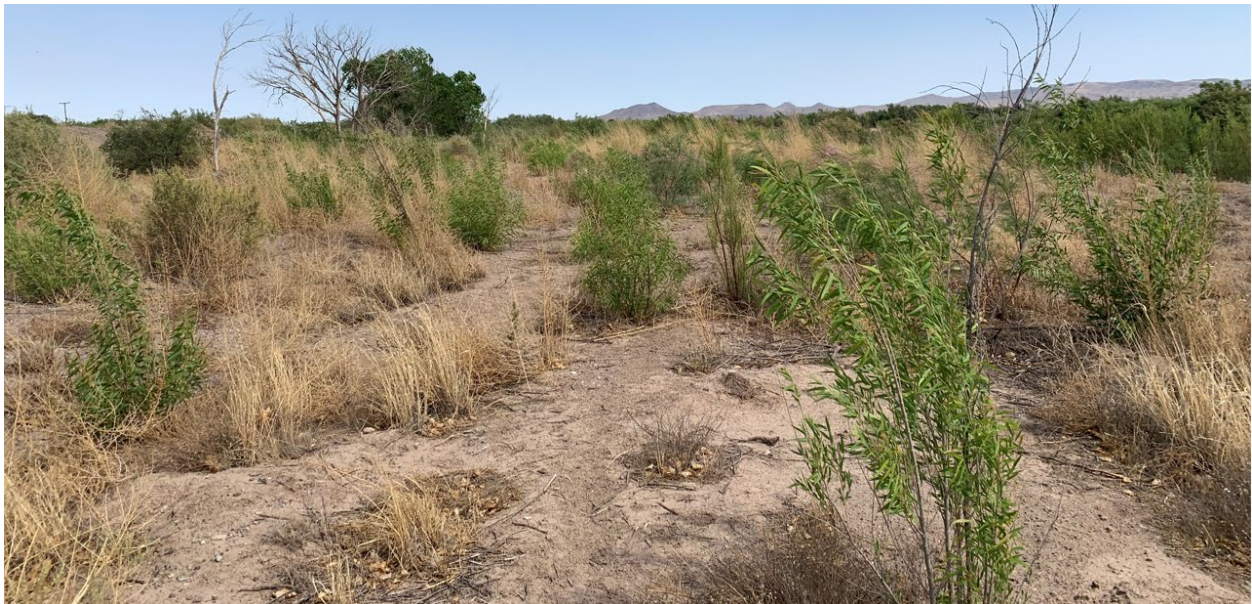
Northern end of site. Plantings are not as tall or vigorous but most Gooddings are still surviving. There are a few visible cottonwood mortalities in this area.

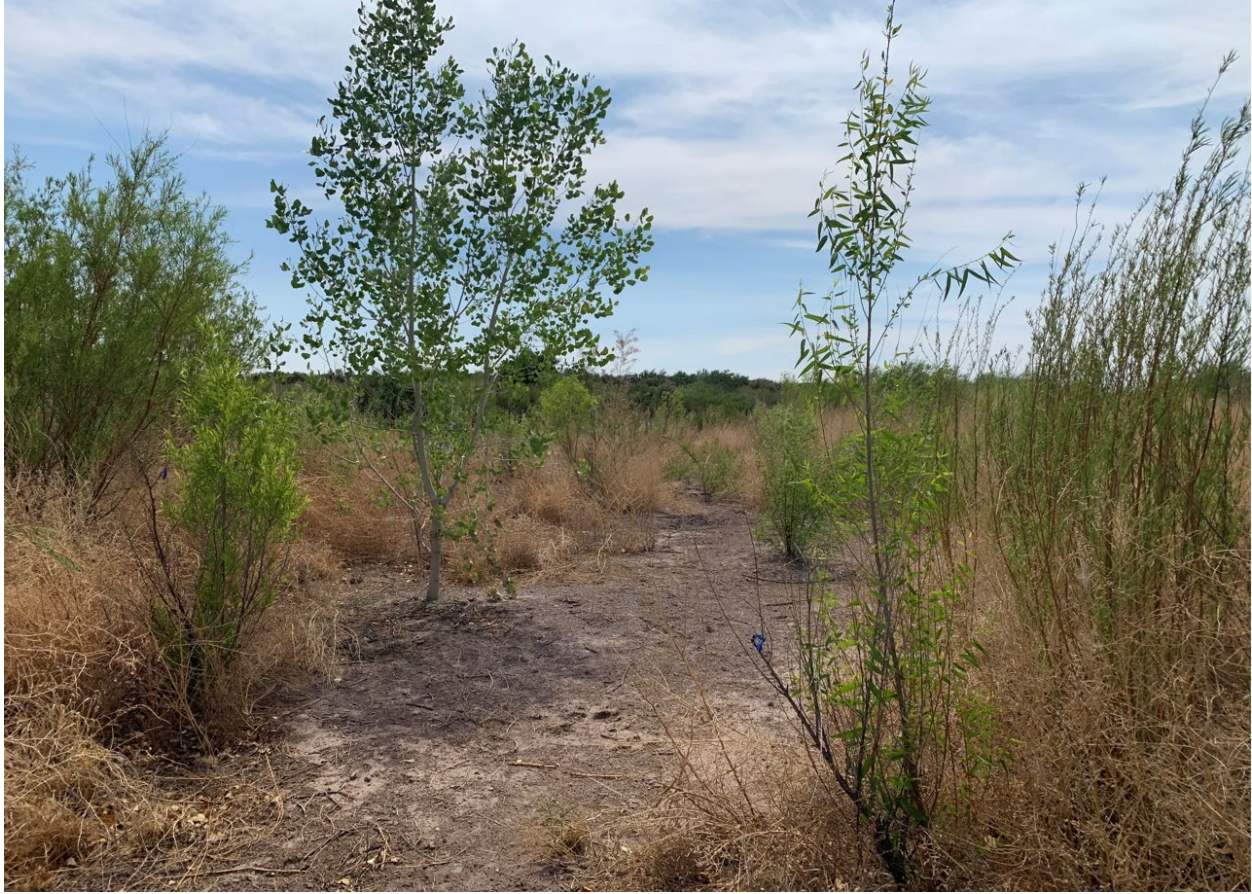
Successful cottonwood and Gooddings willow plantings in the middle of the site.

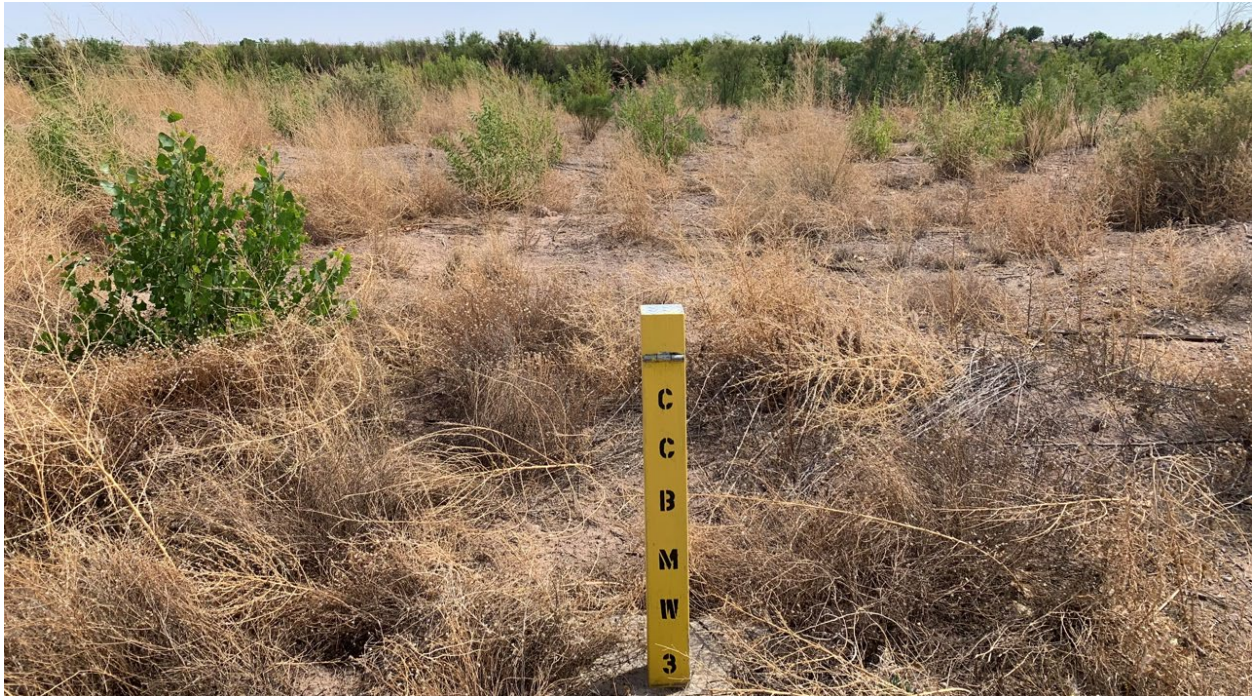
View towards the river at Crow Canyon C, at well 3.

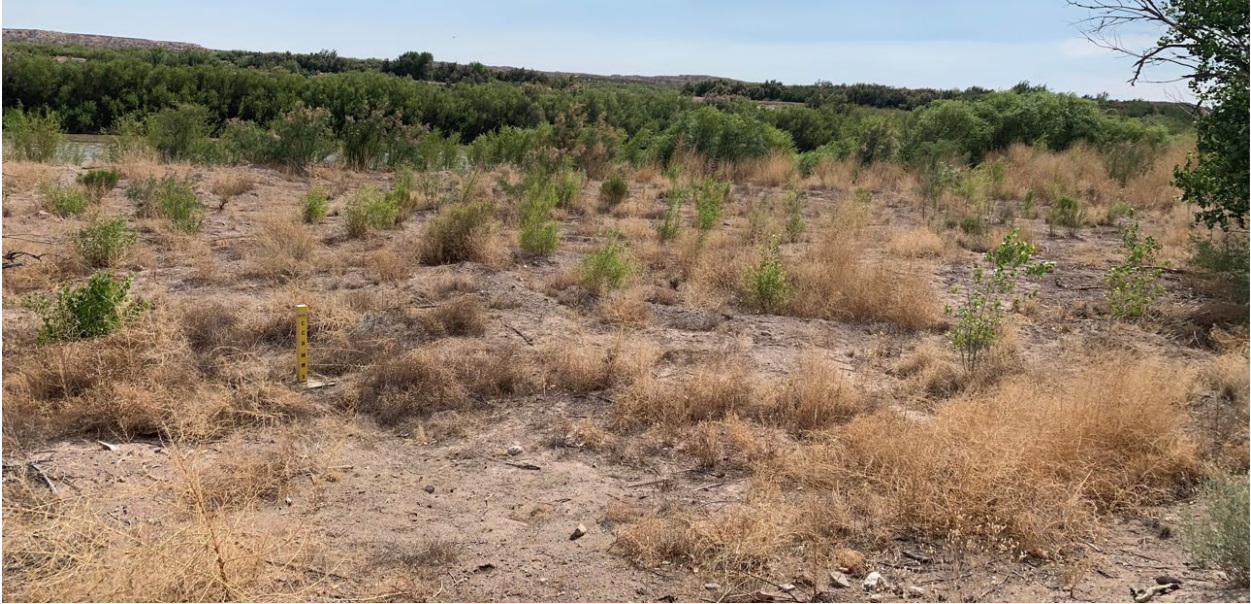
View from above on the ridge, looking down towards the plantings north of Well 3.

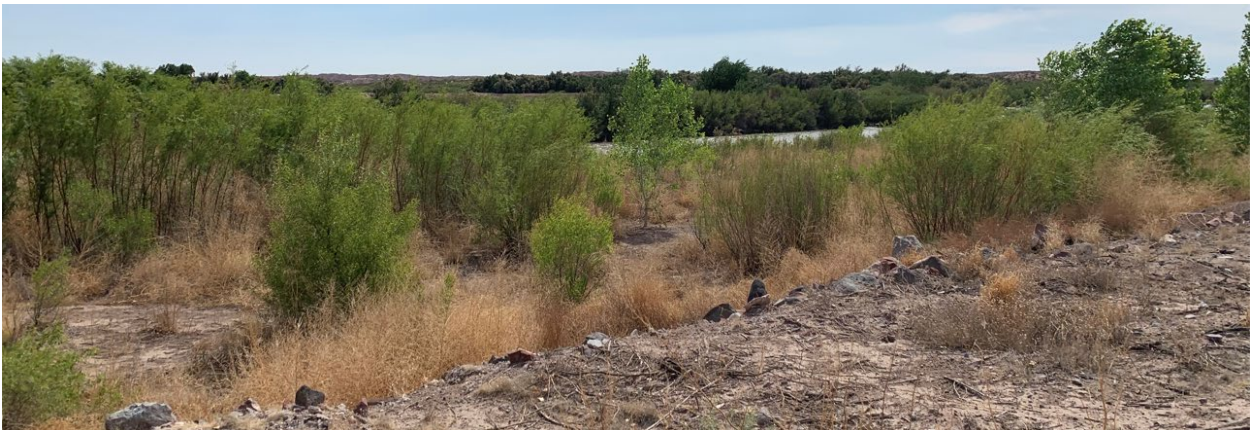
View from the ridge looking south to the dense willows and more vigorous plantings in the southern end of the site.

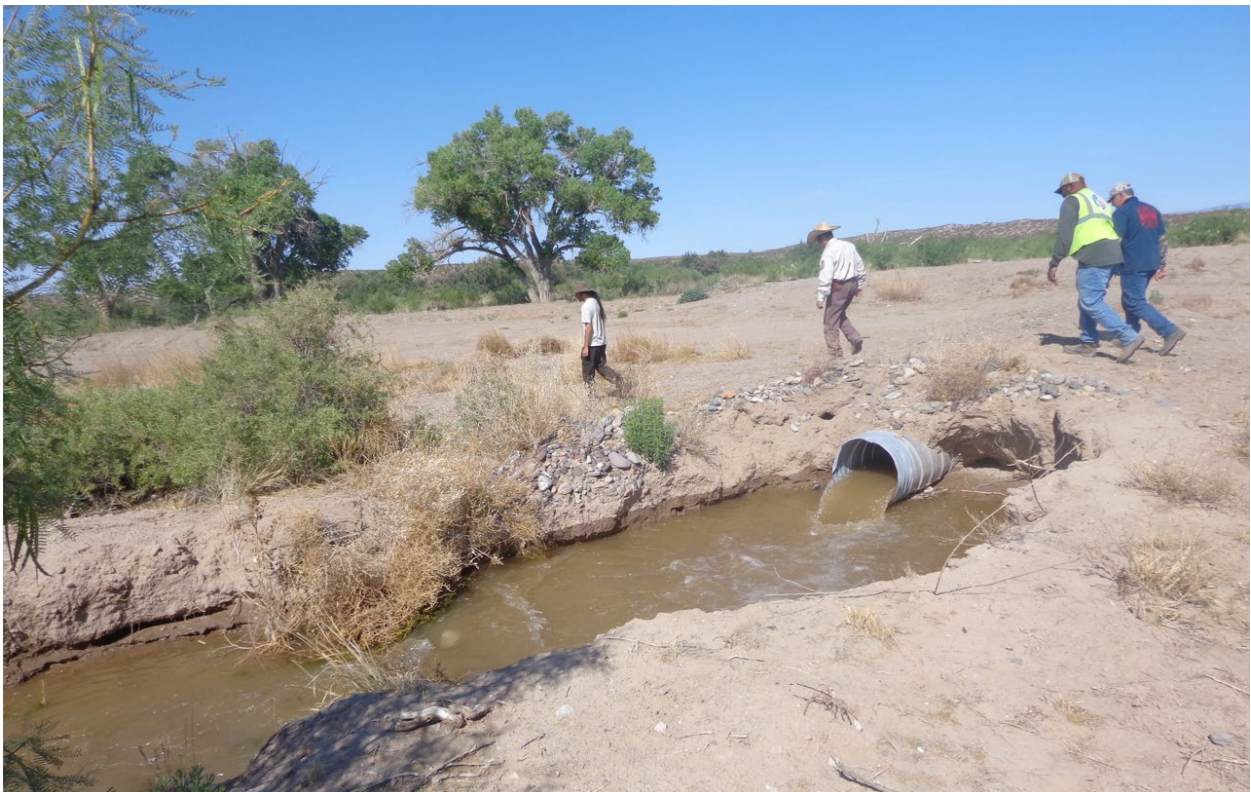
USFWS and USIBWC crews met at the site during the irrigation to discuss logistics of irrigations. Here, the water spills from the new culvert off of the Palmer Lateral into the excavated trench into the site.

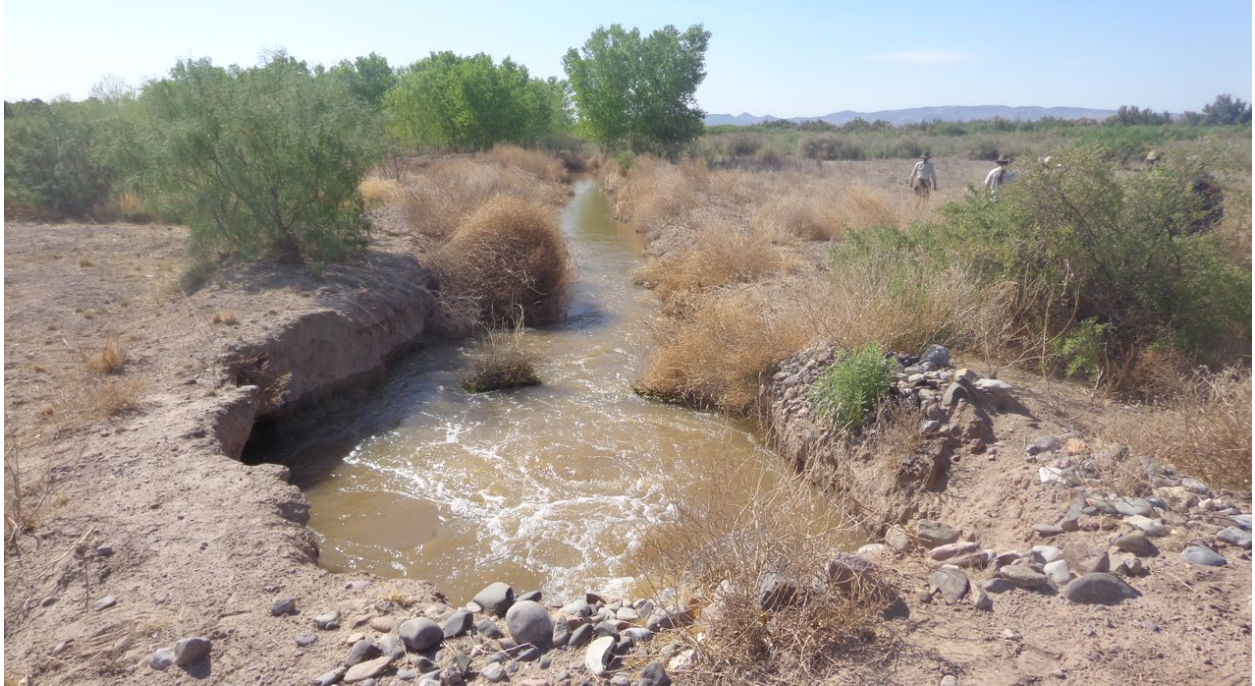
View of the irrigation canal from the pipe towards the site.

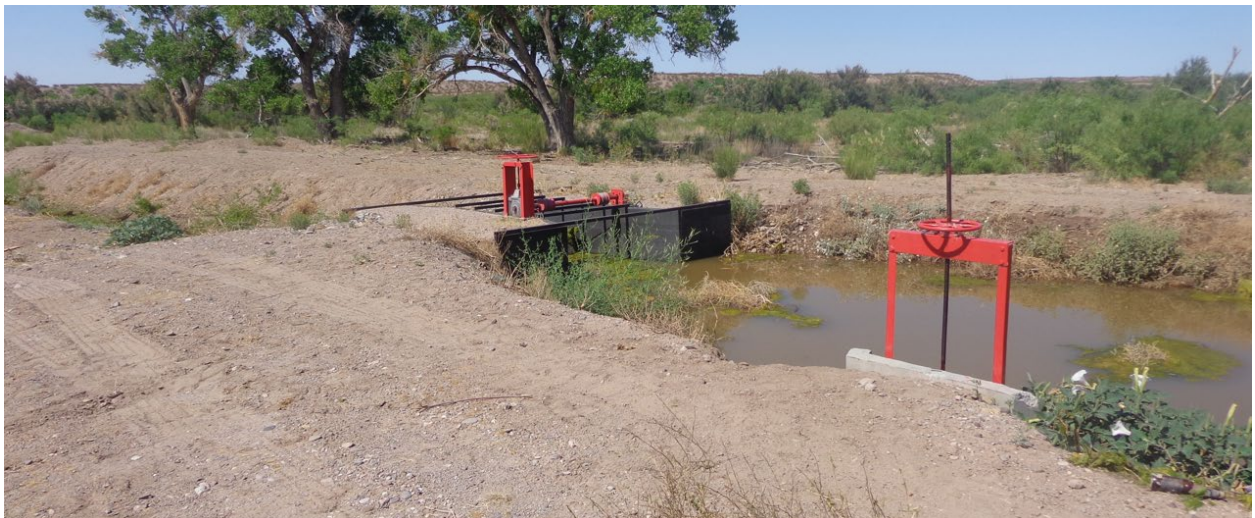
EBID built a turnout at Palmer Lateral in 2019 to irrigate the Yeso East site.

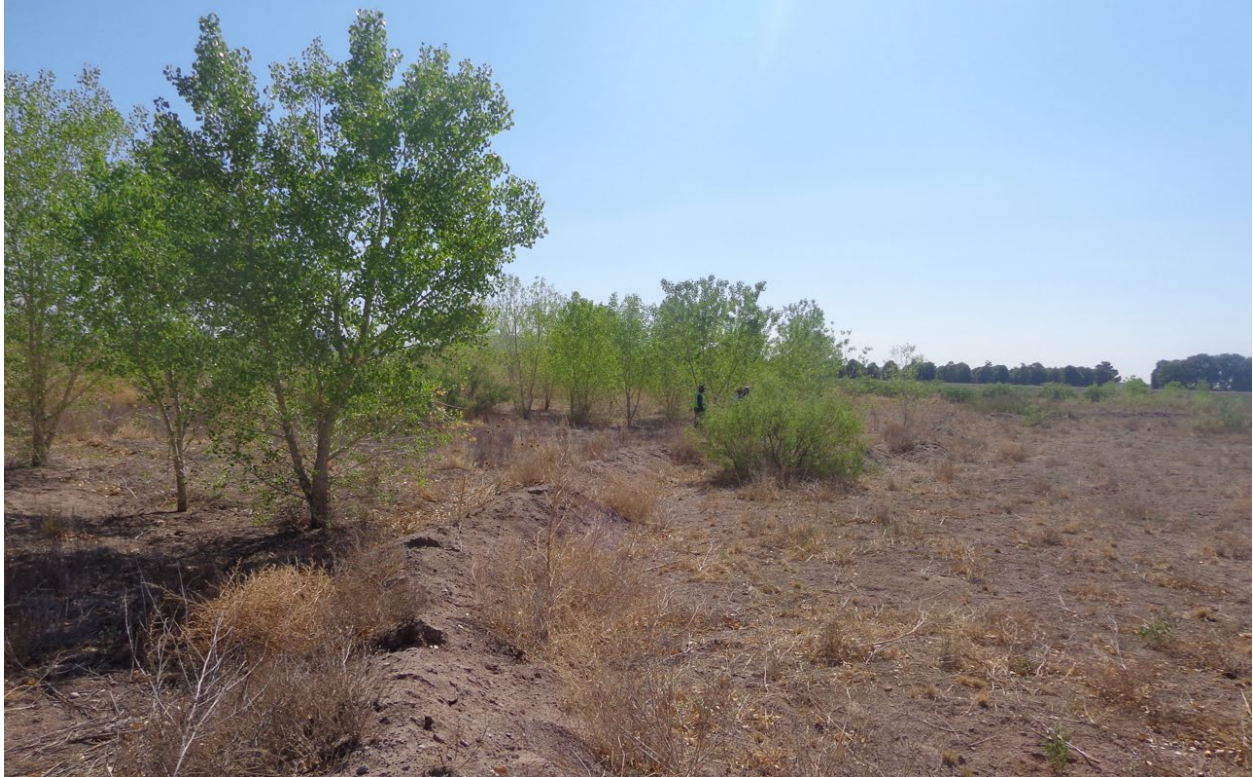
The berm around the trees is visible in the foreground. Cottonwoods in the background are at least two feet tall (USIBWC's crew for scale).

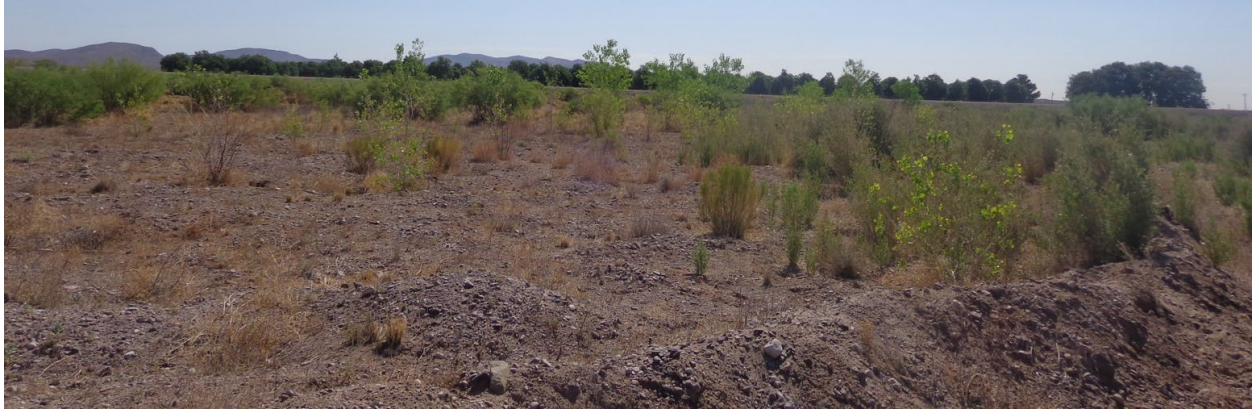
Plantings at the end of bermed area, where water may not reach due to sandy soils that soak up the water on its way to this point. These plantings are not as tall or vigorous.

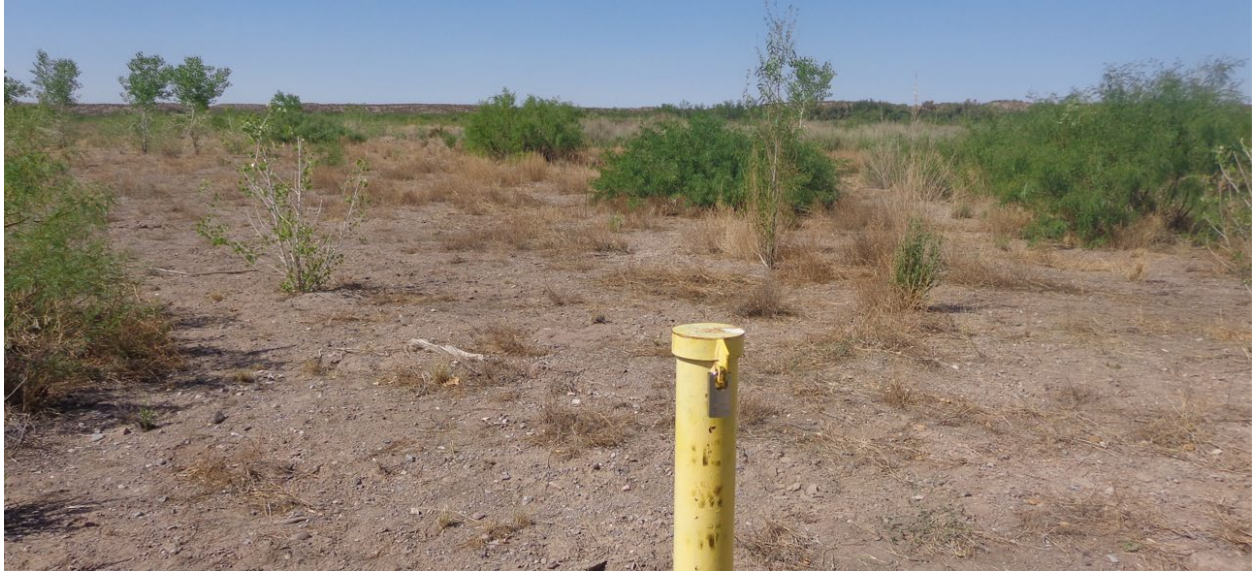
View at Well 3 in the middle of the site.

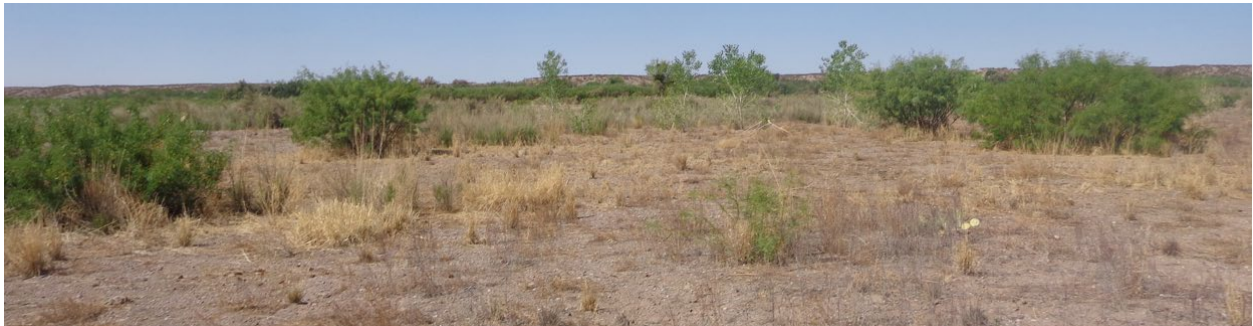
View of the middle of the site, near Well 3. Some plantings are struggling here.

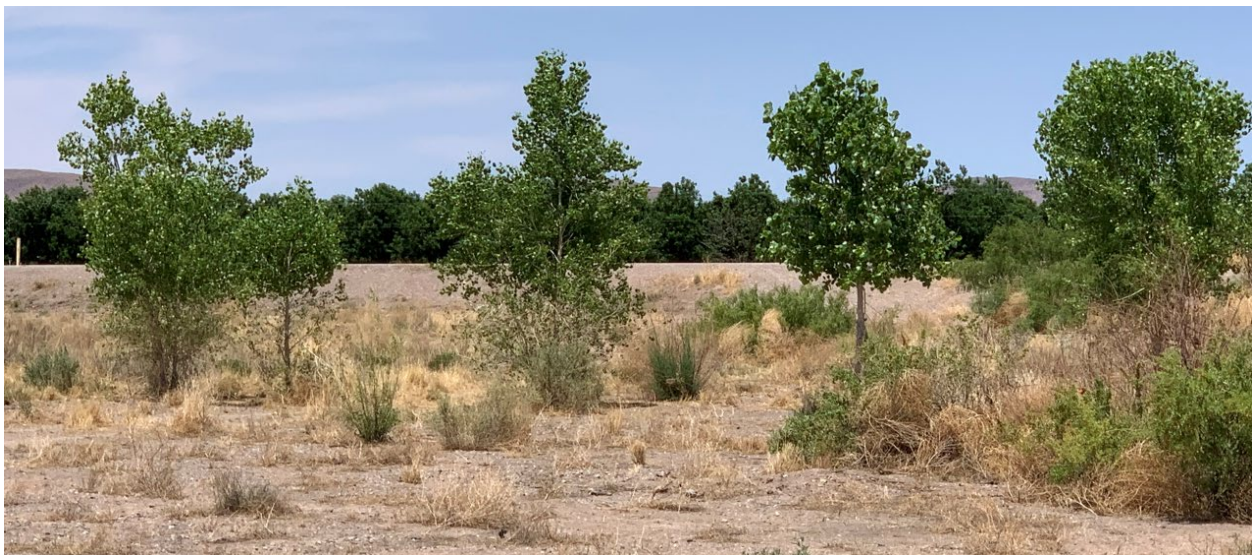
A row of happy cottonwoods near the levee at the southern end of the site, near Well 2.

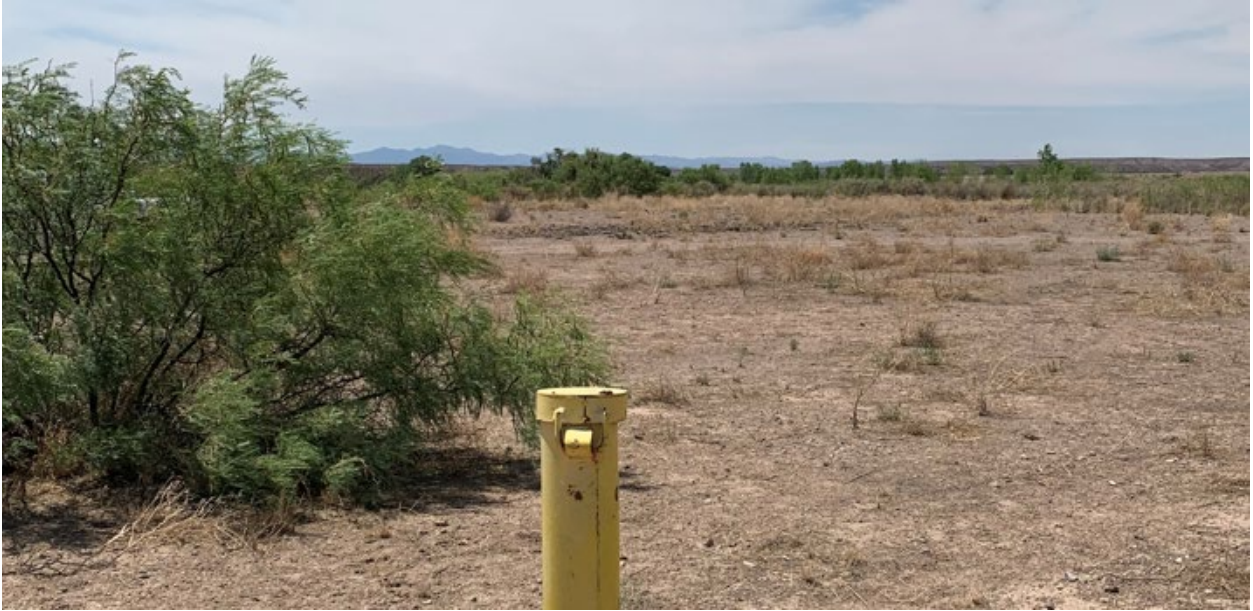
View at Well 2 at the end of the old resaca. Sparse vegetation; few plantings survived here.

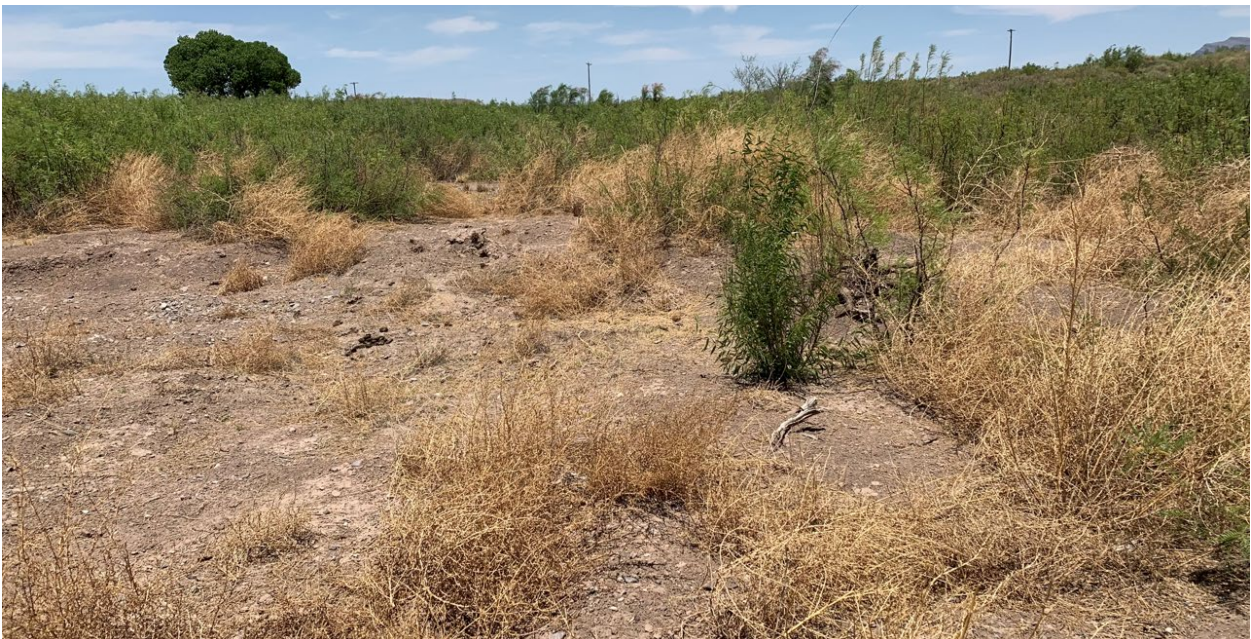
One excavated swale has little cover, although this Gooddings willow is surviving.

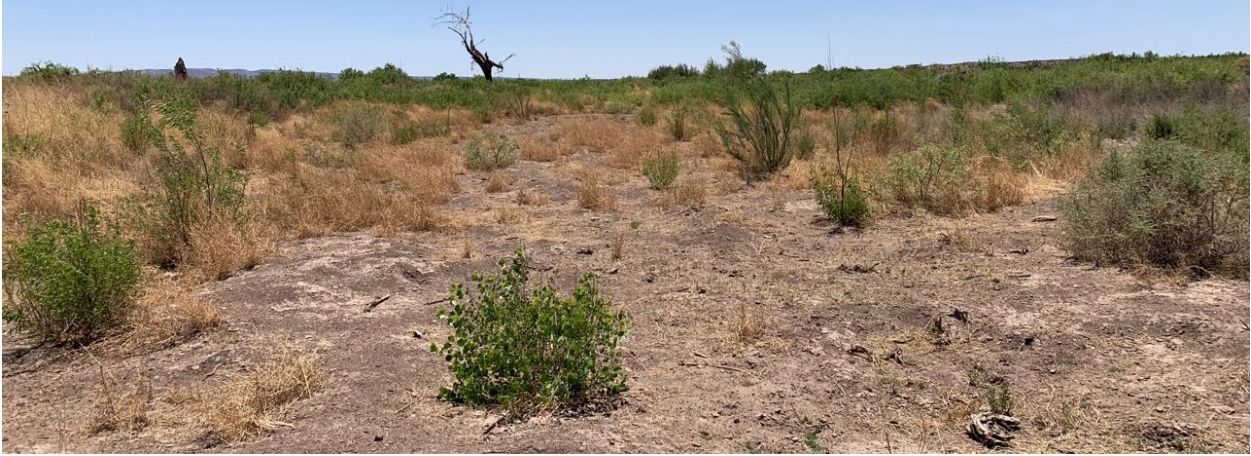
Site conditions appear harsh, as evidenced by the dead old cottonwood in the background. However, numerous cottonwood and Gooddings willow plantings are still hanging in there in this constructed swale. The plantings at this site are not vigours but surviving.

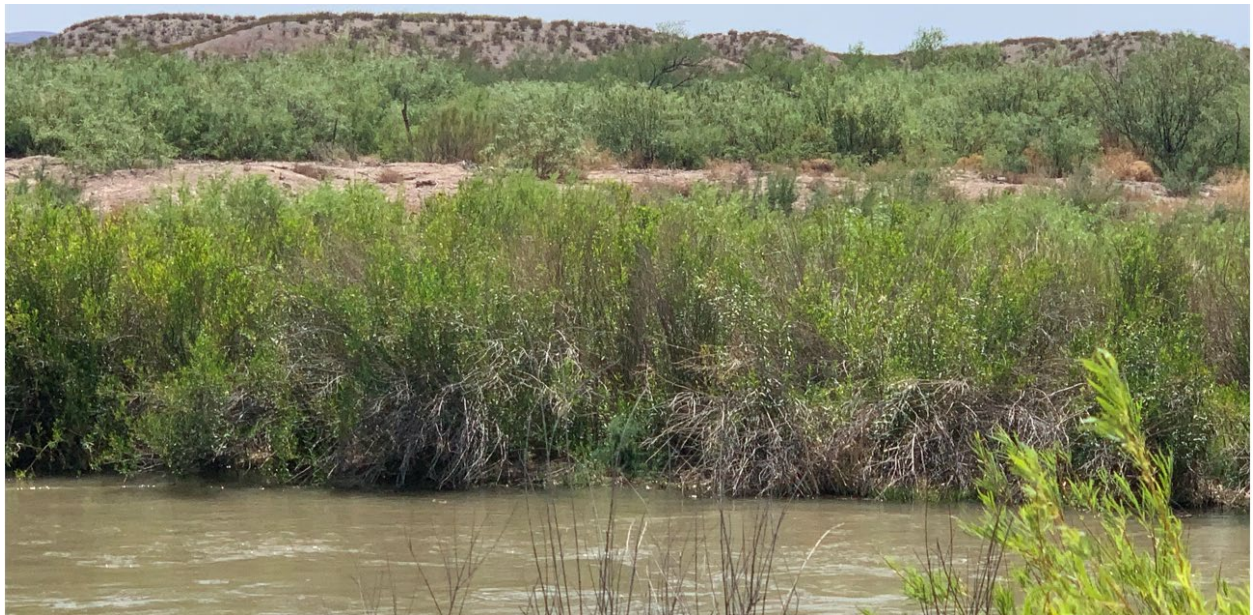
Willows along the bank in the middle of the terrace, with the bare slope visible behind the willows. The slope used to be mature monotypic saltcedar when the site work began in 2017.

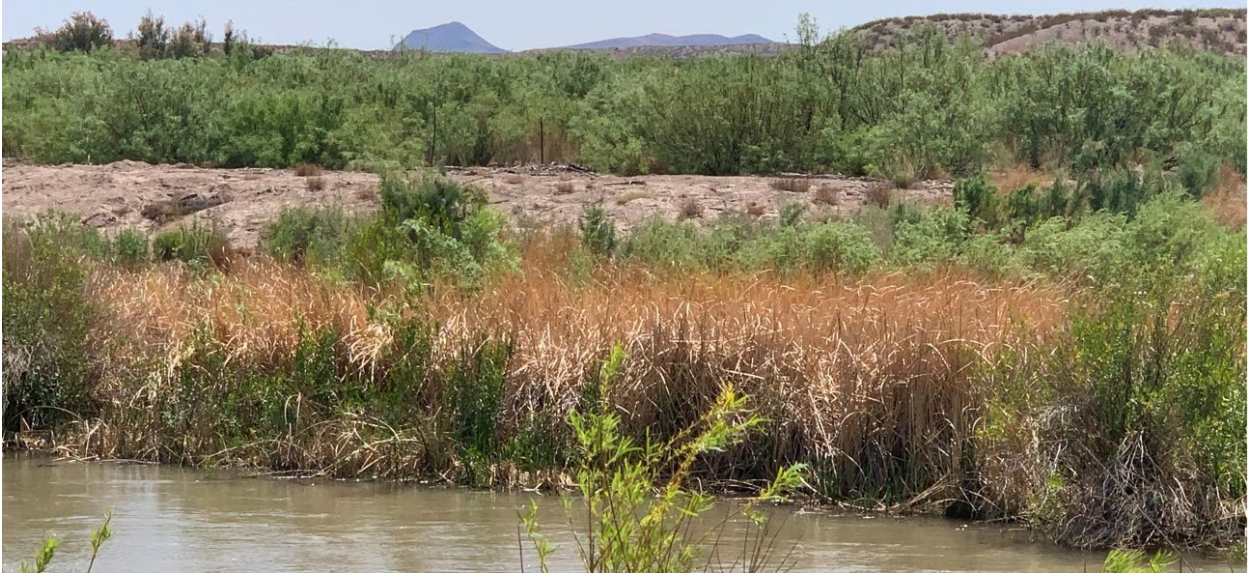
Wetland vegetation and cattails at the bank cut. Willows are visible behind the cattails.

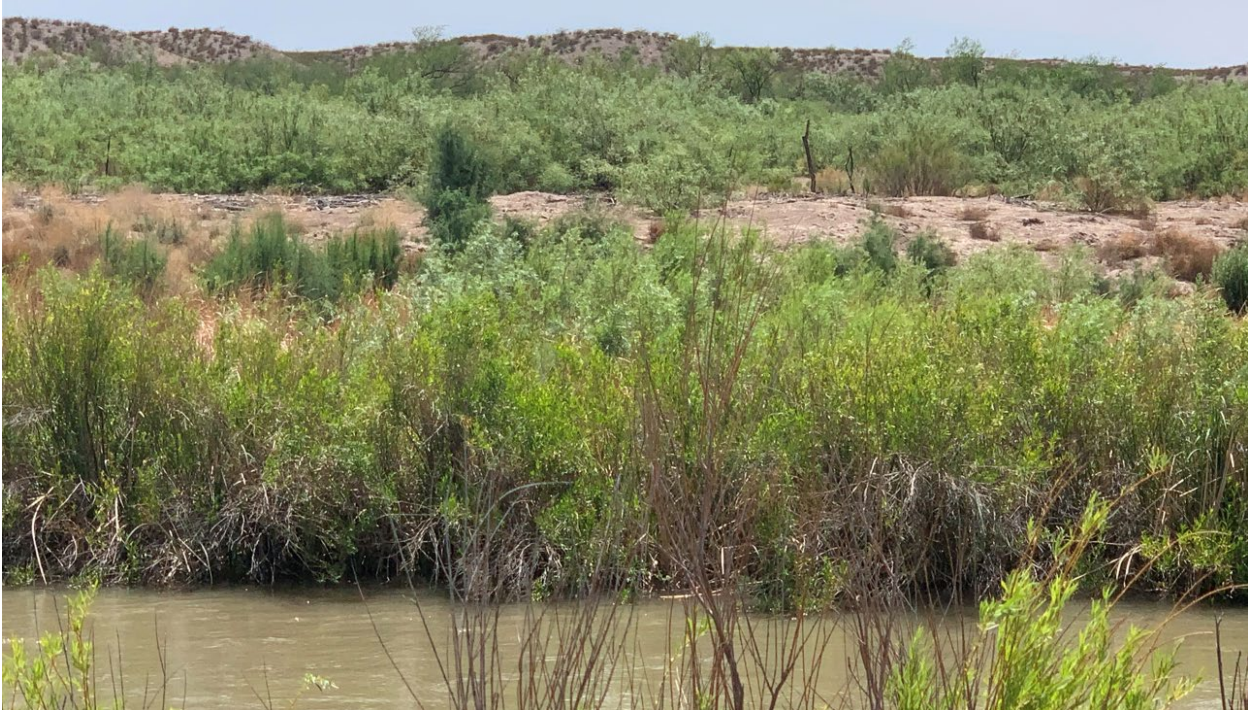
South of the bankcut, willows and baccharus grow along the bank, with coyote willow visible behind that, and saltcedar resprouts at the base of the slope.

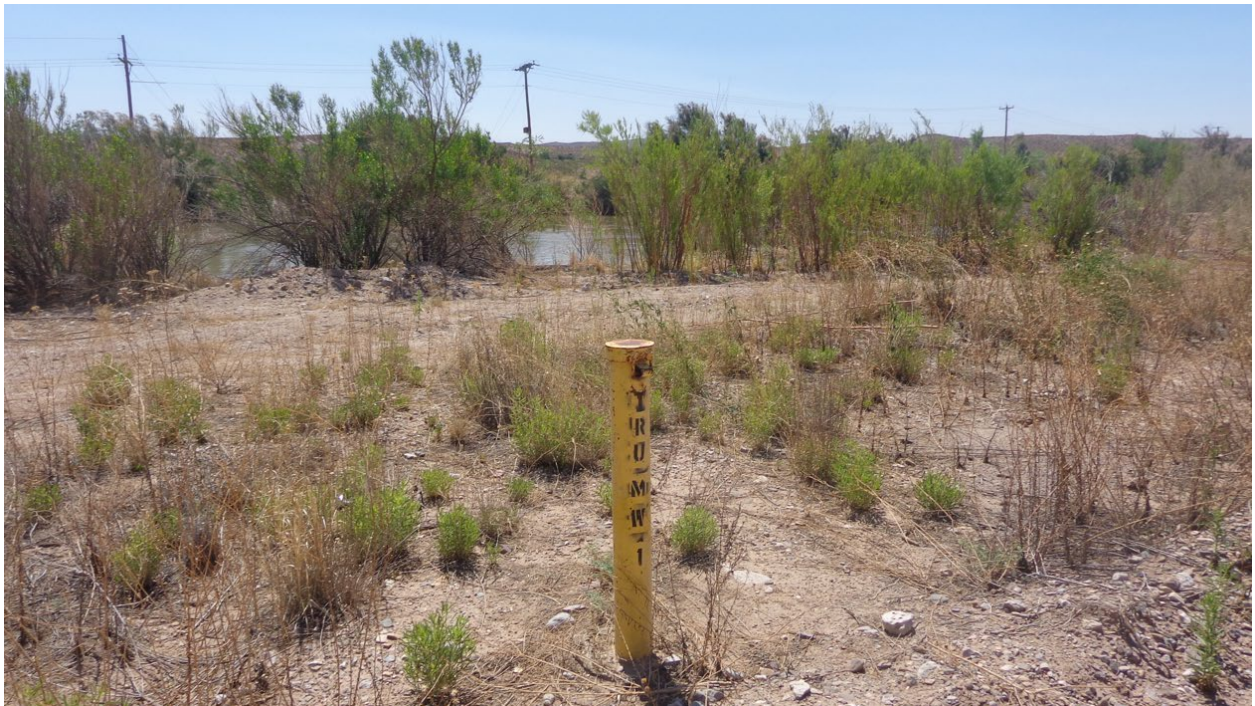
View of well 1 and trench planted willows along the bank. The road is between the well and the river.

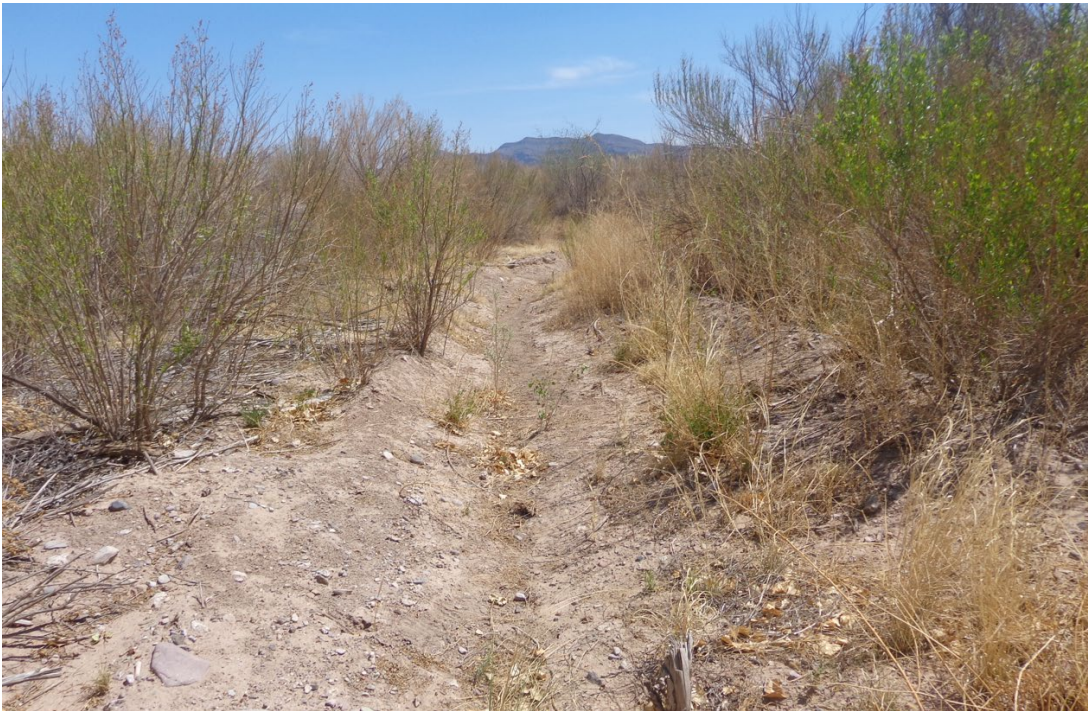
Earthen v-ditch that conveys water upstream of the turnout, prior to water reaching it.

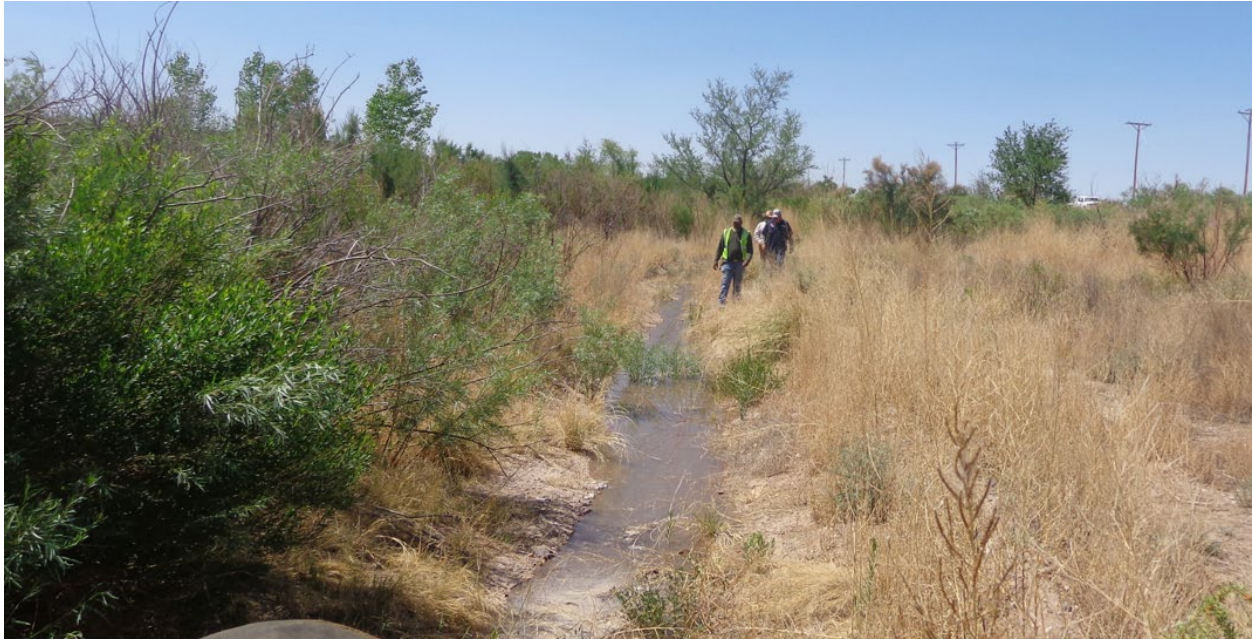
Irrigation water is starting to come down the v-ditch. USIBWC and USFWS staff discuss logistics of irrigation.
