**USIBWC Riparian Habitat Restoration  
MONITORING NOTES AND PHOTOGRAPHS  
SUMMER 2021**

**U.S. Section International Boundary and Water Commission**

**April 20, 2022**

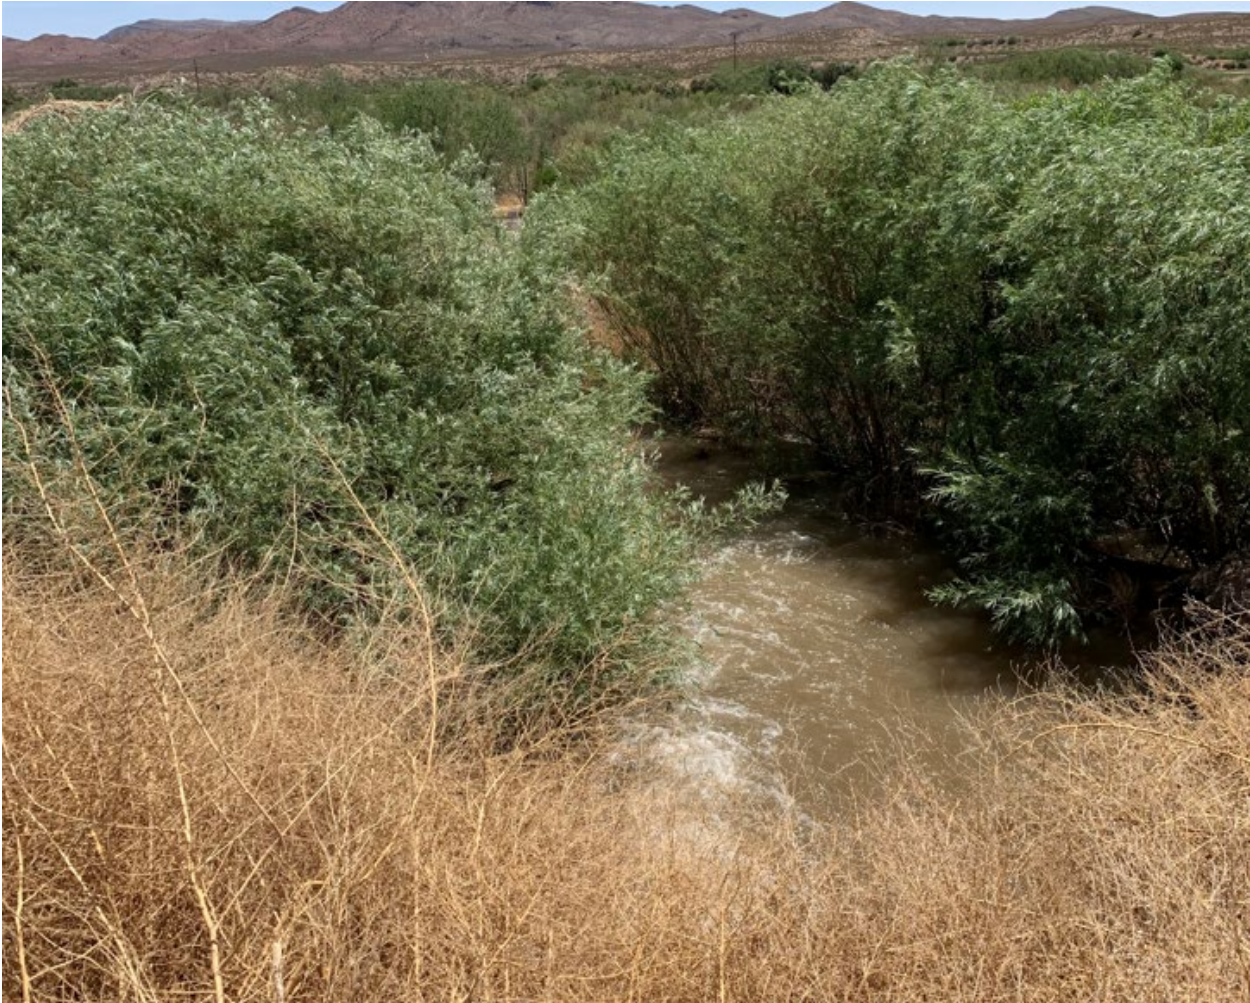
Willows at the culvert where water enters the site.

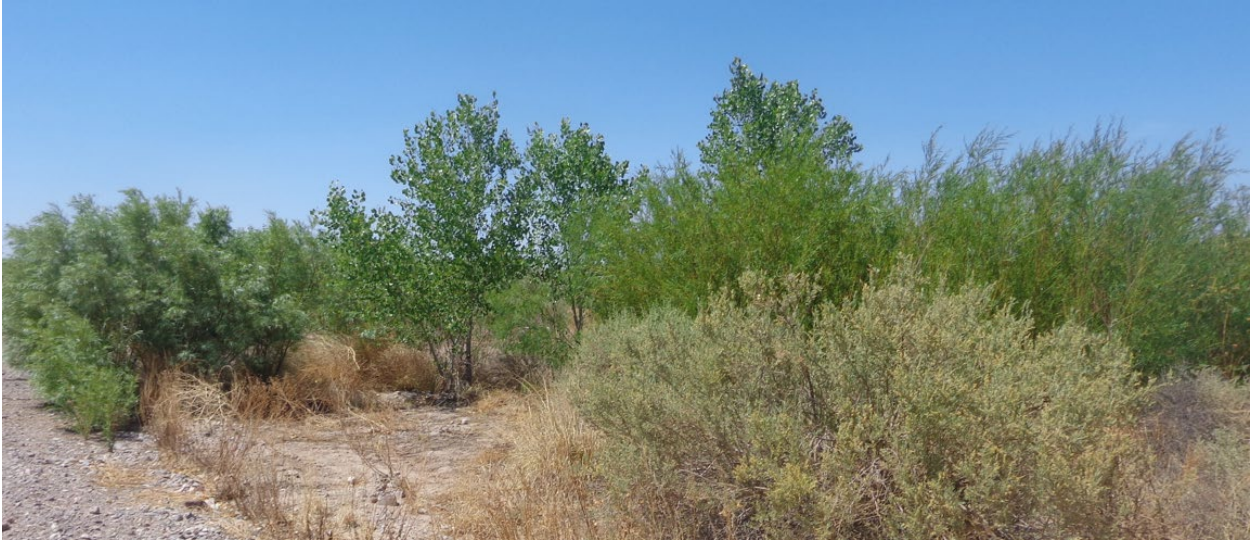
Cottonwood and willow plantings in the middle of the site near the access road.

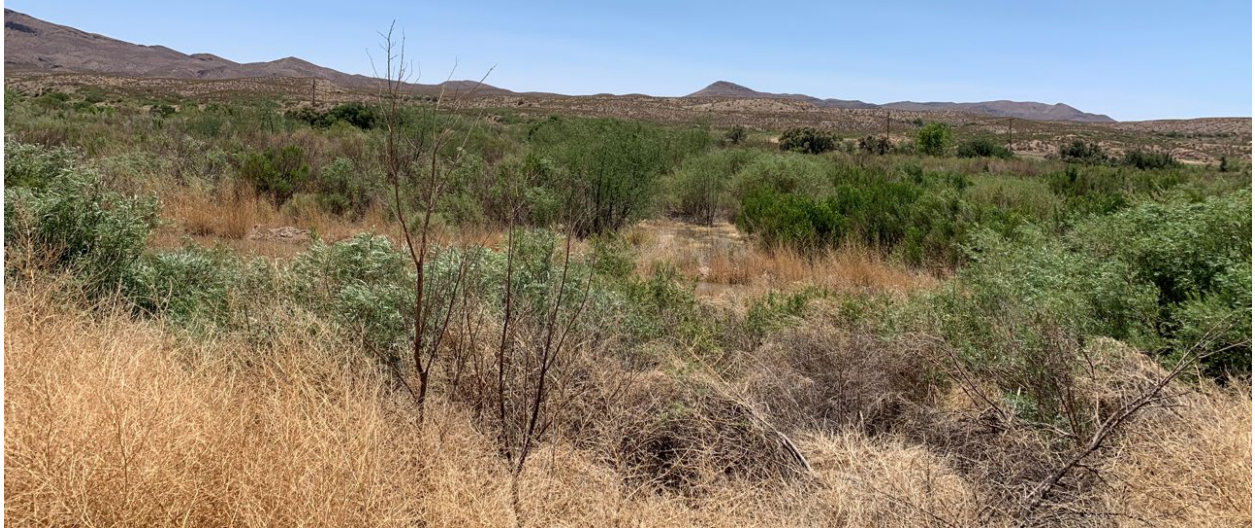
Overview of site from the Trujillo Lateral, looking towards the middle of the site.

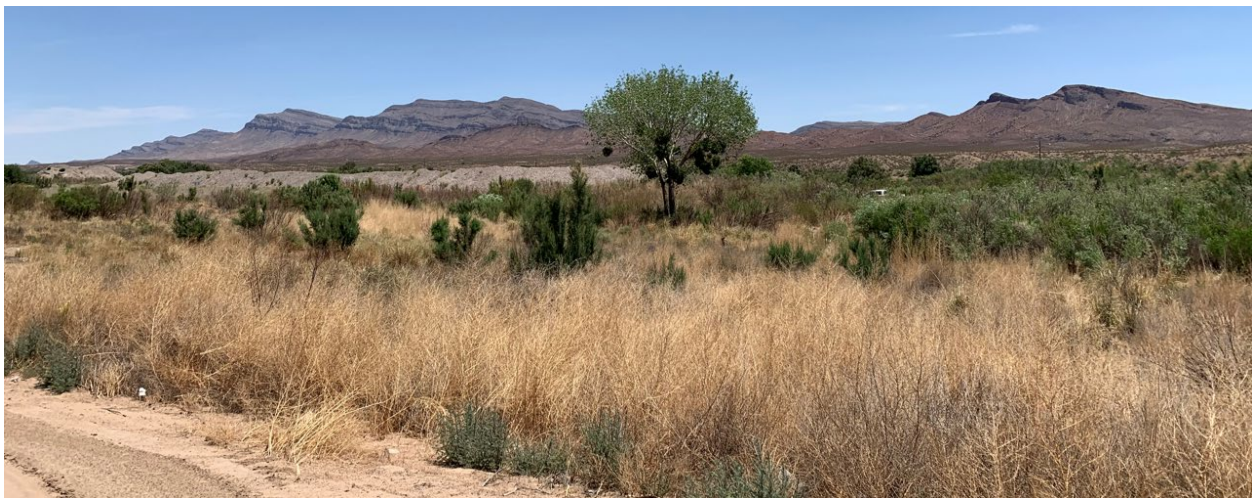
Overview from the Trujillo Lateral, looking north. In the distance is the spoil pile from the Trujillo Arroyo. Also visible is the white USIBWC truck on the road near the river.

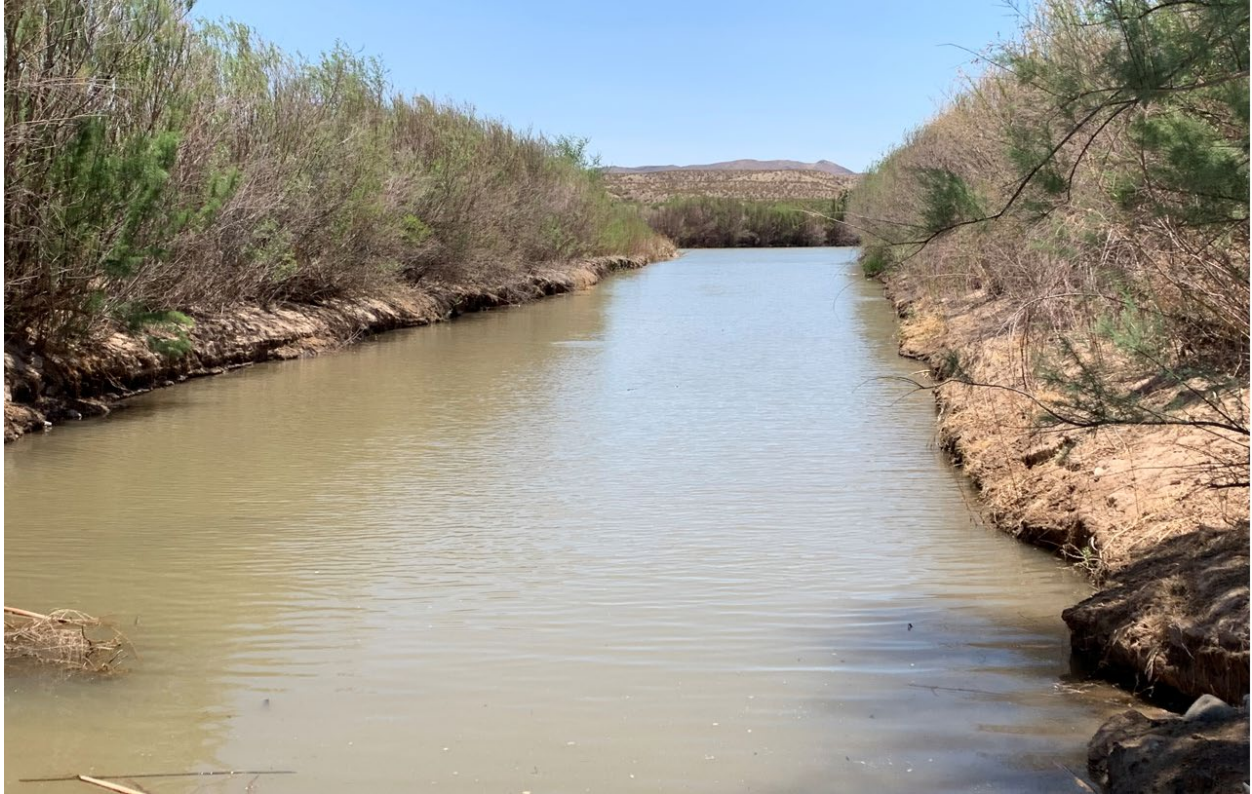
Trujillo Arroyo, where USIBWC had contemplated excavating a terrace on the south bank as part of the Aquatic Habitat EA.

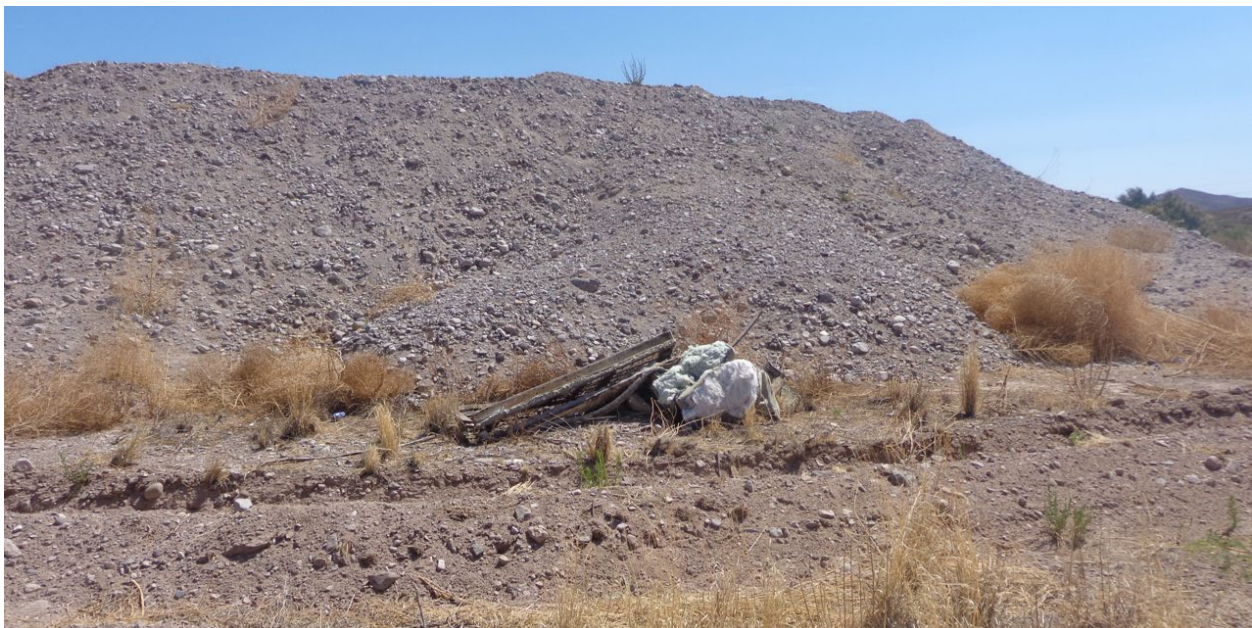
Spoil pile in the northern end of the site is about 30 feet high. This portion of the site is unrestorable and should be excluded from the site. The EA considered excavating this as part of the arroyo terracing, but costs and logistics to remove such a pile is cost prohibitive.
