***Rio Grande Canalization Project Aquatic
Habitat Restoration Site Alternatives and
Conceptual Designs***

*Prepared for:
United States Section
International Boundary &
Water Commission and Gulf
South Research Corporation*

*Prepared by:
GeoSystems Analysis
3150 Carlisle Blvd. NE,
Albuquerque, NM 87110
www.gsanalysis.com*

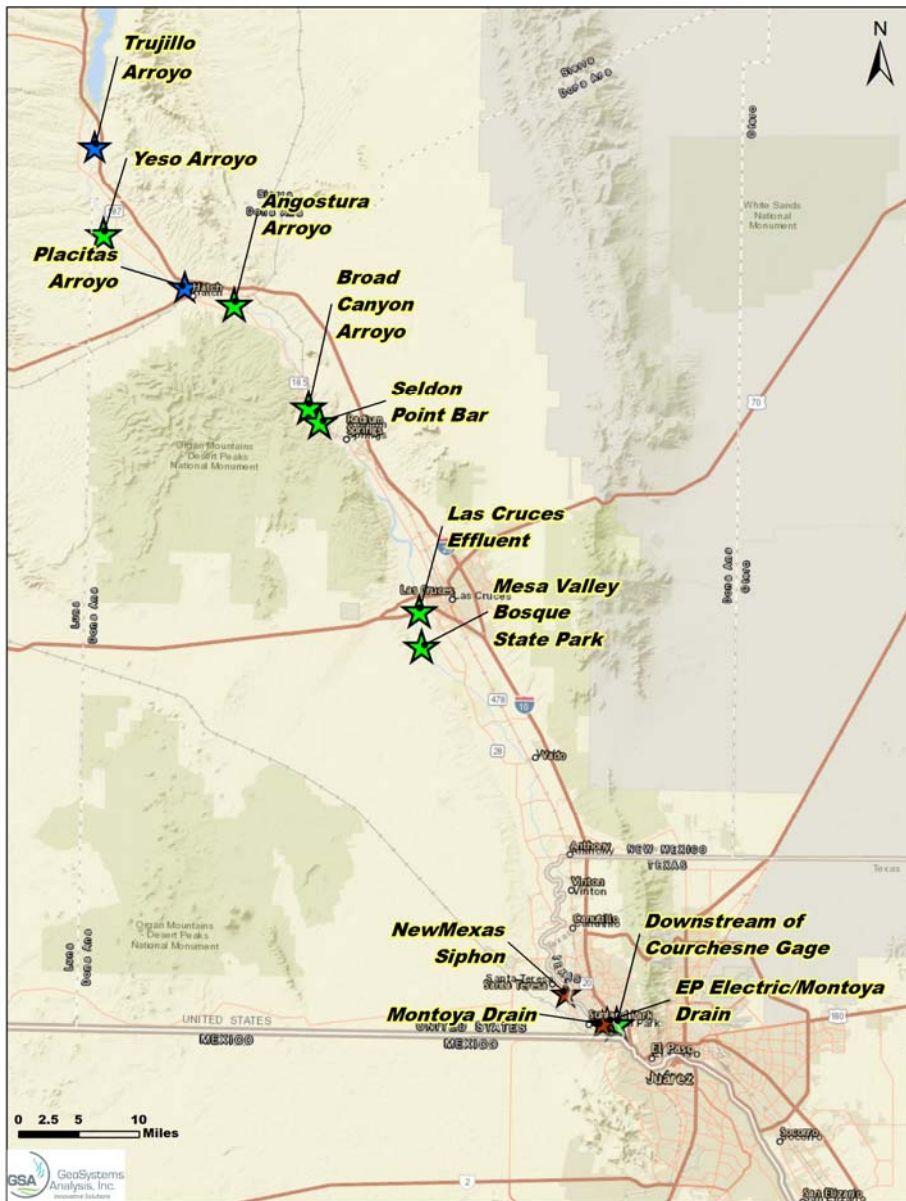
Figure 1. Project area map showing locations of project sites under consideration.

* Red stars indicate sites removed during the conceptual design phase but evaluated in the field, green stars indicate sites with designs/alternatives still in consideration, blue stars mark sites discussed but not evaluated.

A map showing the location of these project sites is presented in Figure 1.

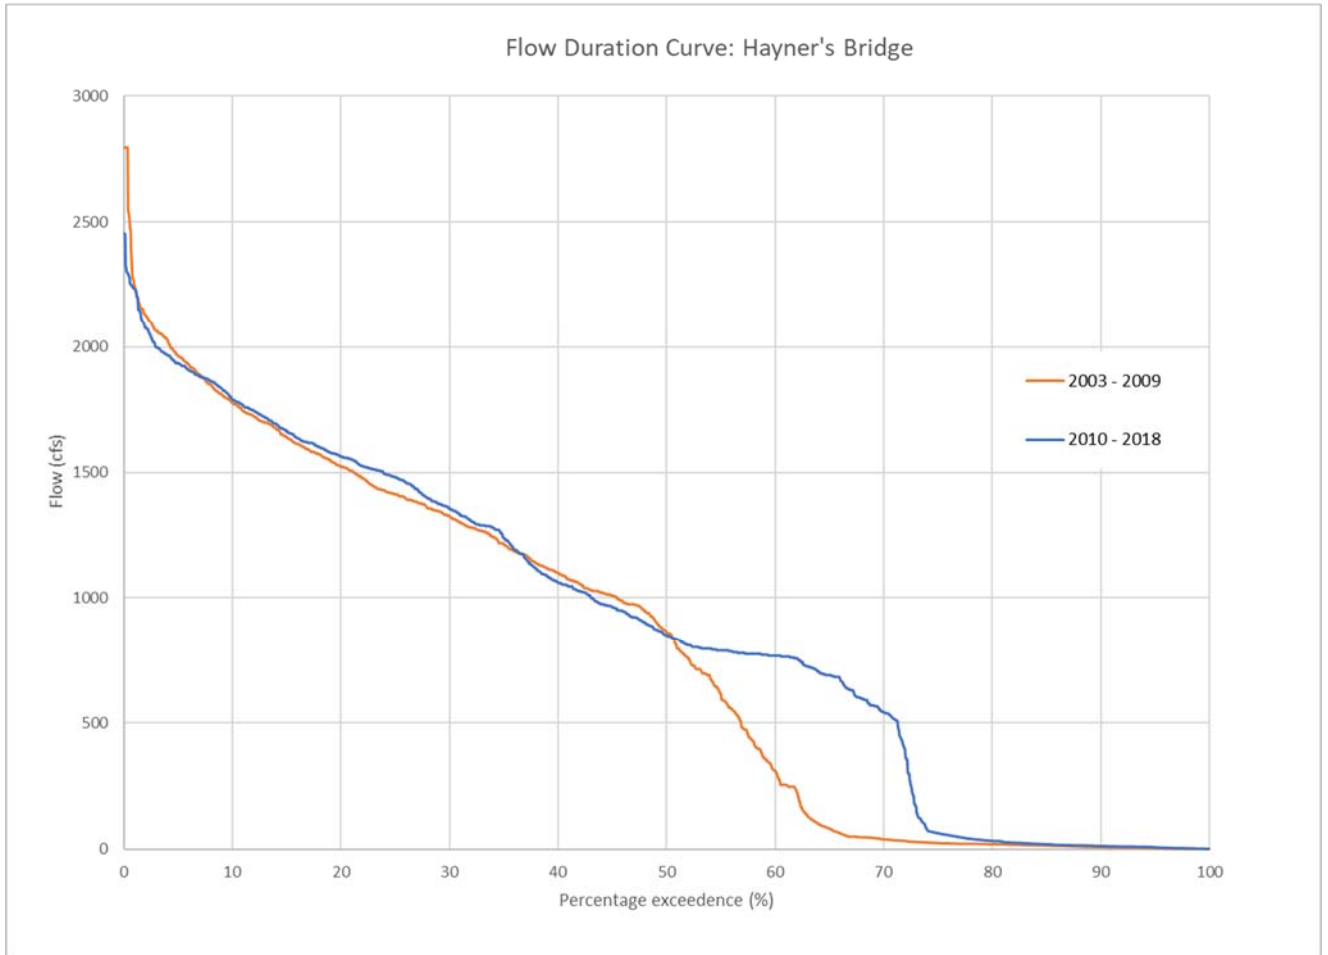
Figure 3. Flow duration curves at Hayner's Bridge Gage for two periods: 2003 to 2009 and 2010 to 2018.

Analysis at Hayner's Bridge (about 10 miles south of Hatch, NM) revealed that streamflow was very similar for 50% of the year during the past decade compared to the decade prior (Figure 3). However, at 60% exceedance, discharge increased by 150% during 2010-2018 compared to 2003-2009 (Table 2). Flows continued to be substantially higher at 75% and 90% exceedance since 2010. Comparably, between 2011-2018, the 50% exceedance discharge was 618 cubic feet per second (cfs) at Leasburg Dam (near Radium Springs, NM) while 60% exceedance was 320 cfs (Figure 4). Downstream at the Mesilla Dam gage, which lies below the Las Cruces sites, 50% exceedance discharge was 388 cfs while 60% exceedance was 196 cfs (Figure 5).

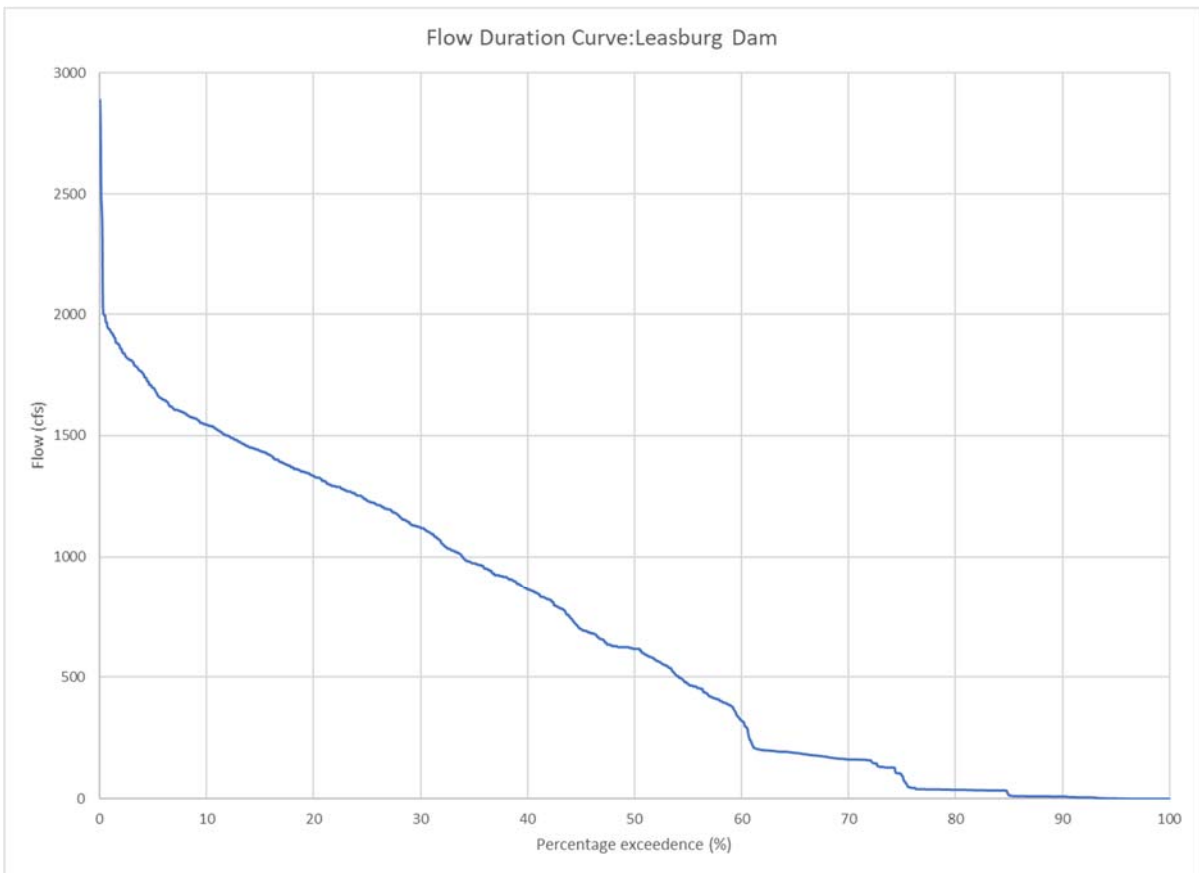
Figure 4. Flow duration curve at the Leasburg Dam Gage from 2011 to 2018.

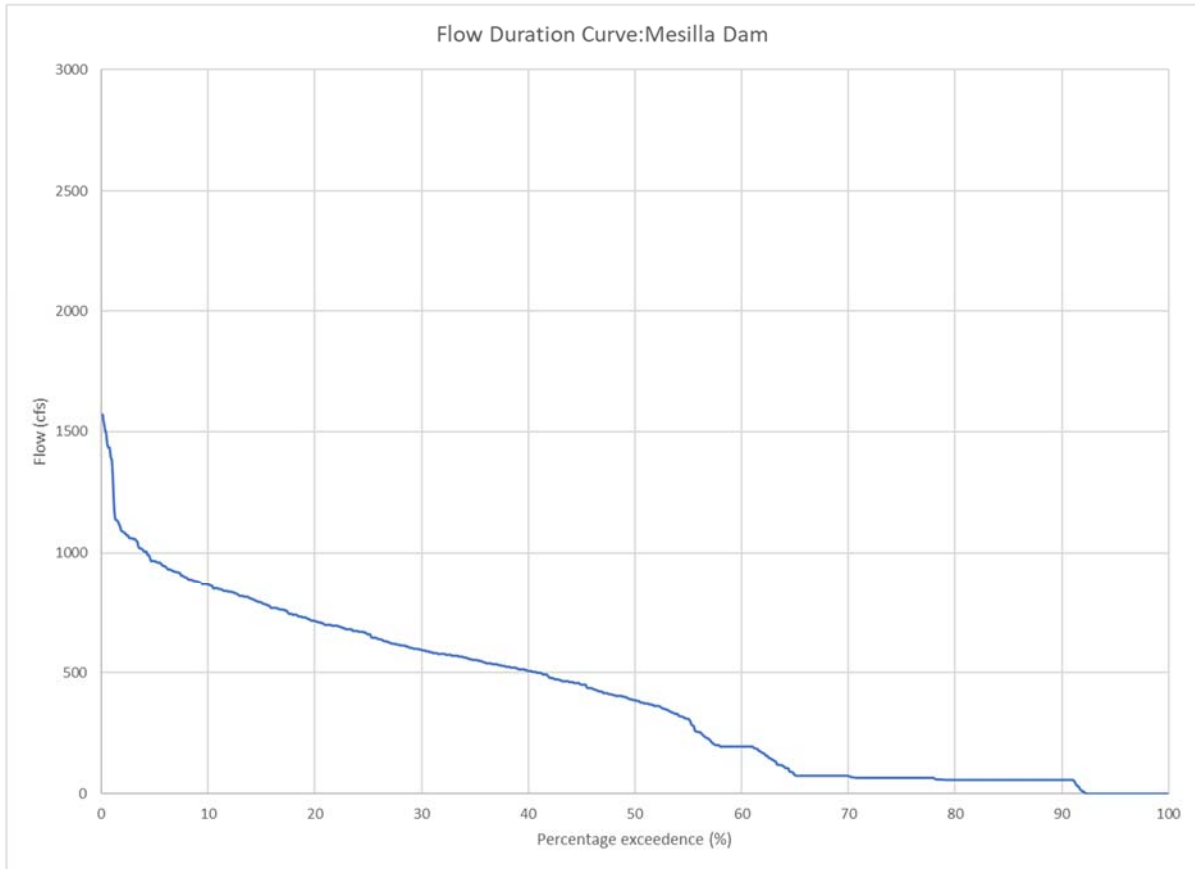
Figure 5. Flow duration curve at the Mesilla Dam gage from 2011 to 2018.

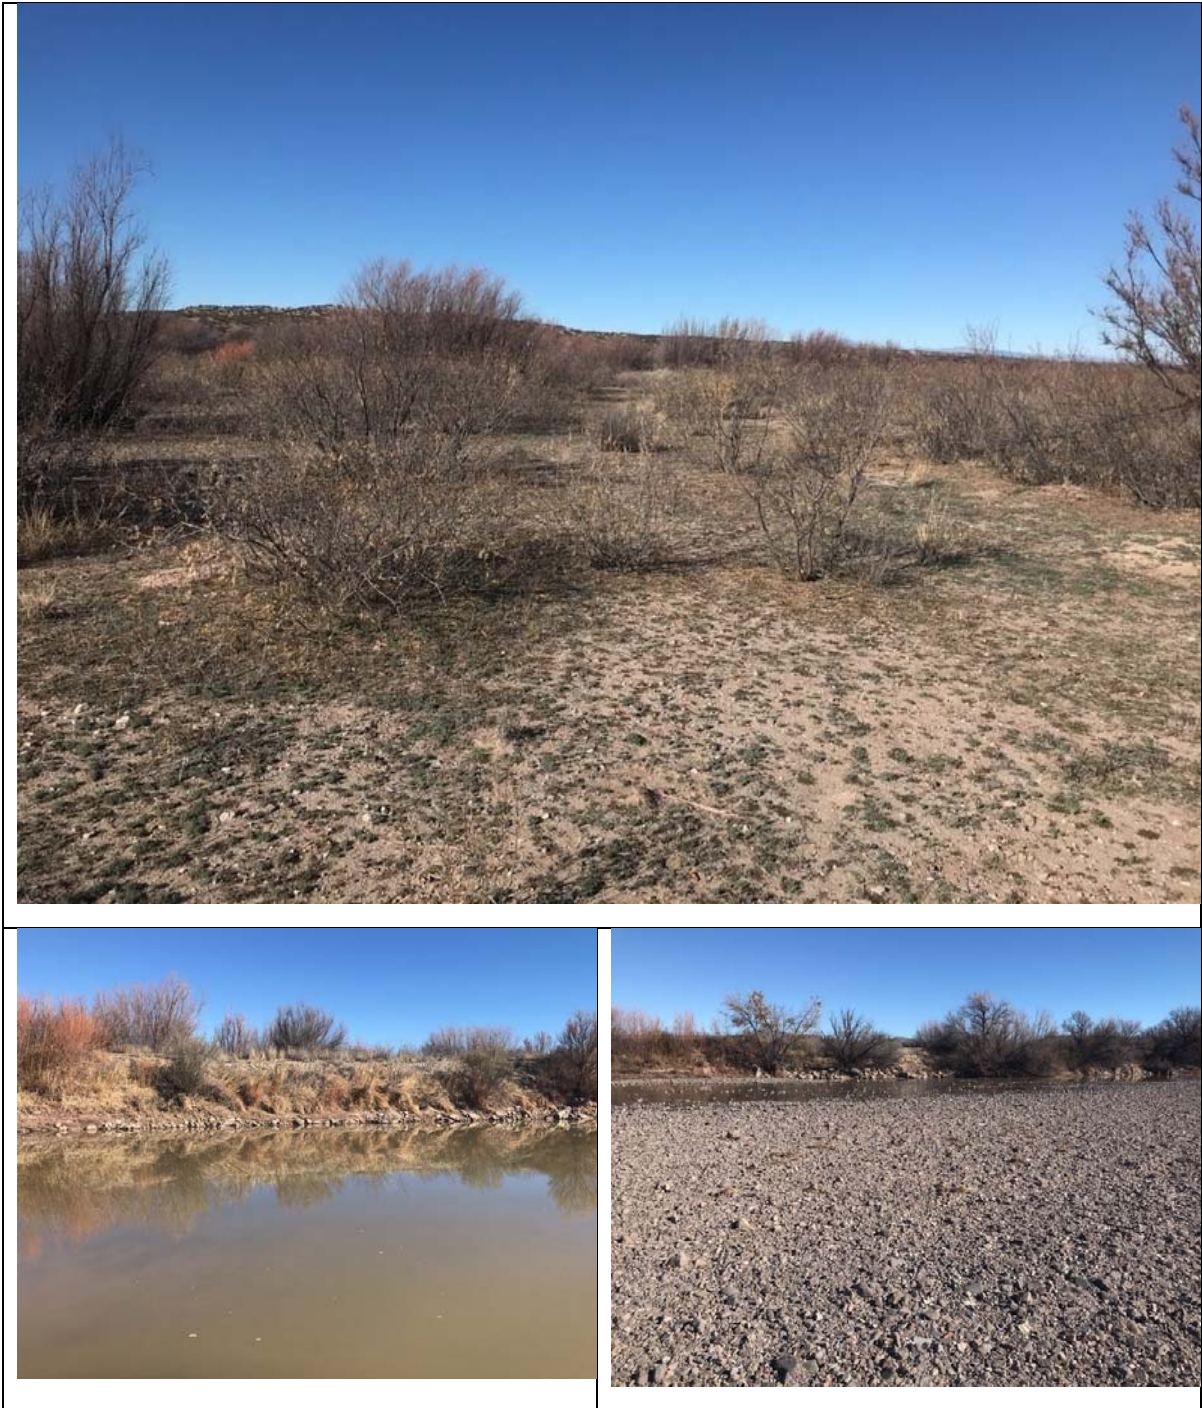
Figure 7. Representative photos of the Yeso Arroyo site. Top photo: typical vegetation conditions on the elevated floodplain terrace. Bottom left: riprap on toe of bank. Bottom right: bed conditions in the Rio Grande near the site.

The elevated floodplain terrace above the bankline slope is currently dominated by Jimmyweed (*Isocoma pluriflora*), a native shrub (Figure 7). Other woody species documented on the floodplain terrace include saltcedar, honey mesquite, arrowweed, prickly pear, fourwing saltbush, whitethorn acacia, indigobush (*Psoralea scoparius*), and longleaf jointfir (*Ephedra trifurca*). The herbaceous layer is dominated by spike dropseed with interstices filled by winter annuals including redstem filaree (*Erodium cicutarium*), tansymustard (*Descurainia pinnata*), and annual Townsend daisy (*Townsendia annua*). Desert marigold (*Baileya multiradiata*), tansyaster (*Machaeranthera tanacetifolia*) globemallow, spectacle pod (*Dimorphocarpa wislizeni*), (*Schismus* sp.), silverleaf nightshade (*Solanum elaeagnifolium*), Lehmann lovegrass (*Eragrostis lehmanniana*) Russian thistle, bush muhly (*Muhlenbergia porteri*), twinpod (*Physaria* sp), needle grama (*Bouteloua aristidoides*) and woollygrass (*Dasyochloa pulchella*).

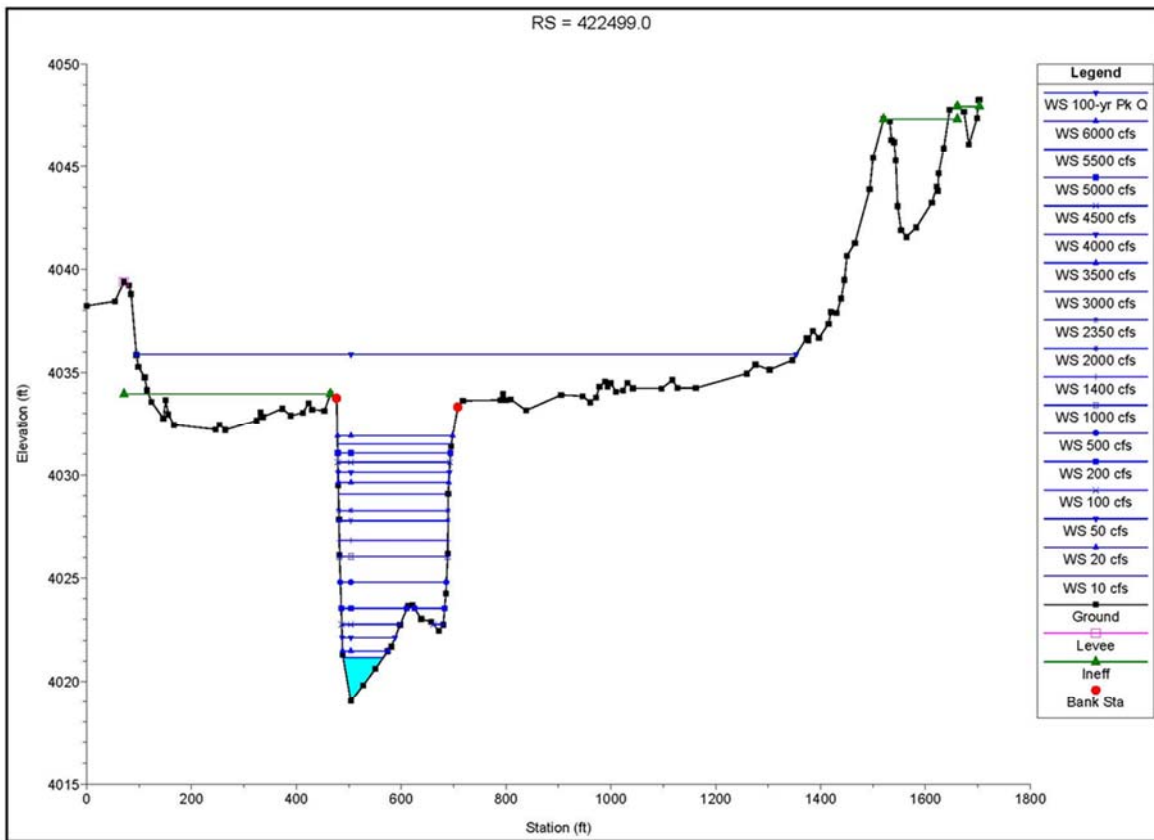
Figure 12. Representative channel cross-section of Rio Grande at Angostura Arroyo site showing predicted surface-water elevations under a range of discharges.

Flows in the Rio Grande appear to be persistent (possibly perennial) at this site, even outside the irrigation delivery season. LiDAR data indicates that much of the floodplain terrace is approximately 10 feet above the riverbed at this site (Appendix B) and hydraulic model results show that the site does not inundate until flows approach the 100-year discharge event (Figure 12). GSA scientists did not auger holes at this site, however, soils at the site are very coarse grained on the surface. The east bank of the river has large rock (likely riprap) along the toe.

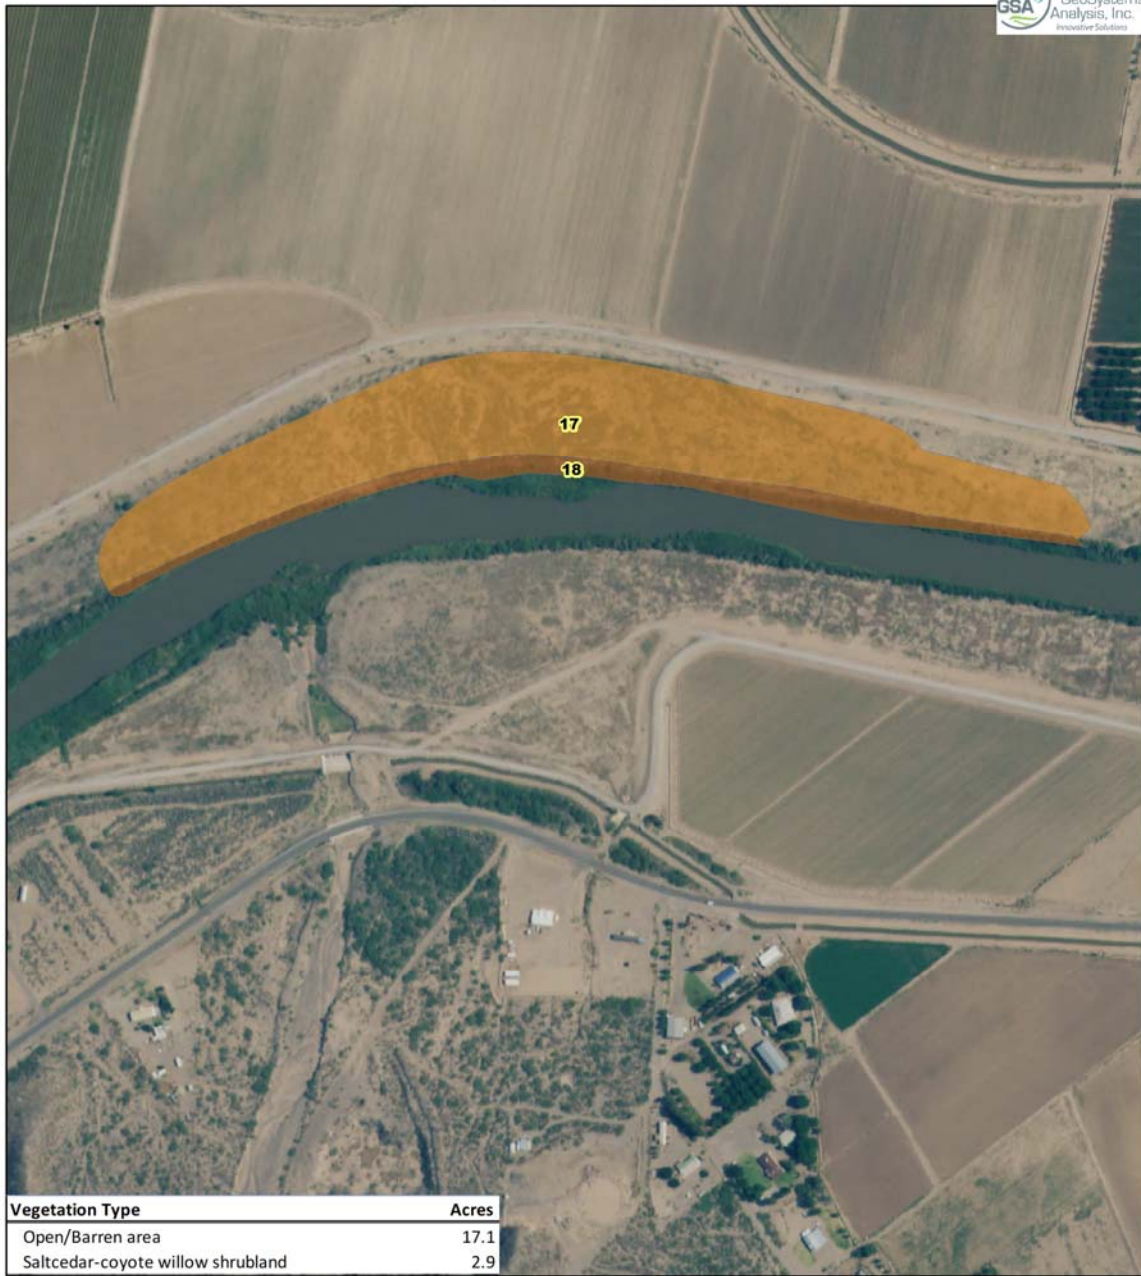
Figure 13. Angostura Arroyo vegetation map

Two vegetation types were identified at the proposed Angostura Arroyo restoration site (Figure 13). A saltcedar-coyote willow shrubland inhabits the bankline slope. Other woody species observed on the bankline include saltcedar, arrowweed, screwbean mesquite (*Prosopis pubescens*), Baccharis (*Baccharis salicifolia* and *salicina*), honey mesquite, fourwing saltbush, wolfberry, and skunkbush sumac (*Rhus trilobata*). Saltcedar is more prevalent on top of slope while coyote willow and *Baccharis* spp. are more common on lower portions of the slope. Spiny chloracantha (*Chloracantha spinosa*) bands inhabit the slope/terrace transition. A bench of cattail (*Typha domingensis*) and bulrush (*Schoenoplectus* sp.) occurs at the bottom of the bank. Bermudagrass, alkali sacaton (*Sporobolus airoides*), and bearded sprangletop (*Leptochloa fusca*) are the most abundant graminoids on the bankline slope.

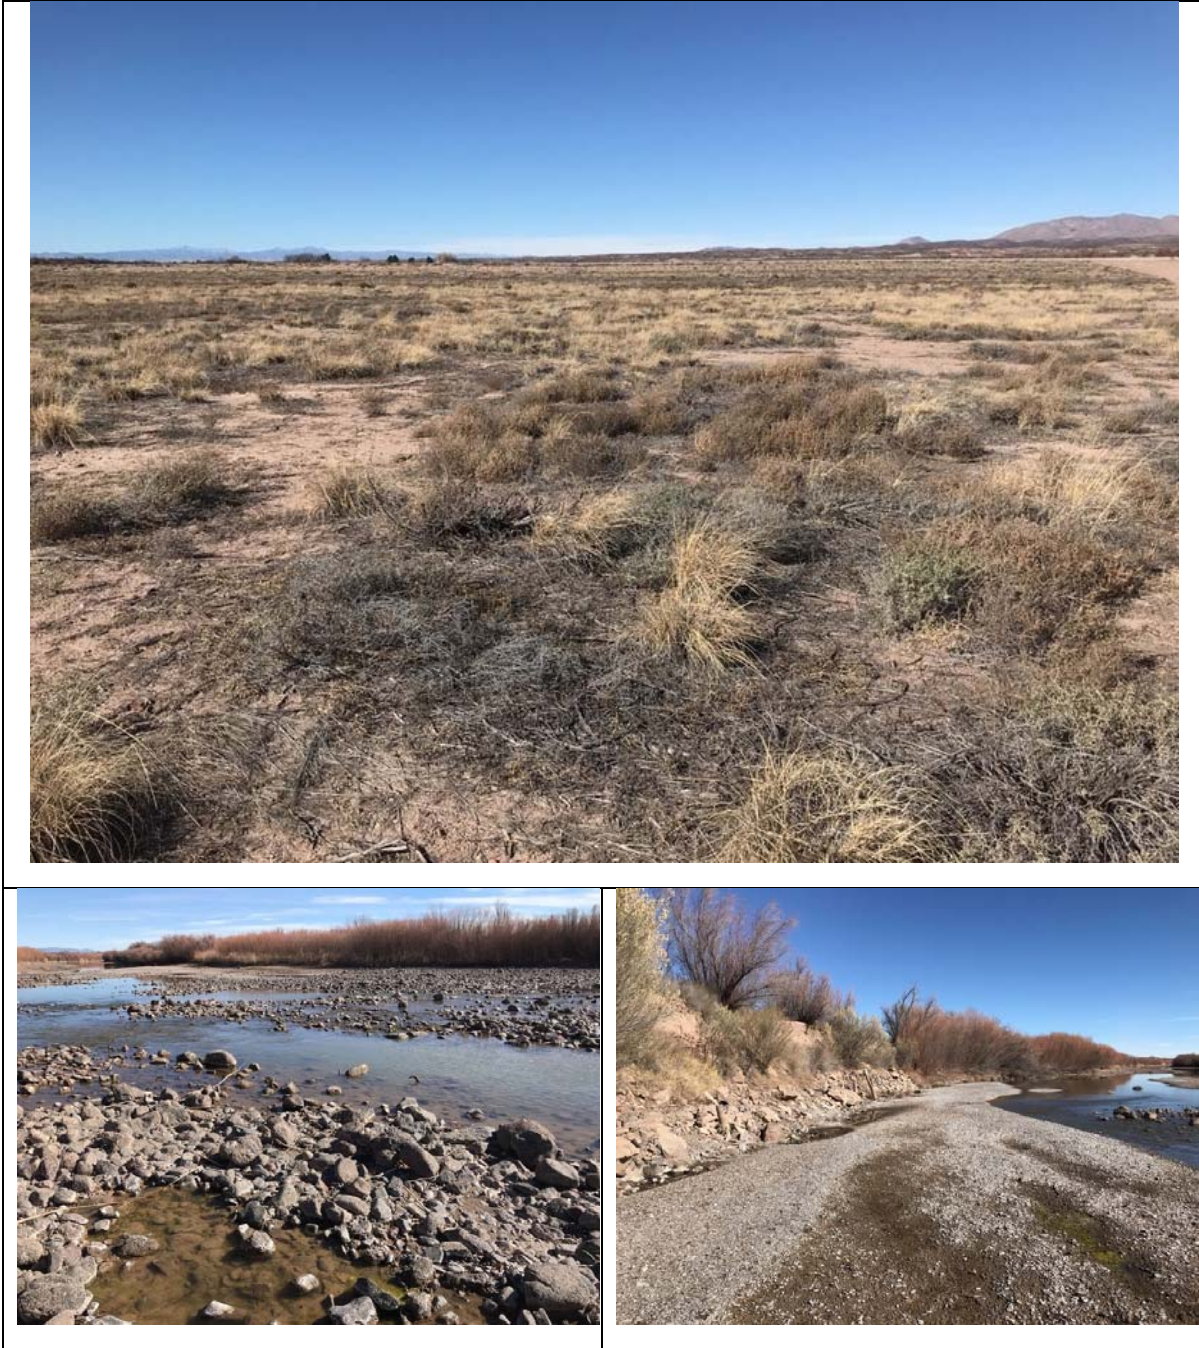
Figure 14. Representative photos from the Angostura Arroyo site. Top photo: typical conditions on the elevated floodplain terrace. Bottom left and right, Rio Grande channel adjacent to the site.

The floodplain terrace is actively mowed by USIBWC so woody vegetation is mostly absent (Figure 14). The terrace is characterized as an open/barren area and Russian thistle is the most abundant species. Mowed saltcedar and arrowweed stems are patchy while Jimmyweed, spiny chloracantha, and fourwing saltbush stems are evenly distributed. Mowed whitethorn acacia, wolfberry, fourwing saltbush, and screwbean mesquite individuals are occasional. Alkali sacaton is the most abundant graminoid while bermudagrass, scratchgrass, needle grama, spike dropseed, Mediterranean (*Schismus* sp), feathertop (*Chloris virgata*), and mesa dropseed (*Sporobolus flexulosus*). Other annual weeds like kochia (*Bassia scoparia*) and amaranth (*Amaranthus* sp.) scorpionweed (*Phacelia* sp.), London rocket (*Sisymbrium irio*), and western tansymustard occur but at lower frequency than expected given the high degree of site disturbance.

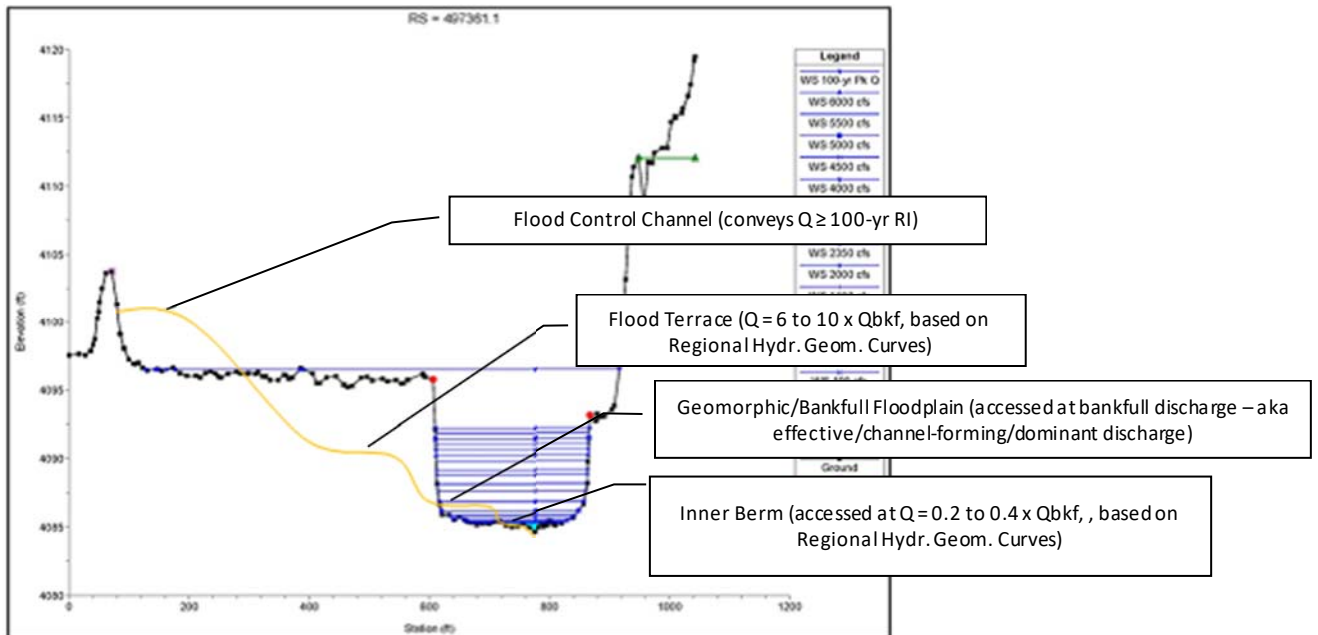
Figure 16. Example geomorphic surfaces targeted in the nested terrace design. Lower terrace and bank full elevations and their associated terraces are representative of the secondary and overbank (i.e. effective/channel forming/dominant) discharges.

This site has potential to improve in-channel and off channel aquatic habitats with a nested geomorphic floodplain (e.g. terraced approach). Design discharges are intended to achieve a low-flow bench at approximately 800 cfs, moderate flow bench at approximately 1,400 cfs, a high flow bench at approximately 2,500 cfs, with the remainder of the terrace remaining protected at the 100-year flood elevation. Over time, this design alternative has potential to encourage natural recruitment of native vegetation recruitment. Cottonwood/willow planting on the higher terrace sections would provide benefits to southwestern willow flycatcher and yellow-billed cuckoo as the trees mature. Deposition of large bed material from the arroyo contributes to increased habitat heterogeneity in the vicinity of the restoration area.

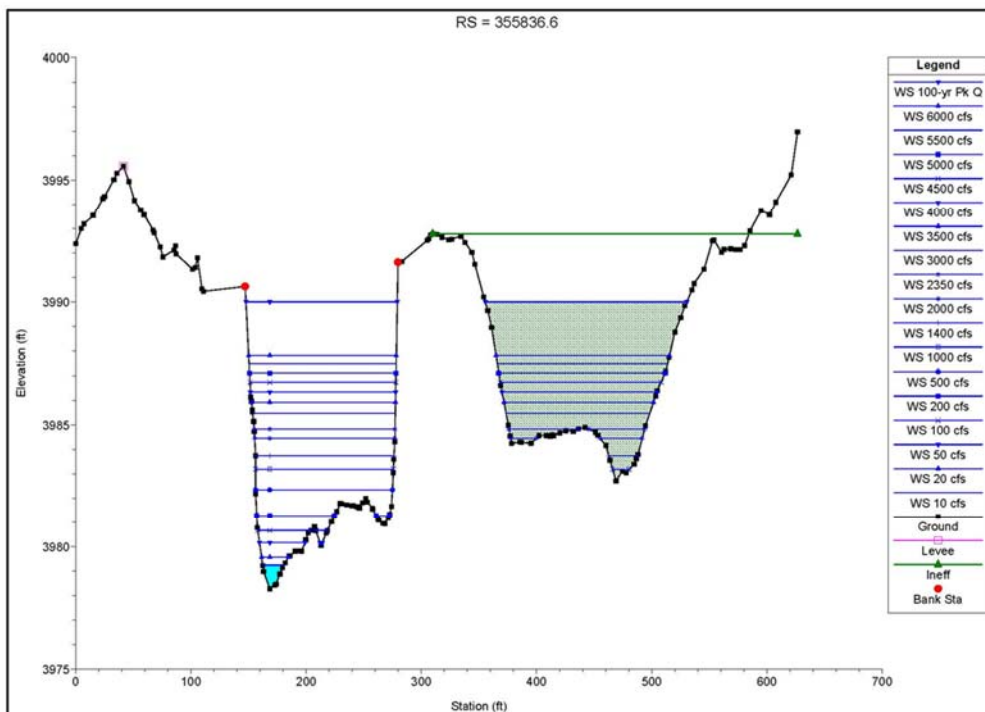
Figure 18. Representative channel cross-section of Rio Grande at the Broad Canyon Arroyo site showing predicted surface-water elevations under a range of discharges. Green-highlighted area shows predicted surface water elevations at the mouth of Broad Canyon Arroyo.

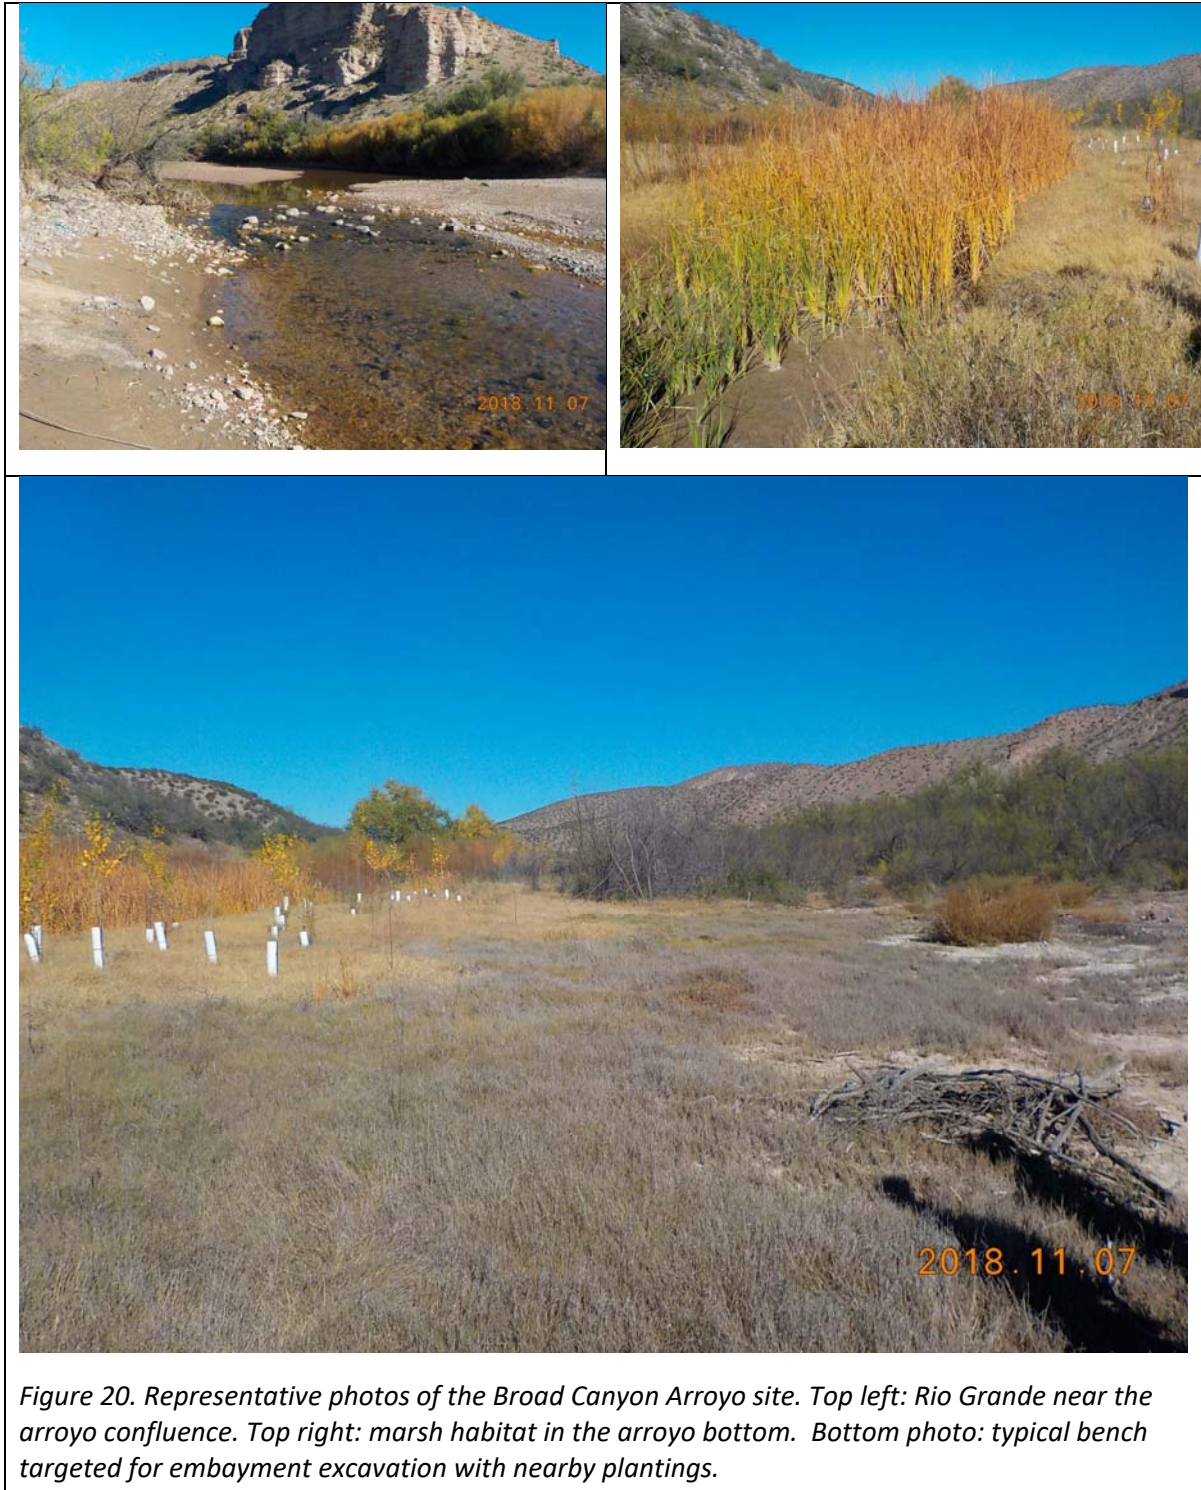
Figure 20. Representative photos of the Broad Canyon Arroyo site. Top left: Rio Grande near the arroyo confluence. Top right: marsh habitat in the arroyo bottom. Bottom photo: typical bench targeted for embayment excavation with nearby plantings.

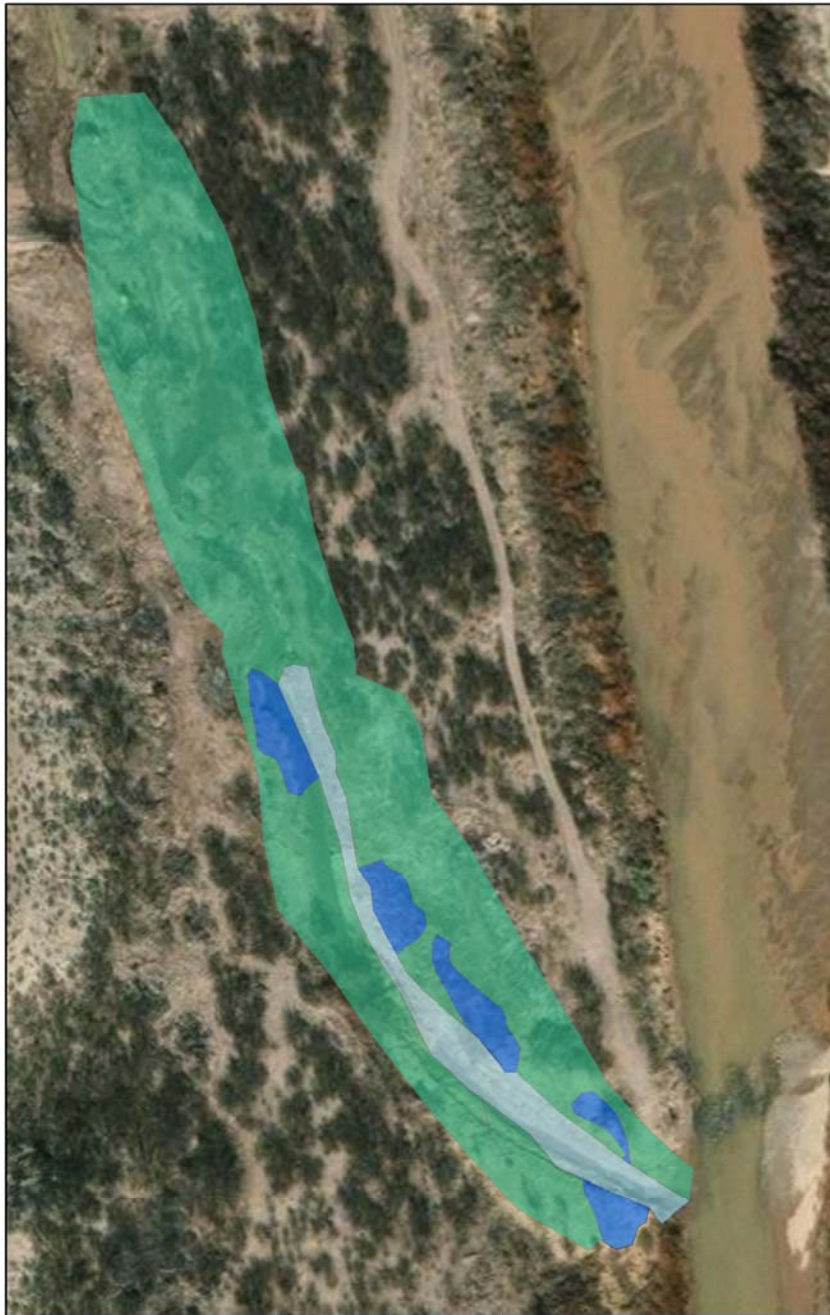
Broad Canyon Arroyo

Construction Elements

1. Clear and grub vegetation in excavation footprint
2. Ensure existing plantings and marsh habitats are not impacted during excavation
3. Construct backwater embayments at locations shown in the map
4. Average excavation depth is 2-feet in the embayments
5. Plant additional cottonwood-willow in surrounding riparian enhancement area
6. Plant wetland plugs in excavated embayments
7. Spoil excavation material in open/barren map units indicated on vegetation map
8. Seed spoil area with a diverse, site appropriate mix of grasses and shrubs

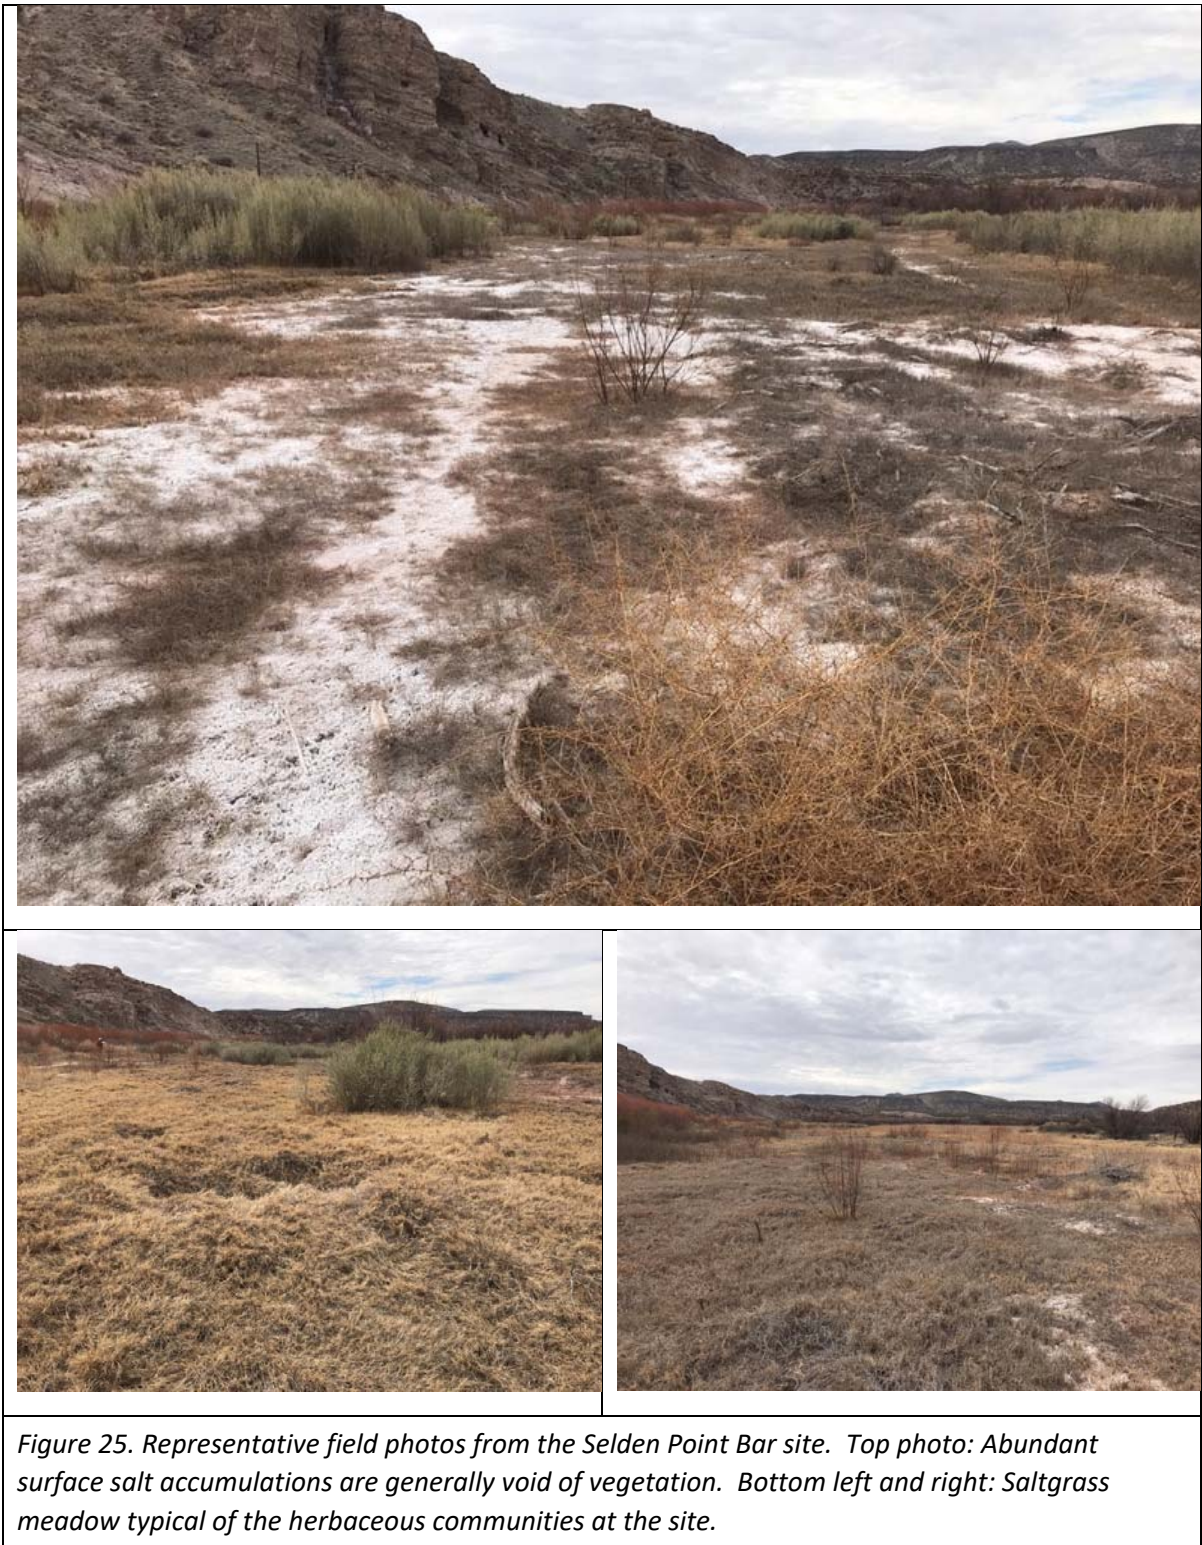
Figure 25. Representative field photos from the Selden Point Bar site. Top photo: Abundant surface salt accumulations are generally void of vegetation. Bottom left and right: Saltgrass meadow typical of the herbaceous communities at the site.

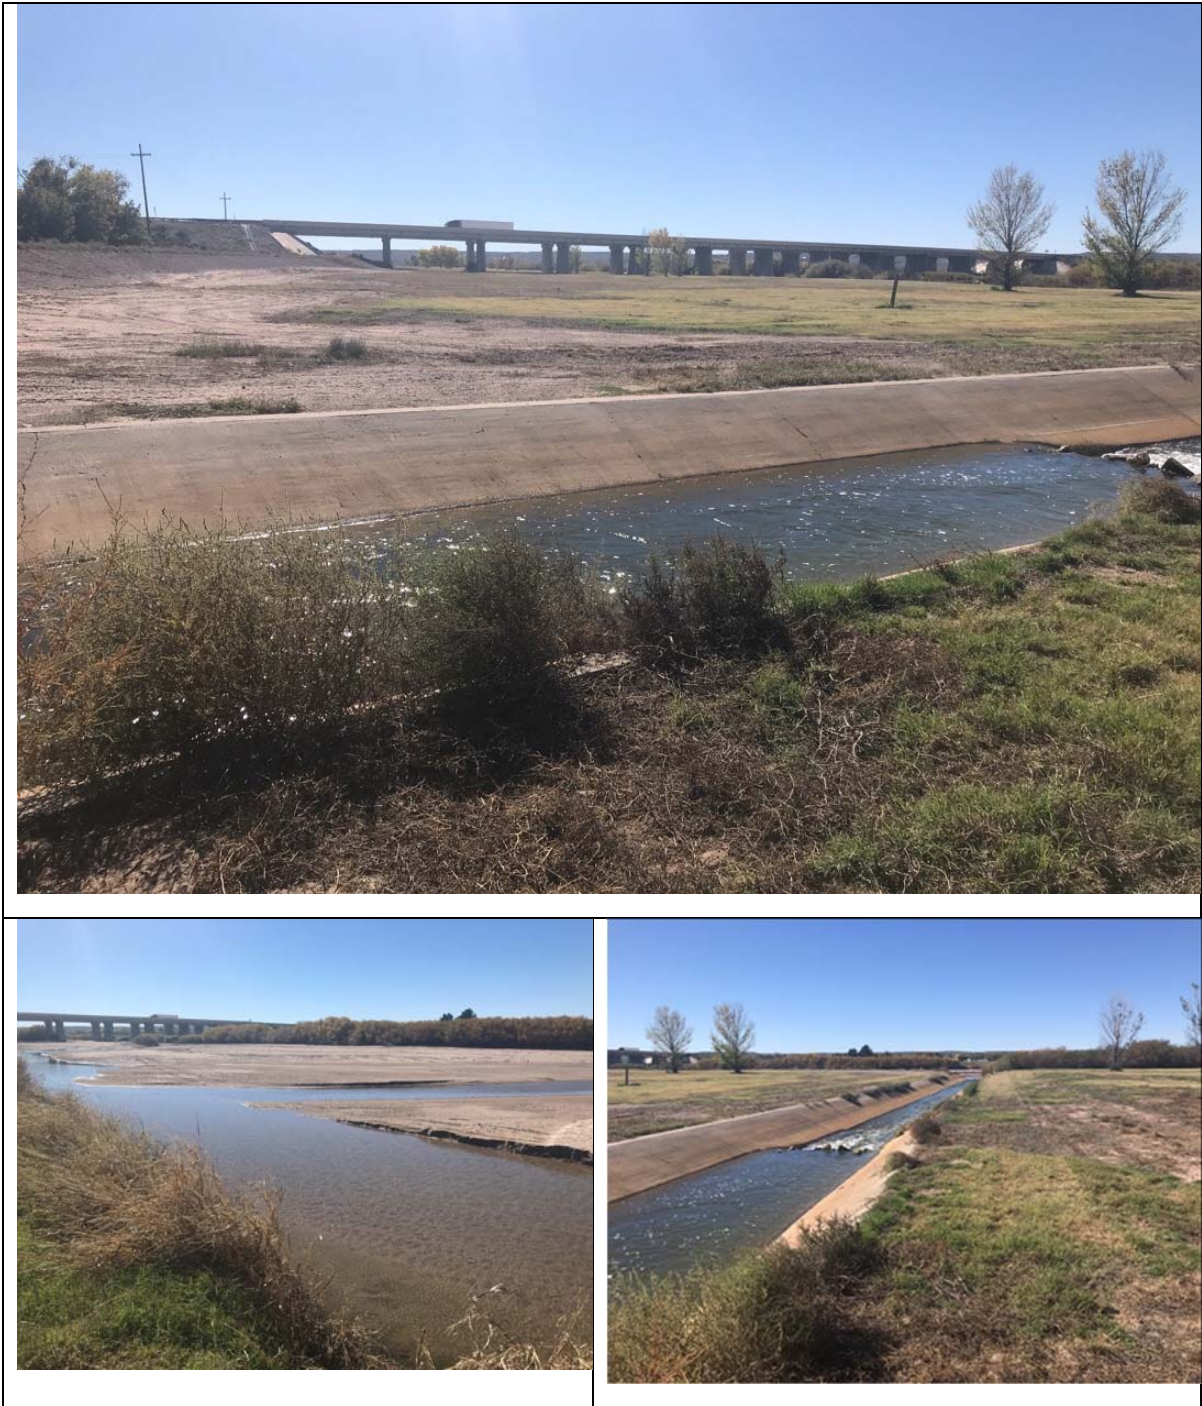
Figure 30. Representative field photos from the Las Cruces Effluent site. Top: Effluent channel with adjacent terrace where constructed channel is proposed. Bottom left: Rio Grande downstream of the effluent channel. Bottom right: effluent discharge channel.

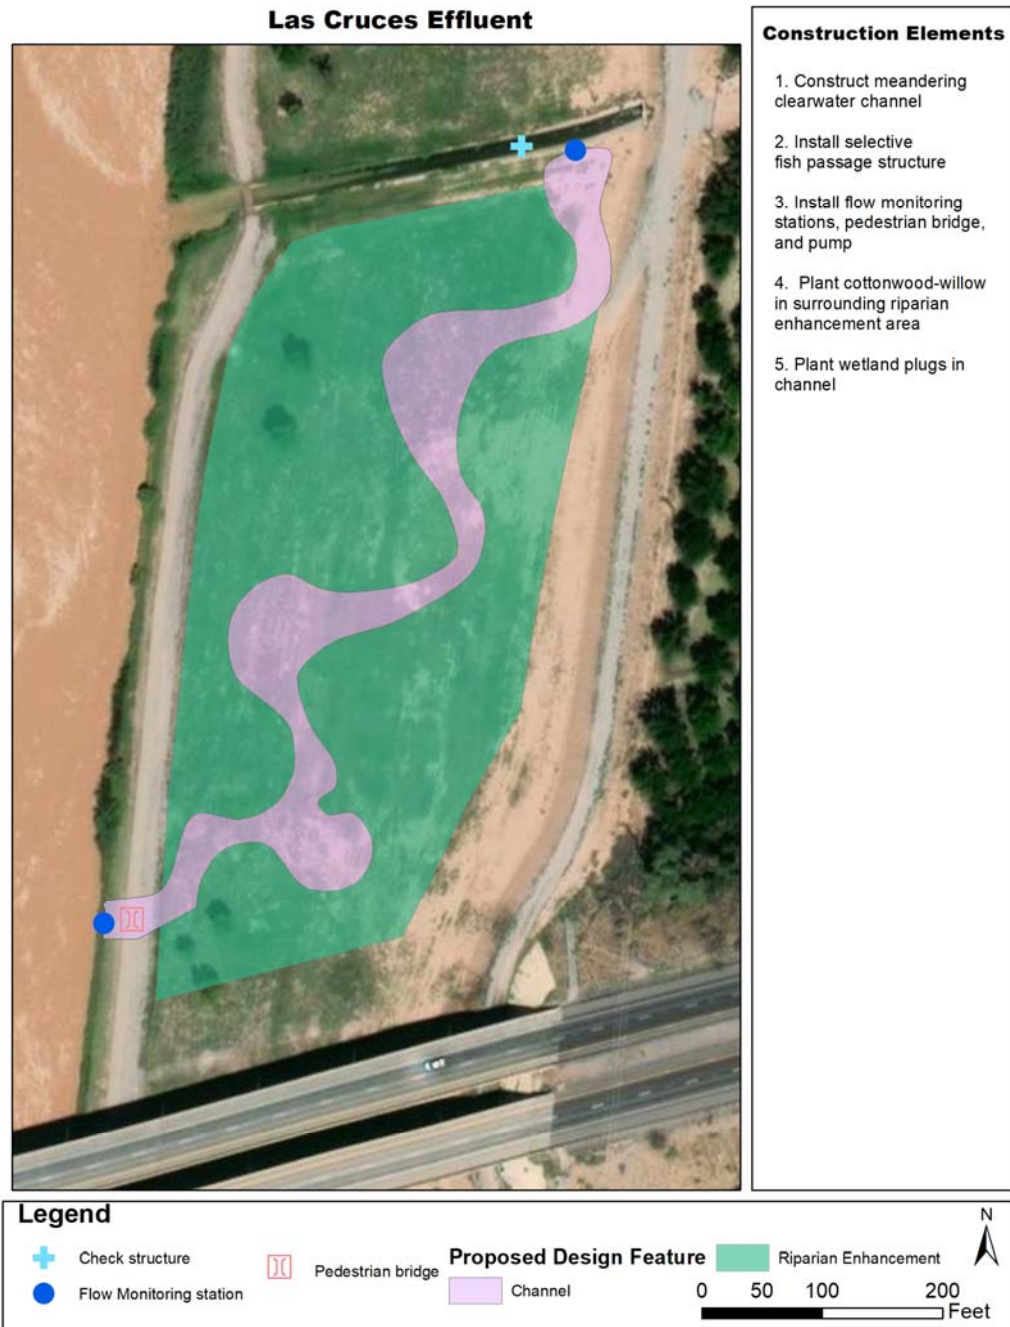
Figure 31. Las Cruces Effluent Site conceptual restoration plan map.

The habitat creation concept for this site is to install a check structure off the concrete lined channel currently used to convey treated wastewater to the Rio Grande and reroute flows through a relatively long, meandering channel with diverse aquatic habitat features (Figure 31). These aquatic habitats would be enhanced by planting aquatic vegetation within backwaters, and riparian vegetation along the channel margins.
