***Rio Grande Canalization Project Aquatic
Habitat Restoration Site Alternatives and
Conceptual Designs***

*Prepared for:
United States Section
International Boundary &
Water Commission and Gulf
South Research Corporation*

*Prepared by:
GeoSystems Analysis
3150 Carlisle Blvd. NE,
Albuquerque, NM 87110
www.gsanalysis.com*

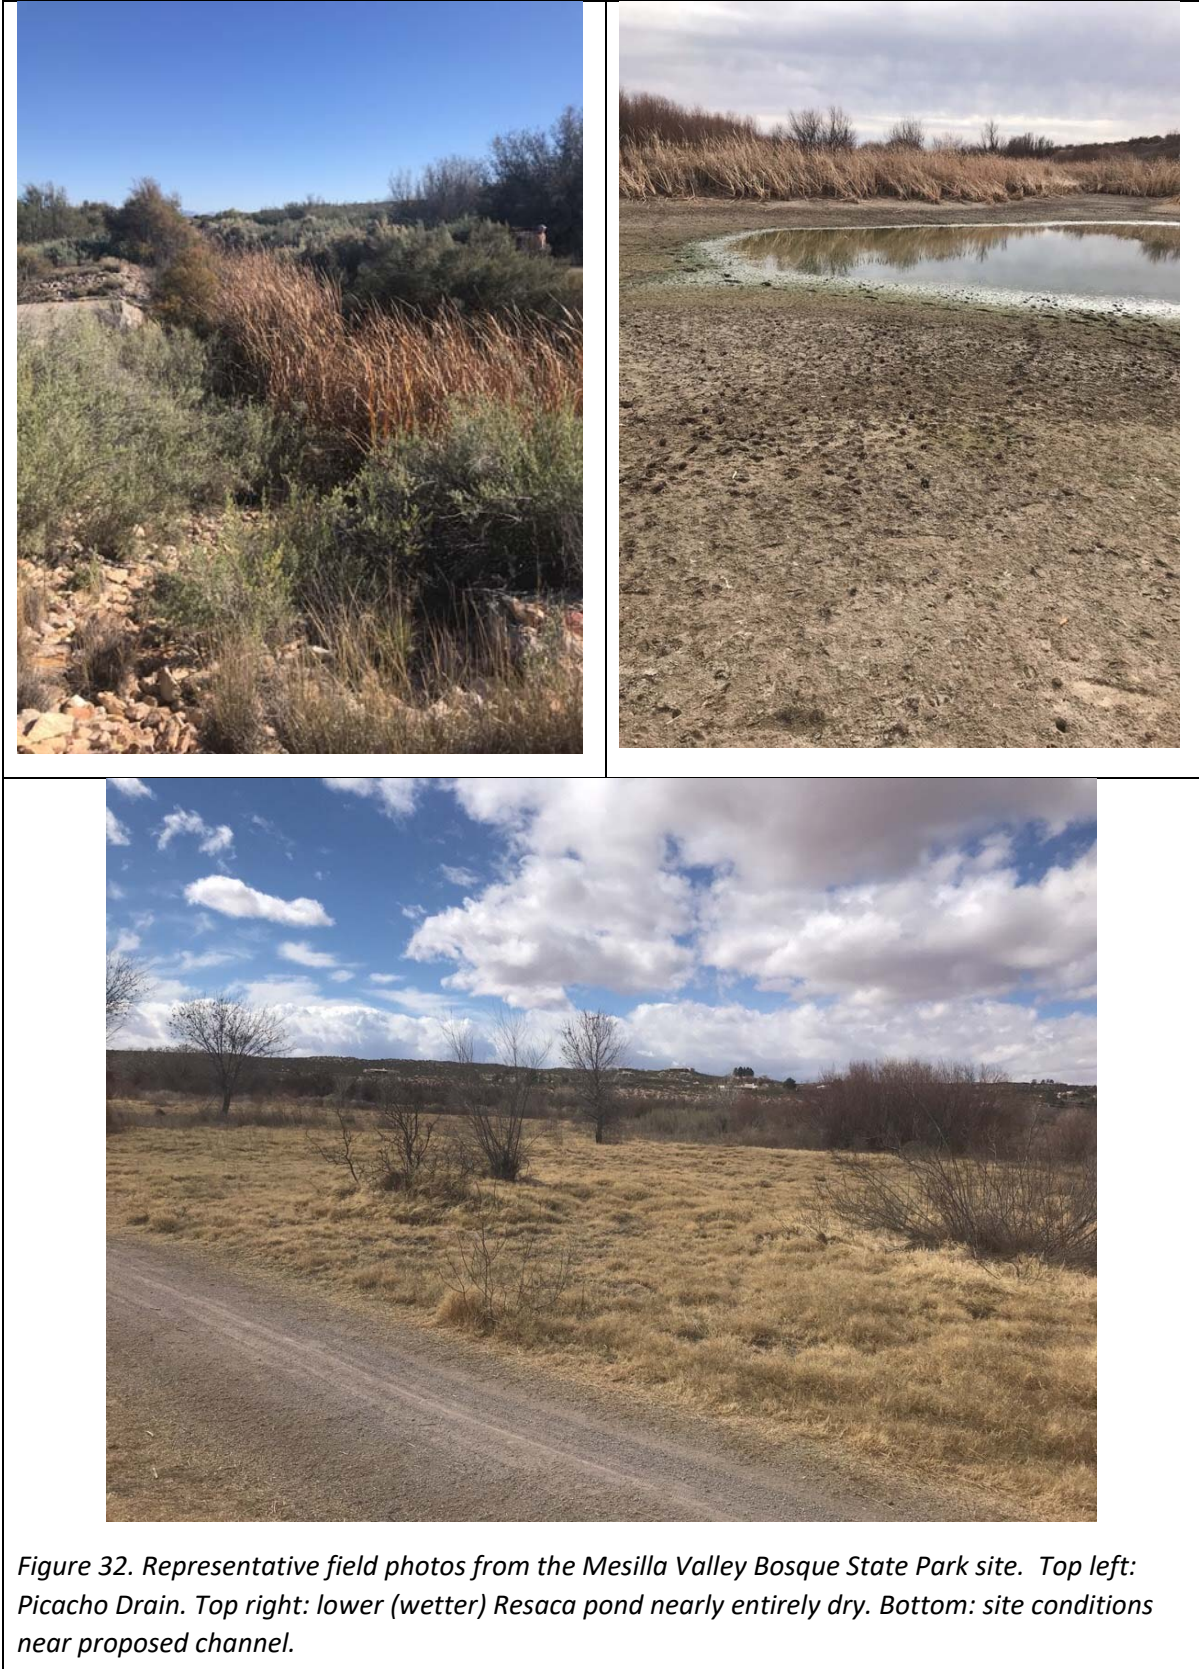
Figure 32. Representative field photos from the Mesilla Valley Bosque State Park site. Top left: Picacho Drain. Top right: lower (wetter) Resaca pond nearly entirely dry. Bottom: site conditions near proposed channel.

Mesilla Valley Bosque State Park (MVBSP), near RM 41, was established in 2005 (Blue Earth 2008). The Park is located on the west side of the Rio Grande near the Town of Mesilla, NM and has been the focal point for other restoration efforts over the past two decades. For example, the Picacho Wetland project was constructed by the Southwest Environmental Center (SWEC), the City of Las Cruces, EBID, and other partners between 2002 and 2005 on a 55-acre tract of land within the Park managed by the New Mexico Department of Game and Fish (NMDGF) (Blue Earth 2008). That project involved excavating two ponds to create aquatic/wetland habitat along the Picacho Drain. A deep 3-acre pond was excavated to a depth of 8 feet with hopes that it would contain perennial surface water to provide year-round aquatic habitat for a variety of species. The deeper pond contains two trenches that connect with the Picacho Drain which allow water to flow between the ponds, the drain, and the Rio Grande. A shallower, adjoining 2-acre shallow pond connects with the deep pond via a culvert and fills when flows in the river are high, thus functioning as a seasonally-flooded meadow. Due to a combination of lower groundwater conditions and sedimentation, the "perennial" pond no longer holds water during droughts and both ponds are being invaded by cattail (Figure 32).

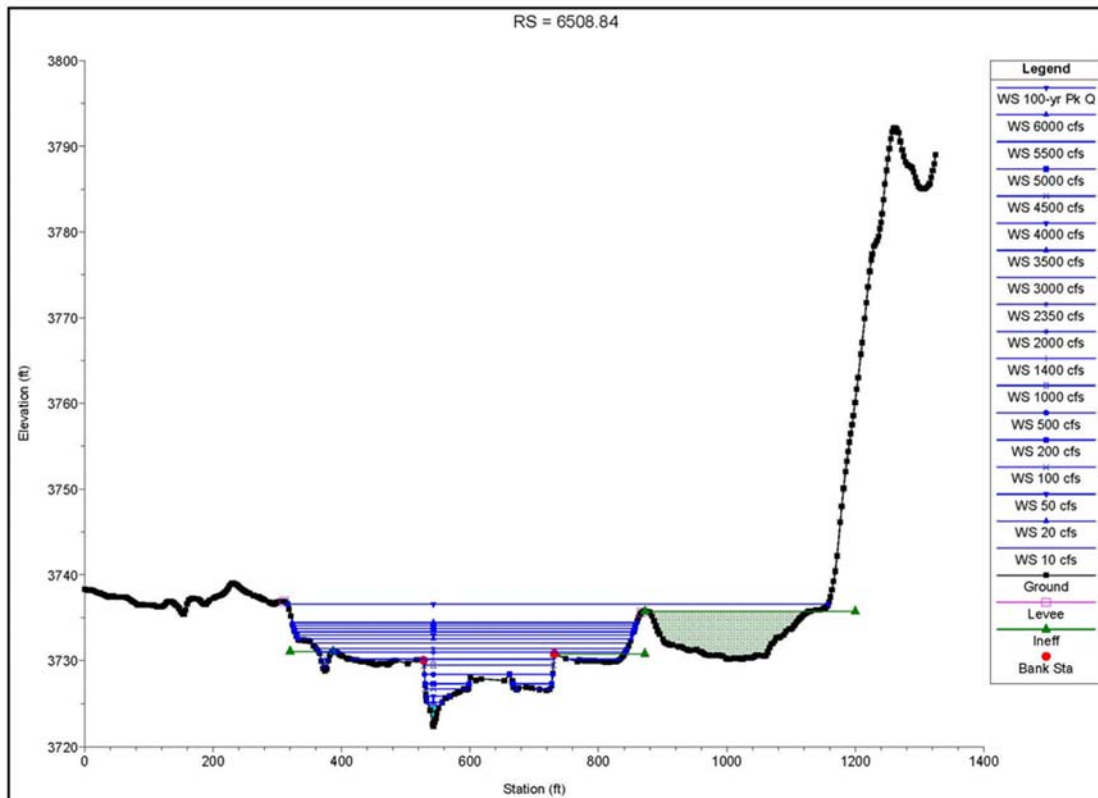
Figure 38. Representative channel cross-section of Rio Grande at the Downstream of Courchesne Gage site showing predicted surface-water elevations under a range of discharges.

The site currently supports a native herbaceous wetland complex with saltcedar largely confined to bankline portions (Figure 39). Groundwater is shallow and the Rio Grande in this reach is perennial due to discharge from Sunland Park Wastewater Treatment Plant. El Paso Irrigation District will not currently allow planting woody vegetation at this site and is encouraging more aggressive mowing at this location. Based on the LiDAR data, much of the site is situated 2 to 4 feet above the riverbed. Hydraulic models indicate inundation has the potential to begin when flows reach approximately 1,400 cfs, particularly with relatively minor bankline excavation (Figure 38).

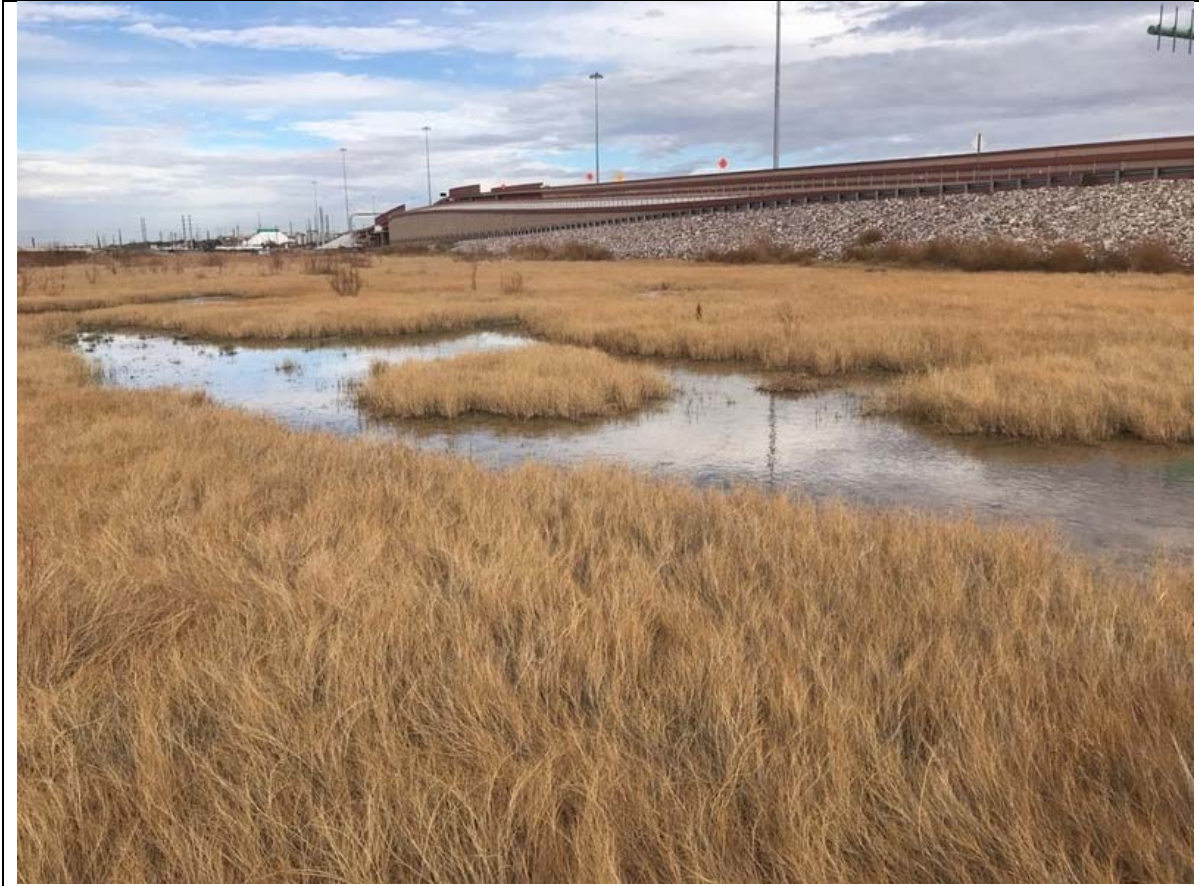
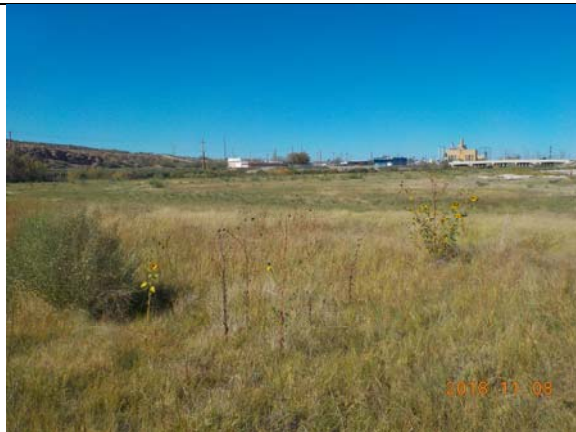
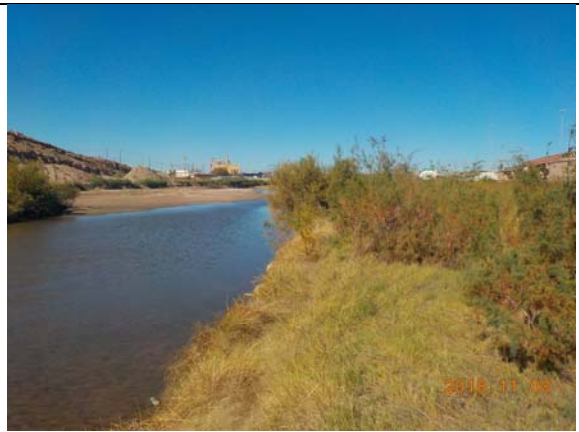
Figure 40. Representative field photos from the downstream of Courchesne Gage site. Top: standing water in an herbaceous wetland. Bottom left, typical wet meadow vegetation conditions. Bottom right: saltcedar along bankline.

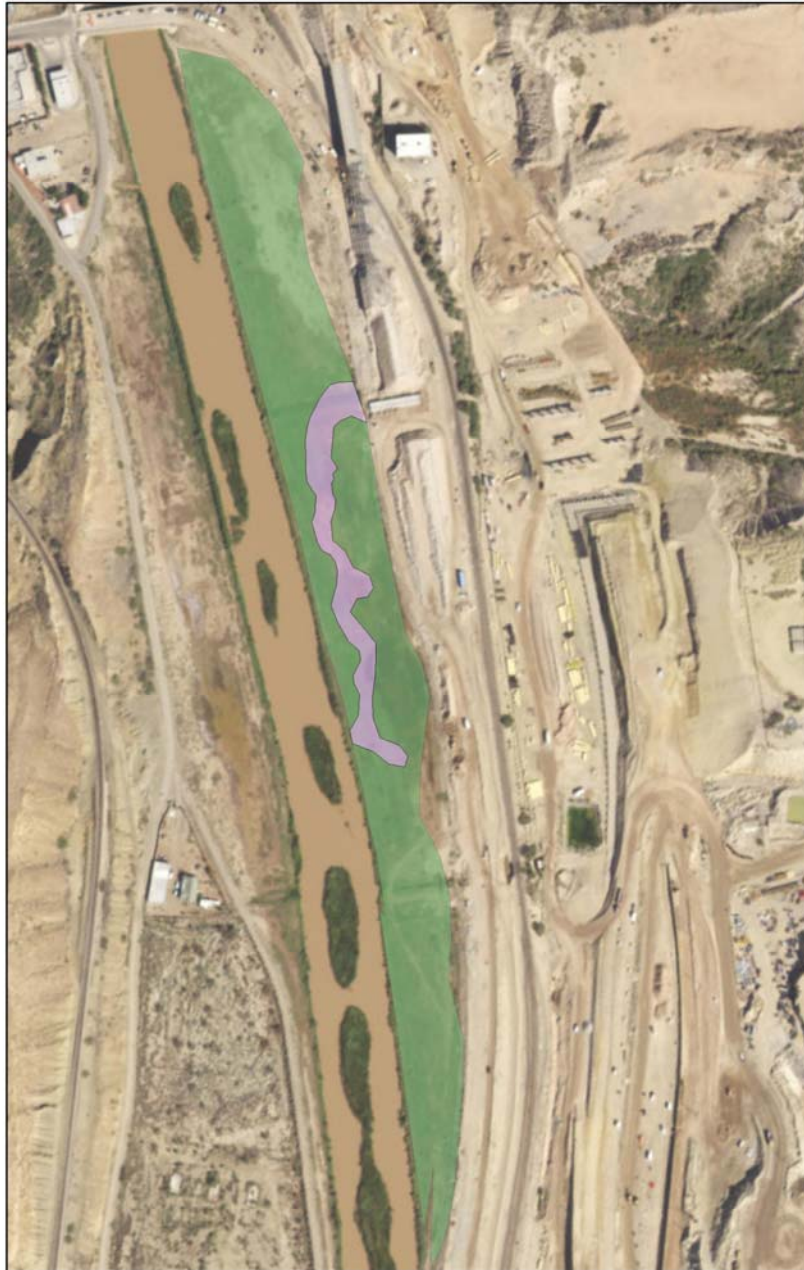
Downstream of Courchesne Gage

- Construction Elements**
1. Treat saltcedar and perennial pepperweed throughout site
 2. Clear and grub vegetation in excavation footprint
 3. Construct meandering side channel that carries stormwater from below the highway to the Rio.
 4. Average excavation depth is 3-feet in the channel
 5. Plant wetland plugs in excavated embayments and on channel side slopes
 6. Spoil excavation material in open/barren map units near former staging area or use during levee constructed if completed in the future
 7. Seed spoil area with a diverse, site appropriate mix of grasses and shrubs
 8. Plant low density woody vegetation along constructed channel margins.

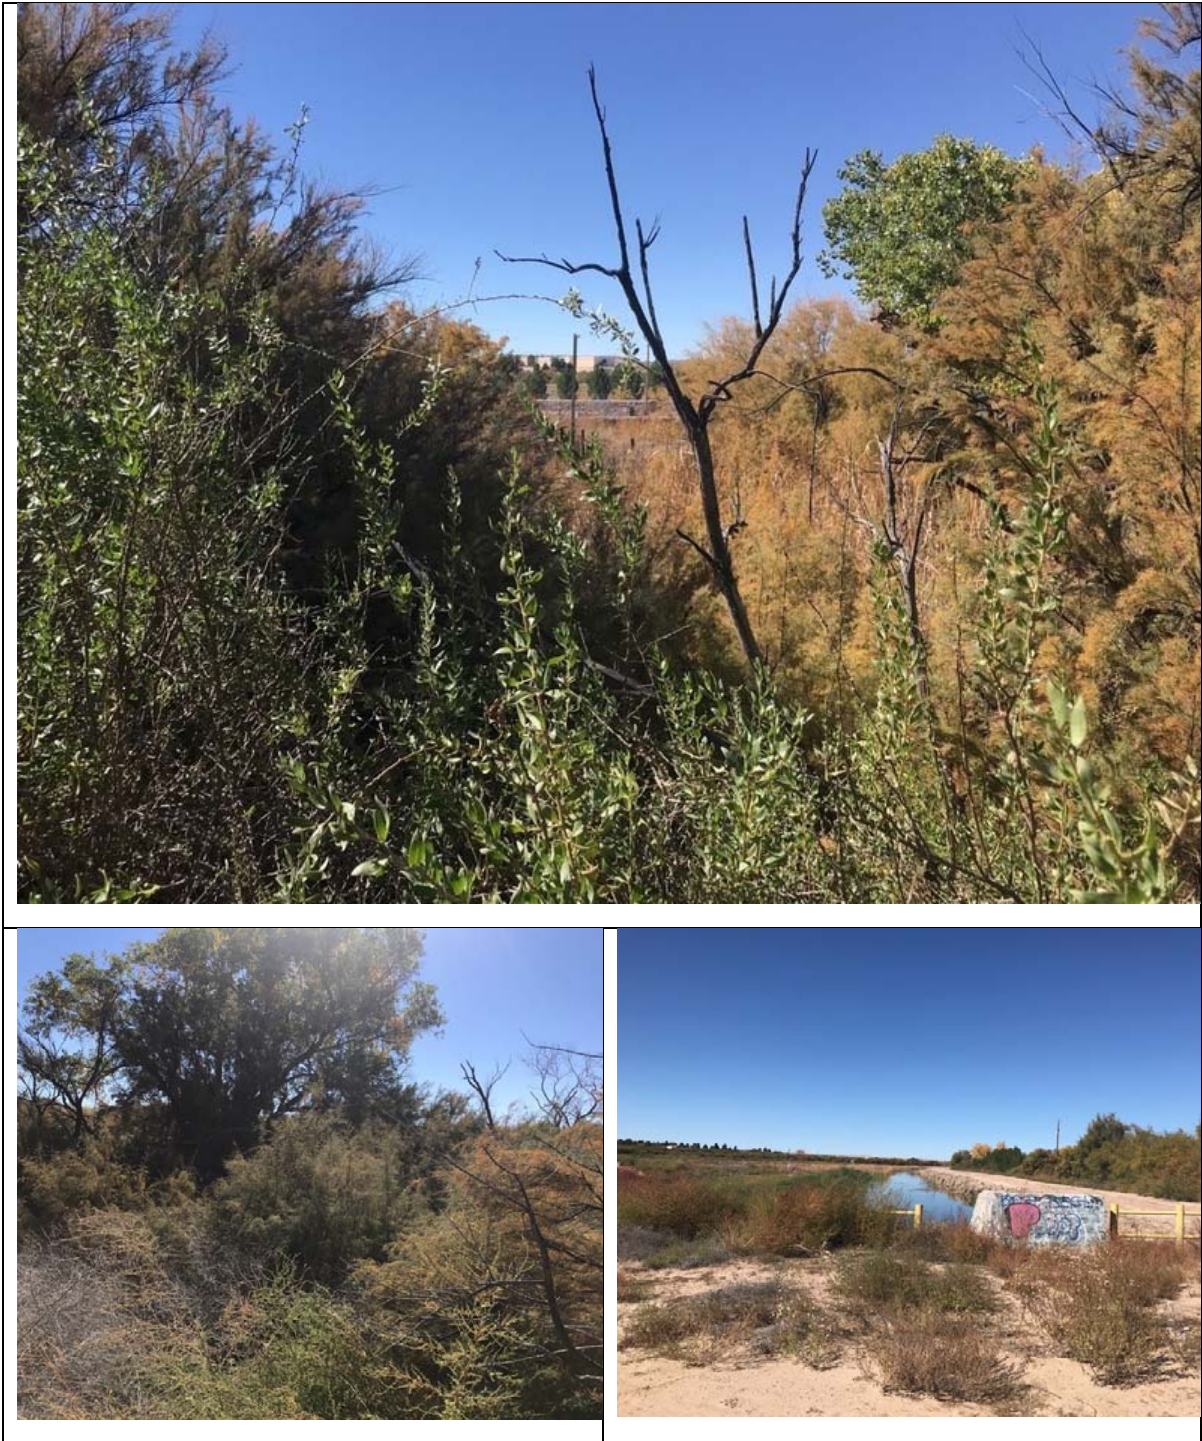
Figure 44. Field photos from NeMexas Siphon site. Top: burn area. Bottom left: mature cottonwood tree outside the burn. Bottom right: constructed wetland at previous EBID site.

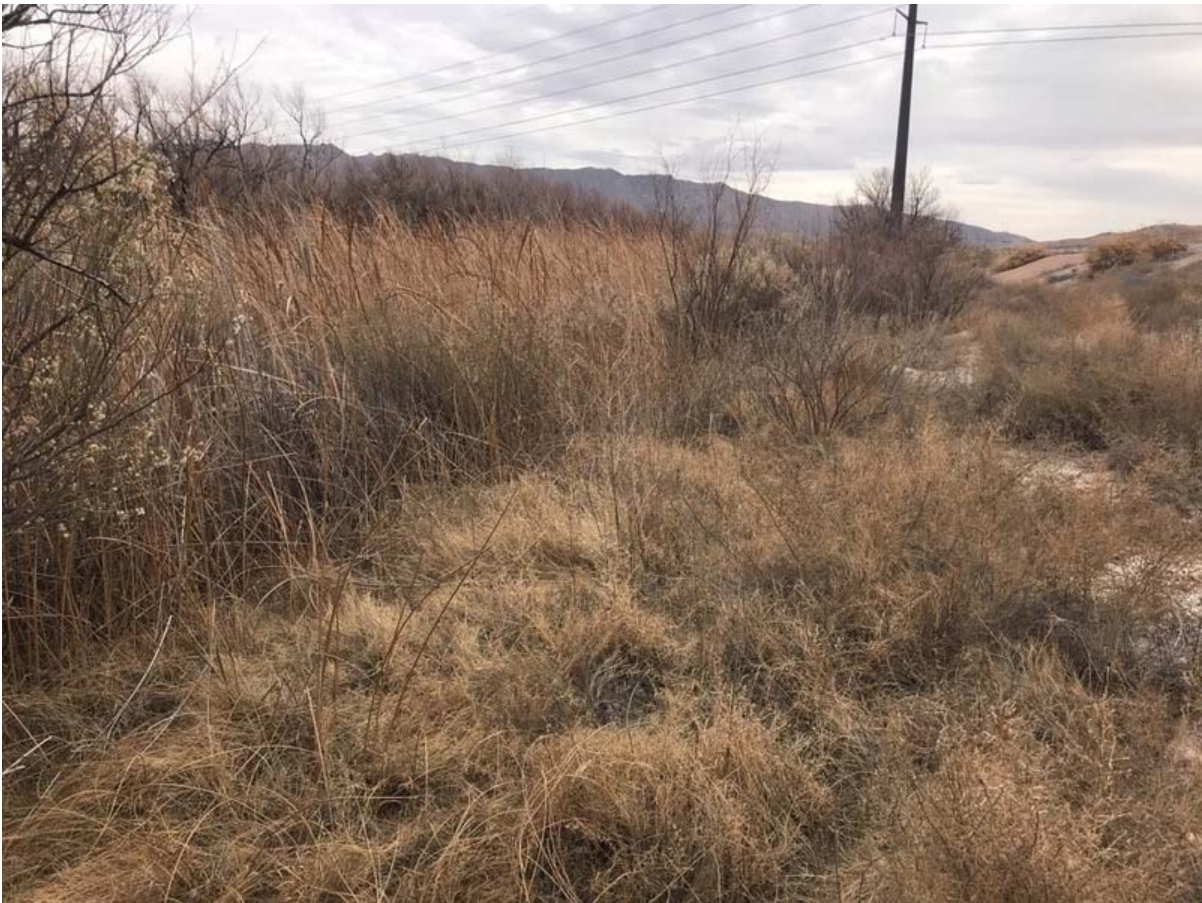
Figure 45. Representative field photo from Montoya Drain Site

The Montoya Intercepting Drain site is an EBID owned irrigation facility near RM 3. The drain does not appear to be actively maintained and is currently overgrown with cattail (Figure 45). Depending on EBID's long term vision for this facility, the site has potential for aquatic habitat creation in the drain, possibly integrated with water conveyance requirements. Groundwater is shallow in the vicinity and standing water was observed in the facility during our November 2018 and January 2019 site visits. This site was removed from the restoration alternatives considered because better potential sites are available, the site is owned by multiple jurisdictions, and USBWC does not have any ROW at this site. No formal conceptual restoration design was developed for this site. However, a site visit was conducted at this location during January 2019 and the results of that assessment are presented here.

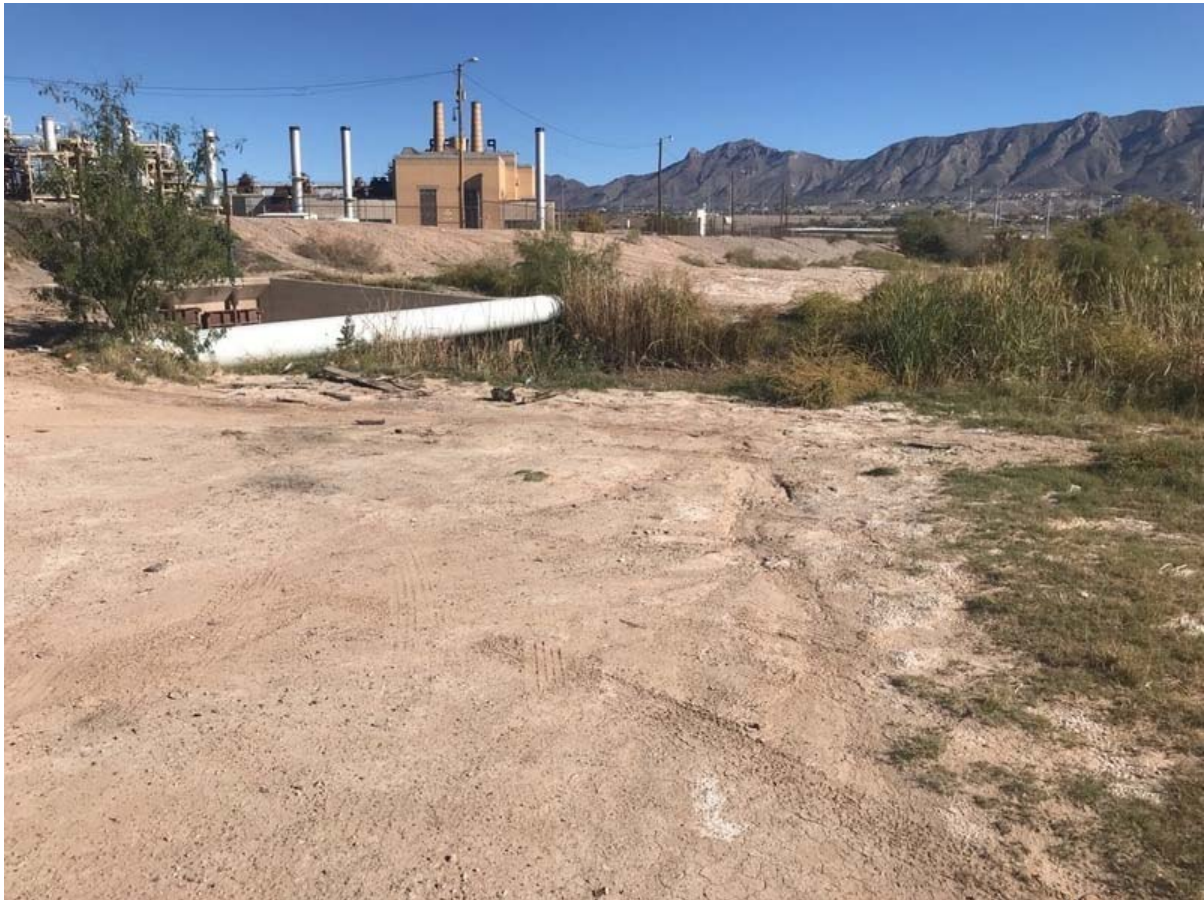
Figure 47. Field photo from EP Electric/Montoya Drain site confluence with the Rio Grande from the USIBWC floodplain.

The El Paso Electric/Montoya Drain site, near RM 2, is located near an electricity generation station (Figure 47). Numerous potential restoration approaches have been voiced by USIBWC, project partners, and other parties including excavation of wetland features along the river near the Montoya Drain outlet, integrating stormwater runoff with new wetland creation, and modifying the drain outlet to improve aquatic habitat quality. El Paso Water and El Paso Electric are considering new storm water catchments in a large open area on the northwest side of Montoya Drain. Due to land ownership complexities, multiple jurisdictions, limited USIBWC ROW, future levee improvements, and uncertain plans for future projects, this site was removed from consideration for this project. During the scoping meeting it was agreed that El Paso Electric and El Paso Water Utilities could collaborate with a third-party proponent (e.g. SWEC or another non-profit), in the future, possibly with USIBWC as a partner. Prior to eliminating this alternative, a rapid site assessment was conducted in January 2019 and observations are included below.

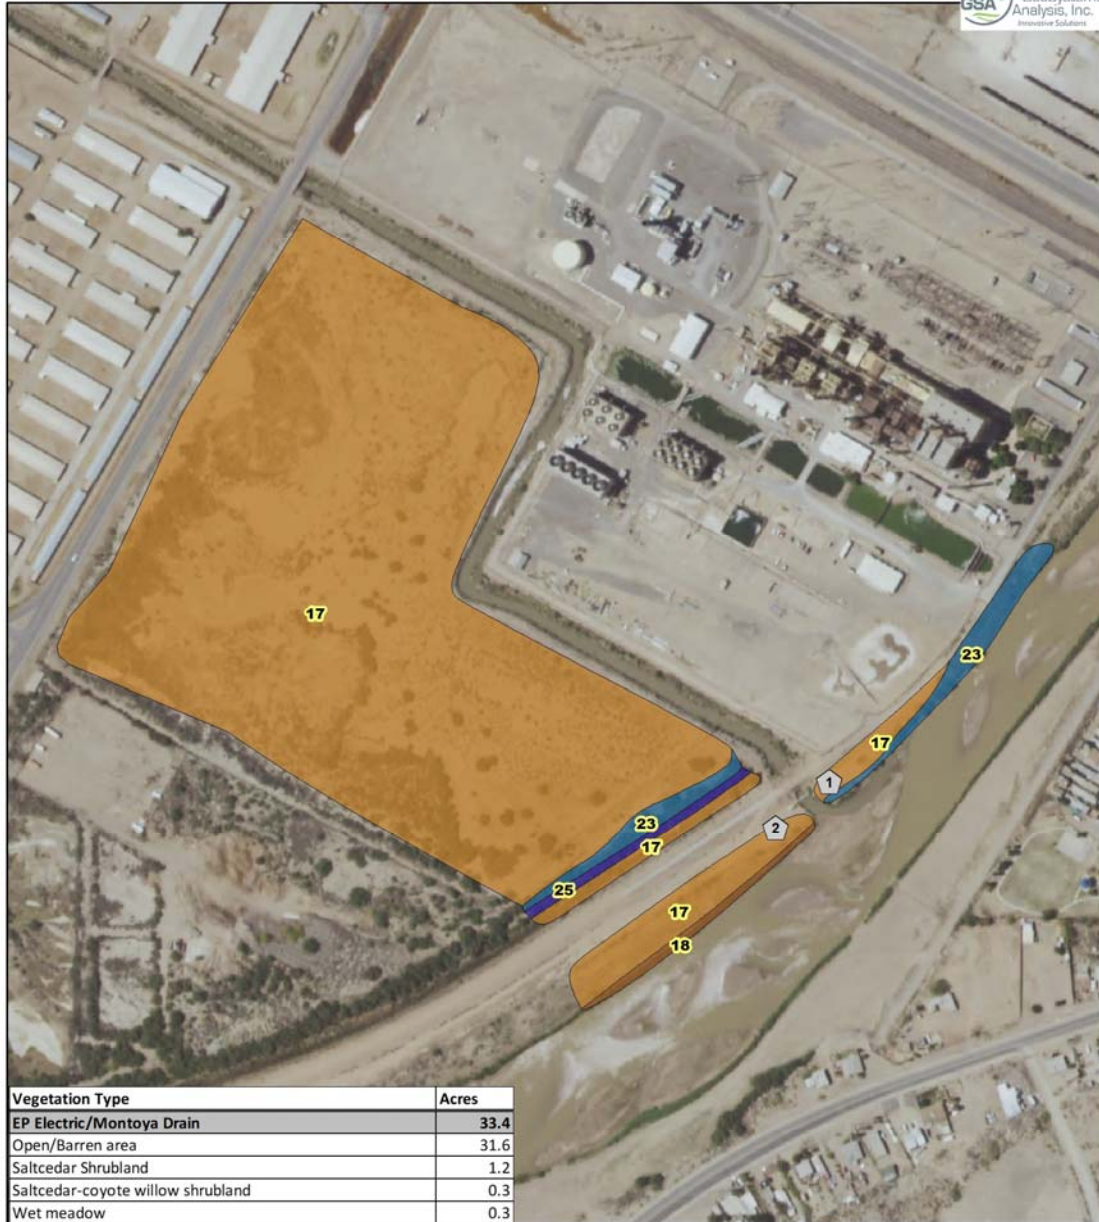
Figure 48. EP Electric/Montoya Drain site vegetation map.

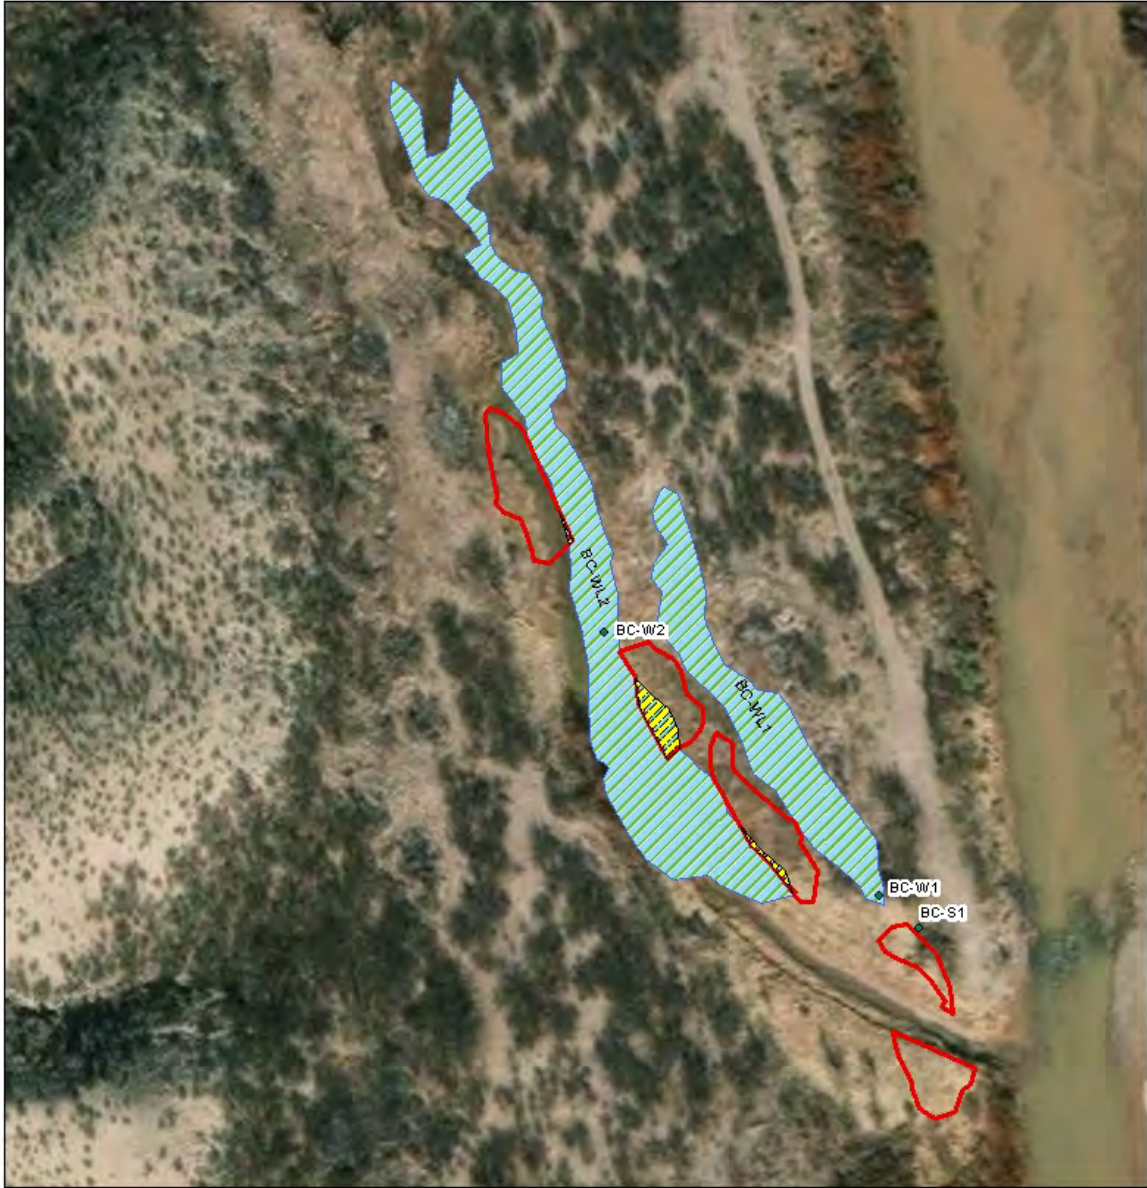
Wetland Findings at Broad Canyon

- ◆ Sample Locations
- ▨ Wetlands in Excavations
- ▭ Excavation Features
- ▨ Suspected wetlands outside excavations

Two potential jurisdictional wetlands were identified at the Broad Canyon site during the field assessment. Both wetlands occur adjacent to but not within the proposed embayments. The first wetland, BC-WL1, is approximately 0.15 acres present as a shallow depression laying between the bermed arroyo bankline and the adjacent sandy hills. Obligate species, such as cattail (*Typha domingensis*) and common threesquare (*Schoenoplectus pungens*) were present in the lowest most point of the depression, with the FAC species, saltgrass (*Distichlis spicata*) covering most of the depression. Cracked soil and salt deposits were present in the depression. Outside of the depression, the surrounding land was mostly covered with the FACU species, Bermudagrass (*Cynodon dactylon*). Per GSA 2019, the arroyo confluence inundates during moderate river flows and forms a backwater. Redox reactions were observed at one location assessed on the upland bench adjacent to the arroyo, though it is expected that inundation events occur only often enough to support wetland vegetation within the smaller depressed area mapped as the wetland.

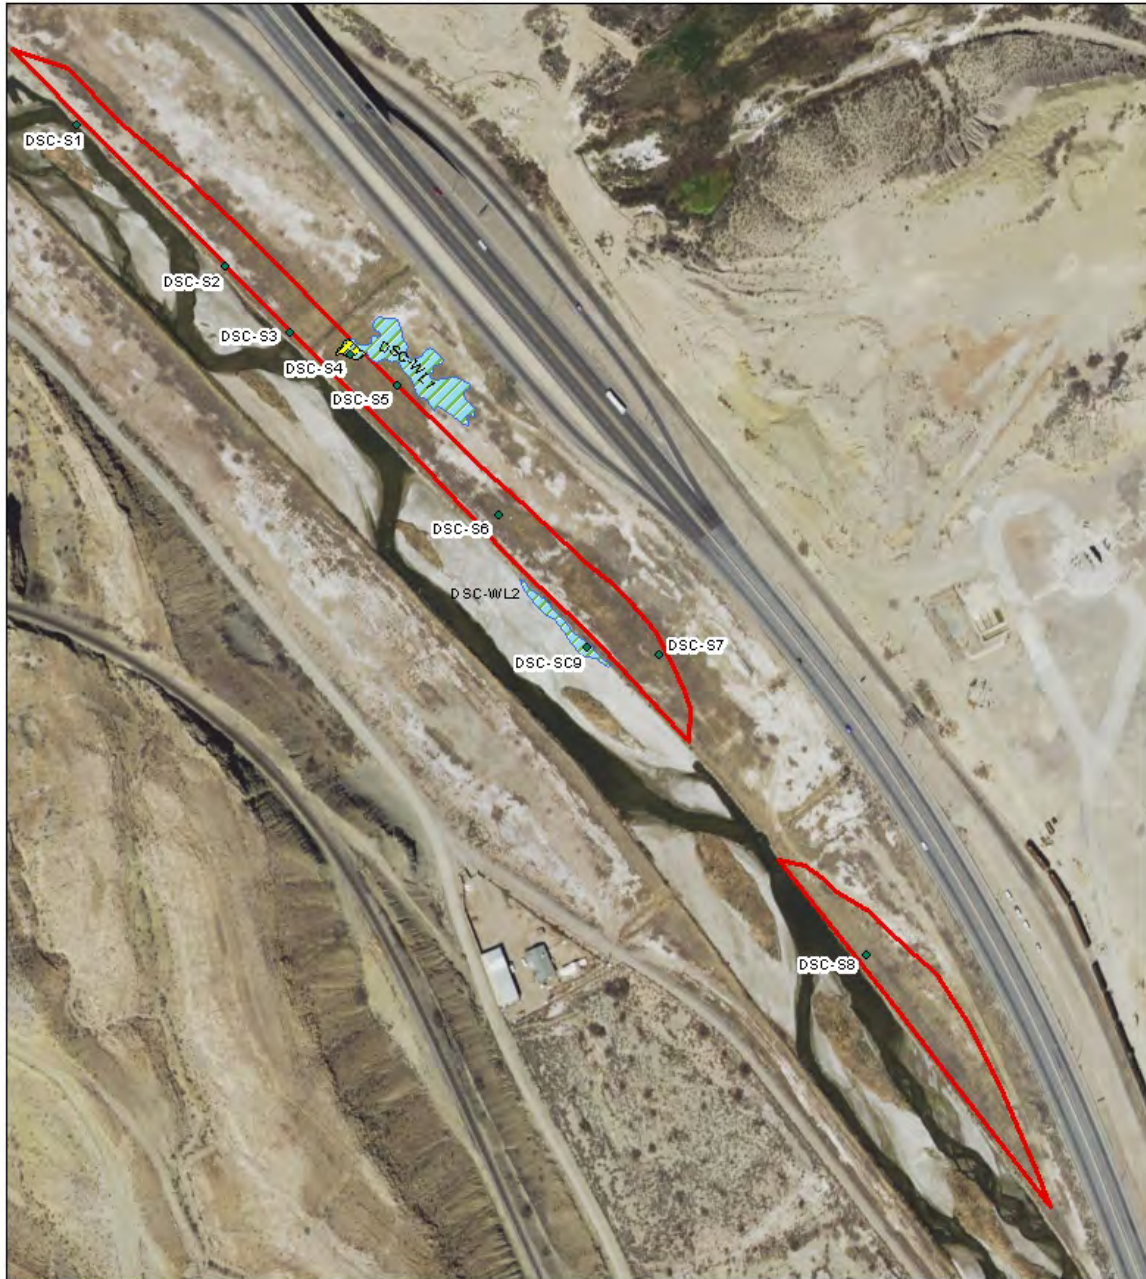
Wetland Findings at Downstream of Courchesne Gauge

- ◆ Sample Locations
- ▨ Wetlands in Excavations
- ▨ Suspected wetlands outside excavations
- ▭ Excavation Features

DSC-WL1 is an approximately 0.33-acre emergent wetland dominated by common threesquare, with some saltgrass and scratchgrass intruding from the adjacent meadow area, and small patches of common reed (*Phragmites australis*) are present. The wetland lies in a depressional surface lower in elevation than the surrounding saltgrass meadow. The hydrologic conditions in this wetland are strongly correlated with water released from the box culvert, adjacent to where a new trench to the river was recently dug. Ponded water was present in this wetland during site visits conducted prior to recent drainage modifications.

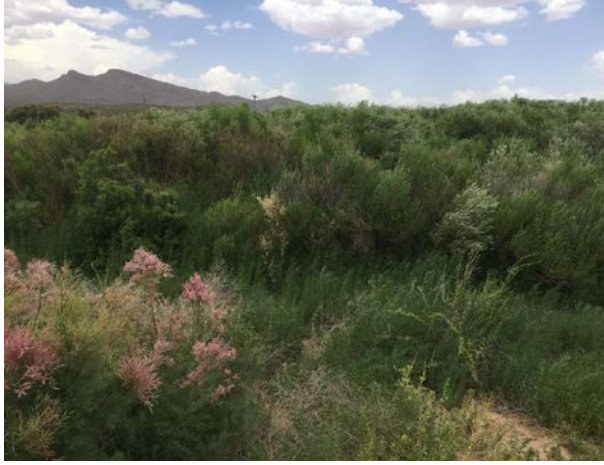
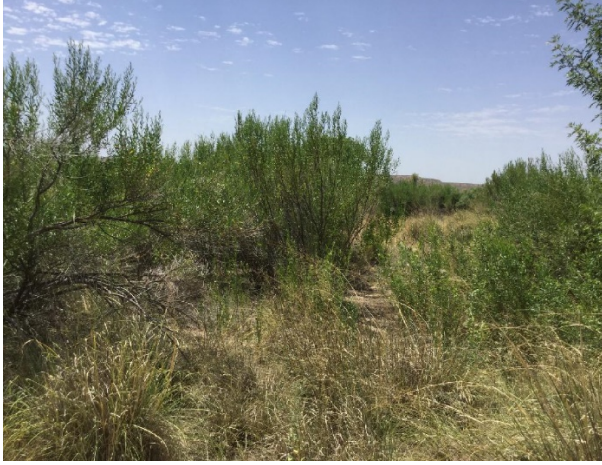
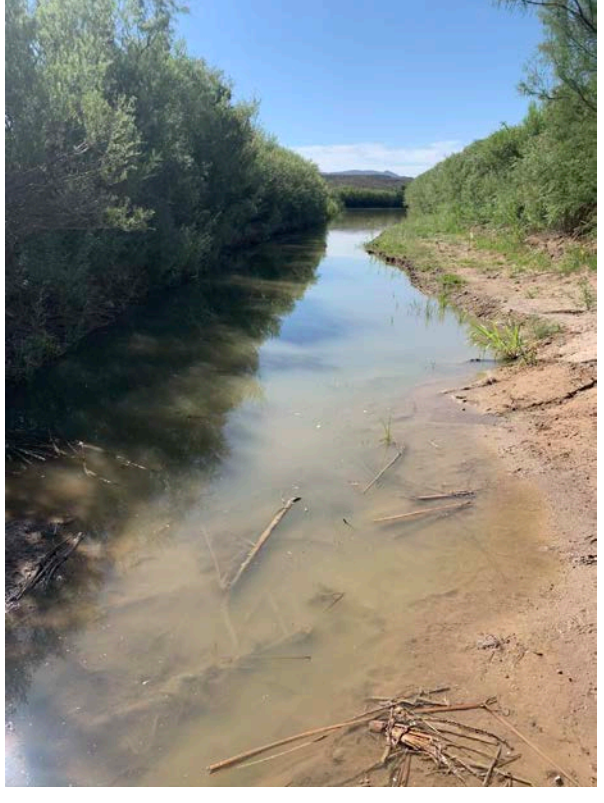
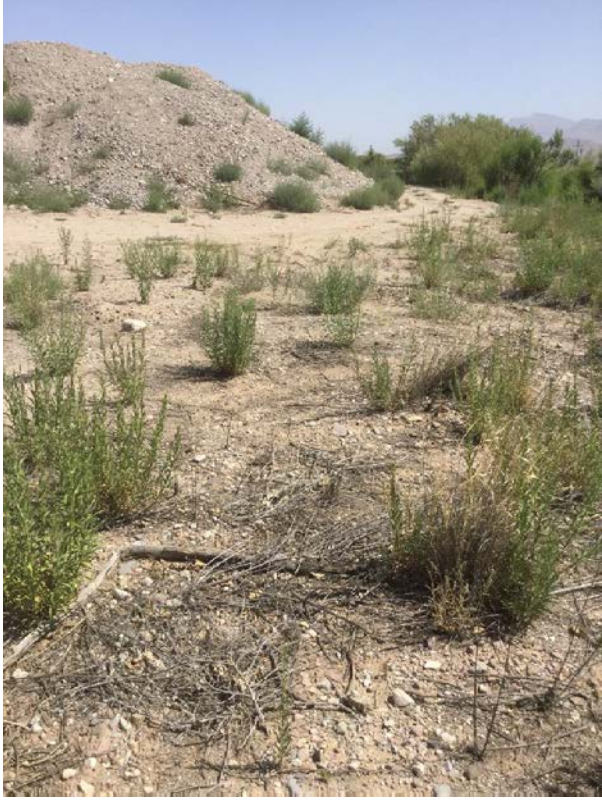
Figure 6. Representative photographs of the project site.

<p>a. Willow and baccharis are widespread across the southern half of the project site</p>	<p>b. A mosaic of native and non-native grasses and woody plants comprise the northern half of the floodplain</p>

<p>c. View of Trujillo Arroyo looking towards the Rio Grande.</p>	<p>d. A large spoil pile of cobble and gravel occupies the northern end of the project site.</p>

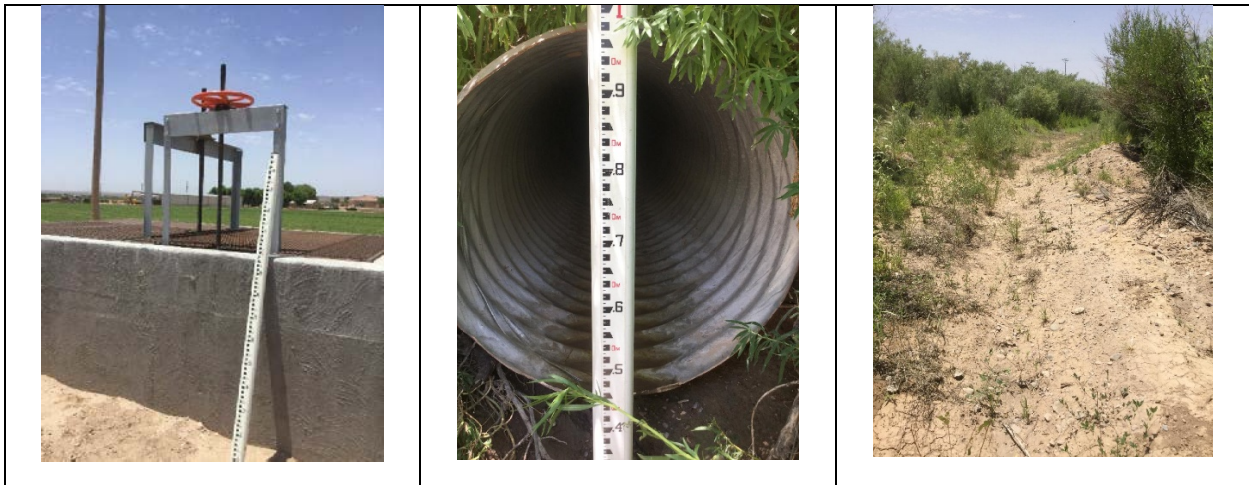
Figure 7. Photographs showing the irrigation turnout (left), 36" culvert (center), and excavated irrigation canal.

Supplemental Irrigation: A reconnaissance-level assessment of the excavated canal was conducted to get a general sense of the canal dimensions. A survey rod and level were used to approximate relative elevation differences between the excavated canal bottom, banks, and adjacent floodplain surface. Measurements indicate an average canal width of 15 feet (bank to bank) and bank heights of approximately 3 feet (**Figure 7**). The floodplain surface ranges between approximately 0.3-ft and 0.7-foot higher than the canal bottom. The canal “dead-ends” where excavated floodplain sediments were left in place. These observations indicate irrigation water released into the canal overtop the berms

once the canal is filled. The irrigation water then spreads across the floodplain as sheet-flow in a relatively non-uniform pattern and percolates into the alluvial aquifer.

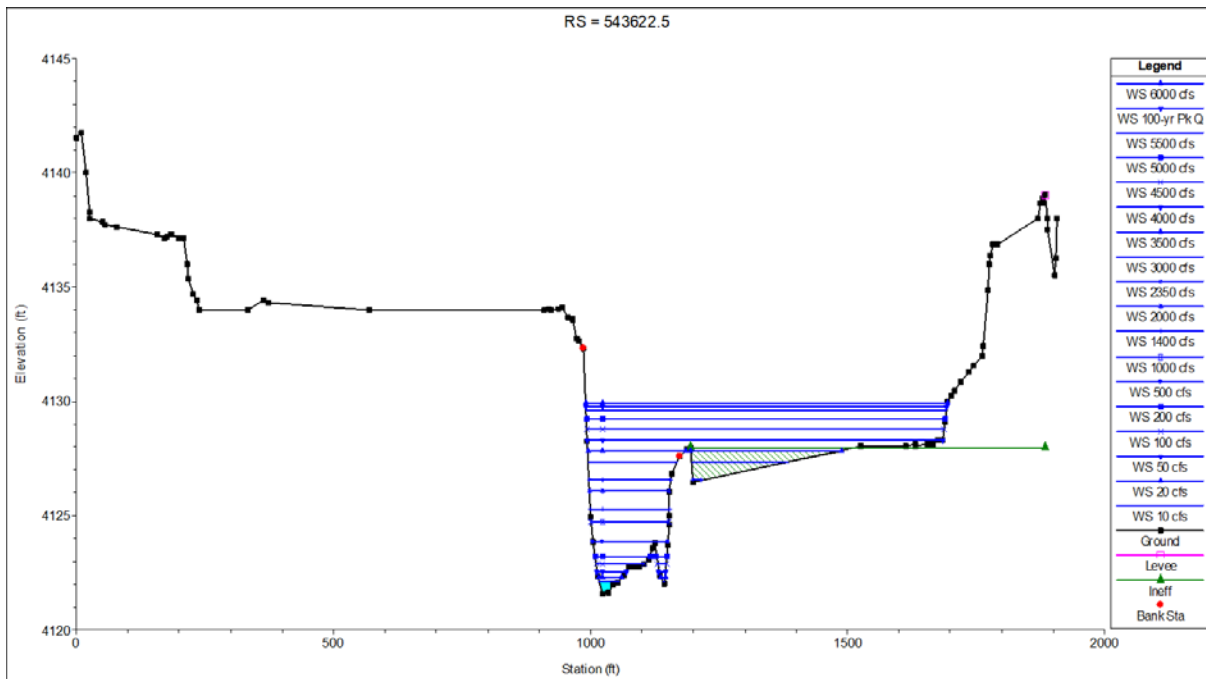
Figure 10. Cross-section generated from the USACE HECRAS Model showing predicted surface water elevations in relation to different Rio Grande discharge levels. This is the upstream most cross-section below Trujillo Arroyo and is oriented west-east (i.e., facing upstream).

River/Surface-Water Hydrology: The existing HEC-RAS 1-D hydrodynamic model developed by the Corps (USACE 2009) was used to evaluate predicted surface water elevations at different river discharges in relation to riverbank height at the project site. The model predicts that flows are bankfull at approximately 2,500 cfs to 3,500 cfs (**Figures 10-12**). The model also indicates the bank elevation is approximately 1-2 feet above the adjacent floodplain at cross-section (XS) 543622.5 (**Figure 10**) and XS 542906.1 (**Figure 11**). Data from XS 543406.4 (**Figure 12**) indicates the ground elevation at this location continuously increases between the bank and the floodplain.

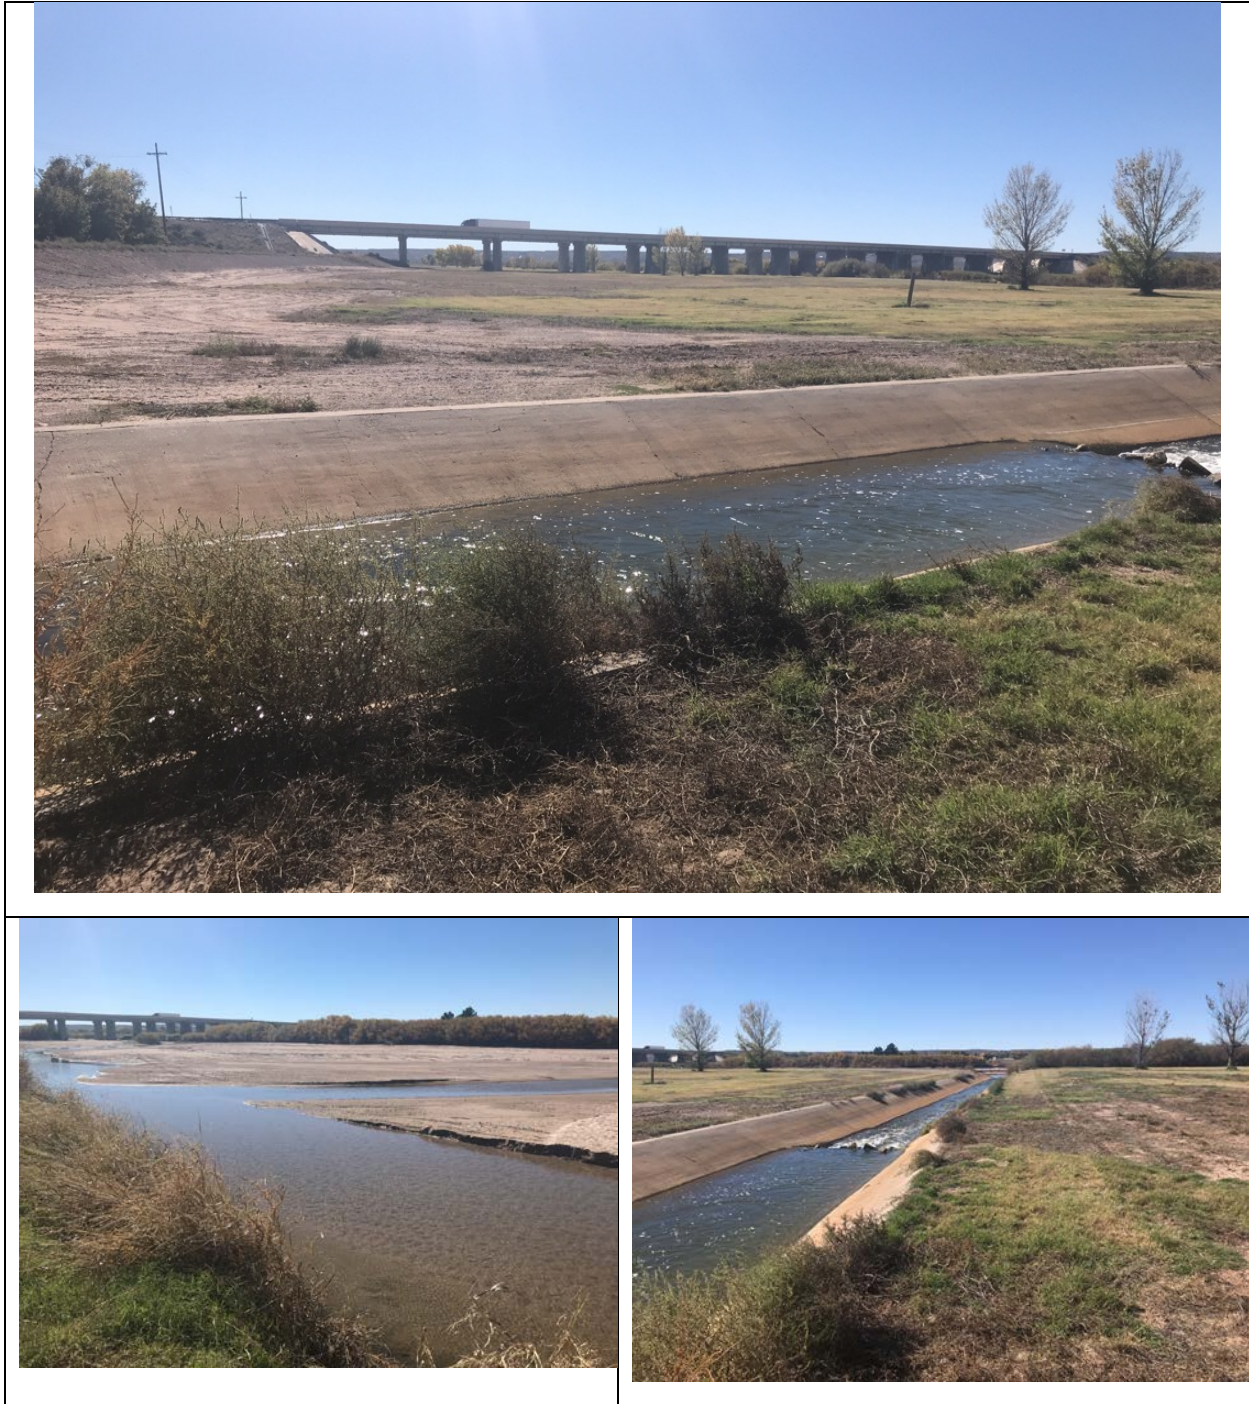
Figure 14. Representative field photos from the Las Cruces Effluent site. Top: Looking downstream across effluent discharge canal with adjacent eastside floodplain where constructed canal is proposed. Bottom left: Rio Grande downstream of the effluent canal. Bottom right: Effluent discharge canal flowing towards Rio Grande.

The Las Cruces Effluent site lies on the east side of the Rio Grande near RM 44. Interstate 10 crosses the Rio Grande near the site (**Figure 14** & **Figure 15**) and the Las Cruces wastewater treatment plant is east of the project area. The wastewater facility discharges about 8 million gallons of water per day (constant discharge of approximately 5 cfs) and effluent passes directly to the river via a concrete lined canal (**Figure 14**). Effluent creates perennial flow in this segment in the Rio Grande that often extends for 2 to 3 river miles through Mesilla Valley State Park before completely seeping into the riverbed. The site is near La Llorona Park and paved walking trails support regular recreation. Propst and Bixby (2018) provide multiple habitat restoration design alternatives that include using effluent discharge to create a new channel or oxbow lake in the east-side floodplain.
