***Rio Grande Canalization Project Aquatic
Habitat Restoration Site Alternatives and
Conceptual Designs***

*Prepared for:
United States Section
International Boundary &
Water Commission and Gulf
South Research Corporation*

*Prepared by:
GeoSystems Analysis
3150 Carlisle Blvd. NE,
Albuquerque, NM 87110
www.gsanalysis.com*

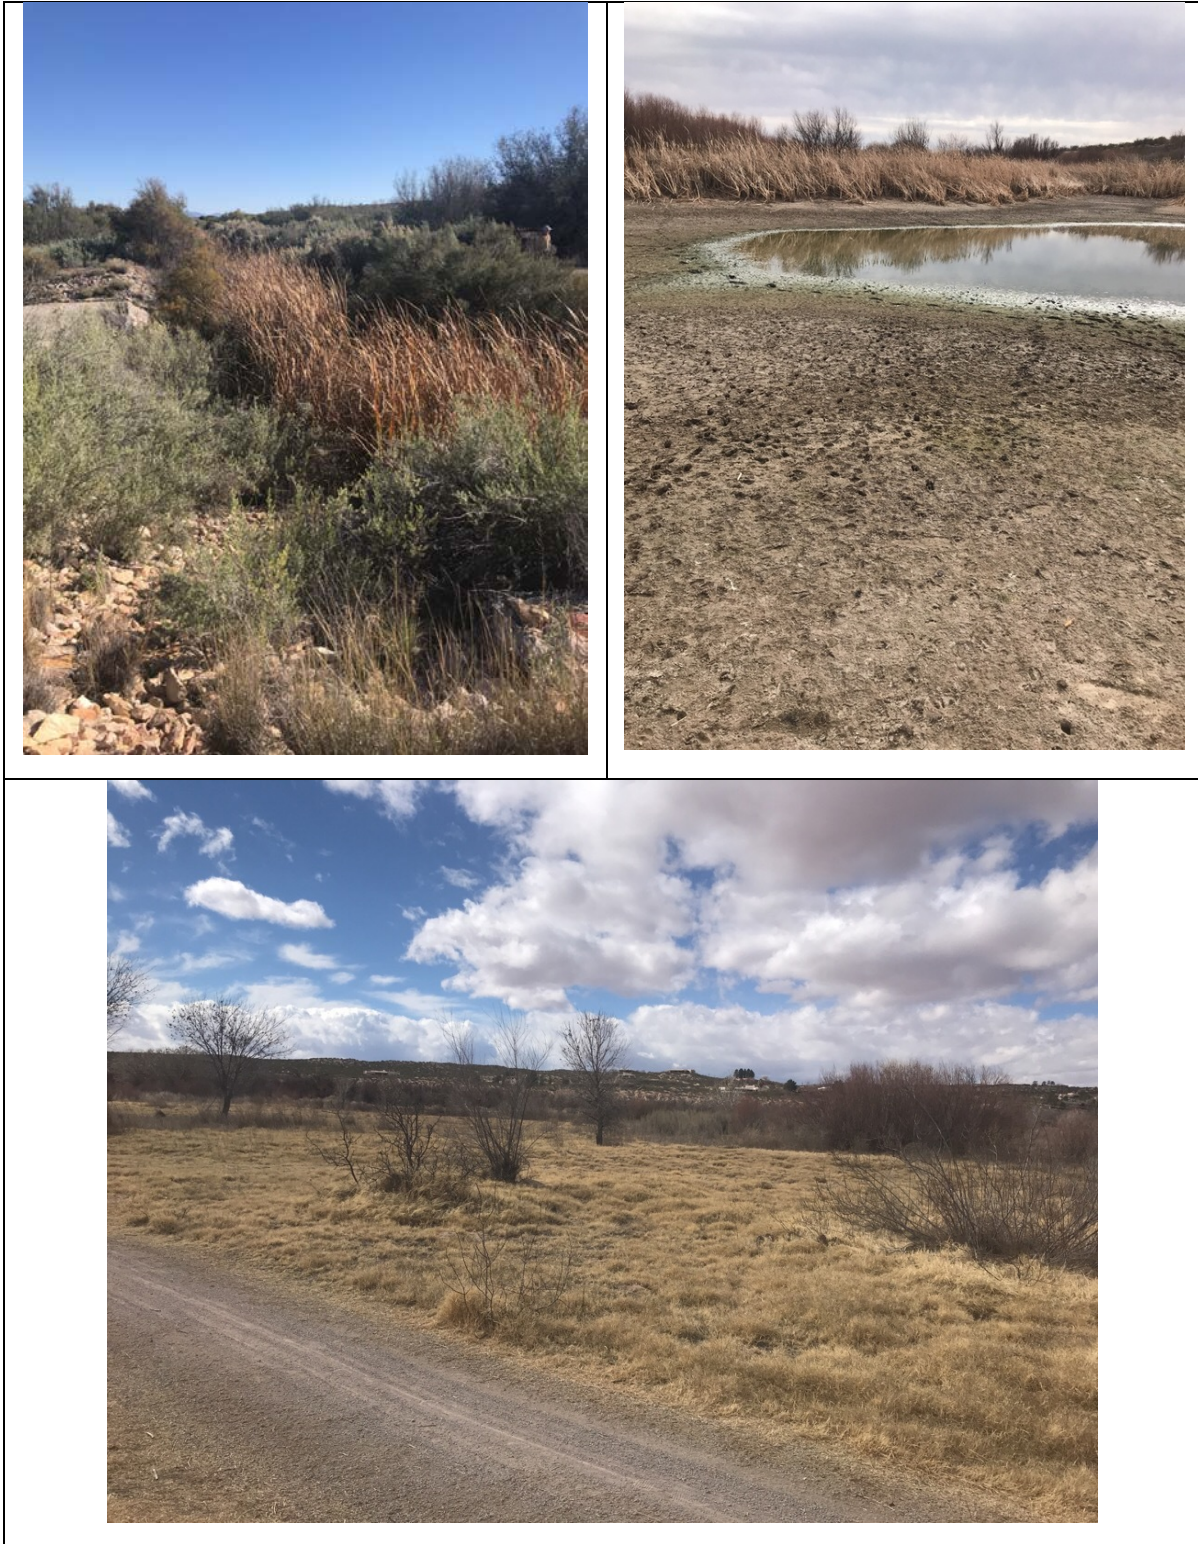
Figure 17. Representative field photos from the Mesilla Valley Bosque State Park site. Top left: Picacho Drain looking downstream from USIBWC levee. Top right: lower (wetter) resaca pond nearly entirely dry. Bottom: site conditions near proposed channel.

Mesilla Valley Bosque State Park (MVBSP), near RM 41, was established in 2005 (Blue Earth 2008). The Park is located on the west side of the Rio Grande near the Town of Mesilla, NM and has been the focal point for other restoration efforts over the past two decades. For example, the Picacho Wetland project was constructed by the Southwest Environmental Center (SWEC), the City of Las Cruces, EBID, and other partners between 2002 and 2005 on a 55-acre tract of land within the Park managed by the New Mexico Department of Game and Fish (NMDGF) (Blue Earth 2008). That project involved excavating two ponds to create aquatic/wetland habitat along the Picacho Drain. A 3-acre pond was excavated to a depth of 8 feet with hopes that it would contain perennial surface water to provide year-round aquatic habitat for a variety of species. The deeper pond contains two trenches that connect with the Picacho Drain which allows water to flow between the ponds, the drain, and the Rio Grande. A shallower, adjoining 2-acre pond connects with the deep pond via a culvert and fills when flows in the river are high, thus functioning as a seasonally flooded meadow. Due to a combination of lower groundwater conditions and sedimentation, the "perennial" pond no longer holds water during droughts and both ponds are being invaded by cattail (**Figure 17**).

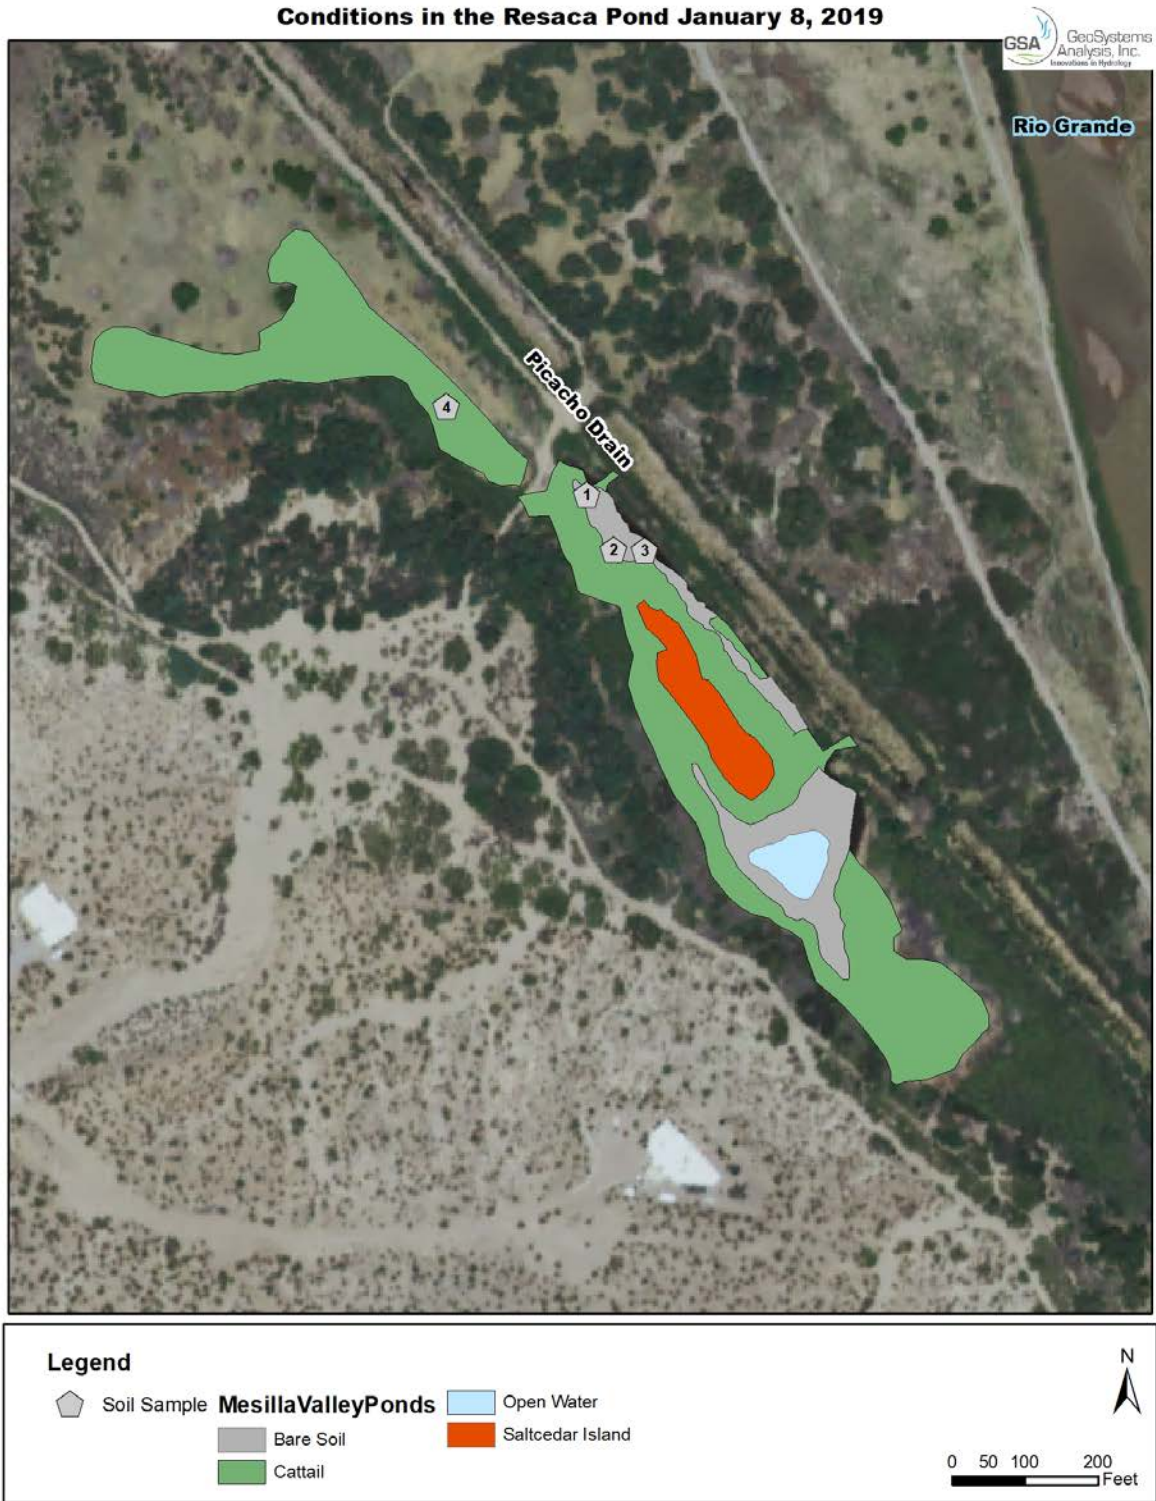
Figure 19. Map showing the condition of the resaca ponds during our January site visit.

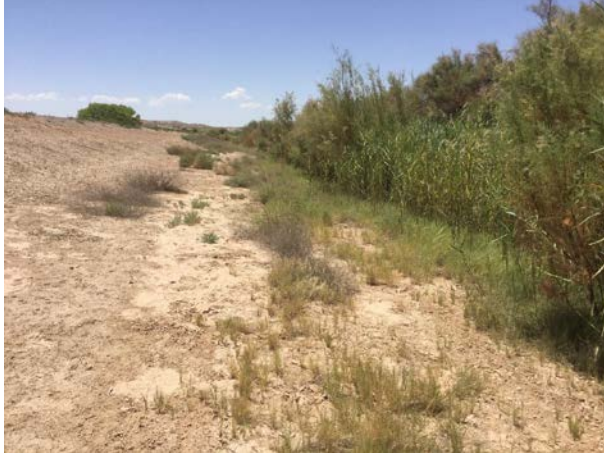
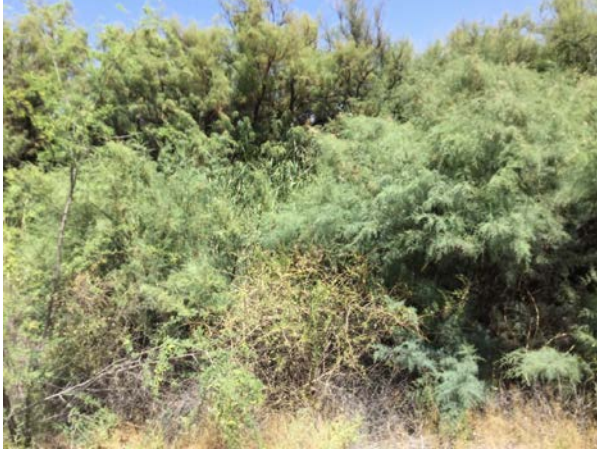
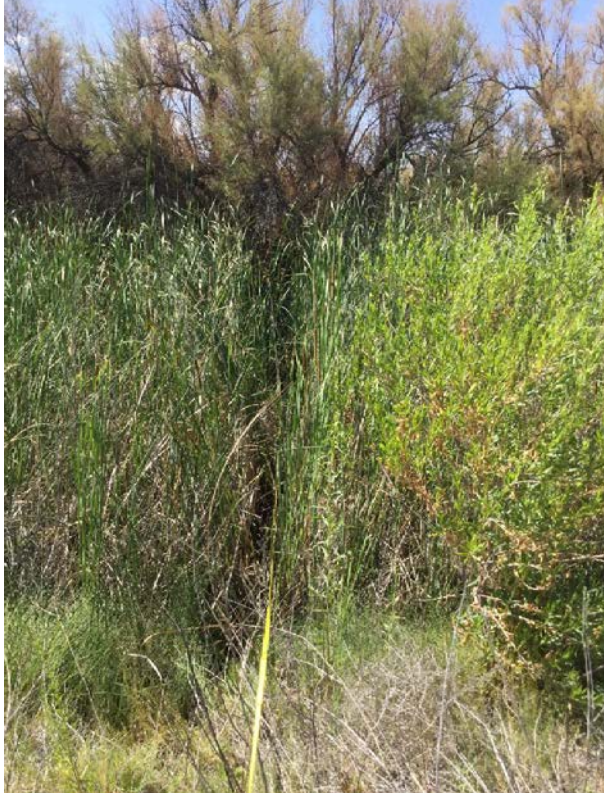
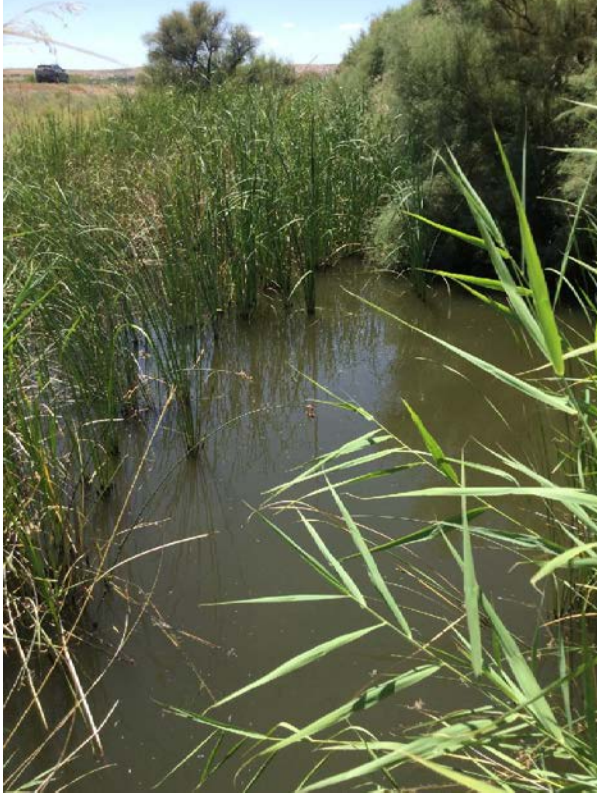
Figure 21. Representative photographs of the Montoya Intercepting Drain site

<p>a. Photo from approximate levee toe looking upstream</p>	<p>b. Dense saltcedar lines the entire north bankline of the MID</p>

<p>c. Looking north from the levee toe through the cattail to the saltcedar on the opposite MID bankline.</p>	<p>d. Small pockets of open water are found close to the culverts where water levels are relatively deep.</p>

On July 8, 2020 GSA performed a site assessment of the MID between the Montoya C Wasteway and the Montoya Drain. The site assessment focused primarily on vegetation mapping and reconnaissance-level topographic assessments of the MID and associated infrastructure (i.e., culverts, weirs, etc.). The objective was to use these data to inform opportunities and constraints for aquatic habitat enhancements along the 1.5-mile section of MID owned by USIBWC. To aid discussion we divide this 1.5-mile section into three half-mile segments: Segment 1 extends from the Montoya C Wasteway to Sunland Park Road; Segment 2 extends from Sunland Park Road to Racetrack Road; Segment 3 extends from Racetrack Road to the Montoya Drain. Representative photographs of the site are provided in **Figure 21**.

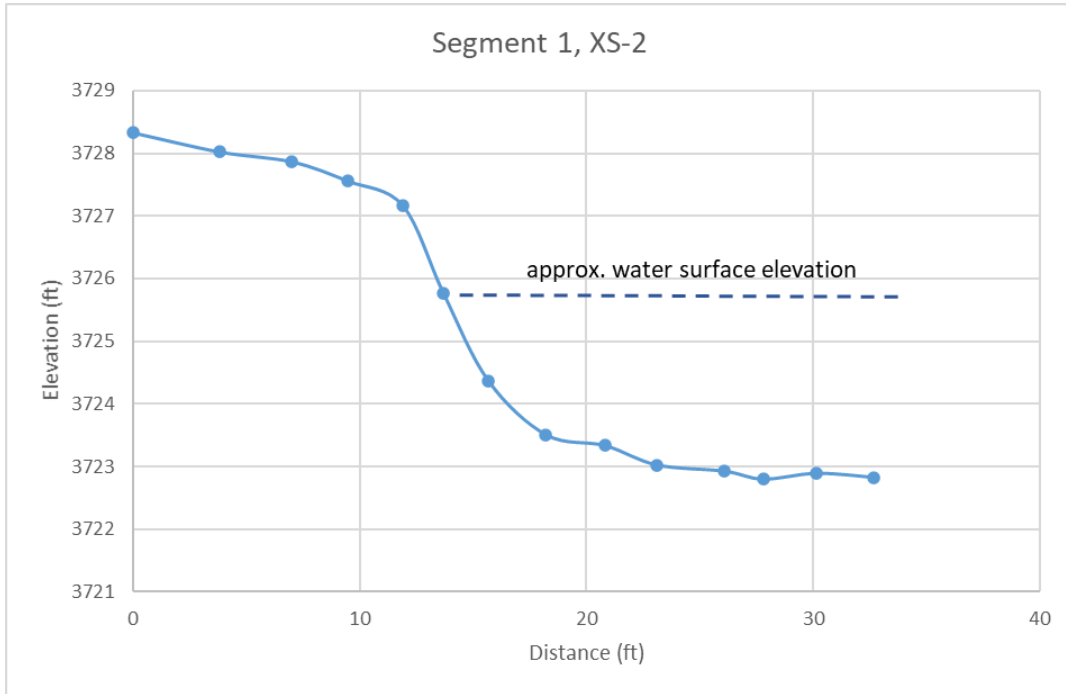
Figure 24. Elevation profile of XS-2, Segment 1. The distance stations displayed along the x-axis extend from left (station 0-ft) to right, facing upstream. Poor satellite coverage precluded extending this cross-section across the entire width of the MID.

MID Geometry: Eight topographic cross-sections were established along the 1.5-mile length of the MID using a Real-Time Kinematic (RTK) global positioning system (GPS). The cross-section locations displayed in **Figures 23 thru 30**. A GPS point was recorded approximately every two feet along each cross-section line. Due to access constraints on the north side of the irrigation drain, the start of each cross-section (i.e., the 0-meter mark along the transect tape) was always on the south (levee) side of the drain. All three cross-sections in Segment 1 (**Figures 23-25**) span only to the approximate center of the MID due to poor satellite configuration, but the other five cross-sections (three in Segment 2 and two in Segment 3) span the entire MID width (**Figures 26-30**). The wetted width at the cross-sections in Segments 2 and 3 range from approximately 35-feet and 50-feet. Water depths during the July 8 site assessment averaged between approximately 2.5 and 3.5 feet in Segments 1 and 2 and between 1.0 and 2.0 feet in Segment 3. Dense saltcedar vegetation along the steep north/east bank restricted access to the north bankline terrace in all locations except at XS-7 in Segment 3 (**Figure 29**).

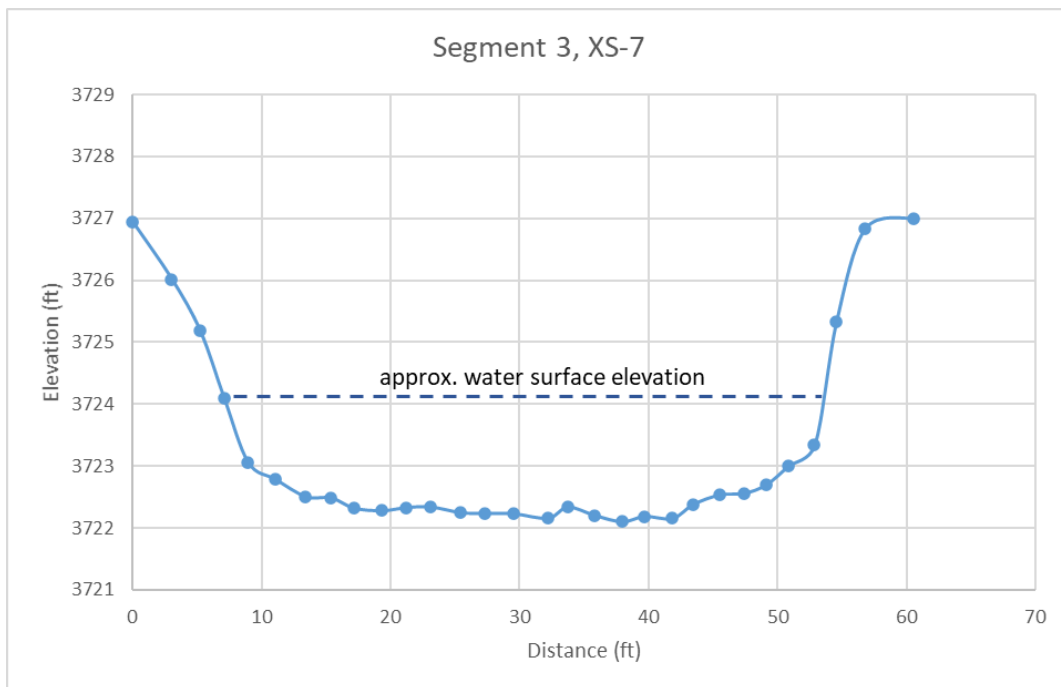
Figure 29. Elevation profile of XS-7, Segment 3. The distance stations displayed along the x-axis extend from left (station 0-ft) to right, facing upstream.

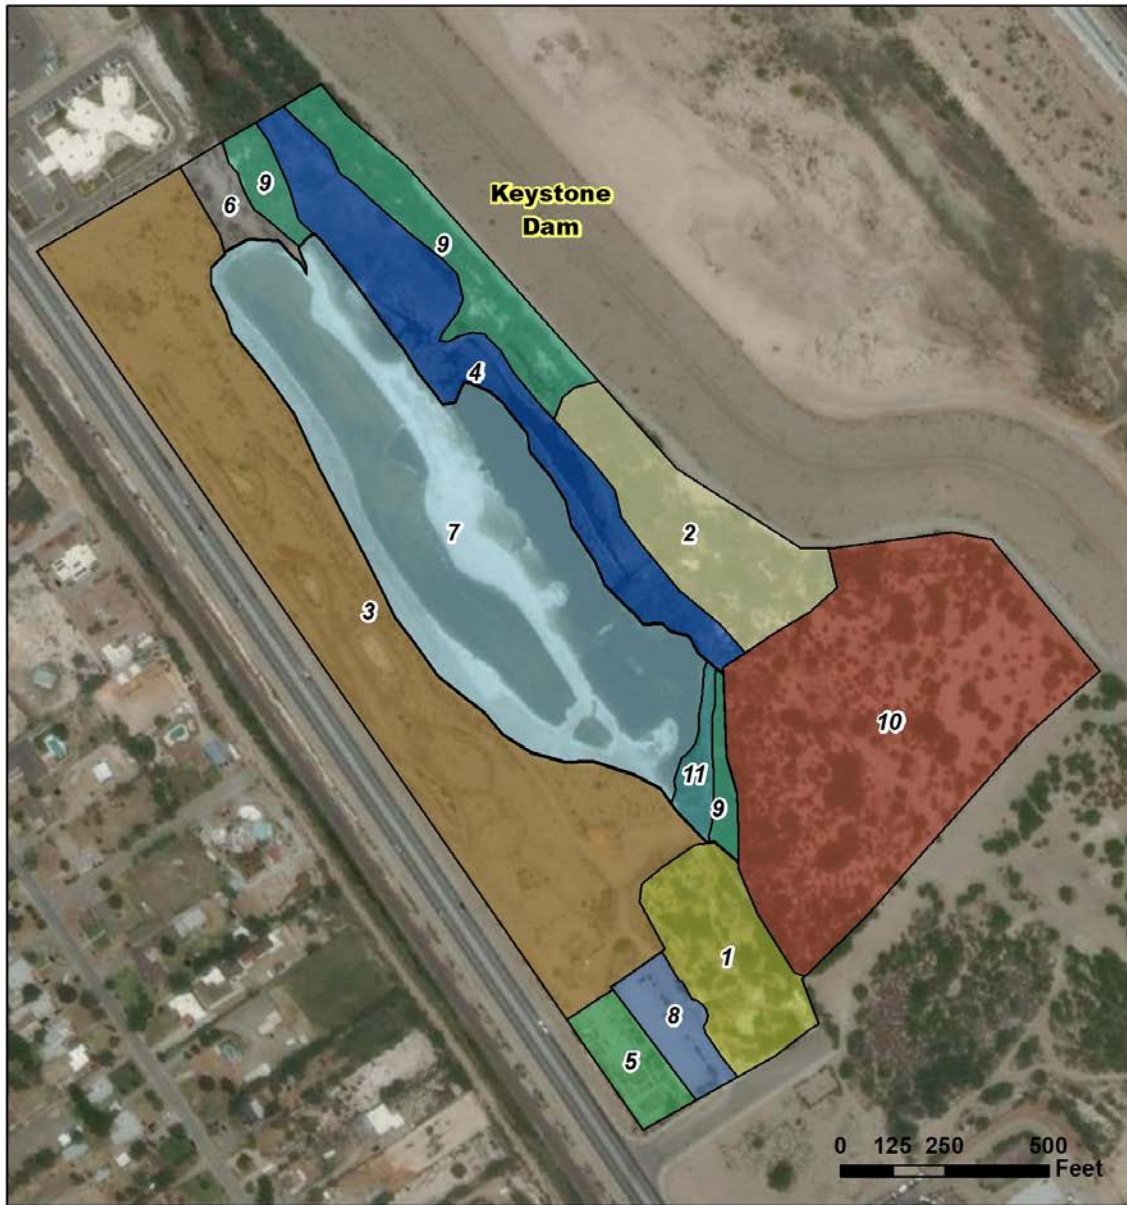
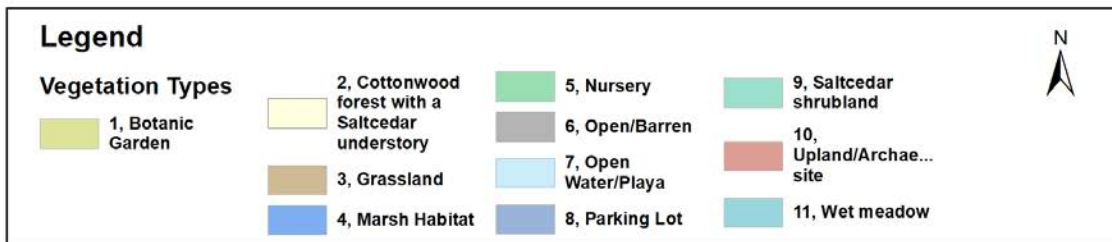
Figure 33. Current vegetation map of the Keystone Heritage Park.

Figure 33. Current vegetation map of the Keystone Heritage Park. 49

Although GSA did not return to KHP after the July 1, 2020 site visit, we have used information from previous site visits to develop a preliminary map showing vegetation conditions on the property (**Figure 33**) and plant species list (**Appendix A**).

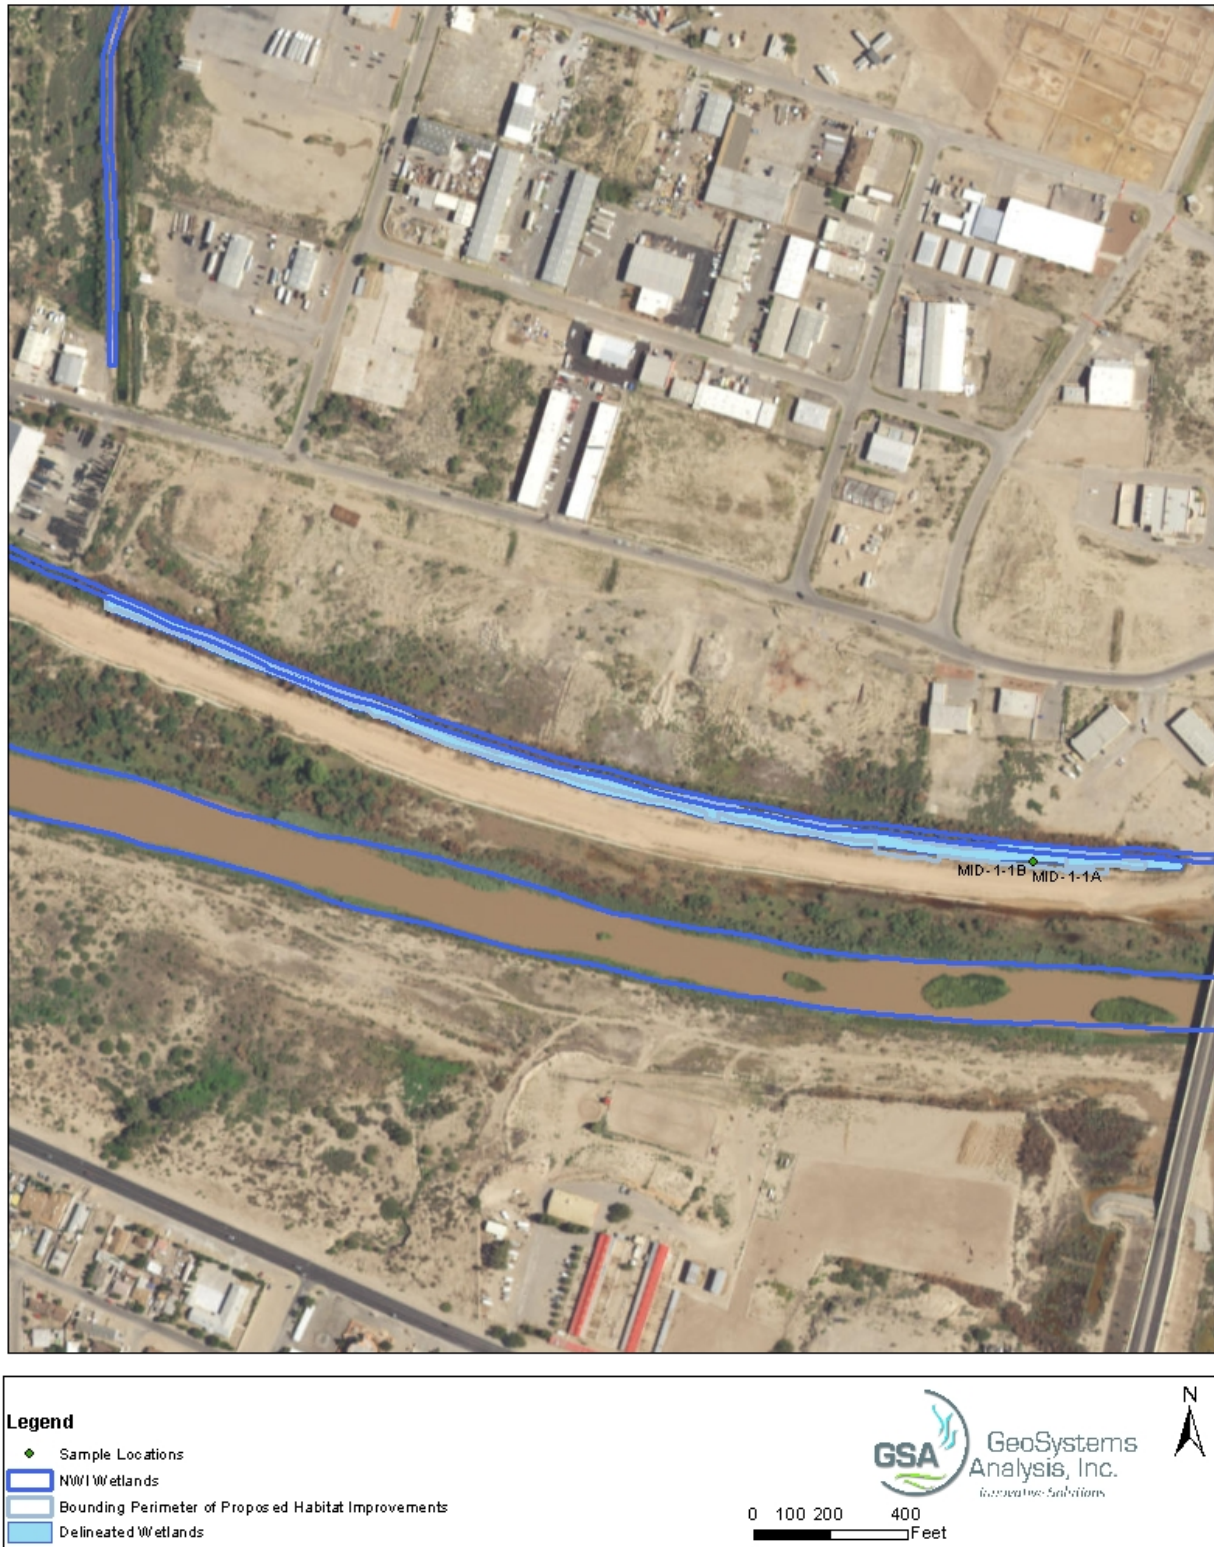
Wetland Findings at Montoya Intercepting Drain (MID-WL 1)

Figure 2. Sample locations and wetland delineation boundaries at MID-WL 1

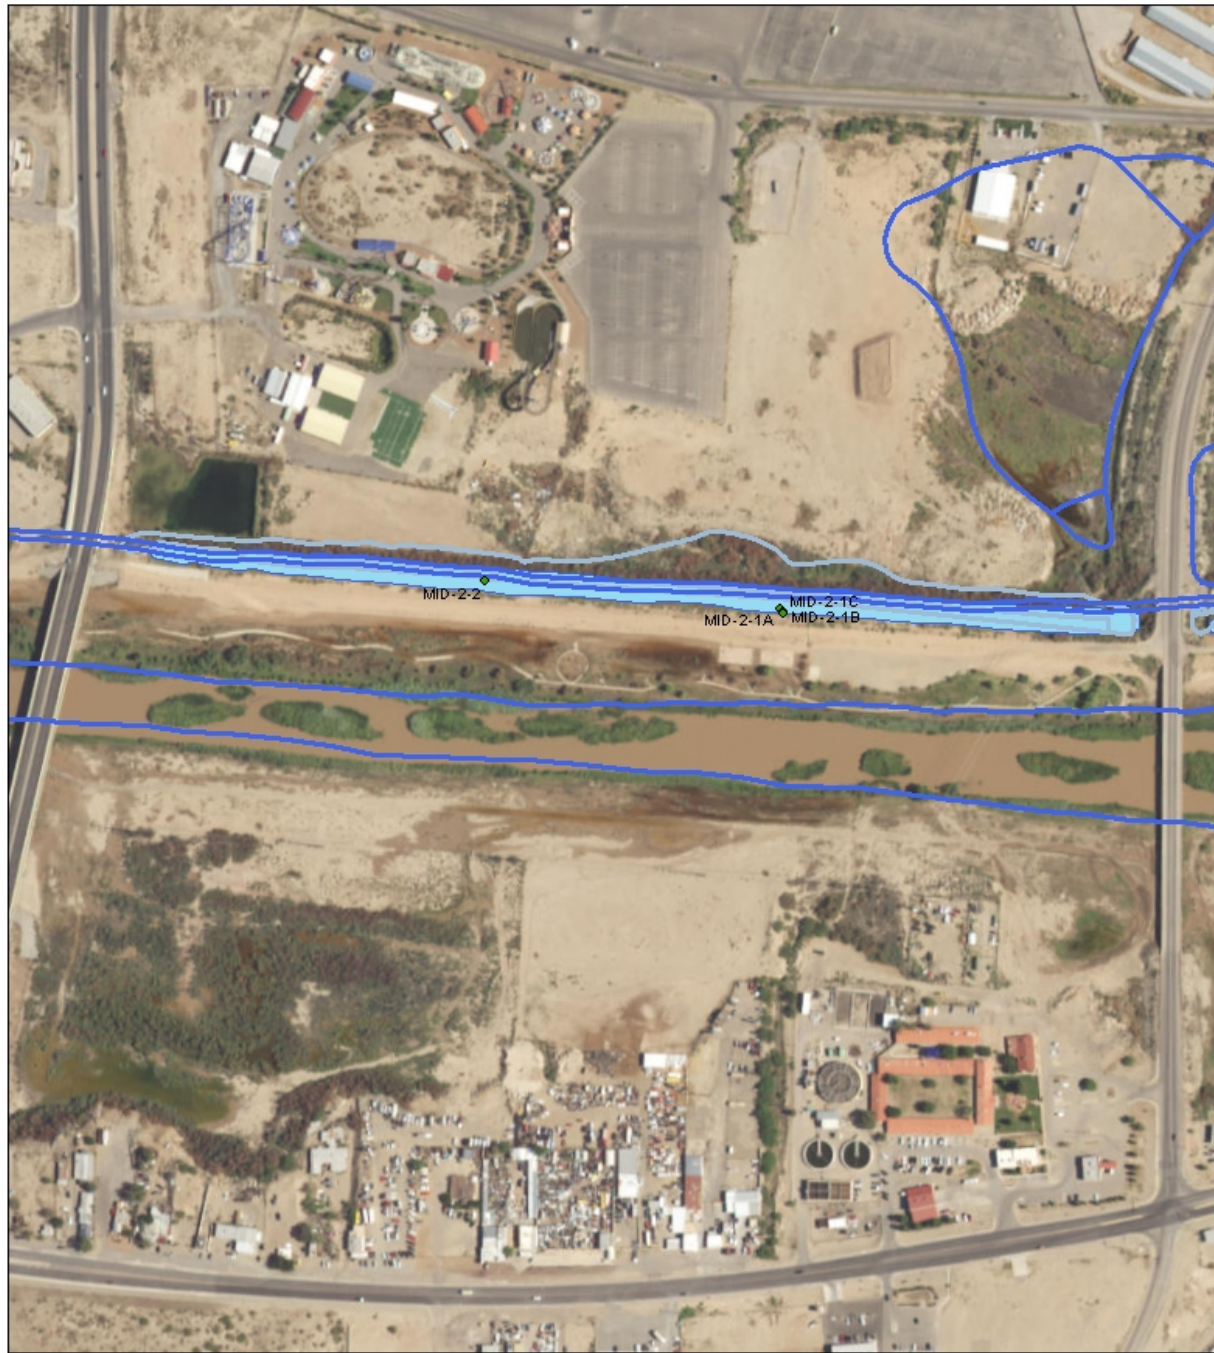
Wetland Findings at Montoya Intercepting Drain (MID-WL2)

Figure 3. Sample locations and wetland delineation boundaries at MID-WL 2

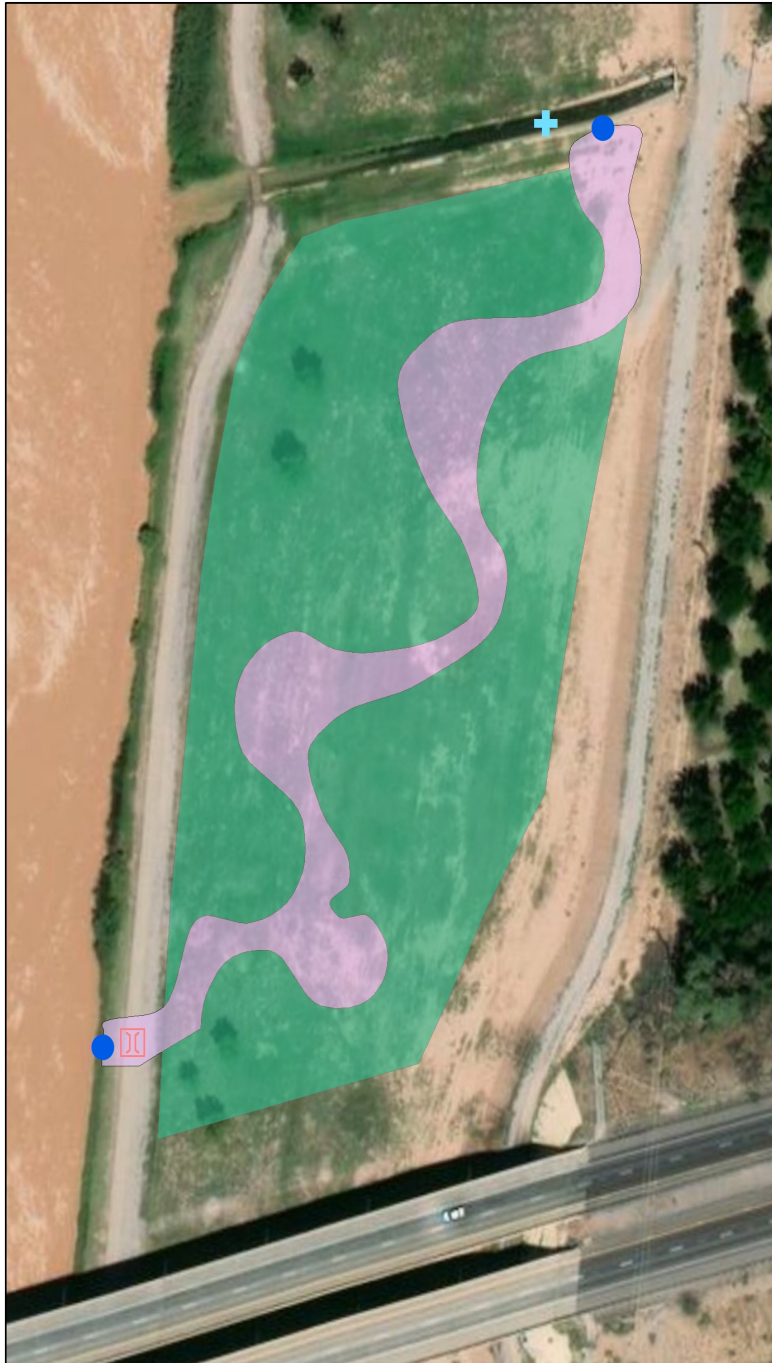
Exhibit 5. Las Cruces Effluent Conceptual Design

1. Construct meandering clearwater channel
2. Install selective fish passage structure
3. Install flow monitoring stations, pedestrian bridge, and pump
4. Plant cottonwood-willow in surrounding riparian enhancement area
5. Plant wetland plugs in channel
