Updated Biological Assessment for Long-Term River Management of the Rio Grande Canalization Project

**United States Section
International Boundary and Water Commission
4171 N Mesa St., Suite C310
El Paso, TX 79902**

Prepared by: ***IDEALS-AGEISS, LLC***

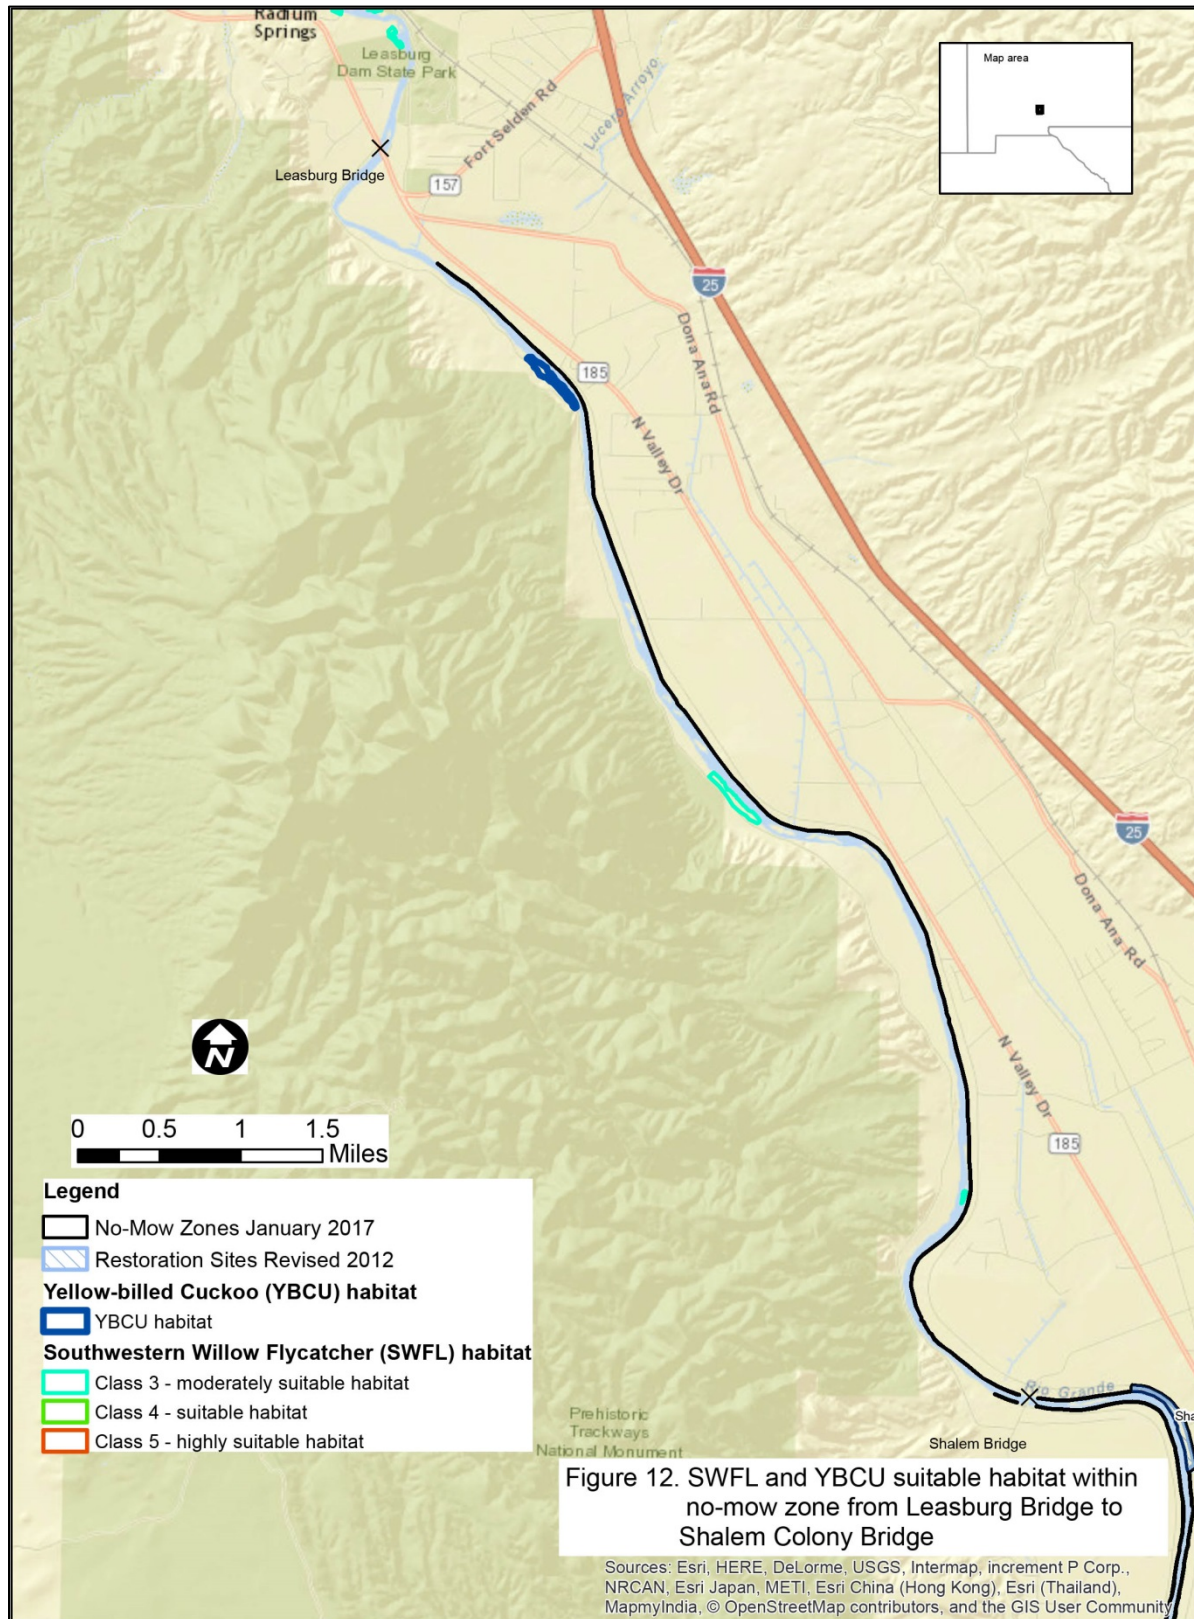
Figure 12. SWFL and YBCU Suitable Habitat within No-Mow Zones from Leasburg Bridge to Shalem Colony Bridge

Within the Las Cruces reach, the only identified area with potential YBCU habitat is protected by the No-Mow Zones on the eastern side of the river. However, the western side is only covered by the Pre-ROD No Maintenance Zones (Figure 12).

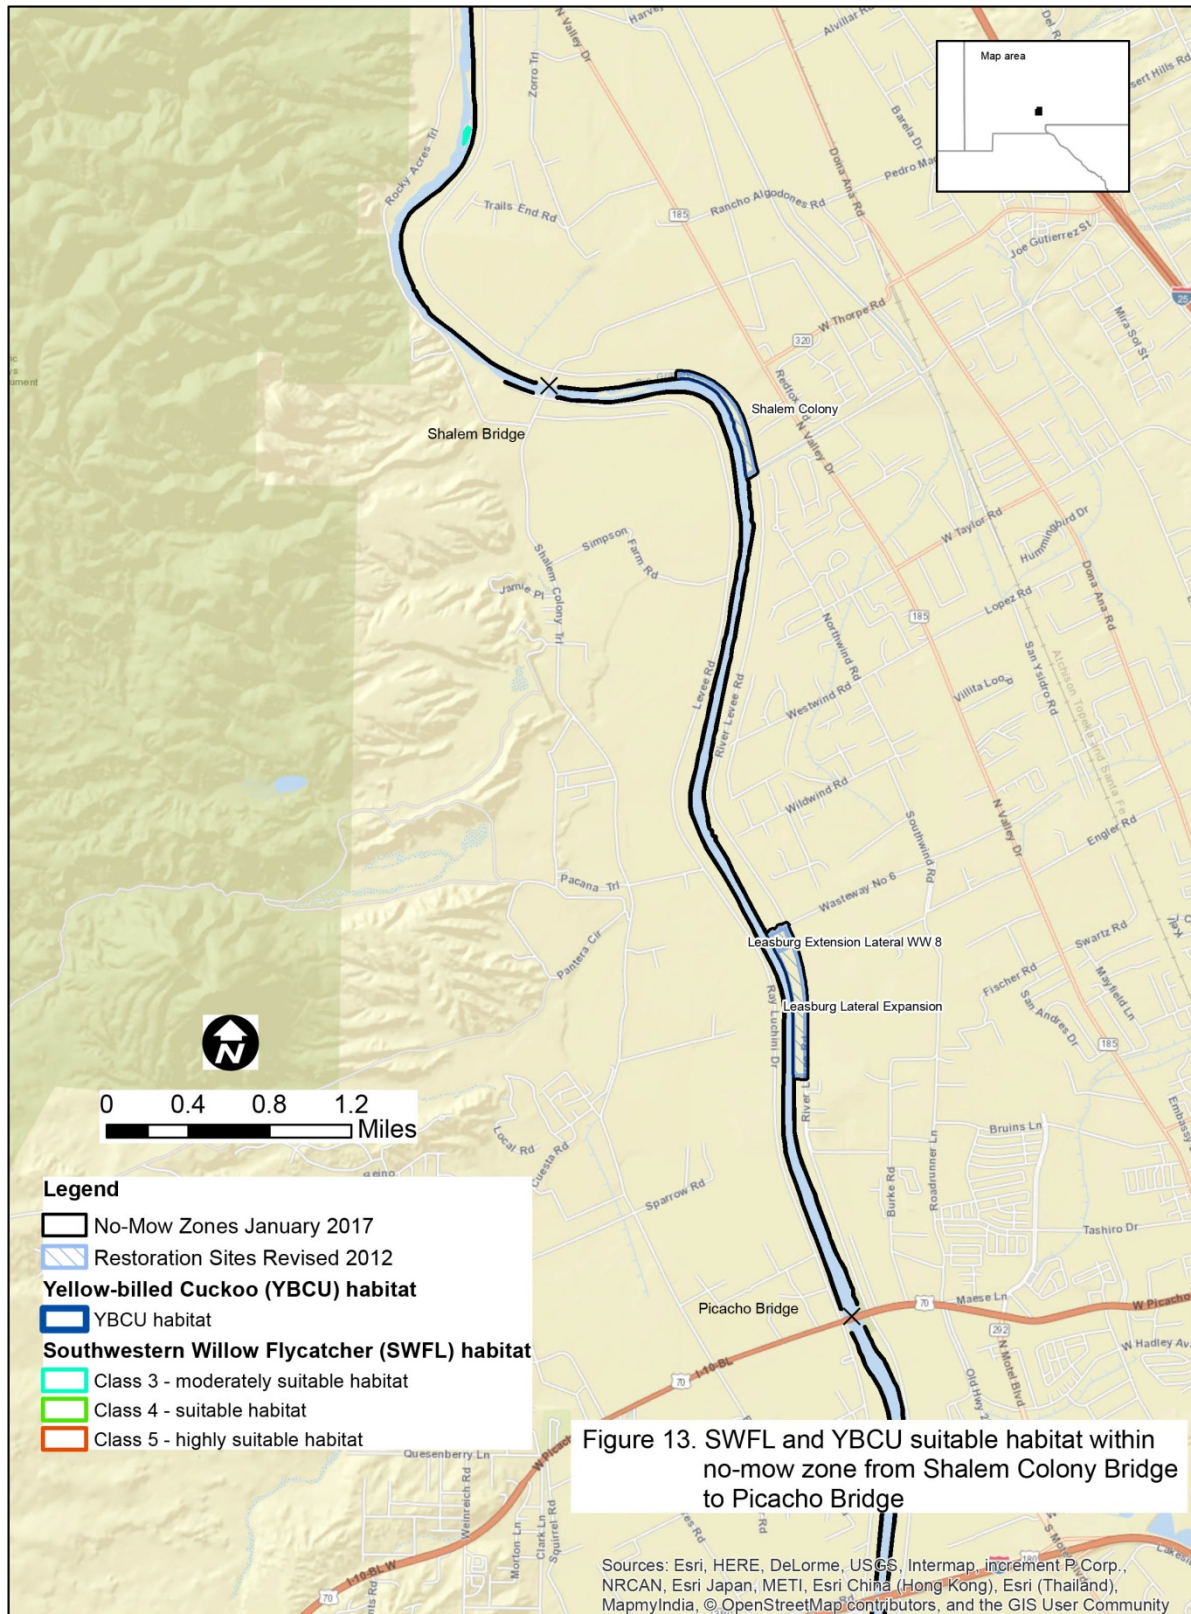
Figure 13. SWFL and YBCU Suitable Habitat within No-Mow Zones from Shalem Colony Bridge to Picacho Bridge

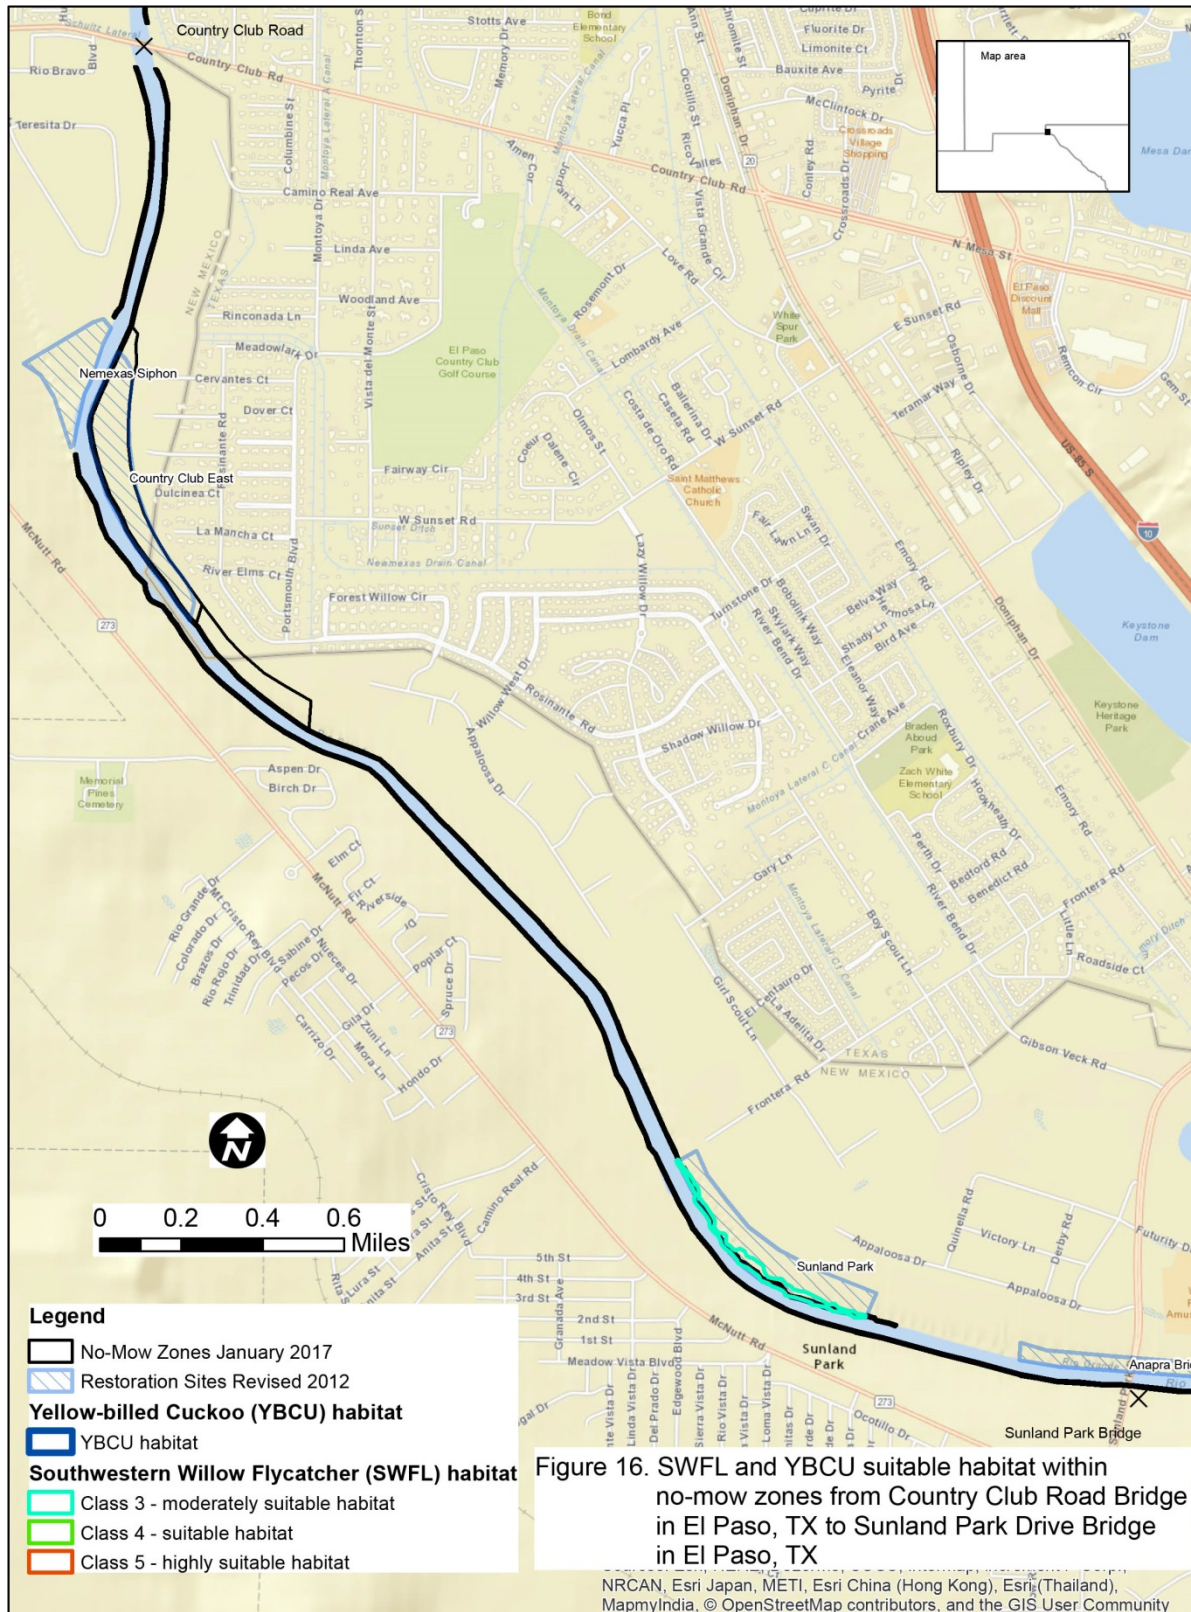
Figure 16. SWFL and YBCU Suitable Habitat within No-Mow Zones from Country Club Road Bridge in El Paso, TX to Sunland Park Drive Bridge in El Paso, TX

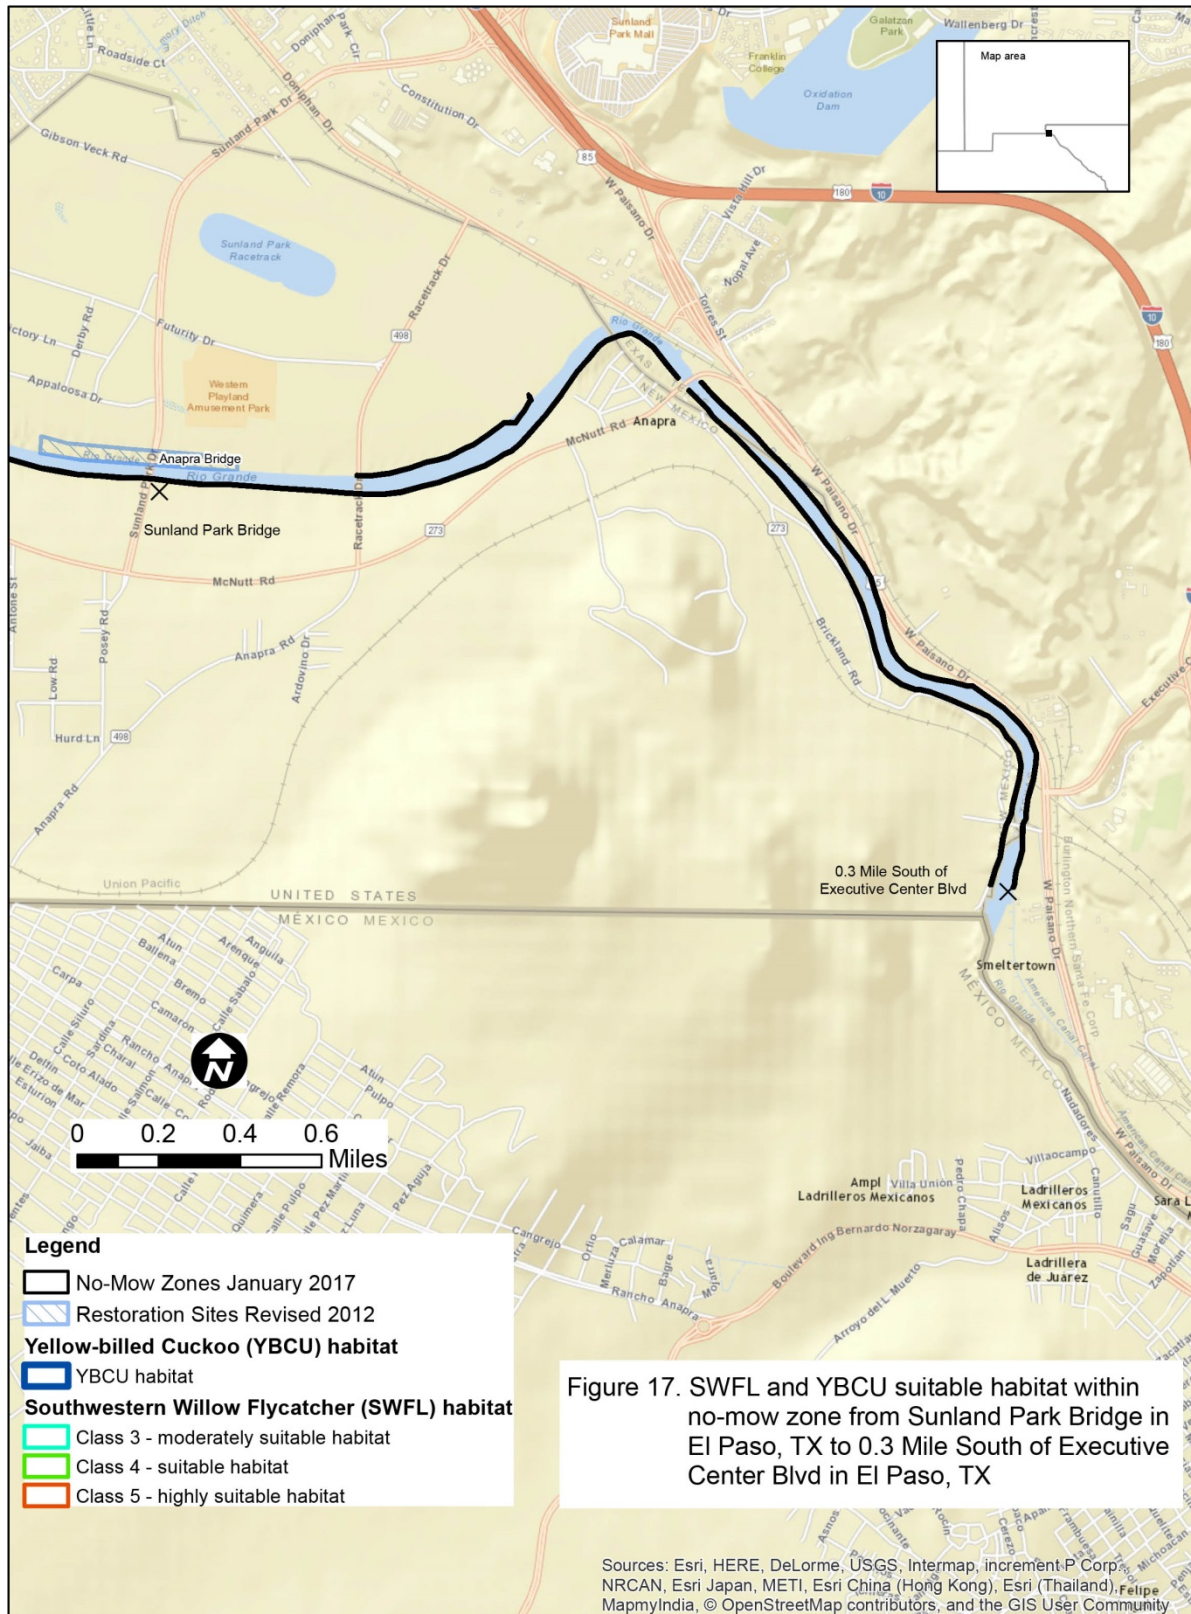
Figure 17. SWFL and YBCU Suitable Habitat within No-Mow Zones from Sunland Park Bridge in El Paso, TX to 0.3 Mile South of Executive Center Blvd in El Paso, TX

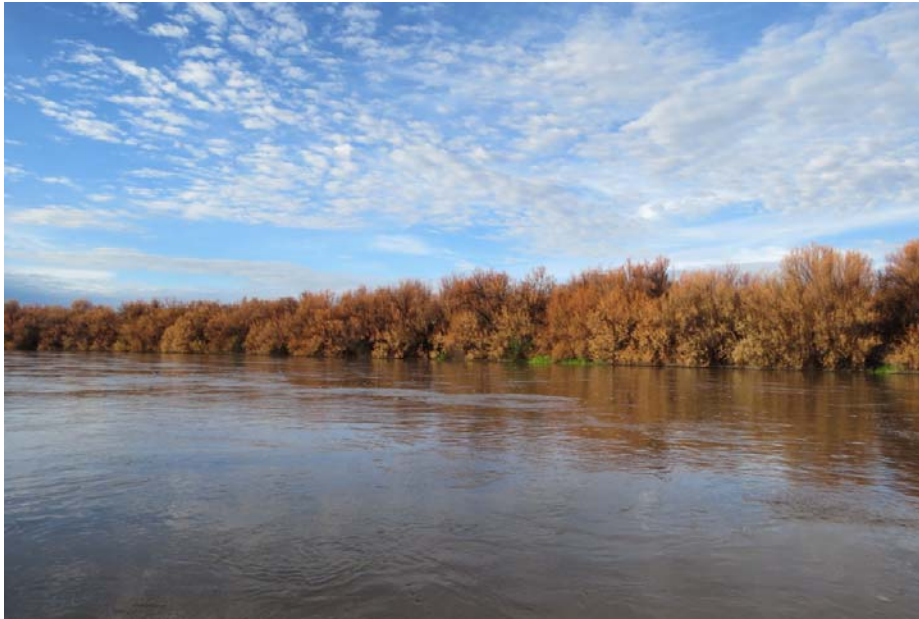
Figure 3. Saltcedar North of Selden Point Bar Showing Severe Stress from *Diorhabda*

Much of the saltcedar in this stretch of the Rio Grande is suffering the effects of *Diorhabda* and is severely stressed from pasture 18 (312300E / 3603634N) south to Selden Point Bar (Figure 3). There was one exception just upstream of Selden Point Bar where a marsh is present on the east side of the river. South of Selden Point Bar, the saltcedar begins to green up and continues to exhibit low levels of stress until downstream of Leasburg Dam. The stress (browning) becomes more apparent at that point. The saltcedar away from the river banks seem to have a higher stress level and are much browner overall.

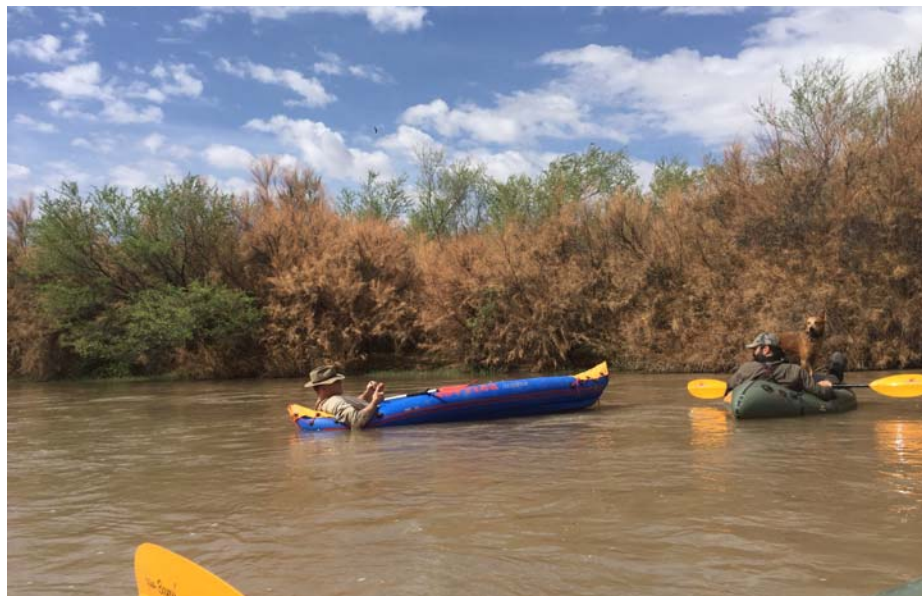
Figure 4. Mixed Vegetation Habitat with Saltcedar Showing Effects of *Diorhabda* and Green Screwbean Mesquite Trees South of Leesburg Dam

Several areas currently falling into categories of mixed vegetation 3 and screwbean mesquite 2 appear to provide habitat potentially suitable for SWFLs. This assertion is supported by the fact that four individual SWFLs were detected in the stretch during this survey effort in these habitat types. Much of the saltcedar habitat has been affected by saltcedar leaf beetles (*Diorhabda* spp.) Many stretches of saltcedar 1 and saltcedar 2 are showing obvious signs of stress. In other large stretches the saltcedar appears to be completely dead. Many of these stretches show robust growth of screwbean mesquite (Figure 4).

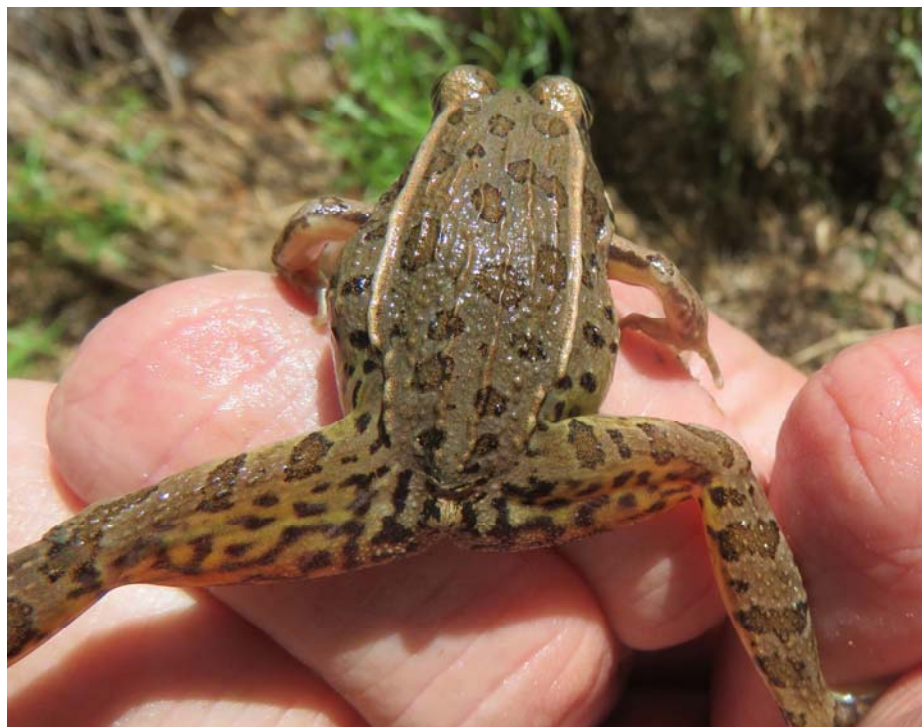
Figure 5. *L. blairi* Captured under the North Main Bridge Just below Leesburg Dam State Park

Also of note during this survey was the detection of Plains leopard frogs (*Lithobates blairi*) at the North Main Bridge south of Leesburg State Park (Figure 5). Several young leopard frogs were seen and two individuals were captured and photographed. This collection represents a county record for Doña Ana County, NM. Leopard frogs are very rarely encountered in the Rio Grande River system.

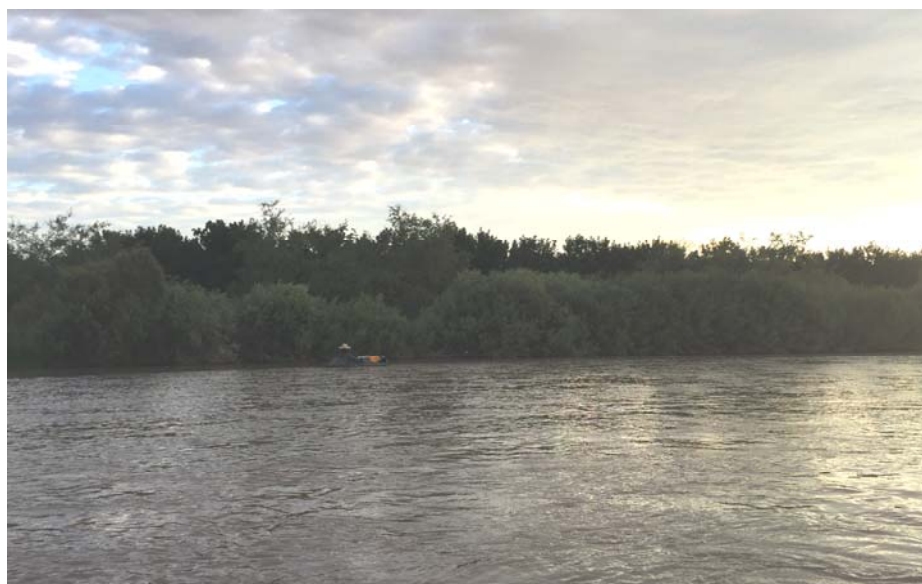
Figure 6. Thin Coyote Willow and Screwbean Mesquite Habitat along the River Bank with Large Mature Pecan Orchards in the Background

Overall habitat quality in this section is fairly low for SWFLs and YBCUs. One YBCU was detected during this survey effort cooing from the pecan orchard habitat at Shalem Colony Bridge. This pecan orchard is located 130 m east of the river bank. Several stretches of river bank have foraging habitat in the form of coyote willow 1 and mixed vegetation 1. The mixed vegetation in several areas at the beginning of this stretch of river is comprised of screwbean mesquite mixed with coyote willow and saltcedar. Foraging habitat along the river bank in close proximity to the pecan orchard (within 300 m) likely provides suitable habitat for YBCUs (Figure 6).

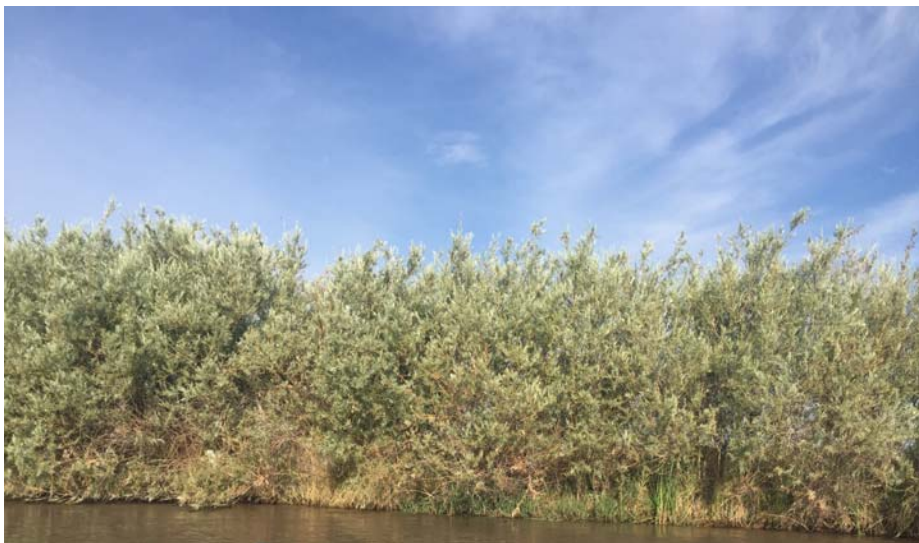
Figure 7. Thin Strip of Coyote Willow that Barely Qualifies as Class 1

Overall, this 10.5-river-km (6.5-river-mile) stretch of the RGCP currently provides fairly limited habitat for YBCUs and a few stretches of adequate habitat for SWFLs that may see improvement in the next few years if water levels remain adequate. No-mow zones occur along almost the entire stretch on both sides of the river. Much of the bank habitat in this stretch has thin stringers of coyote willow that are nearly wide enough to be coyote willow (10 m) but may need another season of growth (Figure 7). These may lack sufficient width to be considered suitable SWFL habitat.

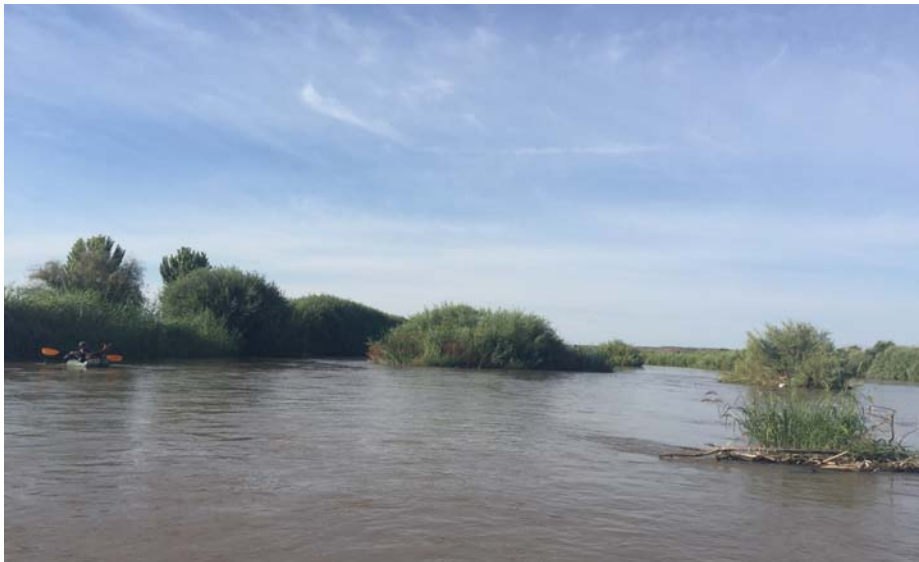
Figure 8. Braided River Channel and Island Habitat South of Interstate 10

A small section south of the Interstate 10 Bridge has habitat that is considered marginally adequate for SWFLs and should be considered for future surveys. This habitat was characterized in 2012 as bank coyote willow 1 and mixed vegetation 1 on the east side, and Class 0 on the west bank. This stretch of the river channel has experienced considerable growth on several islands of coyote willow, and the banks on both sides have coyote willow 2 to coyote willow 3, and mixed vegetation 1 and mixed vegetation 2 habitats (Figure 8). The close proximity of the bank vegetation and the island vegetation combine to make this area a probable Class 3 (moderately suitable) with potential to become better with more consistent water availability.

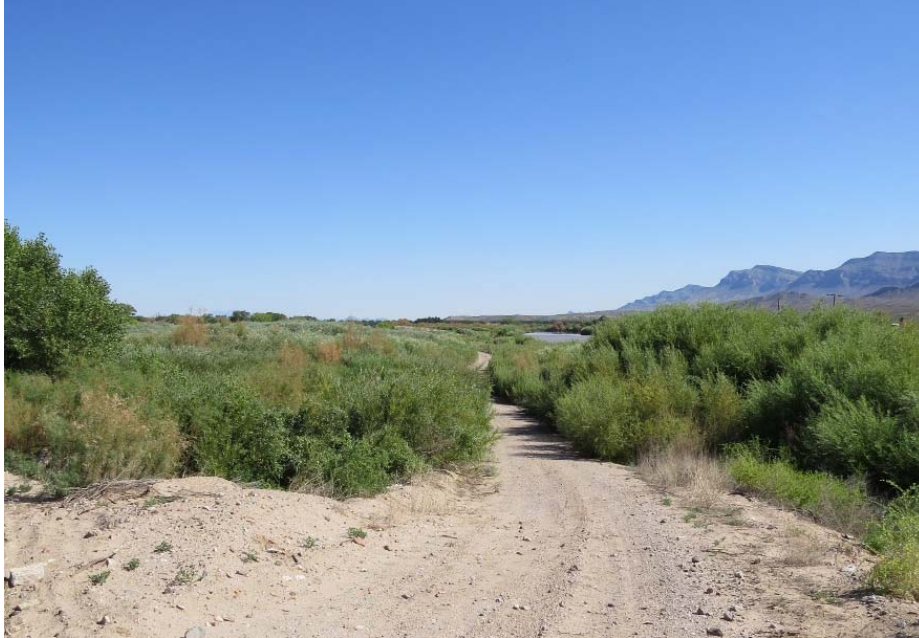
Figure 9. Southern End of Site with Thick, Short Coyote Willow

The southern end of this site has thick coyote willow (Figure 9) but is currently too short for status other than Class 0. In the future, it might provide attractive habitat to SWFLs. Moving north, the habitat along the river is a Class 0 (short coyote willow). The middle and northern part of the side is open and disturbed. Where the Trujillo Arroyo flows to the river, the habitat is Class 0 at the river but with no

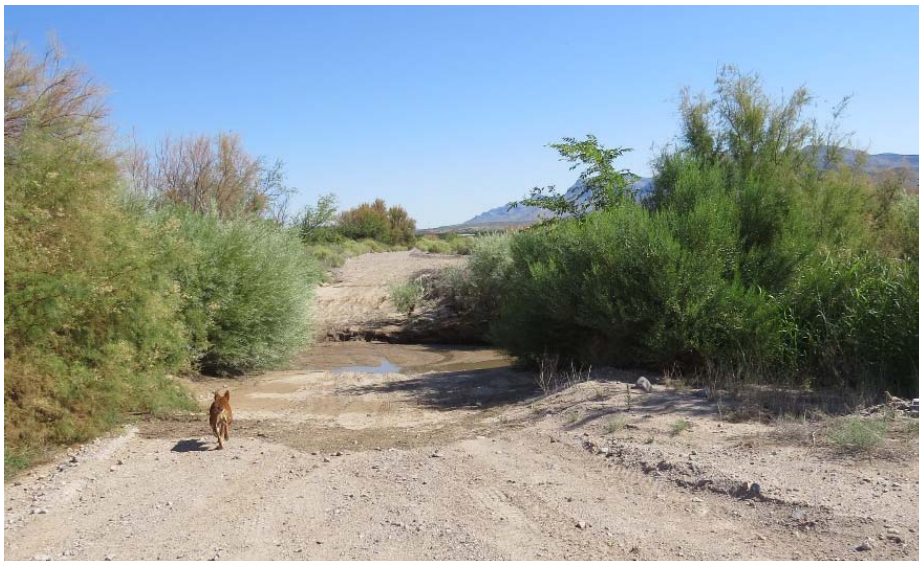
Figure 10. Where the Trujillo Arroyo Flows to the River

mowing and some water in the river may become a coyote willow 1 in a couple of years, and a mixed vegetation 1/2 (coyote willow/saltcedar) further up the arroyo (Figure 10). Flora and fauna species on the site are listed in Tables 1 and 2.

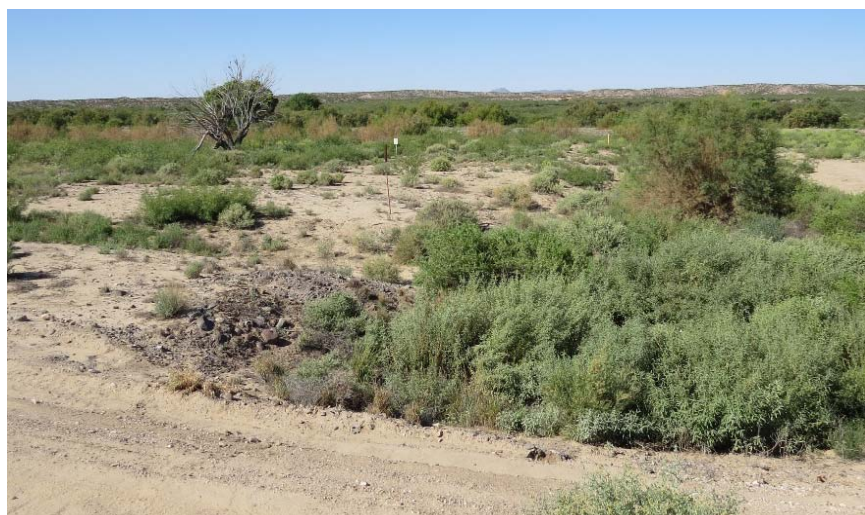
Figure 11. Jaralosa Restoration Site Showing Multiple Class 0 Gaps

This site is characterized as saltcedar1 along the river; however, multiple Class 0 gaps occur (Figure 11). Saltcedar along the riverbank are vigorous and not currently showing signs of *Diorhabda*. Away from the river, saltcedar are small and stressed (Figure 12). Amaranthus, mesquite, and rabbitbrush are also present on the site away from the river. There is currently no suitable YBCU nor SWFL habitats present. Flora and fauna species on the site are listed in Tables 3 and 4.

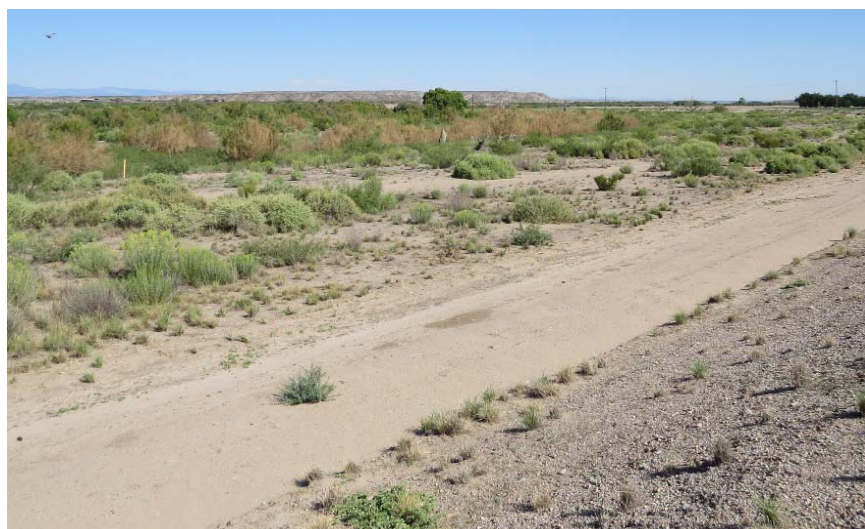
Figure 12. Away from the River, Showing Small and Stressed Saltcedar

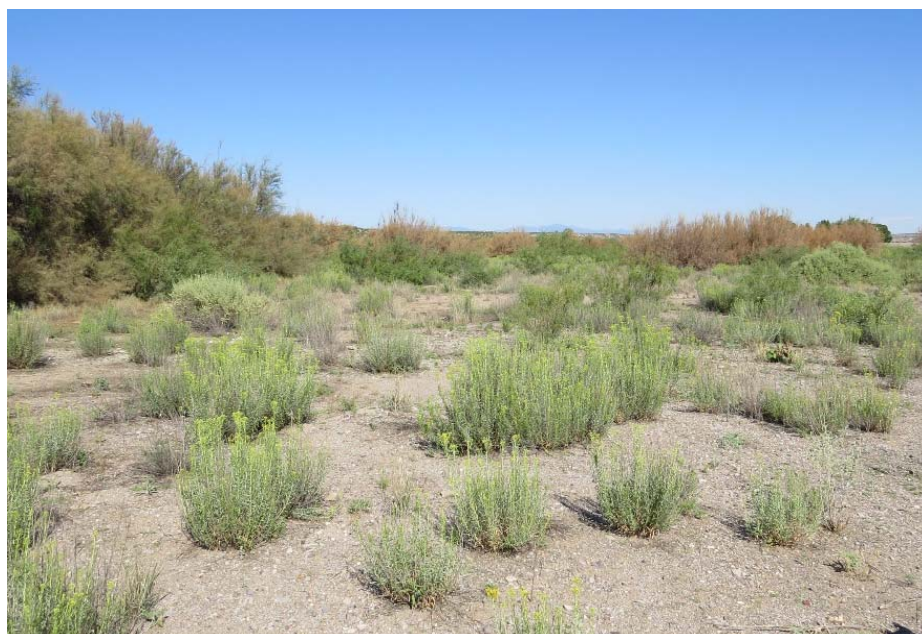
Figure 13. Eastern Portion of Site, Characterized as Saltcedar 1 on the East Bank

This site is characterized as saltcedar 1 on the east bank (Figure 13). Away from the river, vegetation is dominated by scattered, stressed saltcedar, honey mesquite, rabbitbrush and ephedra. The west bank is characterized as saltcedar 2. South of the arroyo is mature saltcedar 3 habitat with a single cottonwood (Table 5). This area, if water remains in the river, provides marginal to good SWFL habitat. No YBCU habitat is present at this site. Faunal species observed at this restoration site are listed in Table 6.

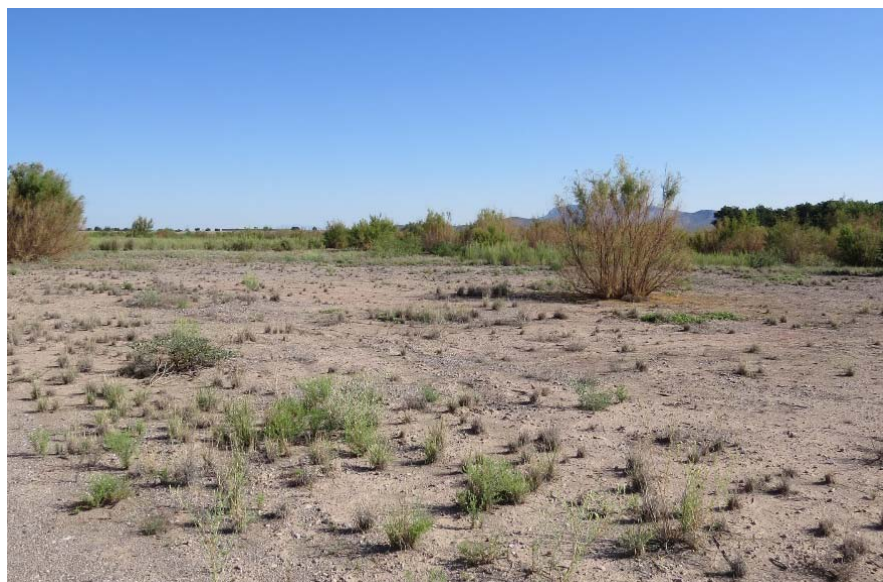
Figure 14. Sparsely Vegetated Yeso East, Located Away From the River

This site is away from the river and is currently categorized as Class 0 (Figure 14). There are young, stressed saltcedar with scattered rabbitbrush. This site is currently unsuitable for either SWFLs or YBCUs (Table 7). There is a pecan orchard to the east of this site and YBCUs might occupy this orchard and fly through the site to forage along the river. A variety of wildlife was present at this restoration site (Table 8).

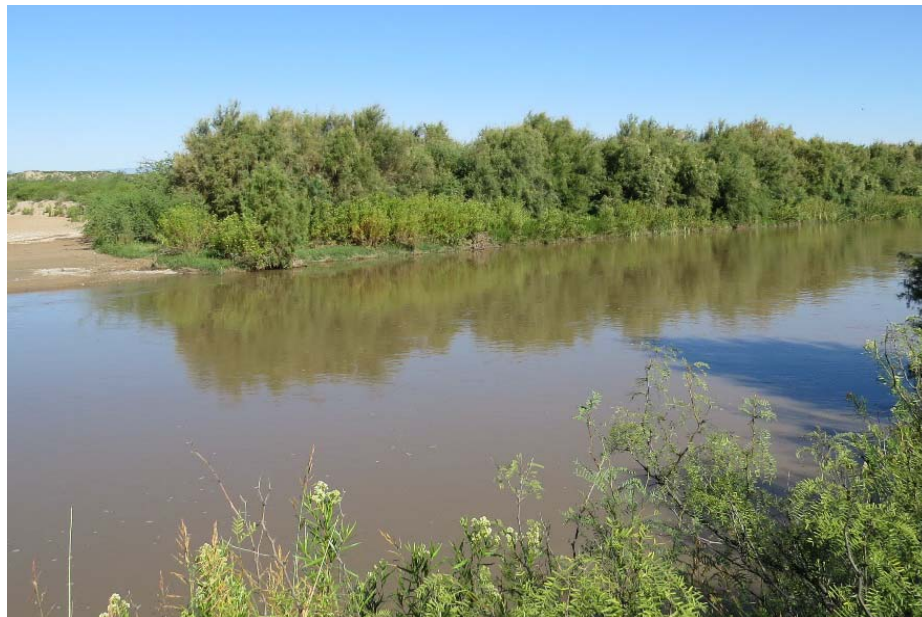
Figure 15. Saltcedar 2 Habitat North of the Arroyo at Yeso West

This site is categorized as saltcedar 2 along the river with mature screwbean mesquite behind it (Figures 15 and 16). Saltcedar at this site is vigorous and not currently showing signs of *Diorhabda*. During a wet year, this area provides moderately suitable habitat for SWFLs (Table 9). This habitat provides some YBCU foraging habitat within close proximity to a small pecan orchard on the east side of the river that could be utilized by YBCUs. Three softshell turtles were observed basking where the arroyo meets the river on the southern boundary of the site (Table 10).

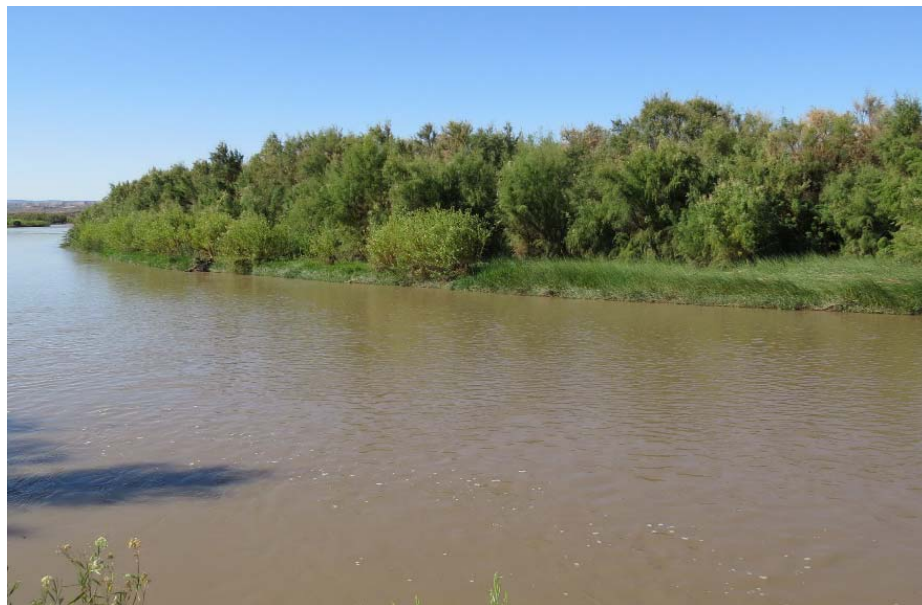
Figure 16. Saltcedar 2 Habitat along the River at Yeso West

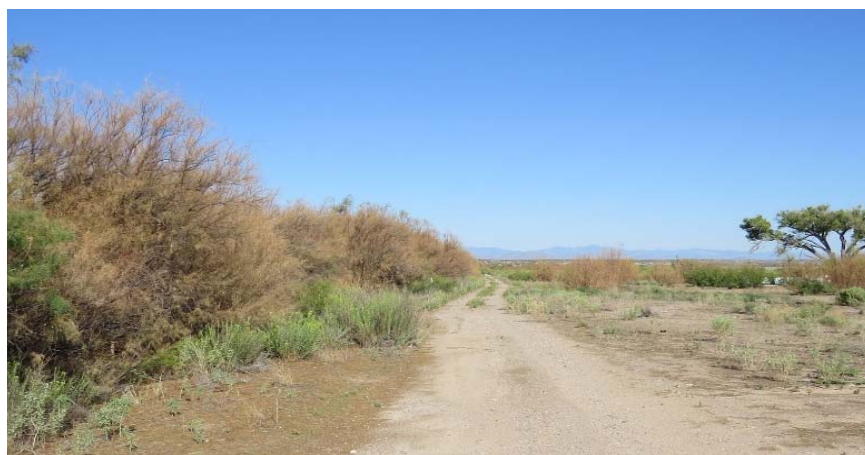
Figure 17. Saltcedar 1 Habitat along River Bank in the Northwest Portion of the Site

The northwest end of this site is comprised of saltcedar 1 along the river (Figure 17). Away from the river, the site is dominated by small honey mesquite and rabbitbrush (Figure 18). There are six cottonwoods scattered widely across this site. Overall, this site provides no suitable habitat for YBCUs or SWFLs. Habitat across the river (mixed vegetation 3) currently provides marginally suitable habitat for SWFLs.

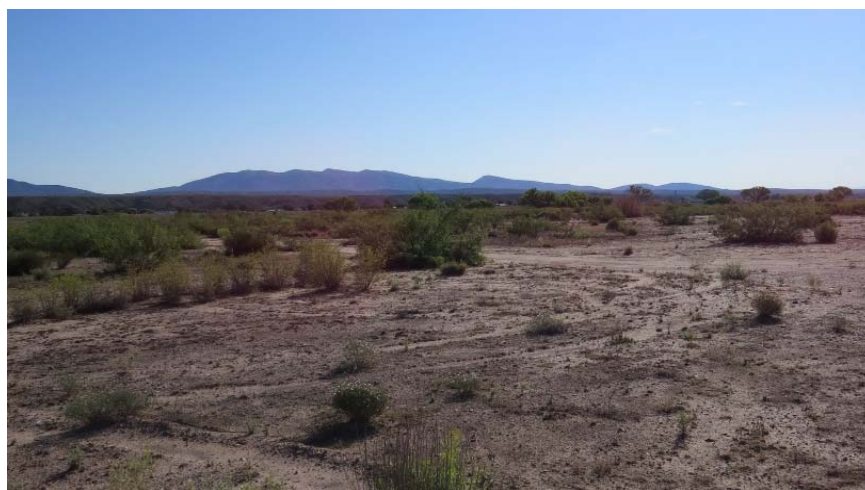
Figure 18. Away from the River, Honey Mesquite, Rabbitbrush, and Bare Ground

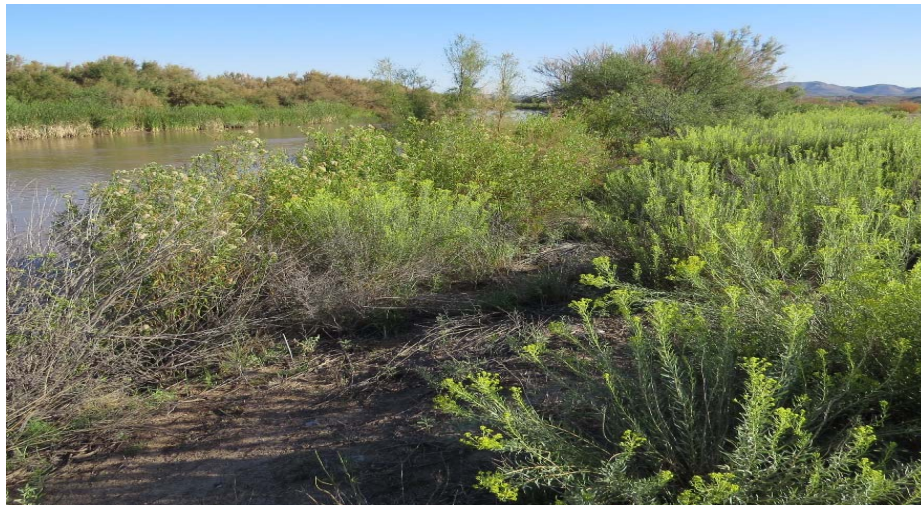
Figure 19. Riverside Rabbitbrush Vegetation (Class 0) with Saltcedar 1 and Mixed Vegetation 1 in Background

This site is mostly categorized as Class 0 along the river, with some saltcedar 1 and mixed vegetation 1. Away from the river, habitat is comprised of small saltcedar, medium screwbean mesquite, rabbitbrush and mixed grasses (Figure 19). All saltcedar are severely stressed from *Diorhabda*. There is no good SWFL or YBCU habitat present within the site. Across the river is a large patch of saltcedar 3 that currently provides marginally adequate SWFL habitat (Figure 20).

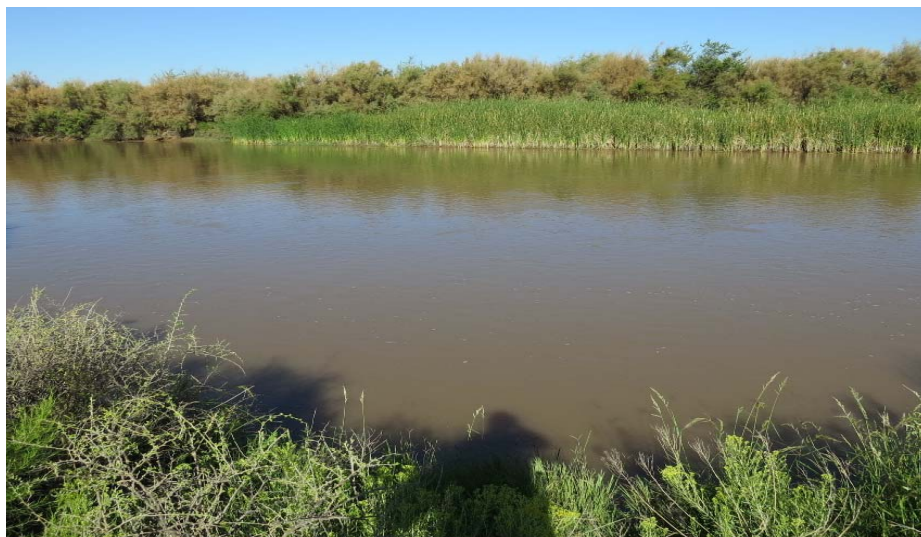
Figure 20. Saltcedar 3 Habitat across River (Marginally Suitable SWFL Habitat)

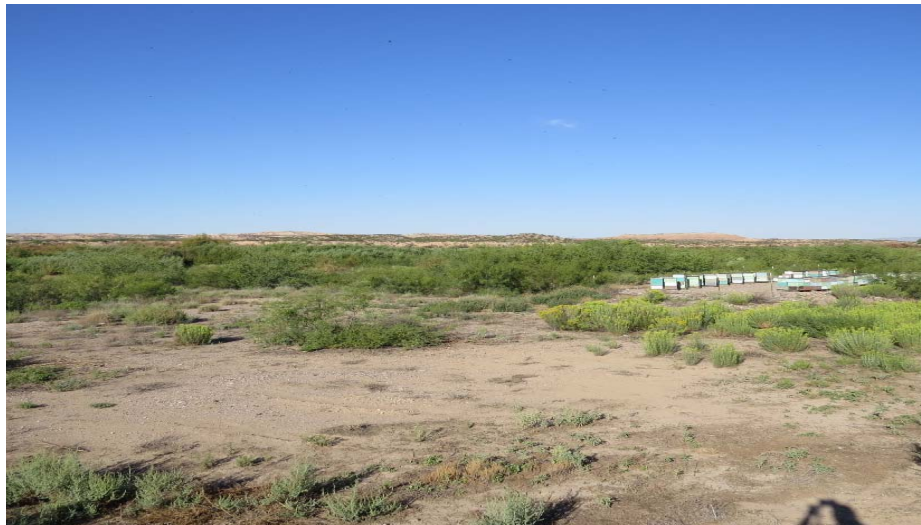
Figure 21. Mixed Vegetation 1 along the River with Maturing Screwbean Mesquite and Scattered Rabbitbrush Away from the River

This site currently has mixed vegetation 1 (coyote willow/saltcedar/screwbean mesquite) along the river. The screwbean mesquite is exhibiting initial stress from *Diorhabda*. Away from the river the saltcedar is maturing (Figure 21). There are also rabbitbrush, dropseed grasses, and a small cluster of cottonwoods on the western end. Away from the river a large area of bare ground and highly disturbed habitat exists with an active bee hive cluster (Figure 22). No SWFL or YBCU habitat is currently present at this site.

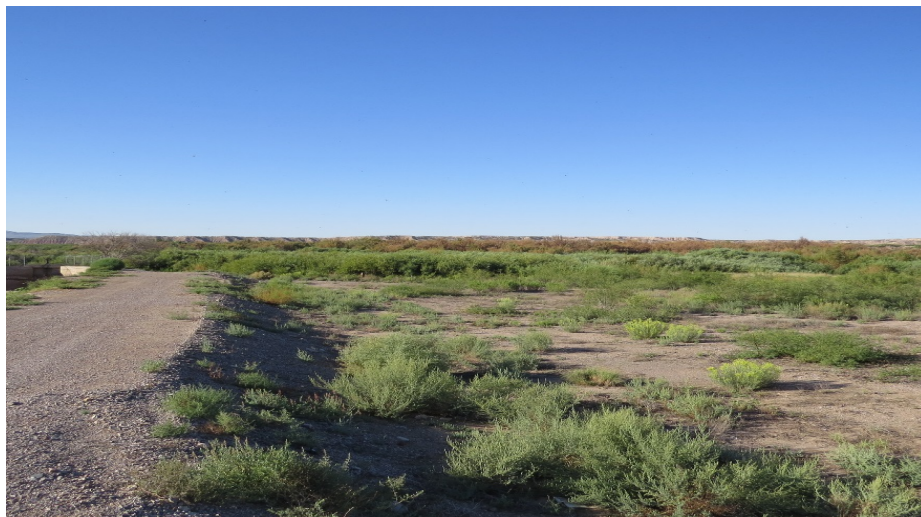
Figure 22. View of the Saltcedar 3 from East Levee toward Western Side of the River

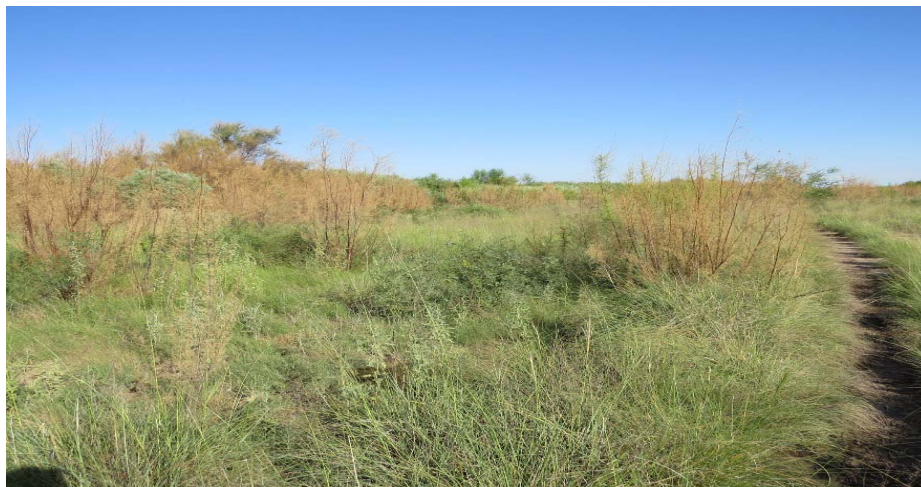
Figure 23. Mixed Vegetation 1 (Saltcedar/Coyote Willow) Away from the River Showing Dense Grass/Young Saltcedar Component

This site includes some habitat categorized as mixed vegetation 1 (saltcedar/coyote willow) with a few cottonwoods (Figures 23 and 24). Current conditions provide no SWFL or YBCU habitat. Away from the river, the site has a dense dropseed grass/saltcedar component. The saltcedar at this site is extremely stressed by *Diorhabda*, particularly away from the river.

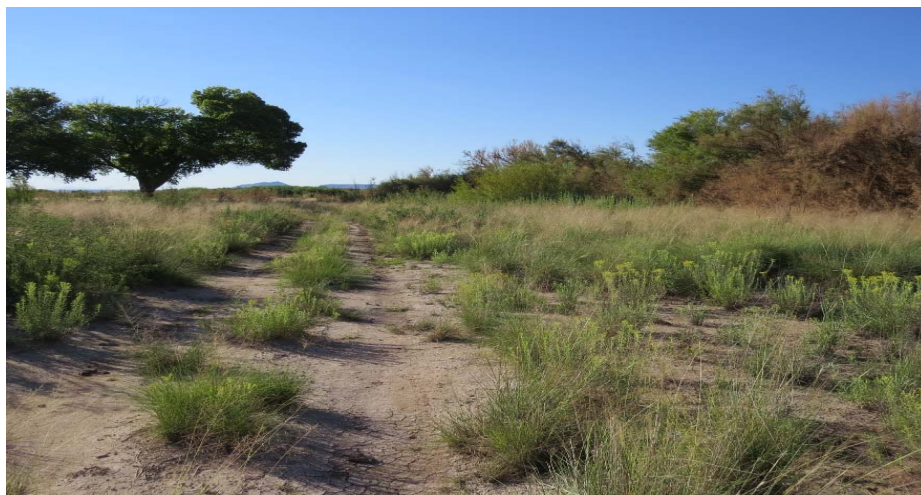
Figure 24. Mature Cottonwoods Adjacent to Mixed Vegetation 1 along the River Bank

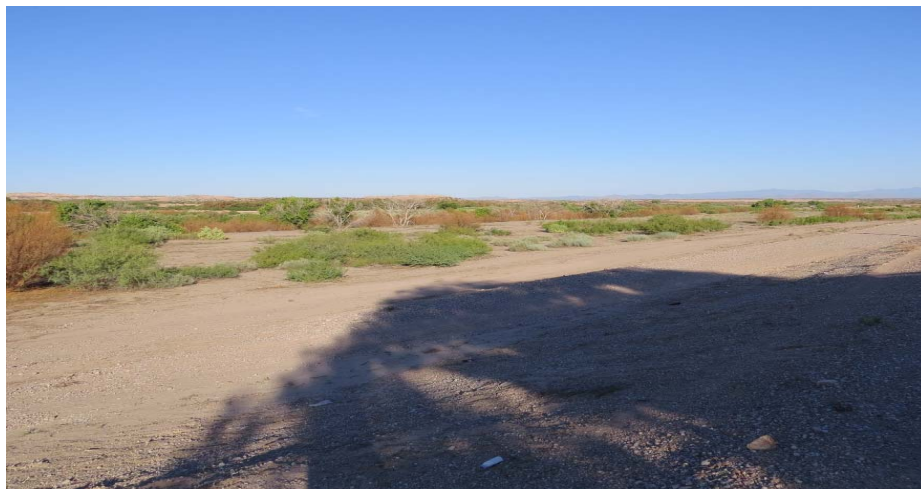
Figure 25. Highly Disturbed Habitat Away from the River in the Eastern Portion of the Site

This site has saltcedar 1 vegetation along the river and mixed vegetation 2 comprised of coyote willow and saltcedar at the western end just below the lateral. The lateral currently provides a small section of marginal SWFL habitat. No YBCU habitat is present at this site (Figures 25 and 26). Habitat away from the river and lateral is highly disturbed and appears to be recently and consistently manipulated.
