Updated Biological Assessment for Long-Term River Management of the Rio Grande Canalization Project

**United States Section
International Boundary and Water Commission
4171 N Mesa St., Suite C310
El Paso, TX 79902**

Prepared by: ***IDEALS-AGEISS, LLC***

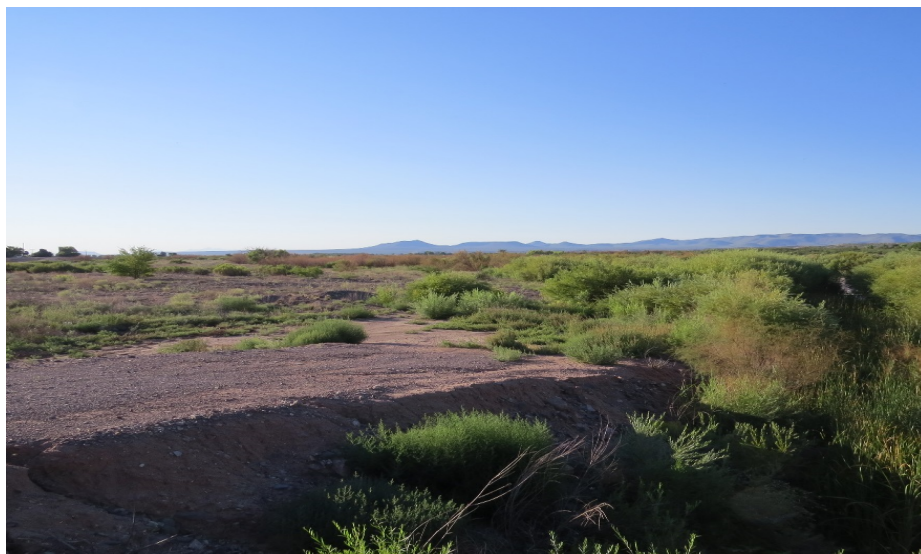
Figure 26. Mixed Vegetation 2 (Coyote Willow/Saltcedar) along the Lateral Confluence at the Western End of the Site

This site has saltcedar 1 vegetation along the river and mixed vegetation 2 comprised of coyote willow and saltcedar at the western end just below the lateral. The lateral currently provides a small section of marginal SWFL habitat. No YBCU habitat is present at this site (Figures 25 and 26). Habitat away from the river and lateral is highly disturbed and appears to be recently and consistently manipulated.
