Riparian Habitat Restoration at Three Sites in New Mexico and Texas: Country Club East, Sunland Park, and Anapra Bridge Restoration Sites

Final Interim Annual Restoration Report

October 2017 to October 2018

IDEALS-AGEISS, LLC

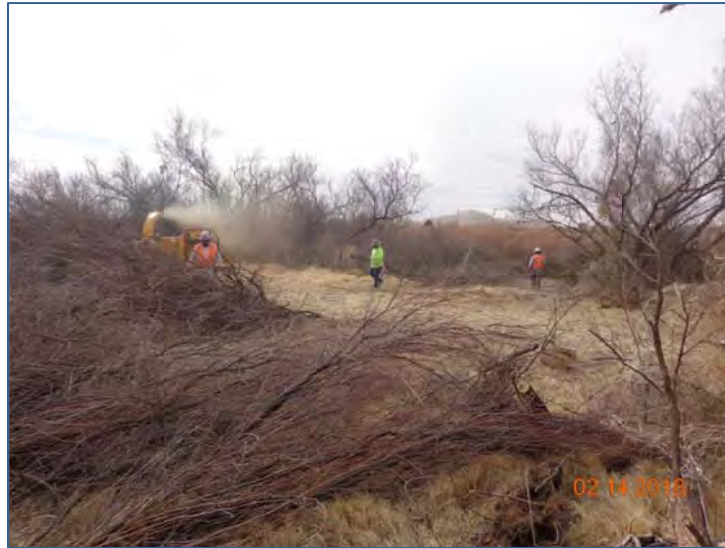
**Saltcedar extraction and chipping at Sunland Park,
13 February 2018**

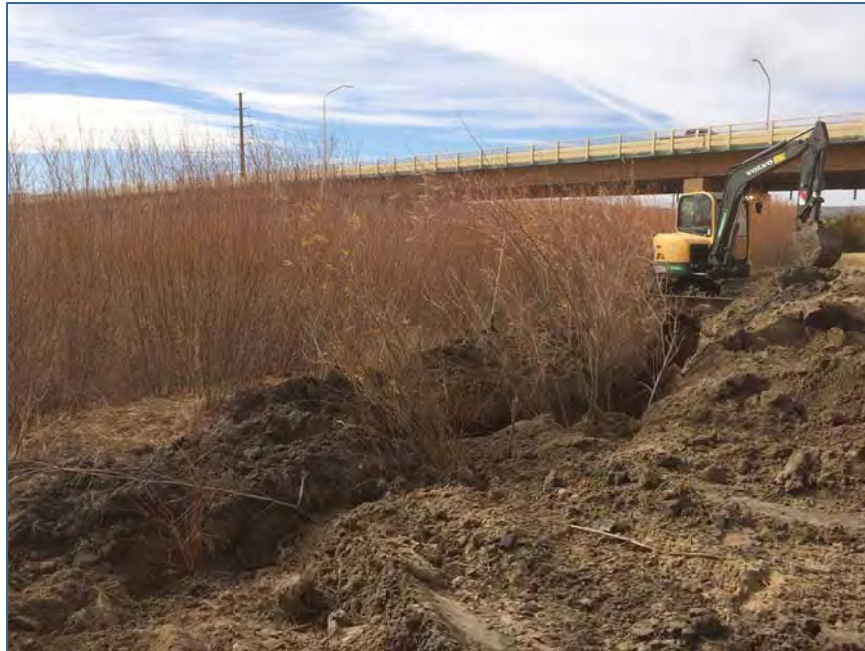
Coyote willow transplants in open ditch at Anapra Bridge, February 2018

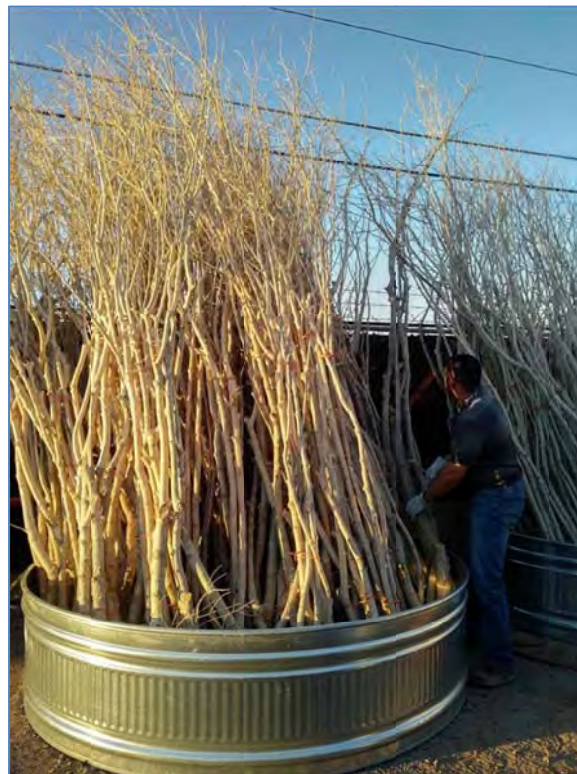
**Cottonwood poles being soaked,
27 February 2018**

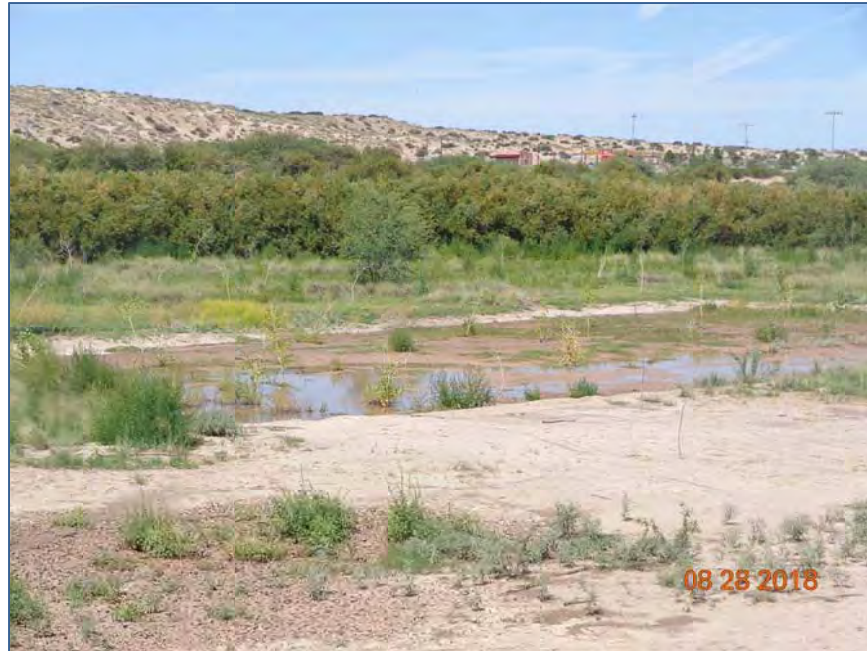
Drainage swales created at Country Club East, 28 August 2018.

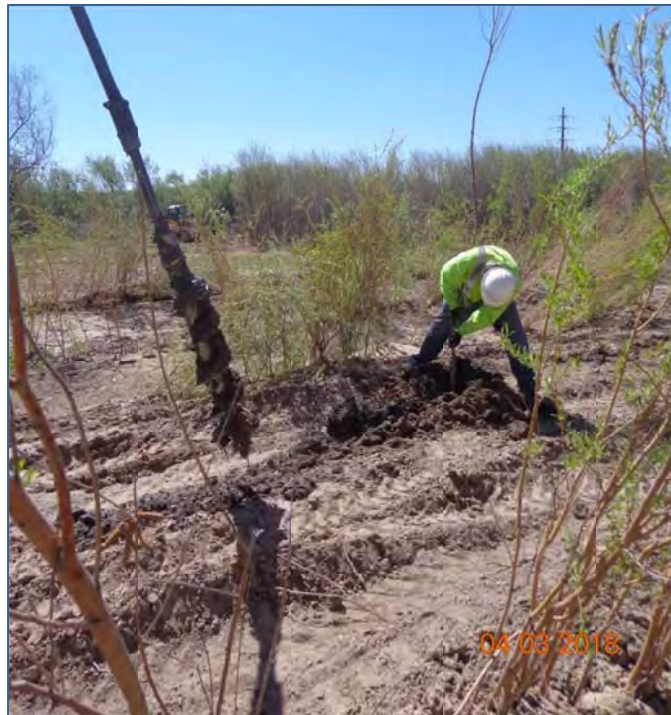
**Planting in the flycatcher habitat at Sunland Park,
4 April 2018**

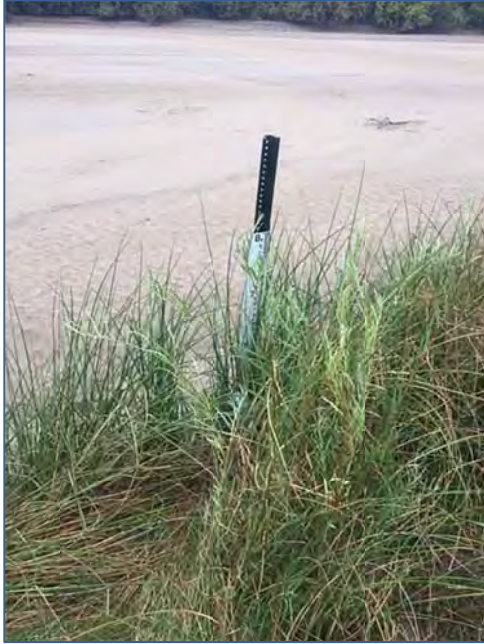
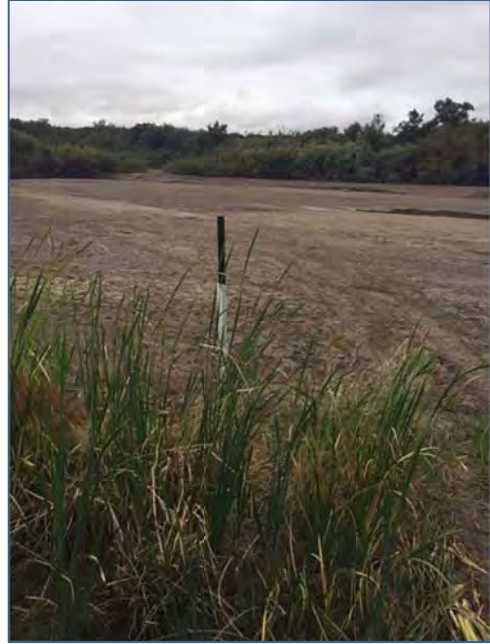
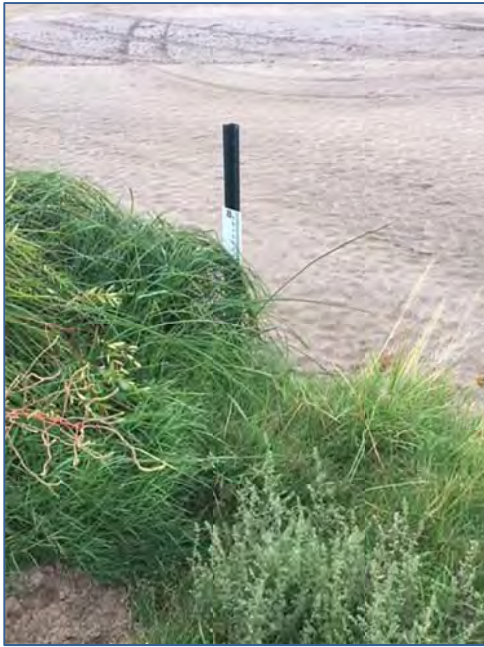
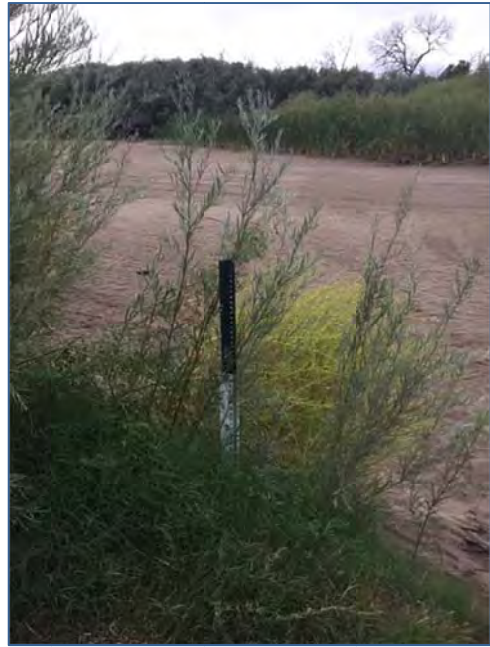
Gauge meters at all four bank cuts at Country Club East during October 2018 from south to north

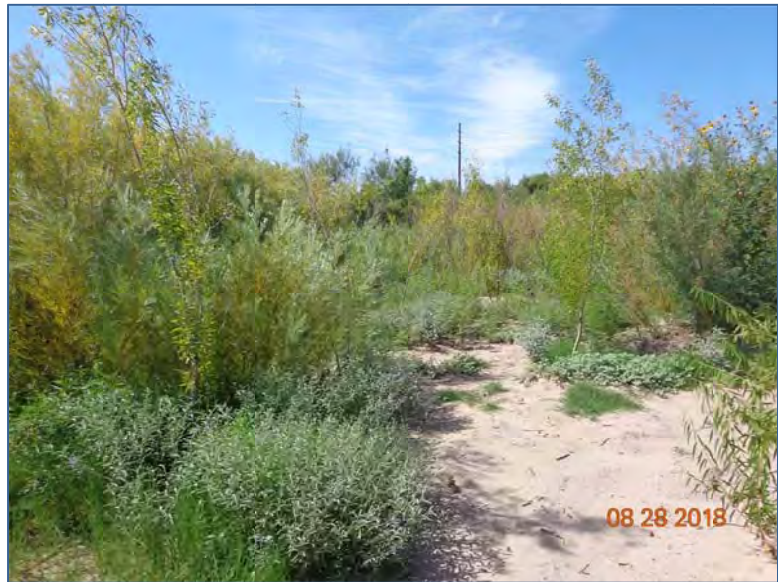
Flycatcher habitat area at Sunland Park in August 2018
