**USIBWC Riparian Habitat Restoration  
MONITORING NOTES AND PHOTOGRAPHS  
SUMMER 2021**

**U.S. Section International Boundary and Water Commission**

**April 20, 2022**

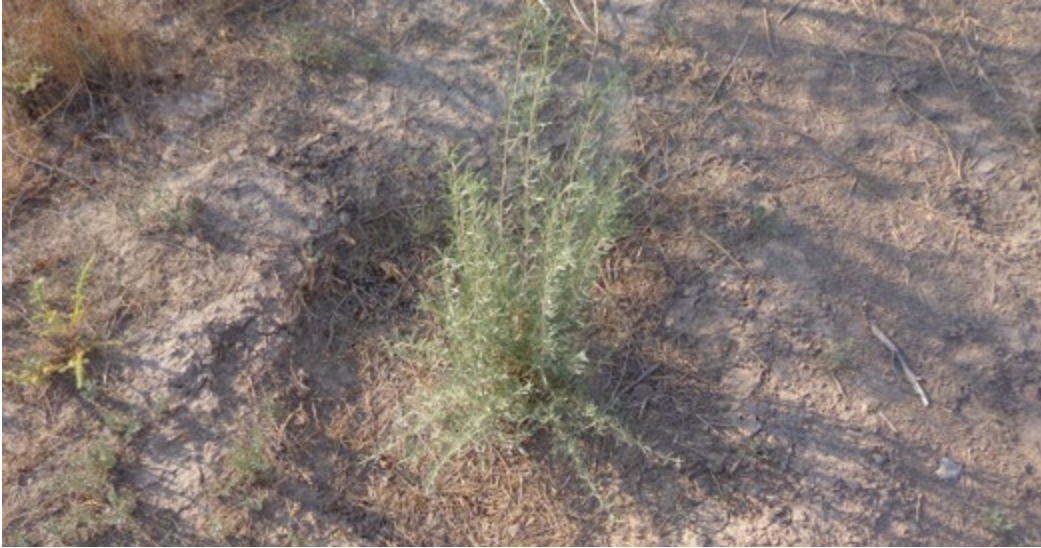
Although shrub survival is generally low, this four-winged saltbush is happy.

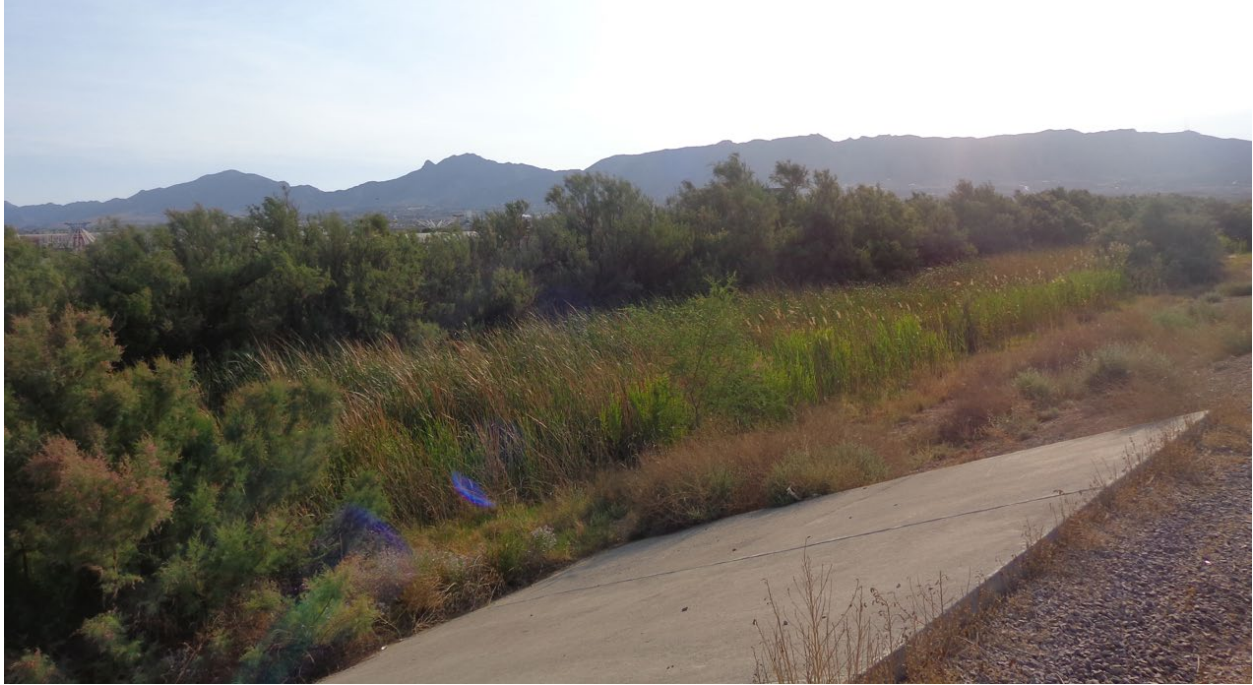
Saltcedar present along the banks and cattails in the bottom of the Montoya Intercepting Drain opposite the City of Sunland Park riverpark.

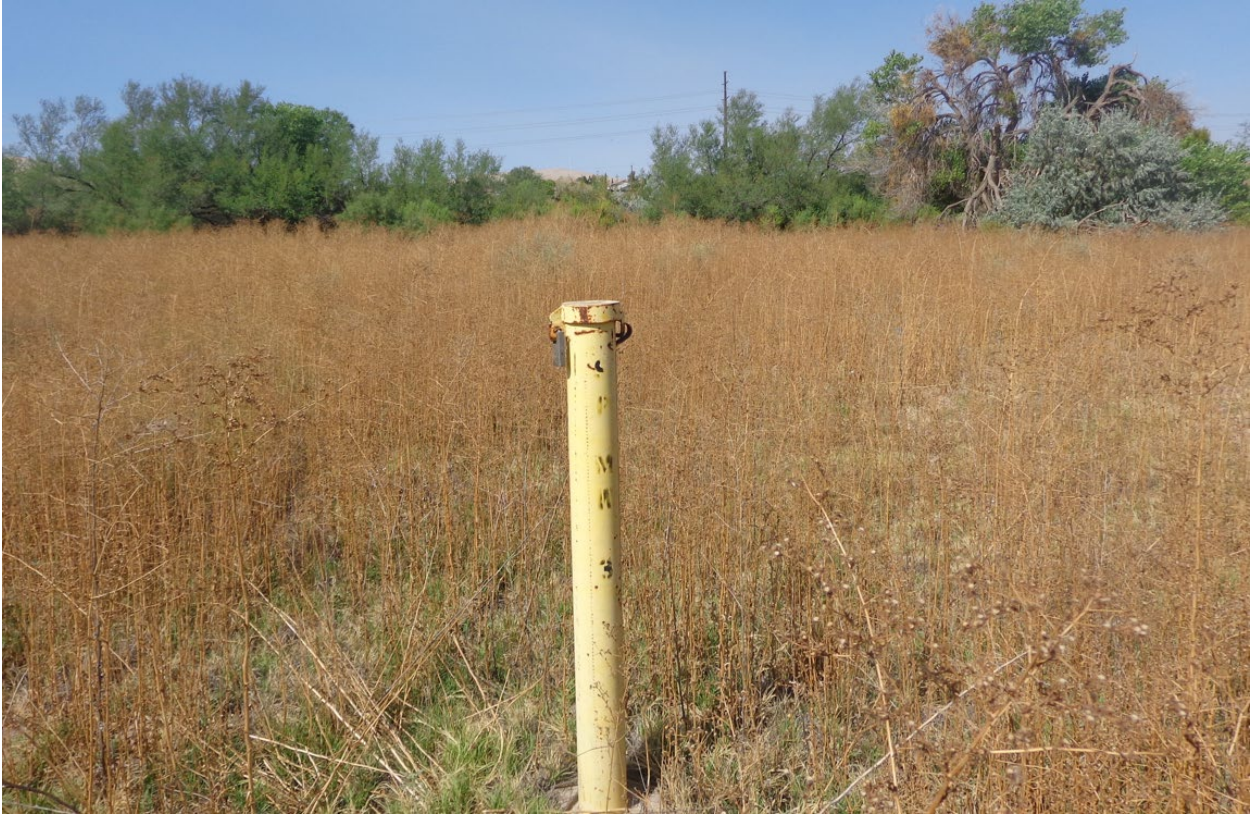
Well 3 was surrounded by a field of brush.

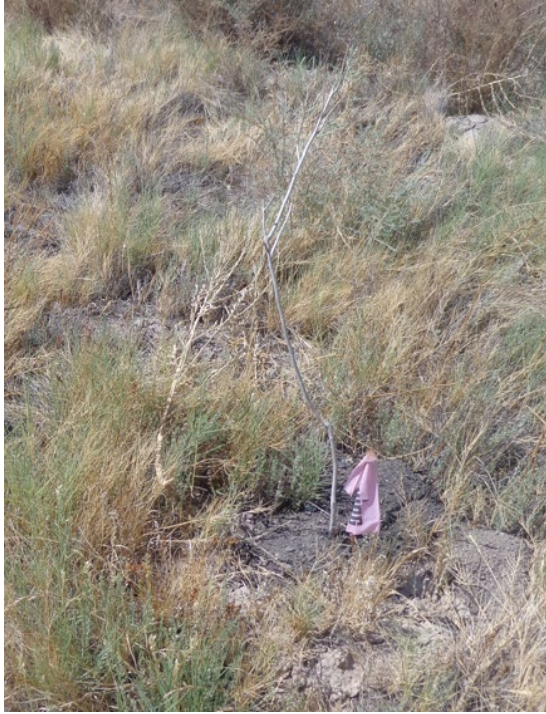
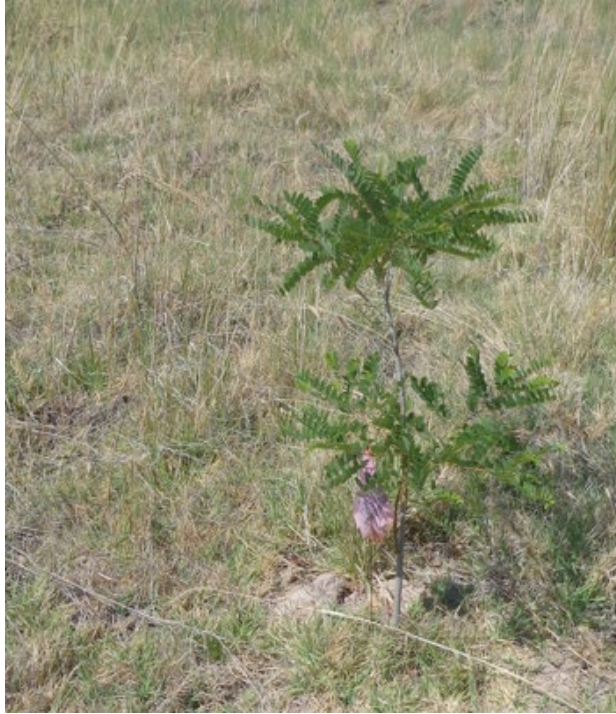
Variable shrub mortality

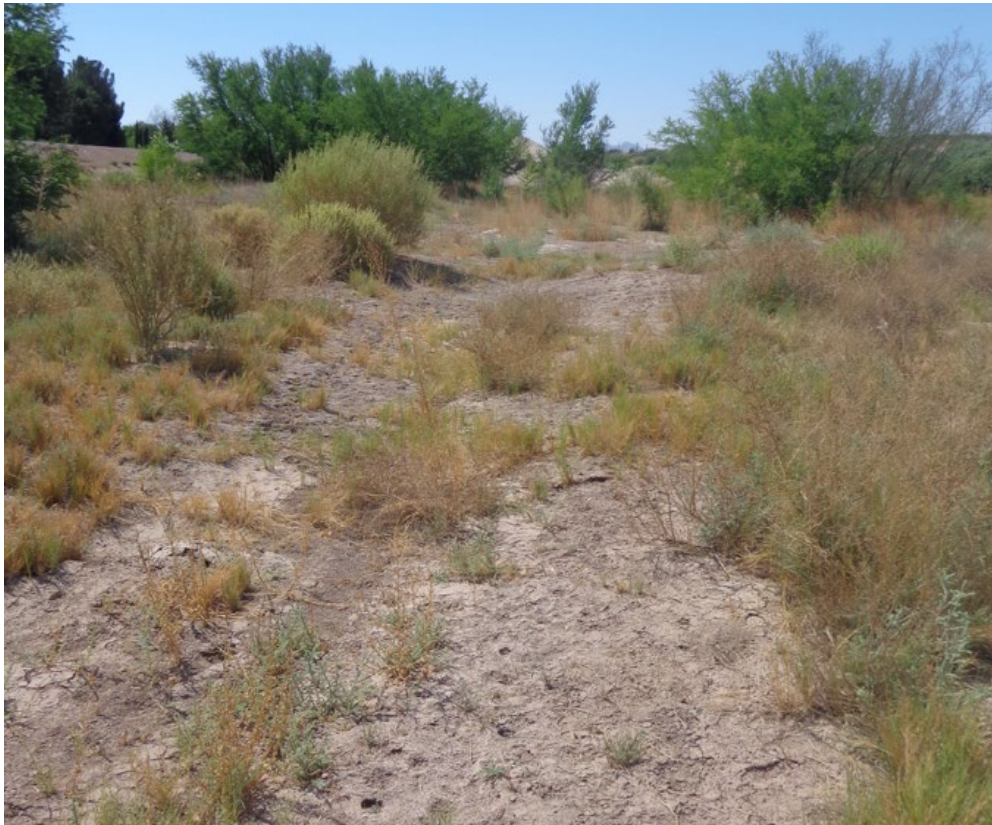
Constructed swale

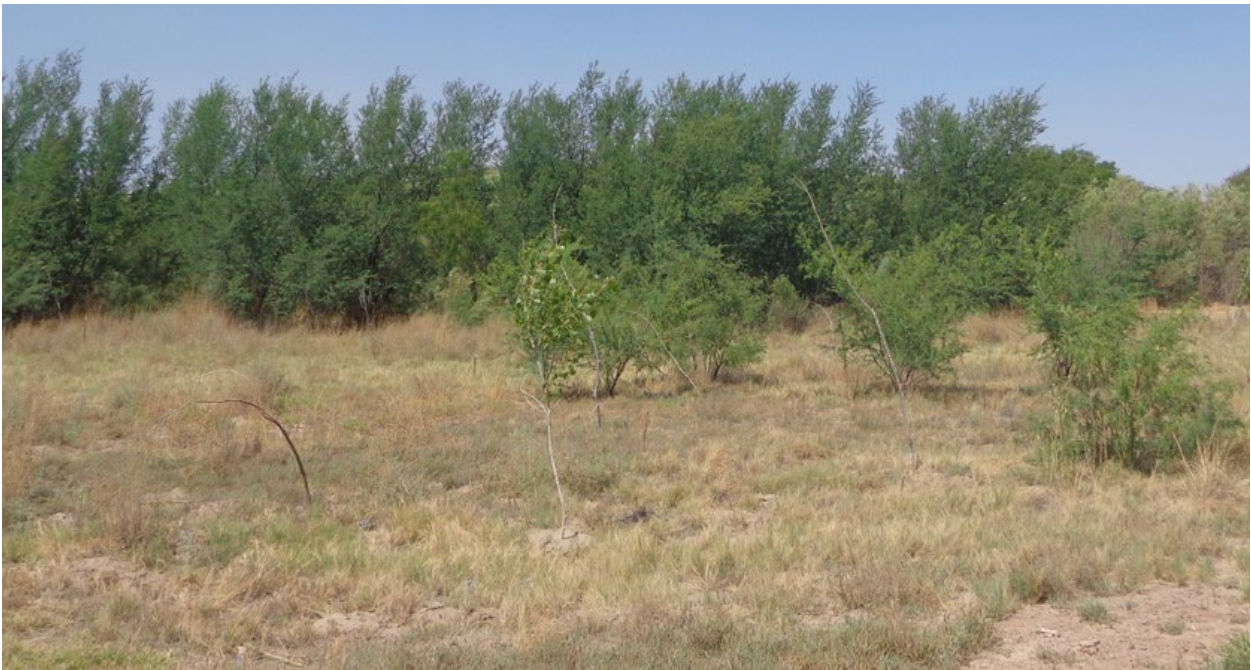
Variable tree survival

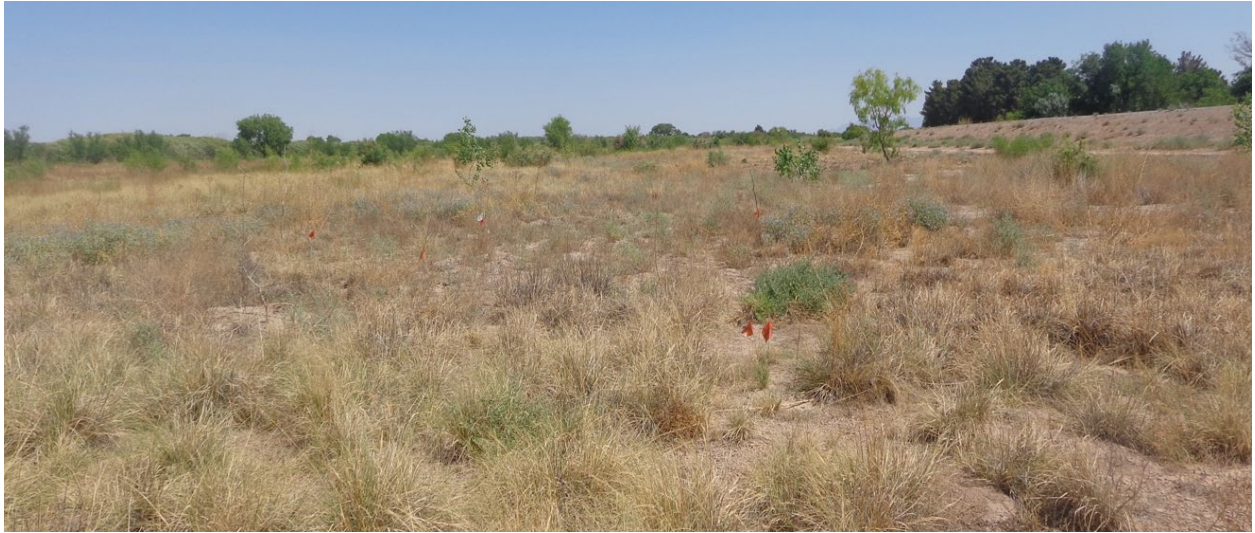
High shrub mortality in the upland shrub planting areas

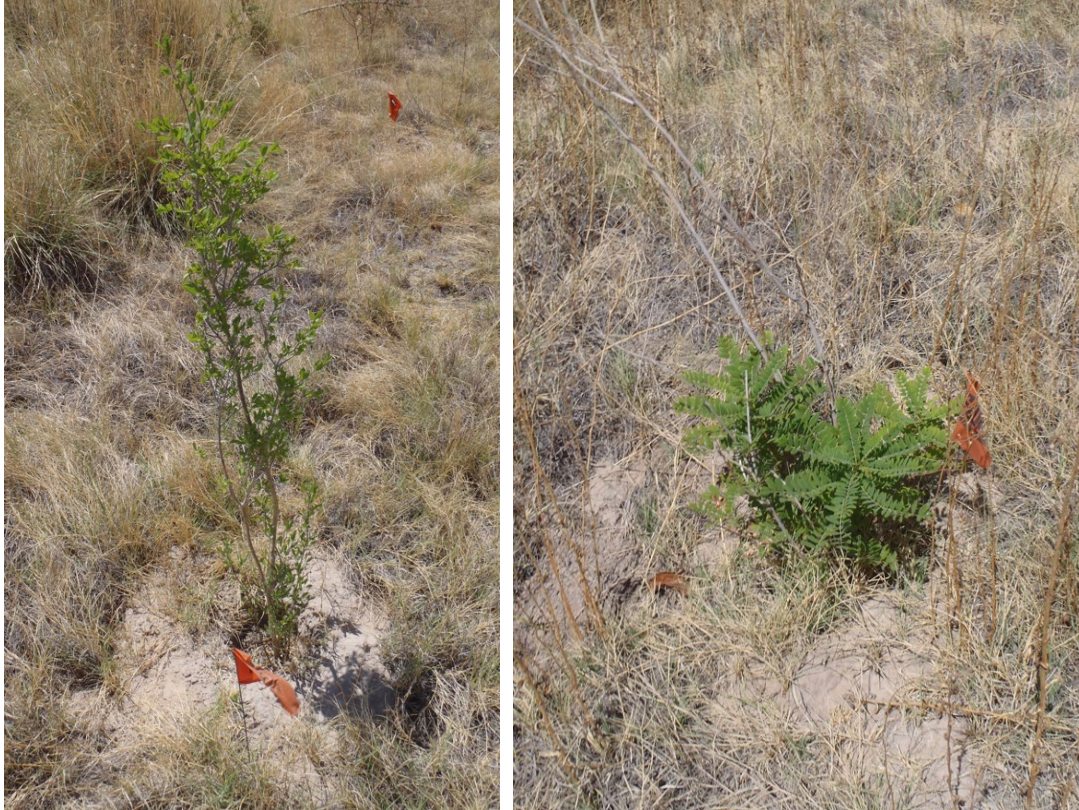
Shrubs had mixed survival.

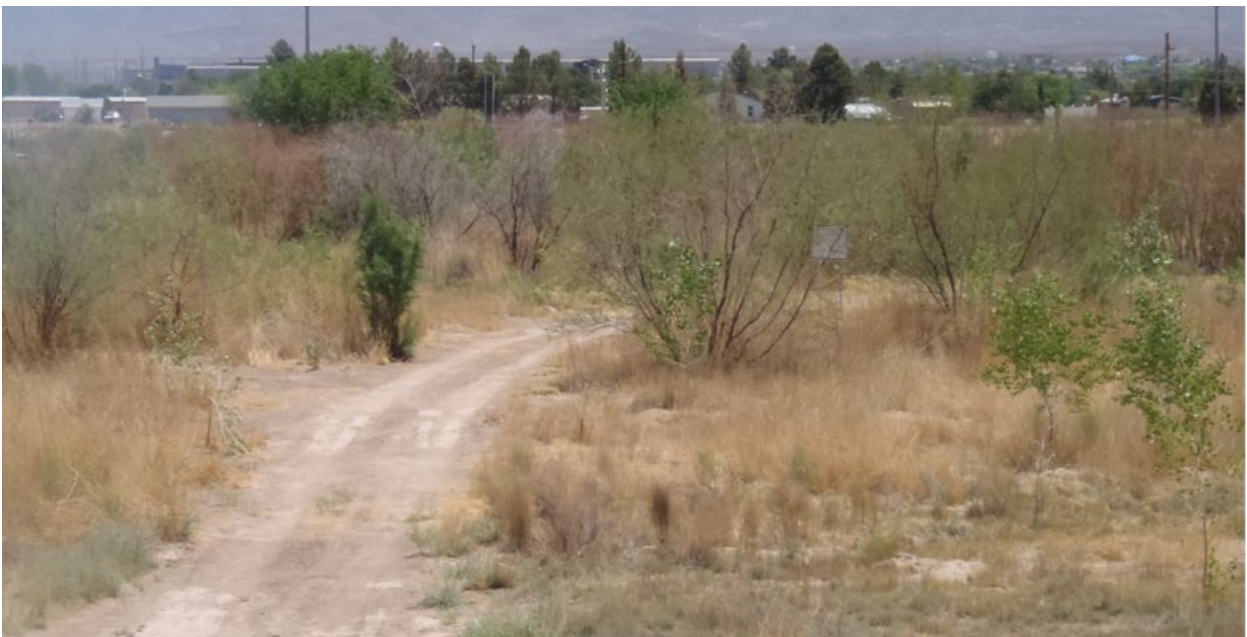
A frequently used road traverses right through the site.

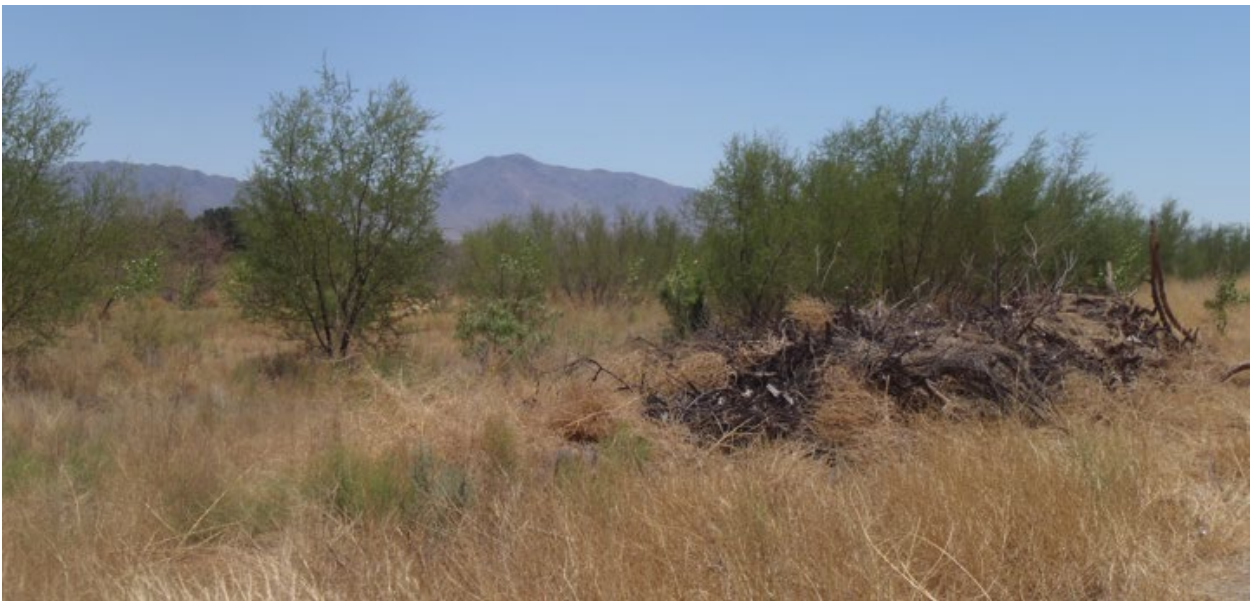
Debris piles still present at Vinton B

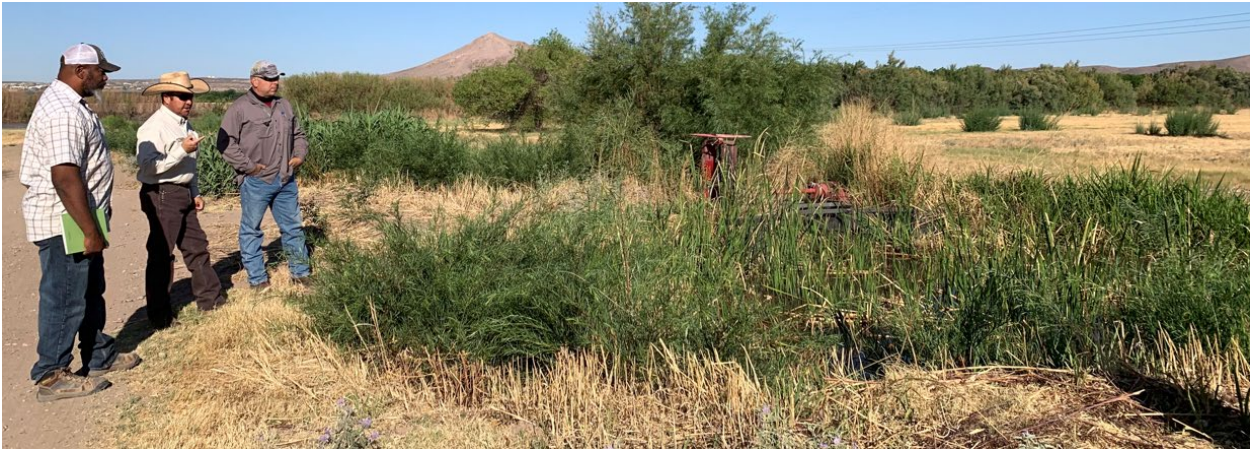
USIBWC and USFWS conduct a hands-on training for irrigating the WW8 site. Here the crews gather at the turnout at the site to discuss logistics of operating the gate and coordinating with the irrigation district.

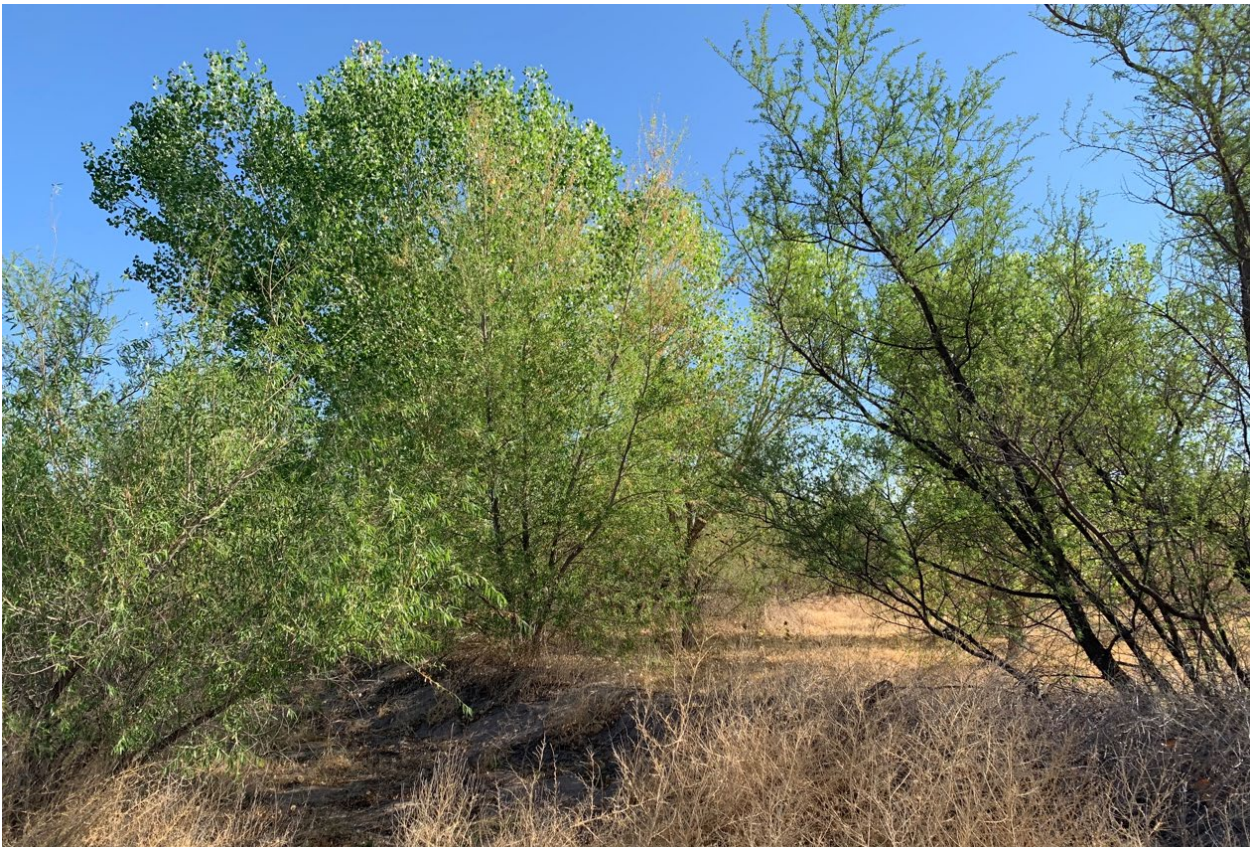
Gooddings willows, cottonwoods, and mesquite with underbrush near well 1.

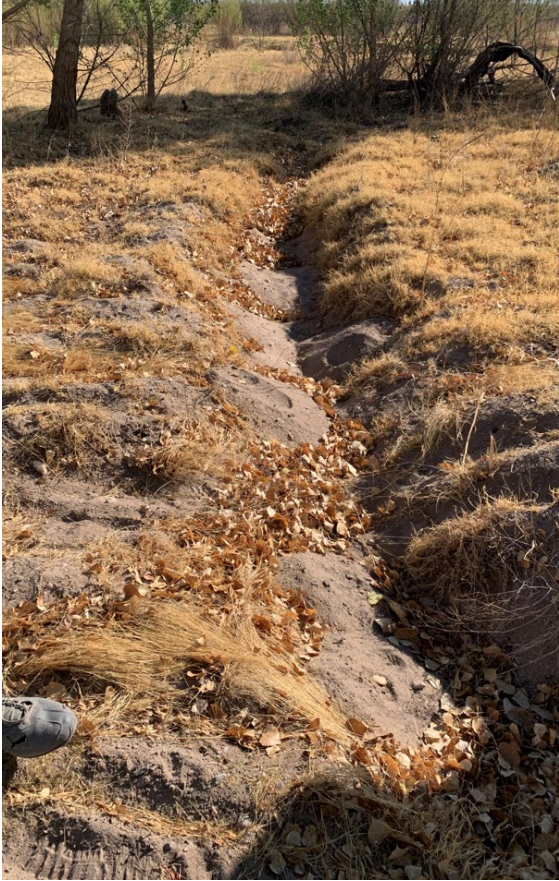
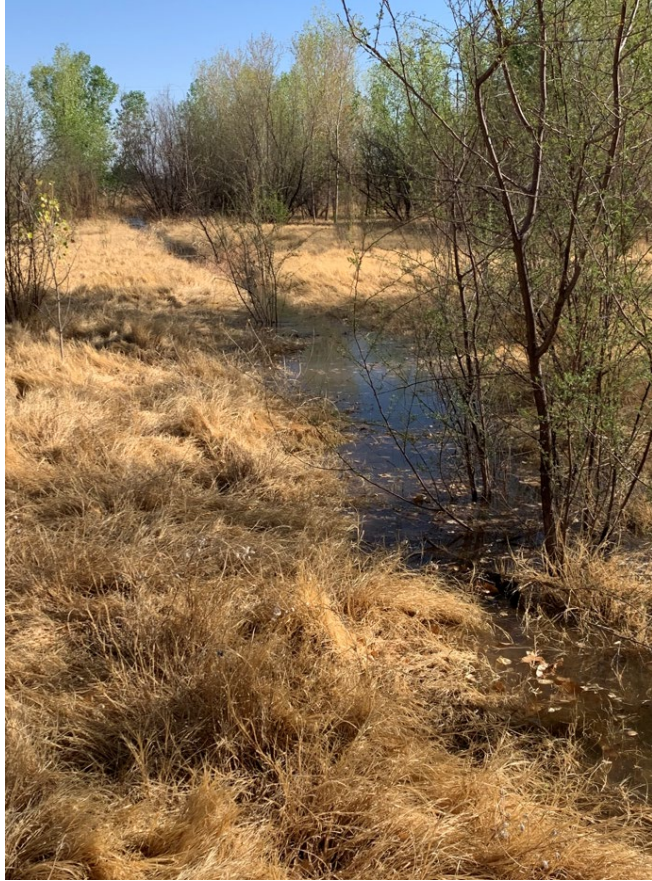
Earthen v-ditch to convey irrigation water around the site (dry, left, and full, right).

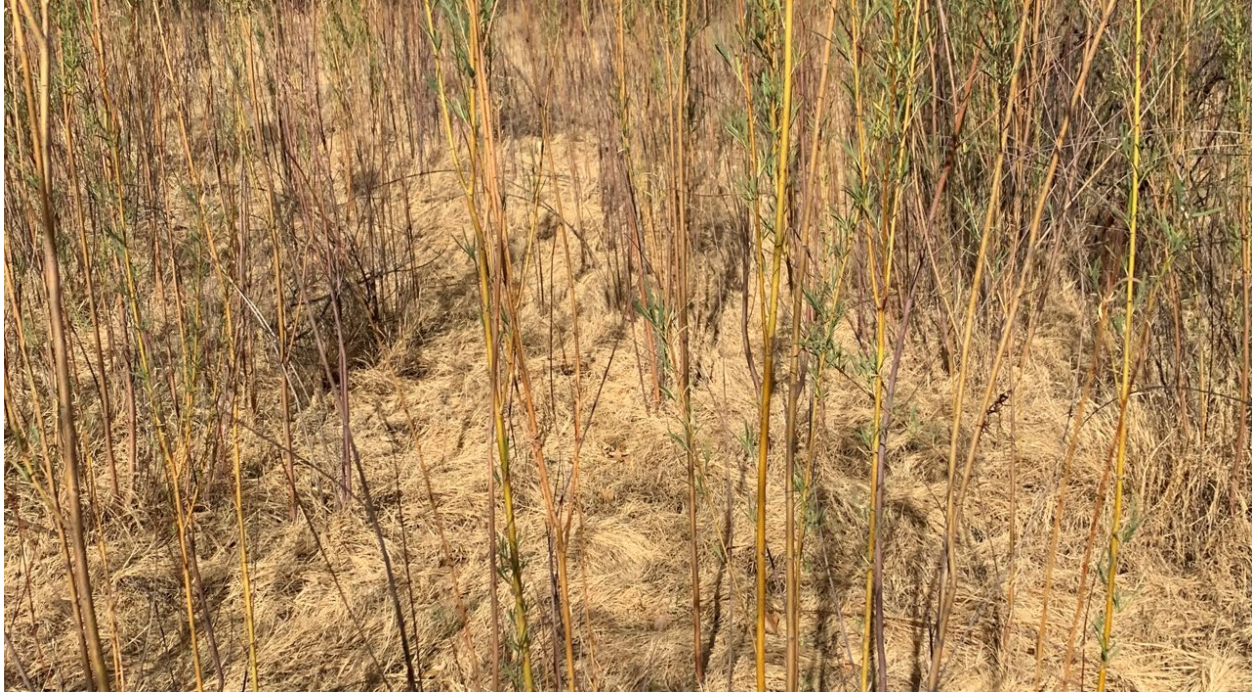
Dense young willow shoots.

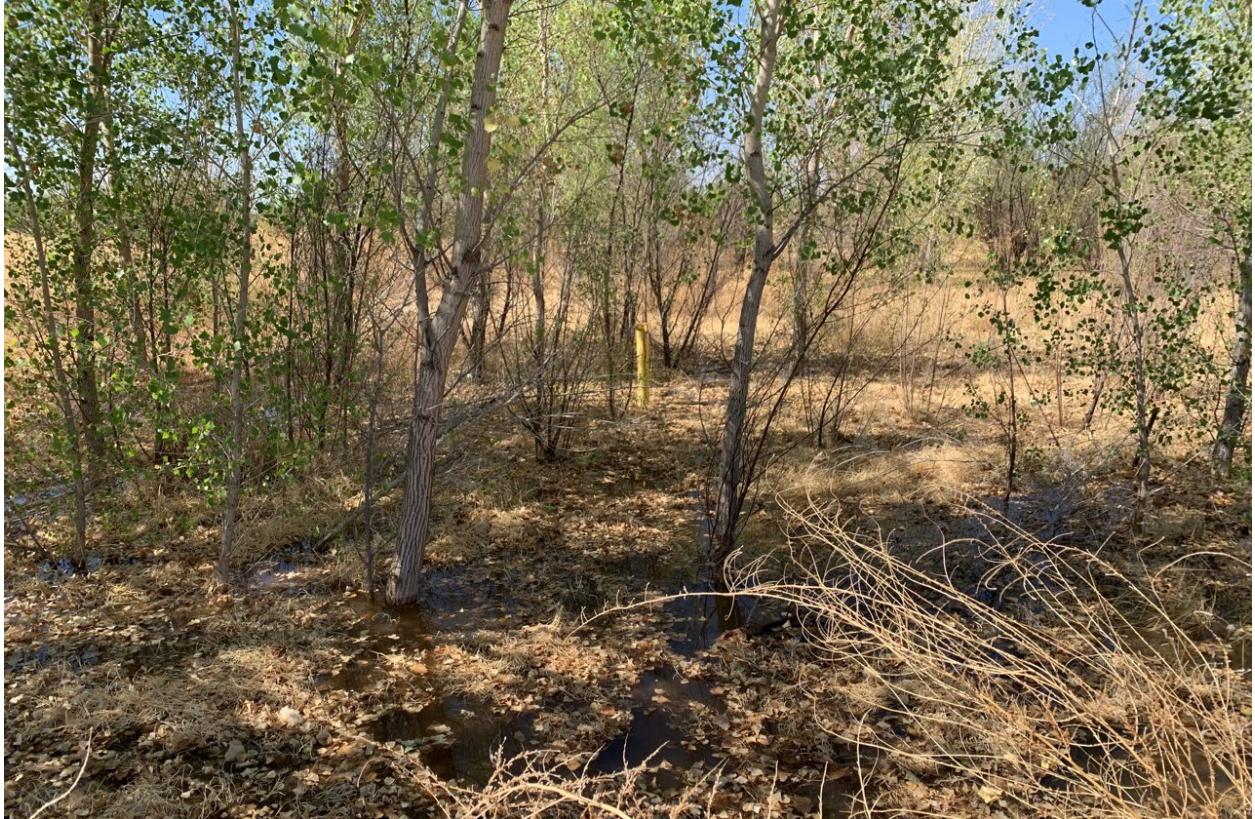
Trees at Well 1 being irrigated.

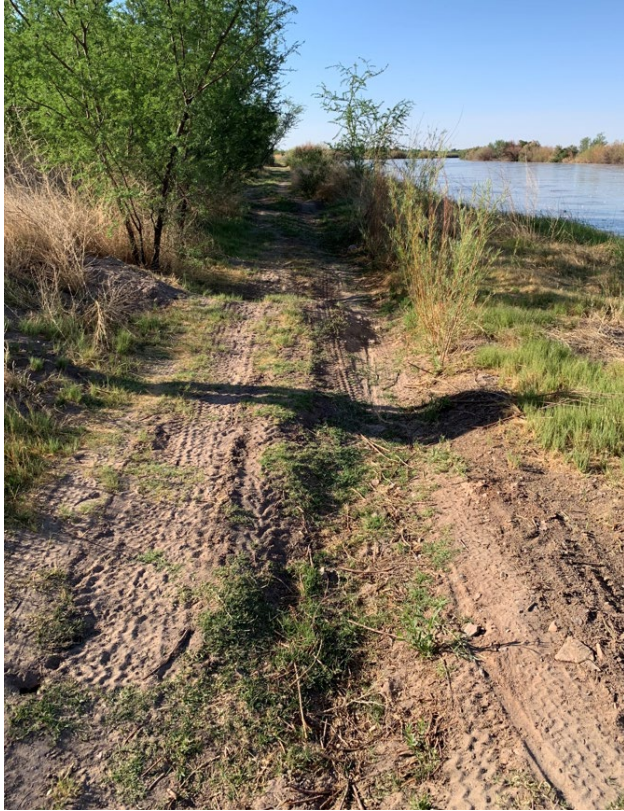
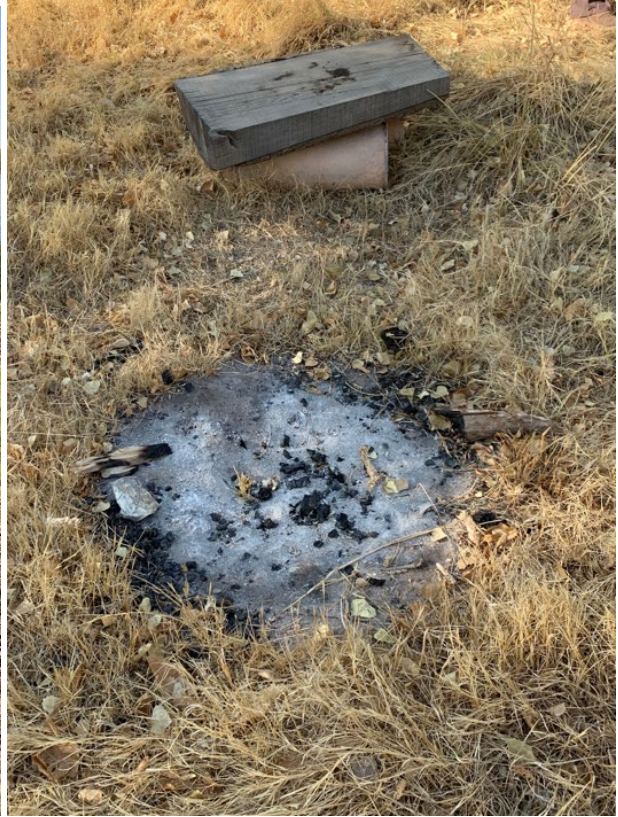
Evidence of frequent recreational use, including campfires, vehicle tracks, and trash.

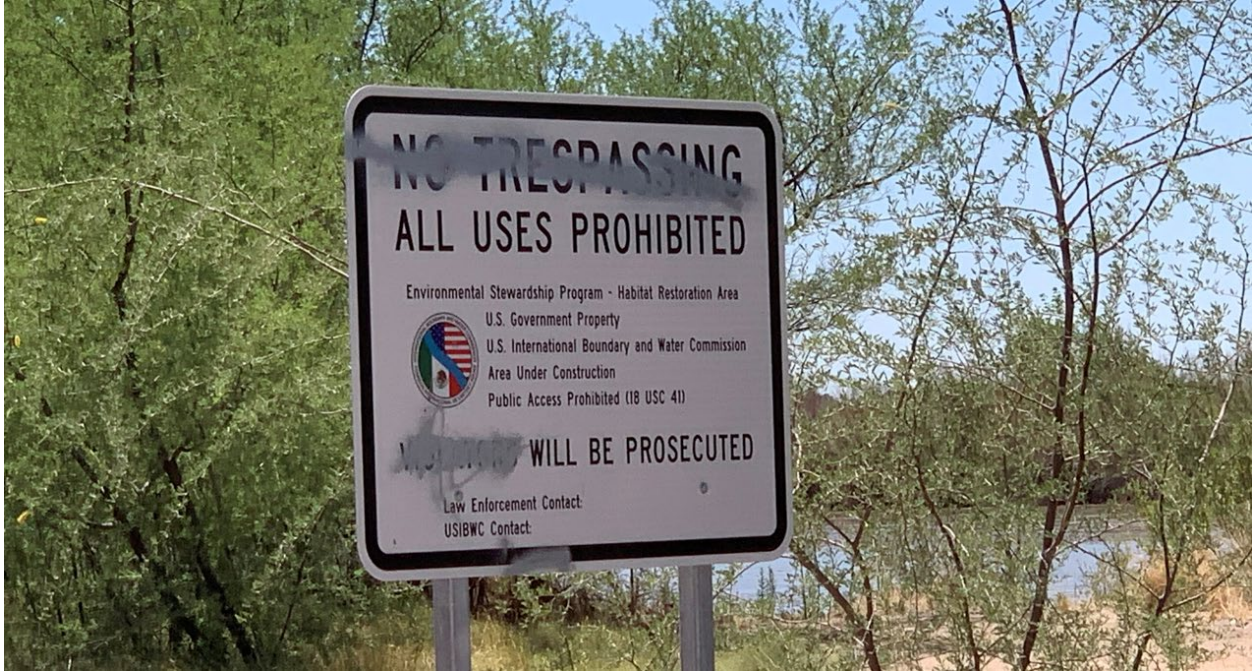
Vandalism of the new sign.

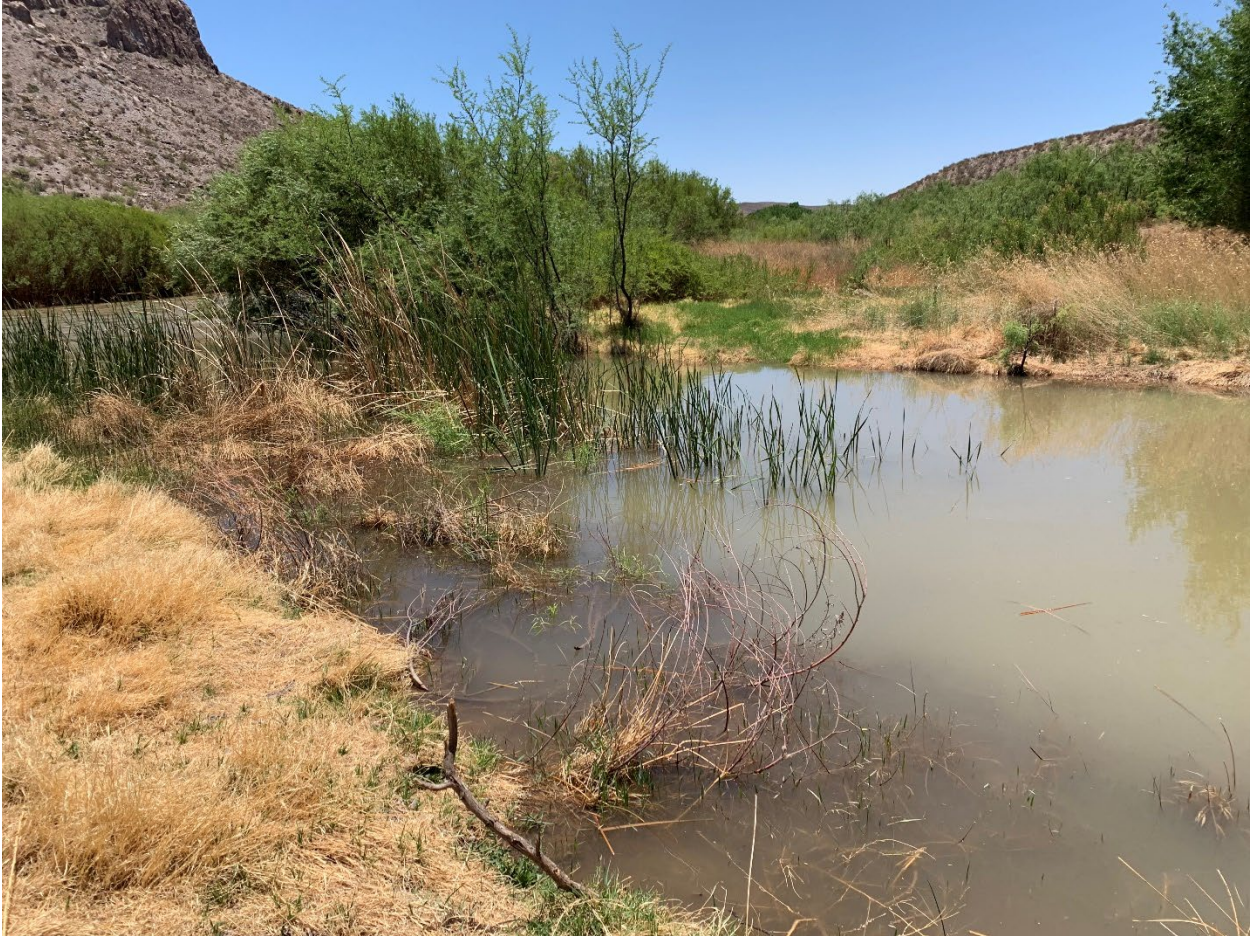
The wetland vegetation at the mouth of the arroyo.

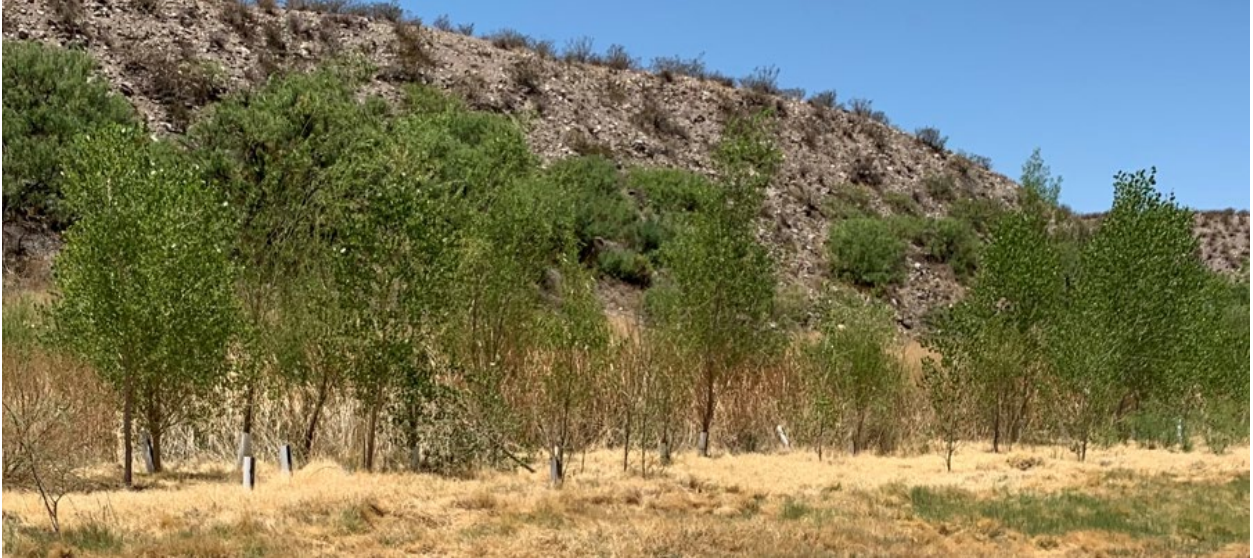
Successful plantings in the more upland portion of the arroyo.

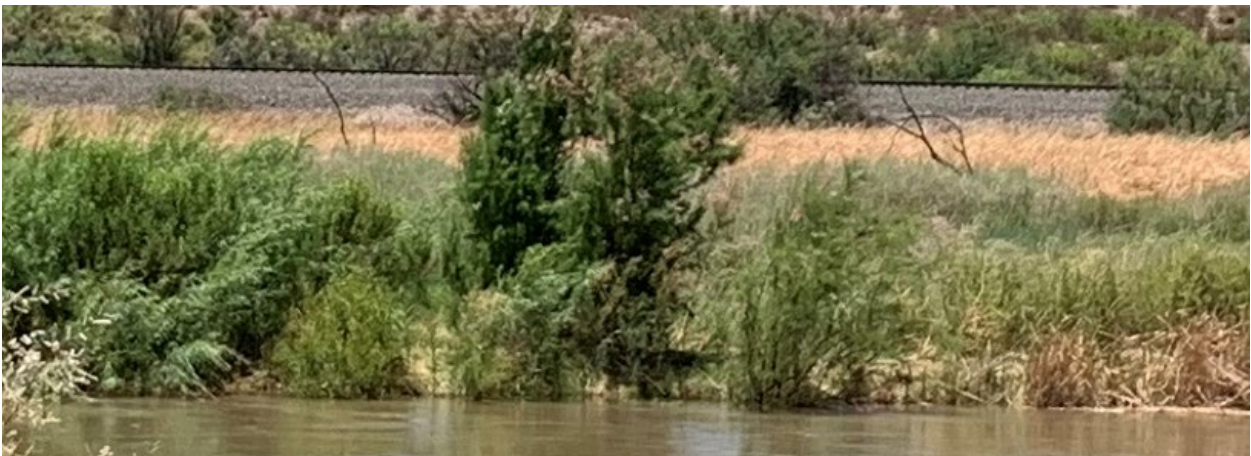
Some saltcedar along the bank and unsuccessful tree plantings within the site. Further back, before the railroad, cattails cover the site indicating water is shallow.

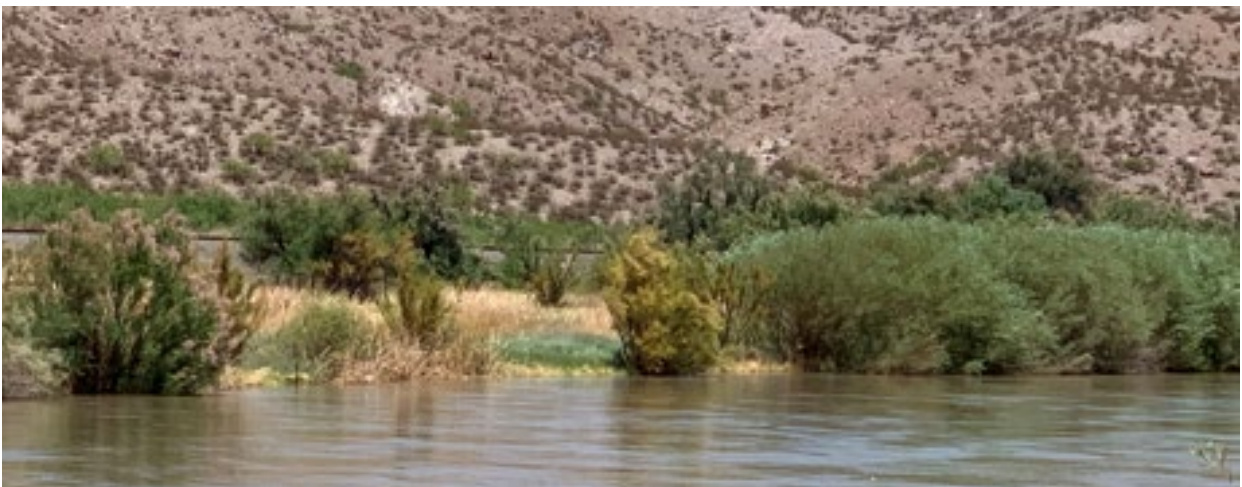
The southern portion of the site supports native willows and some successful tree plantings.

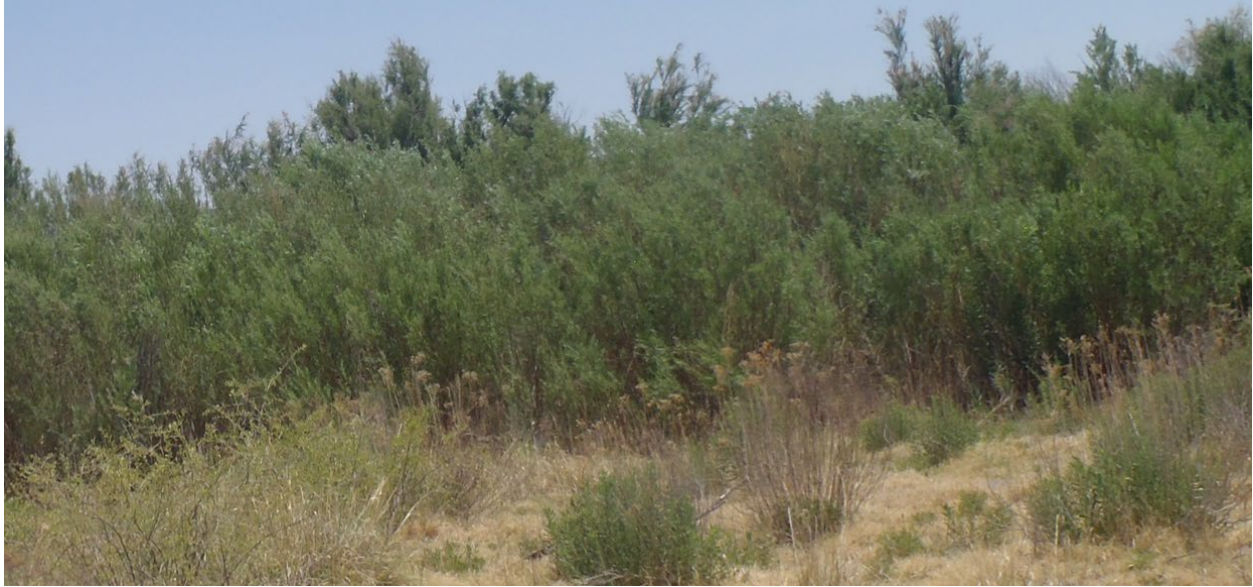
Closeup of successful transplanted willows.

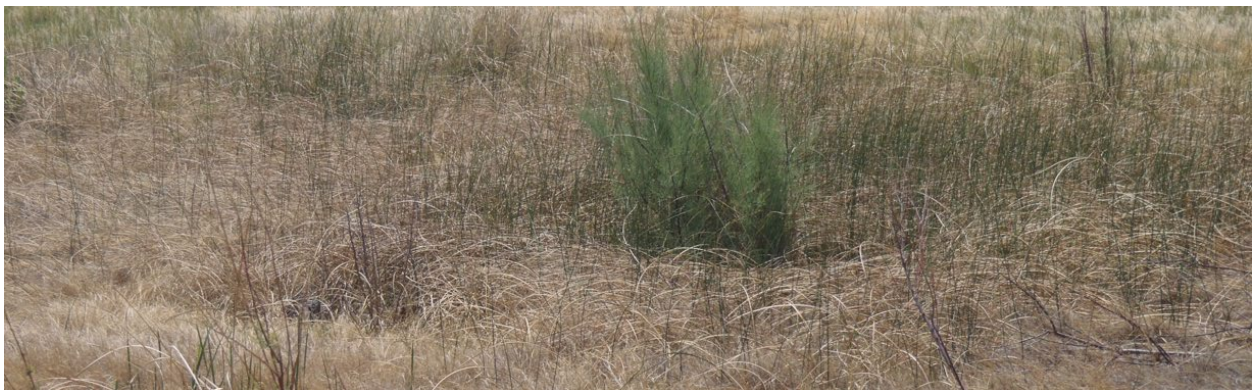
Bullrushes, and a saltcedar resprout, in the floodplain near well 4.

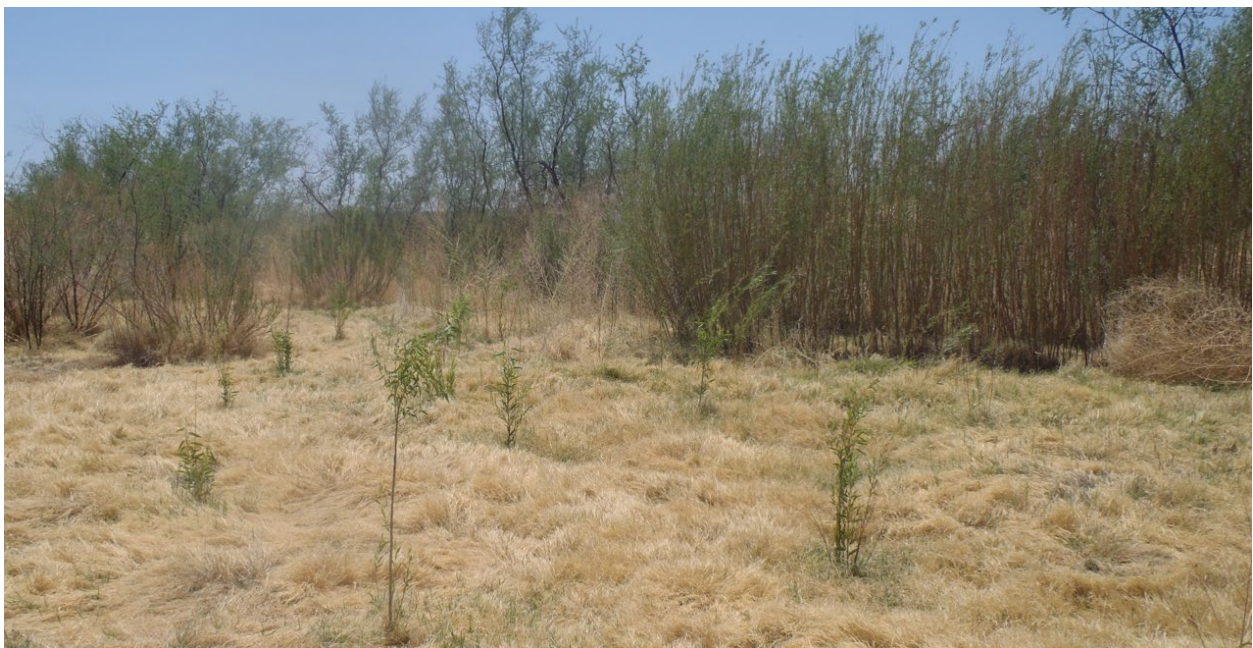
At Rincon Siphon A, plantings near the river are showing success.

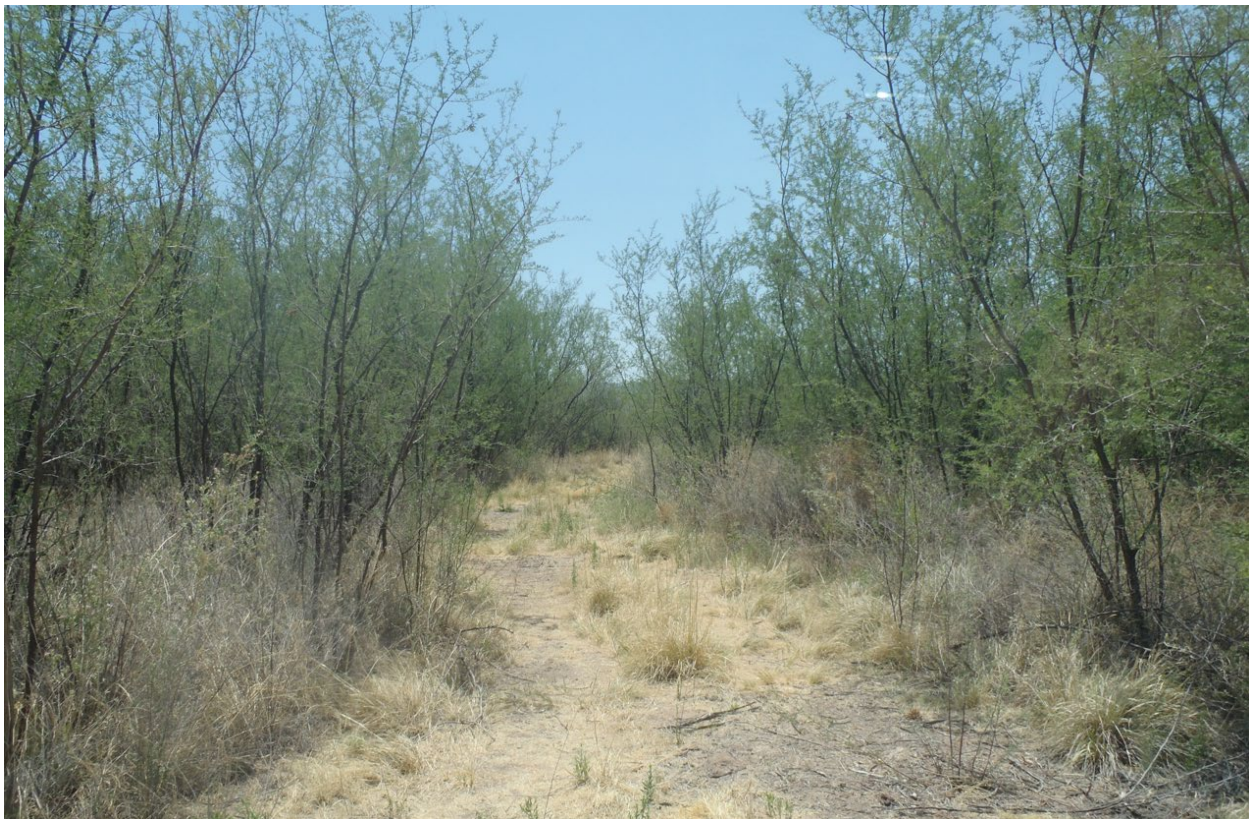
Mesquite forest in Rincon Siphon B.

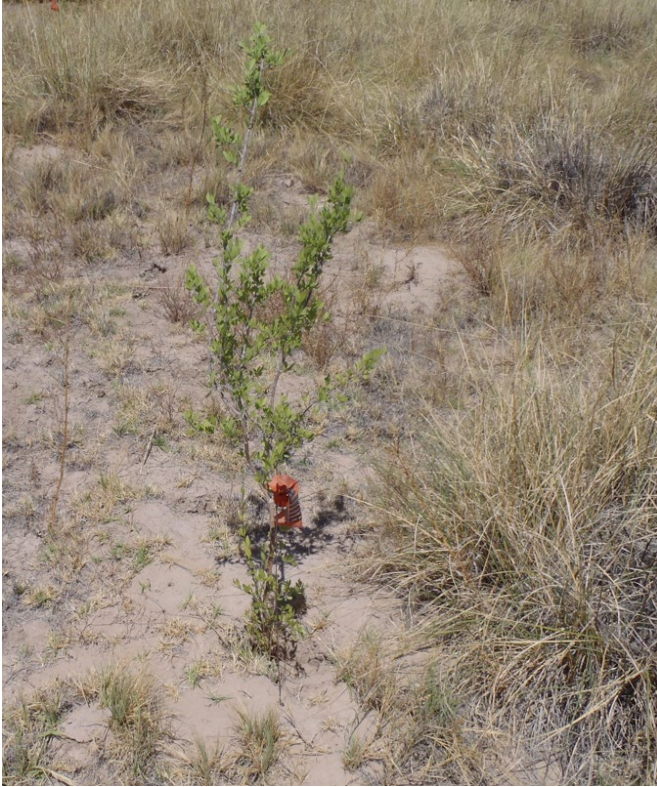
A planted longstem shrub that is surviving

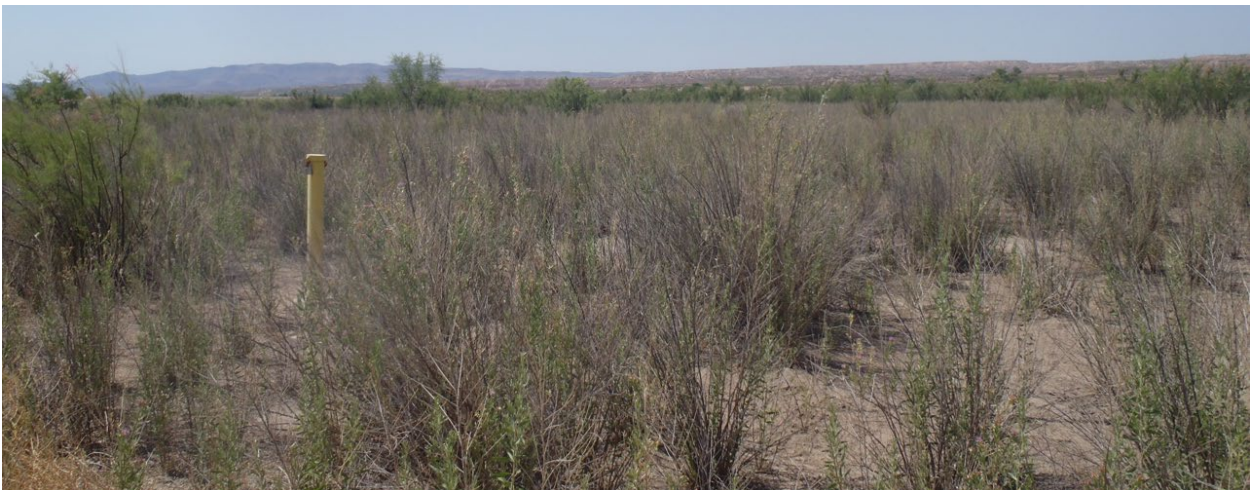
Overview of upland scrub shrub habitat at Well 1.

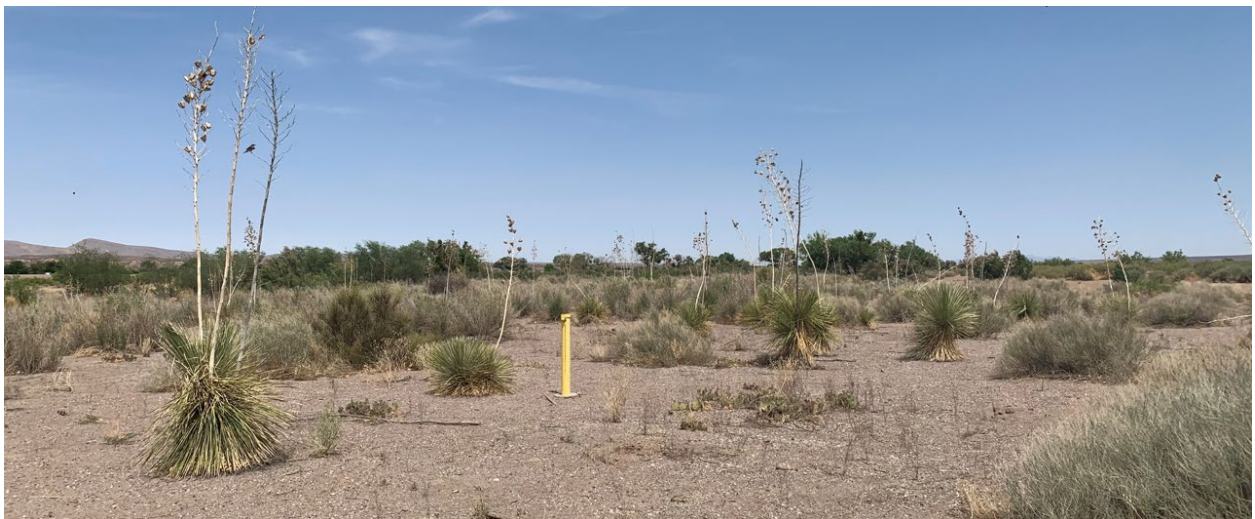
Upland habitat at Well 3, including flowering yucca.
