**USIBWC Riparian Habitat Restoration  
MONITORING NOTES AND PHOTOGRAPHS  
SUMMER 2021**

**U.S. Section International Boundary and Water Commission**

**April 20, 2022**

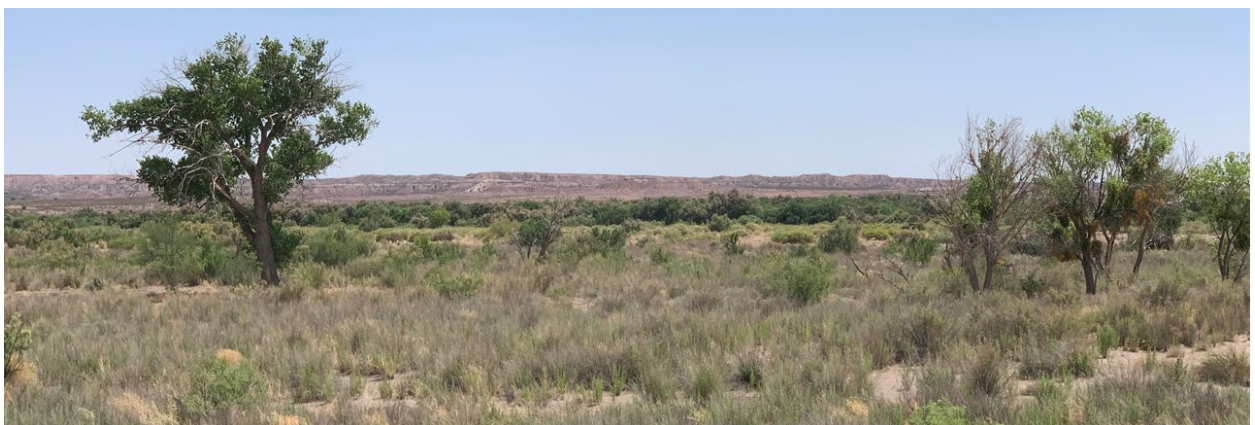
Overview of old resaca, as noted by the cottonwoods.

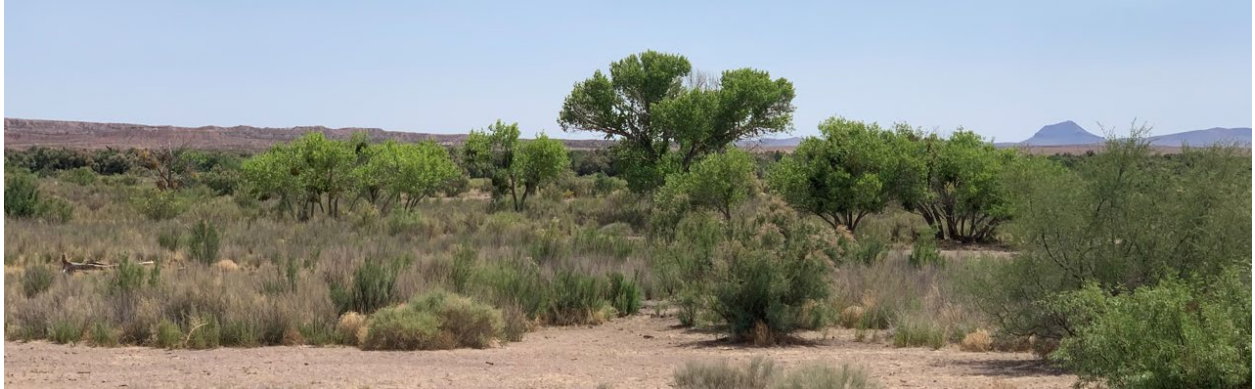
Old resaca, as noted by the cottonwoods.

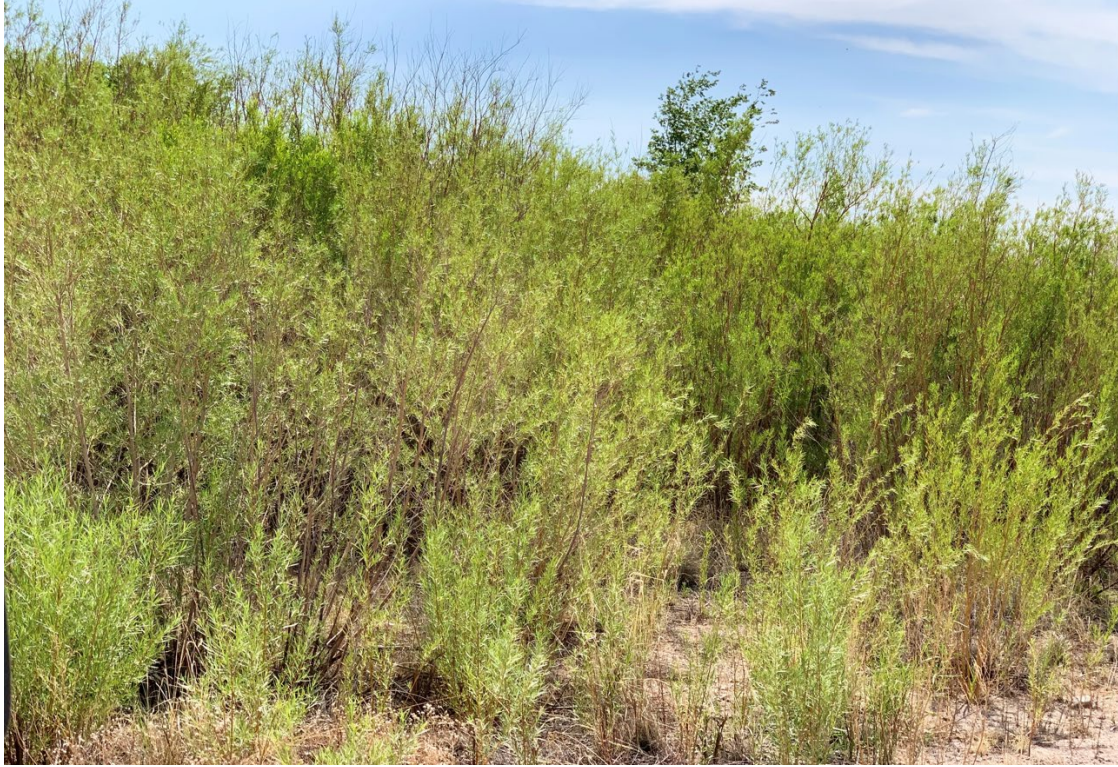
Dense coyote willows near the siphon at Crow Canyon C.

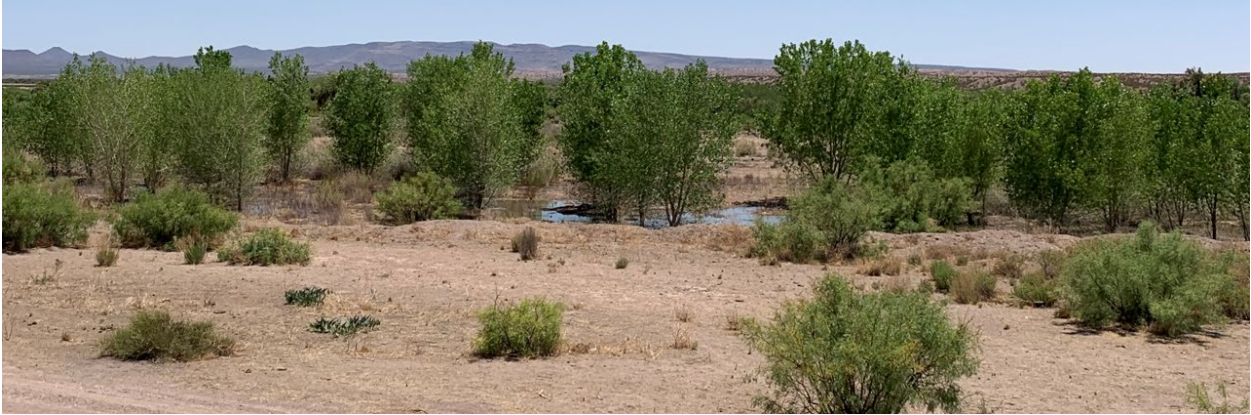
Overview from the levee of northern end of site being irrigated.

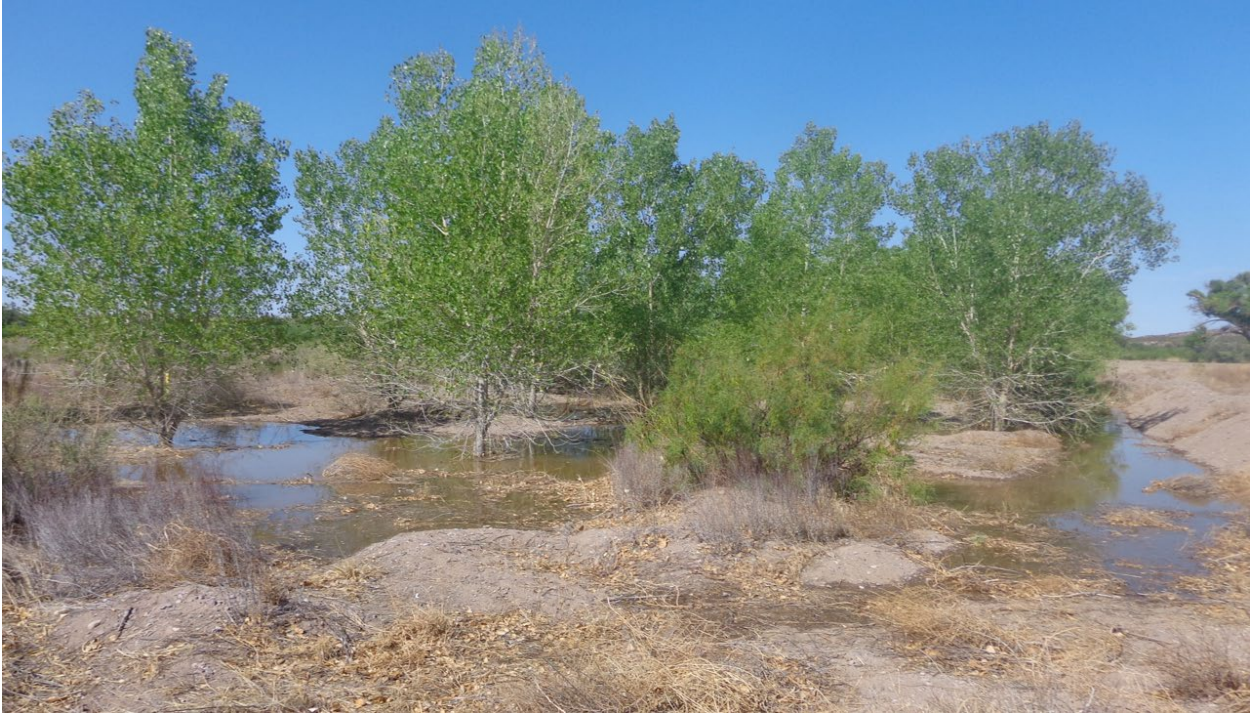
Thriving cottonwoods enjoying their drink.

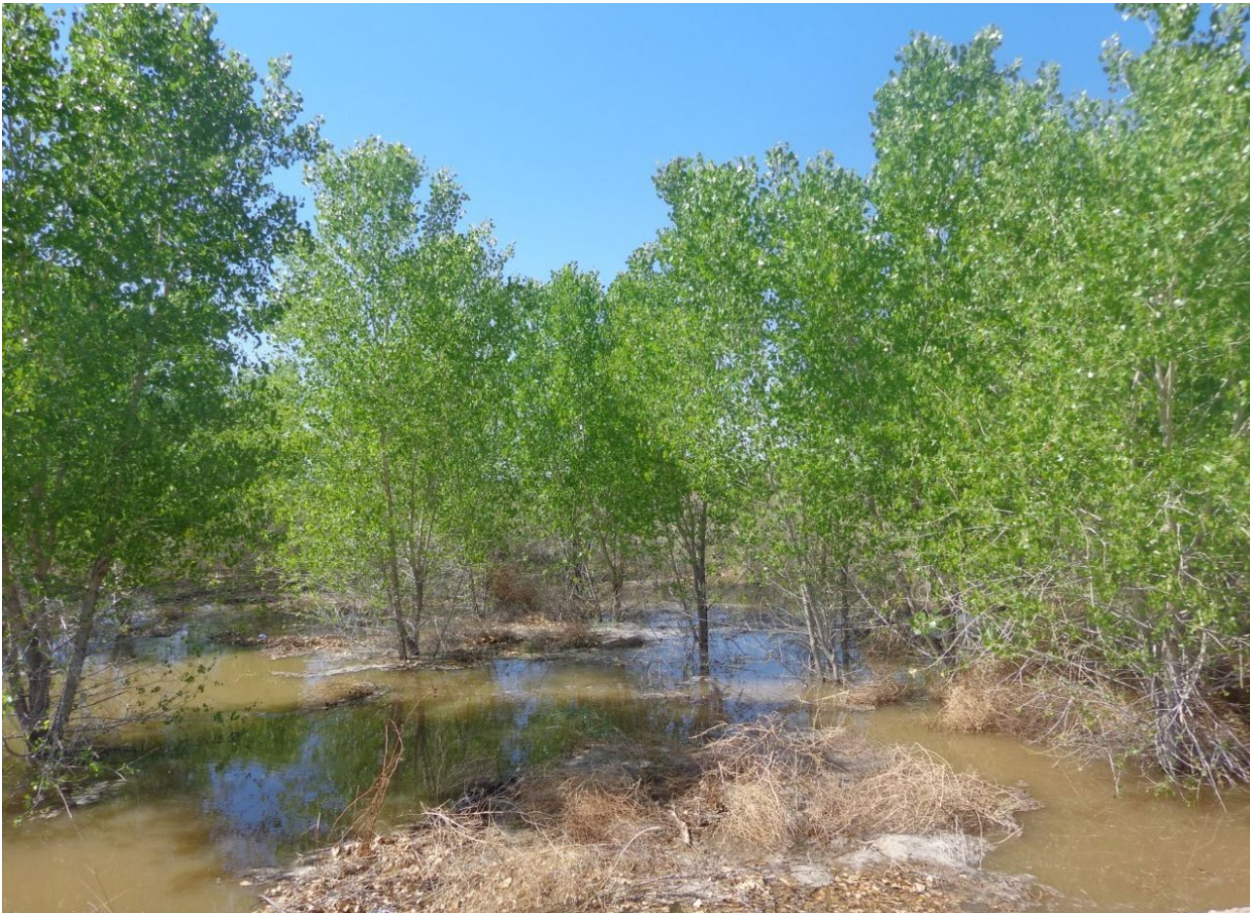
Cottonwoods in the northern part being irrigated.

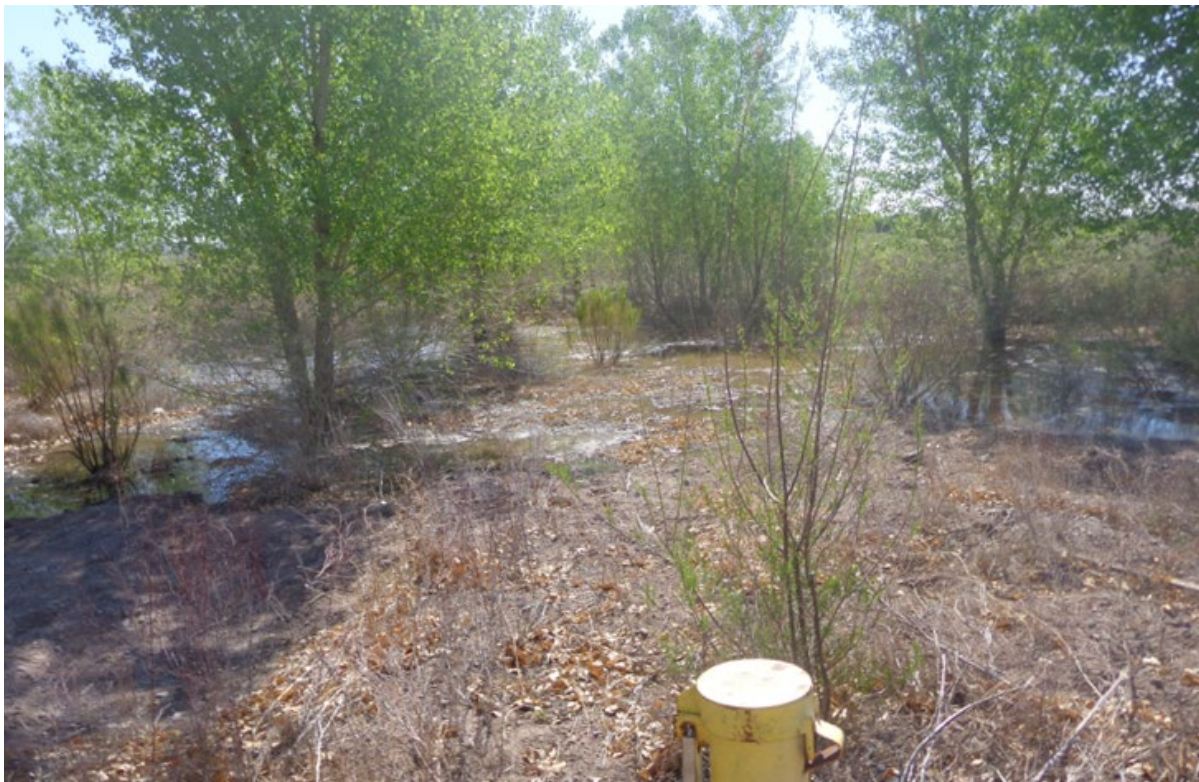
View at Well 1 during the irrigation.

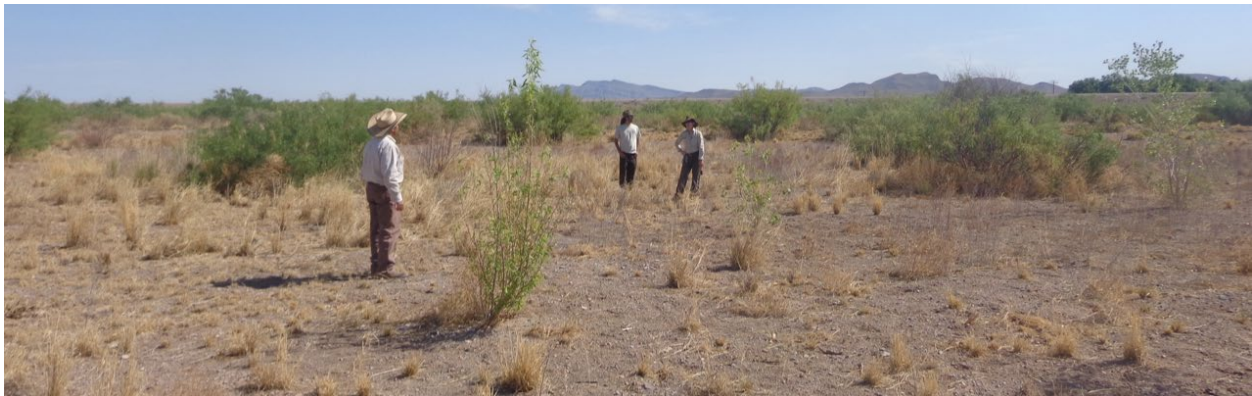
Plantings outside of the irrigation berm.

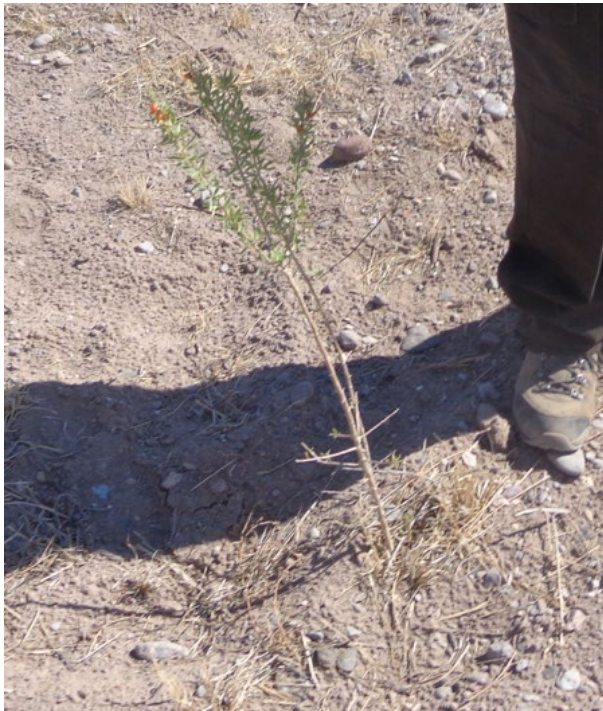
Planted wolfberry longstem shrub.

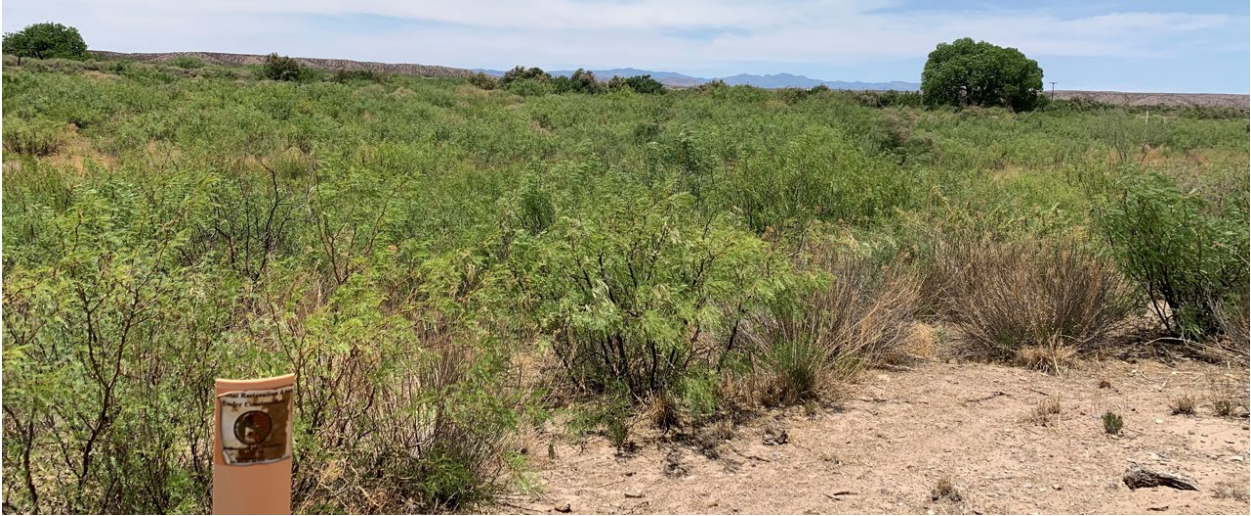
Overview of dense, mesquite forest from the levee road

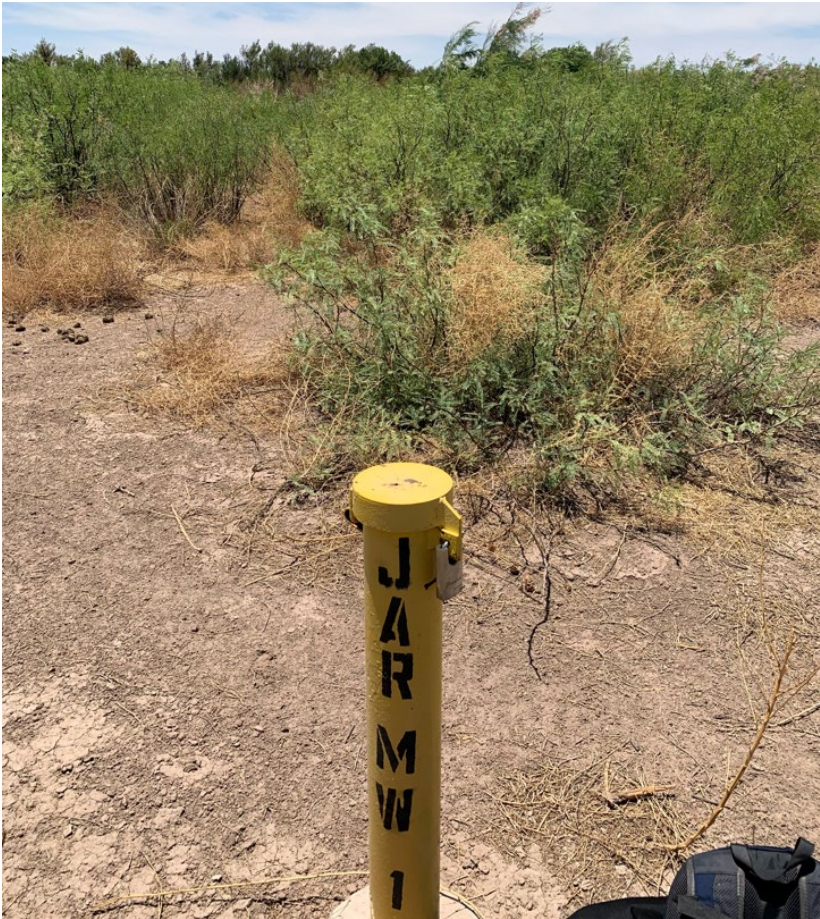
Mesquite forest near Well 1.

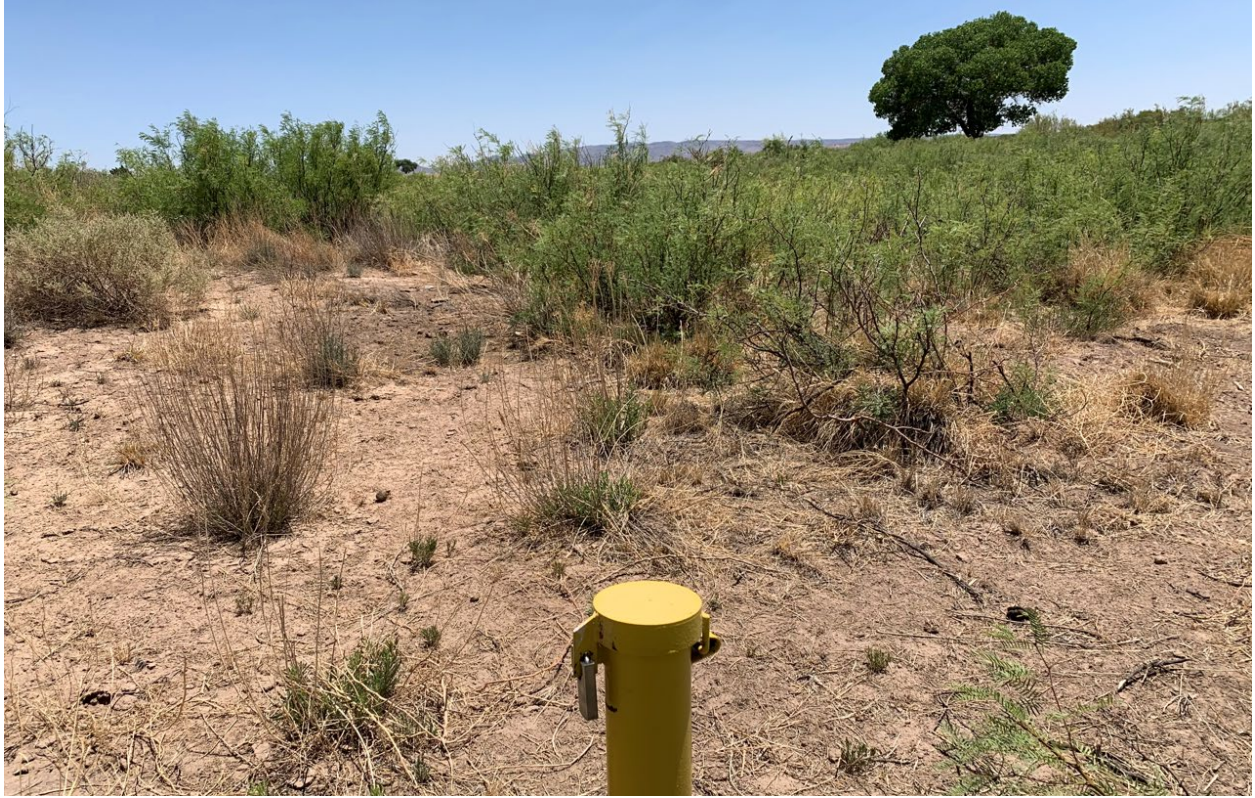
View towards the river at Well 2, inside the old resaca.

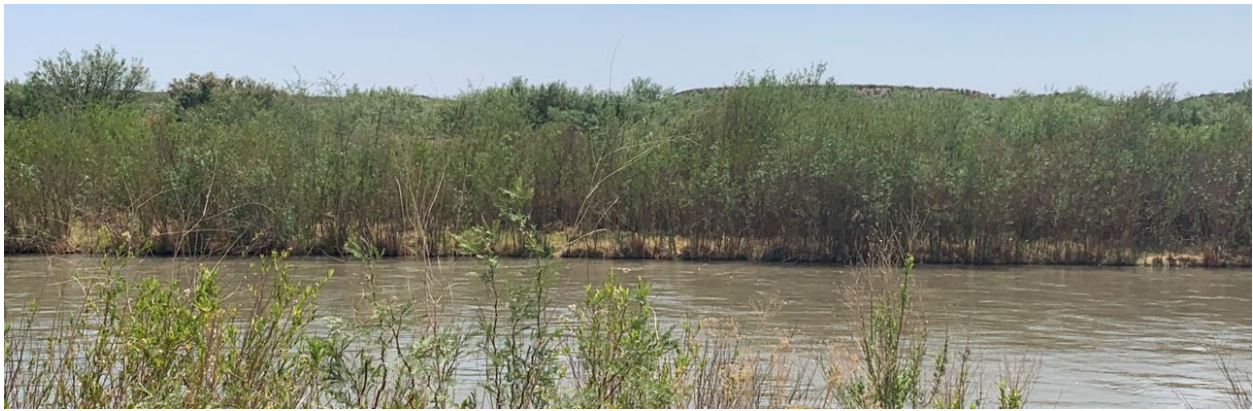
Willows along the bank of the northern portion of the terrace.

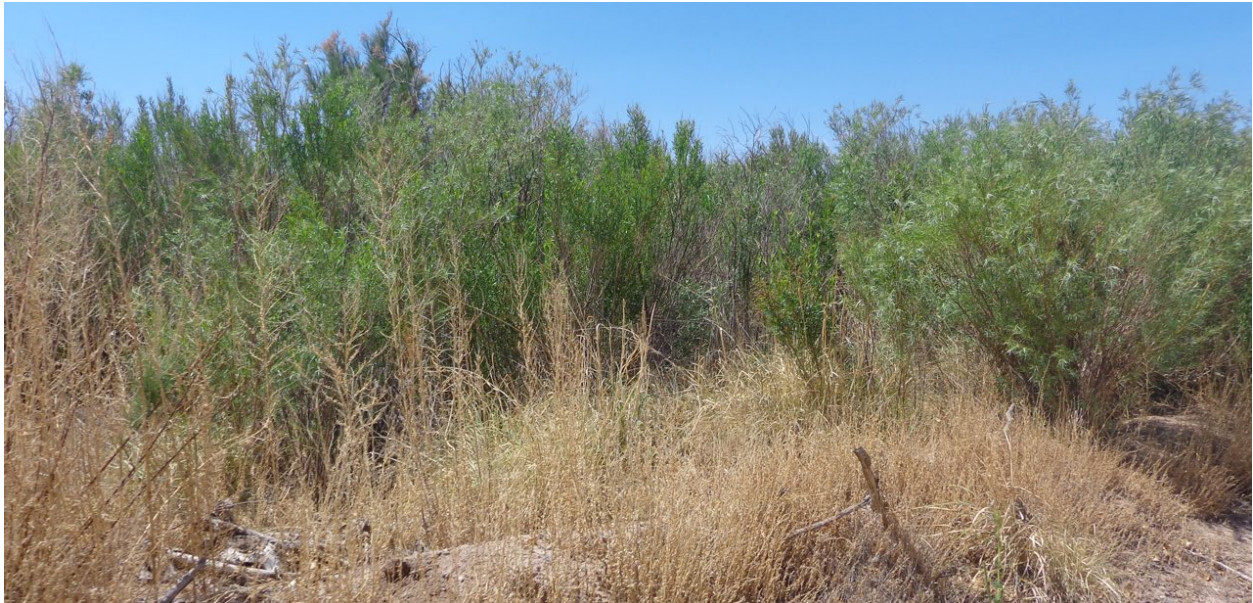
Southern portion of the site is considerably lower elevation and has flycatcher habitat, with occasional migratory flycatchers or cuckoo detections.

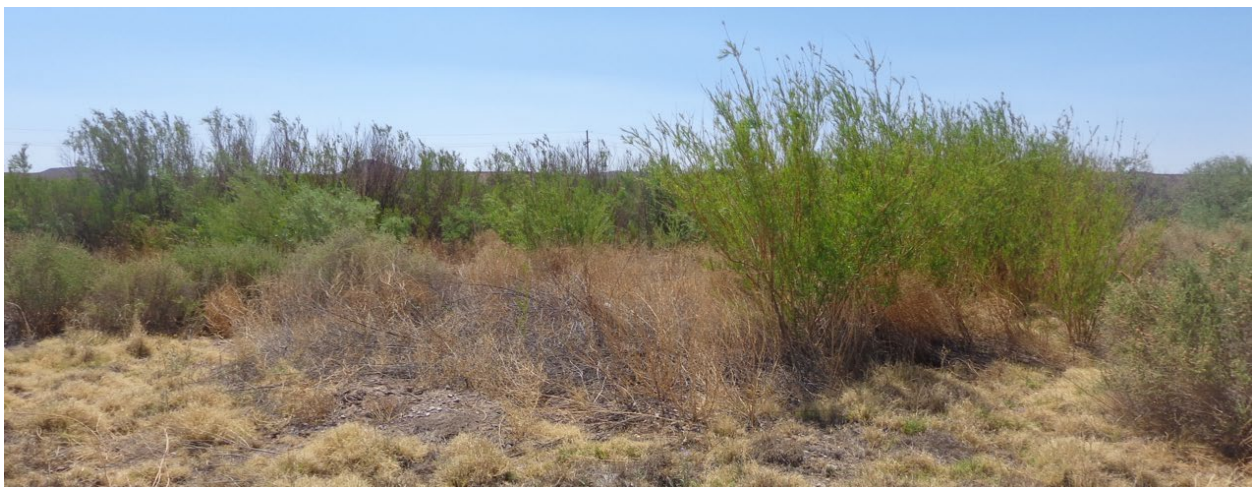
Willows that USFWS planted via trench (right) near the river (background).

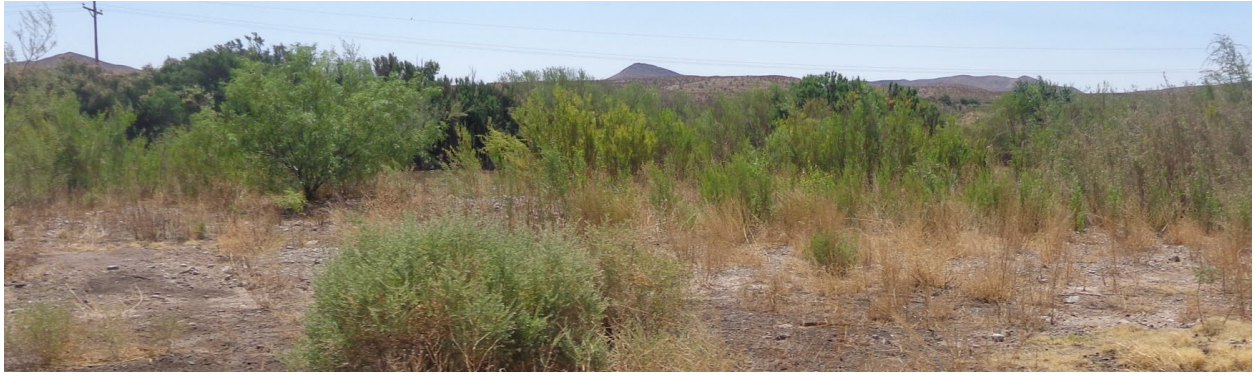
Willows and young cottonwoods planted along the river.

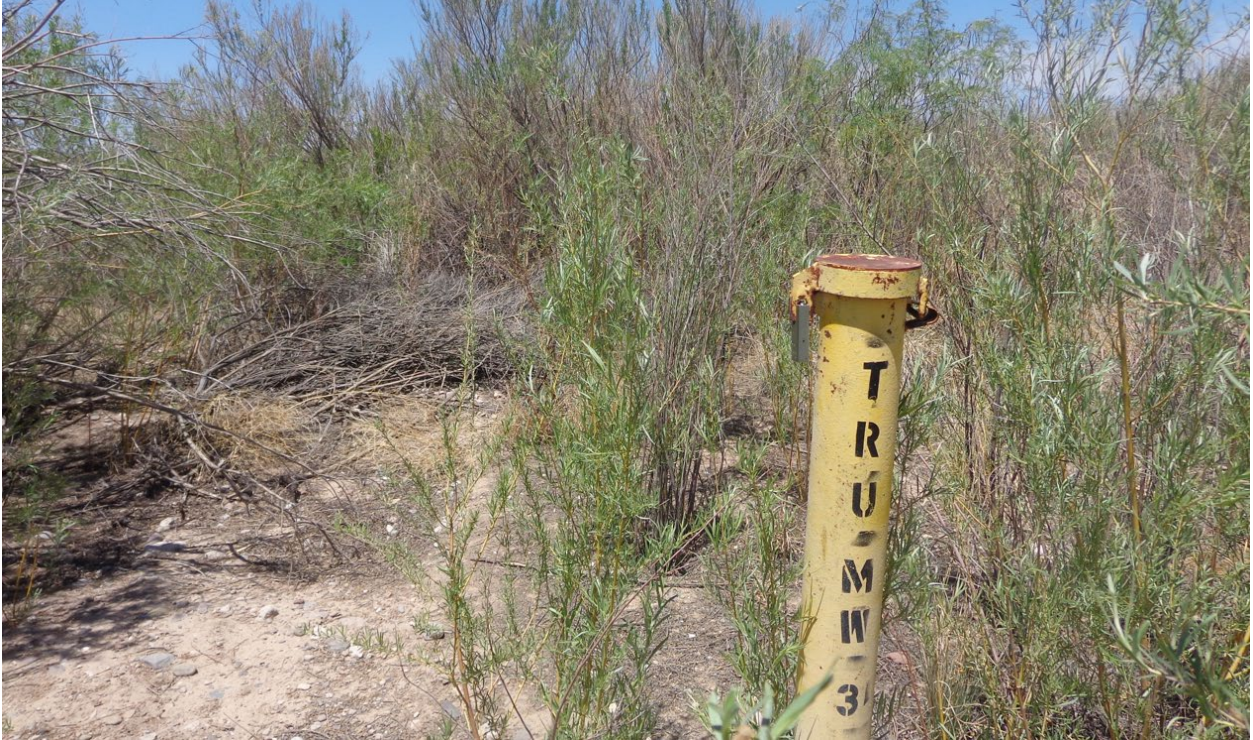
Dense baccharus and willows at Well 3.

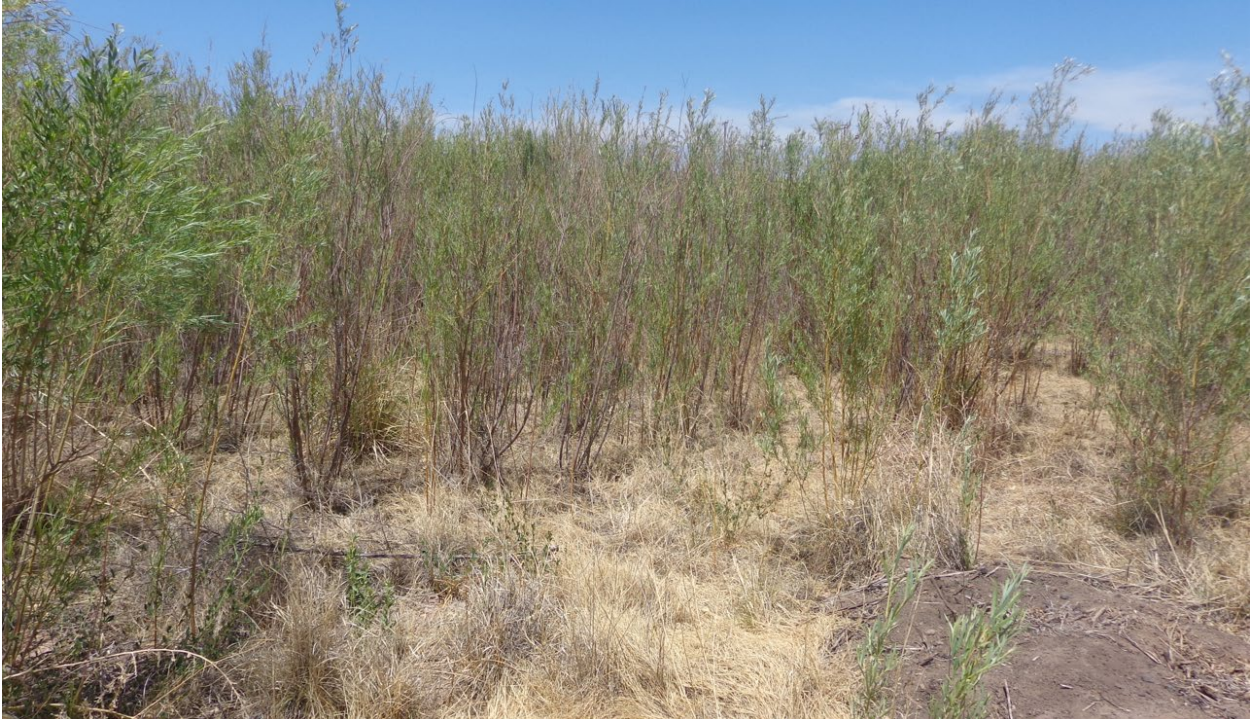
Dense baccharus and willows near Well 3.

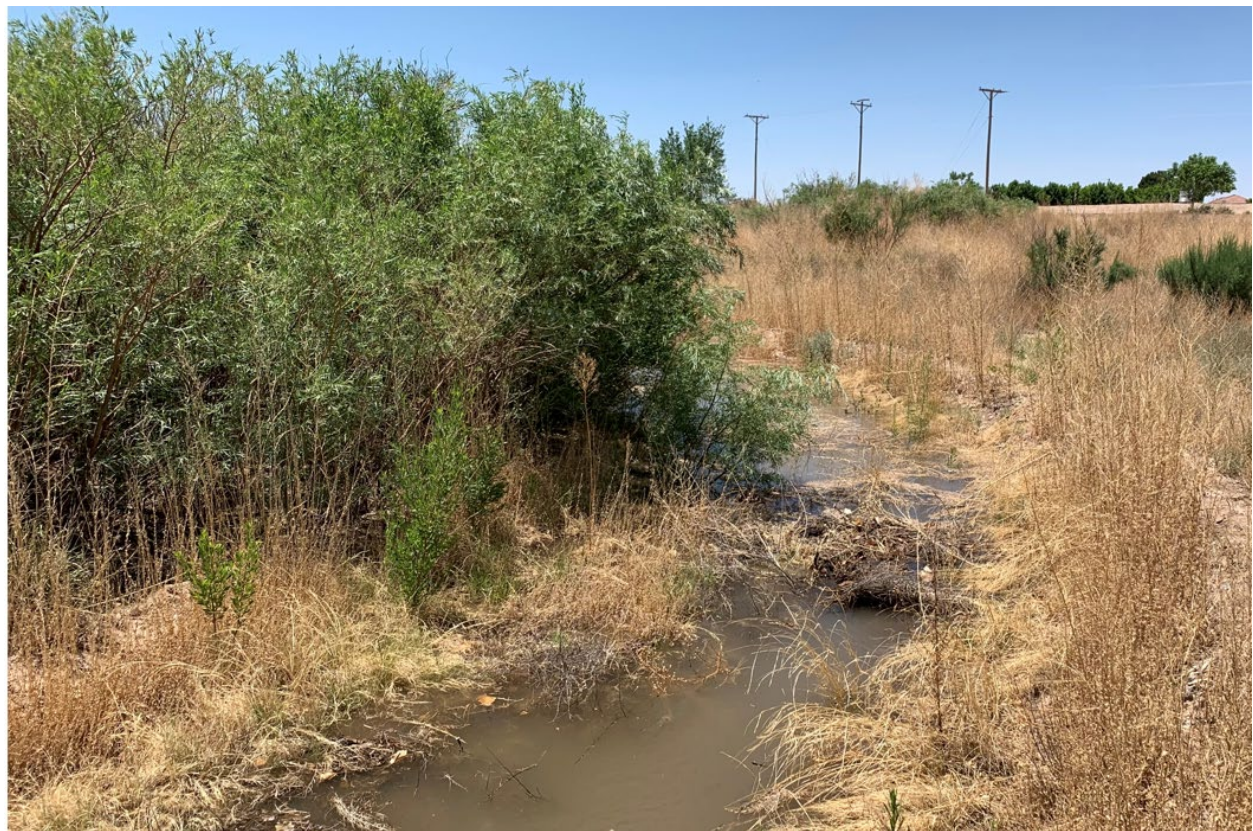
Irrigation berm on the right and willows on the left.
